TMI-2 CORE CAVITY SIDES AND FLOOR EXAMINATIONS

DECEMBER 1985 AND JANUARY 1986

M. L. Russell

Published February 1987

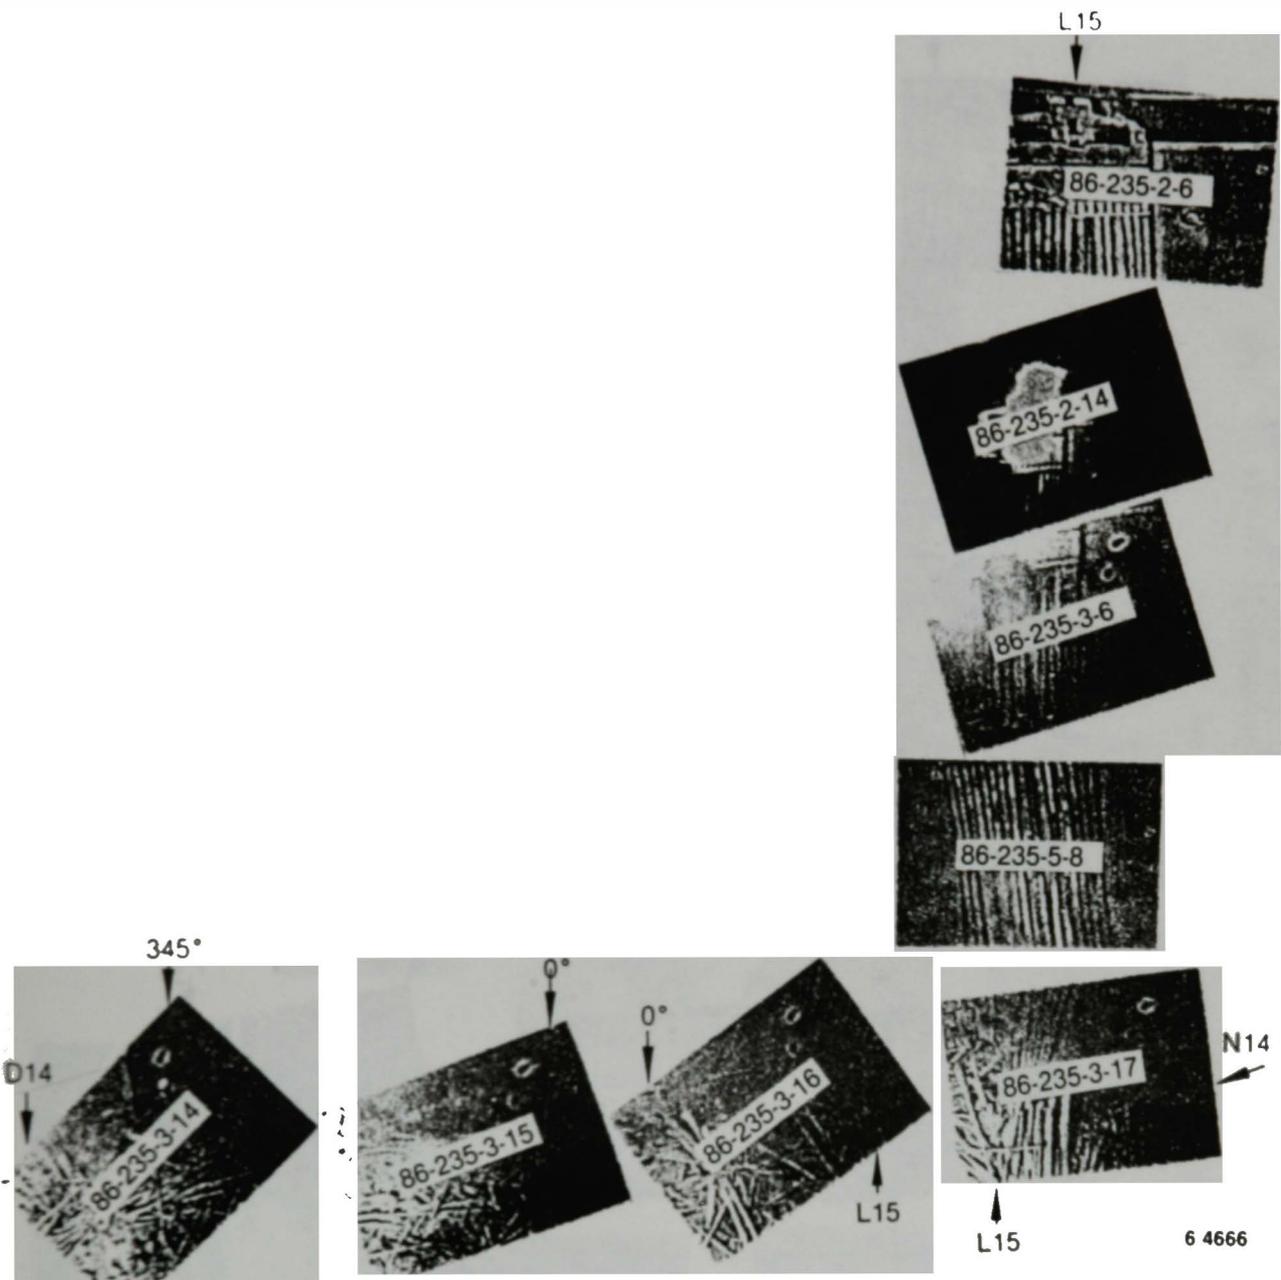
Plate 1. TMI-2 core cavity north side--December 6 through 21, 1985 core position L15 fuel assembly.

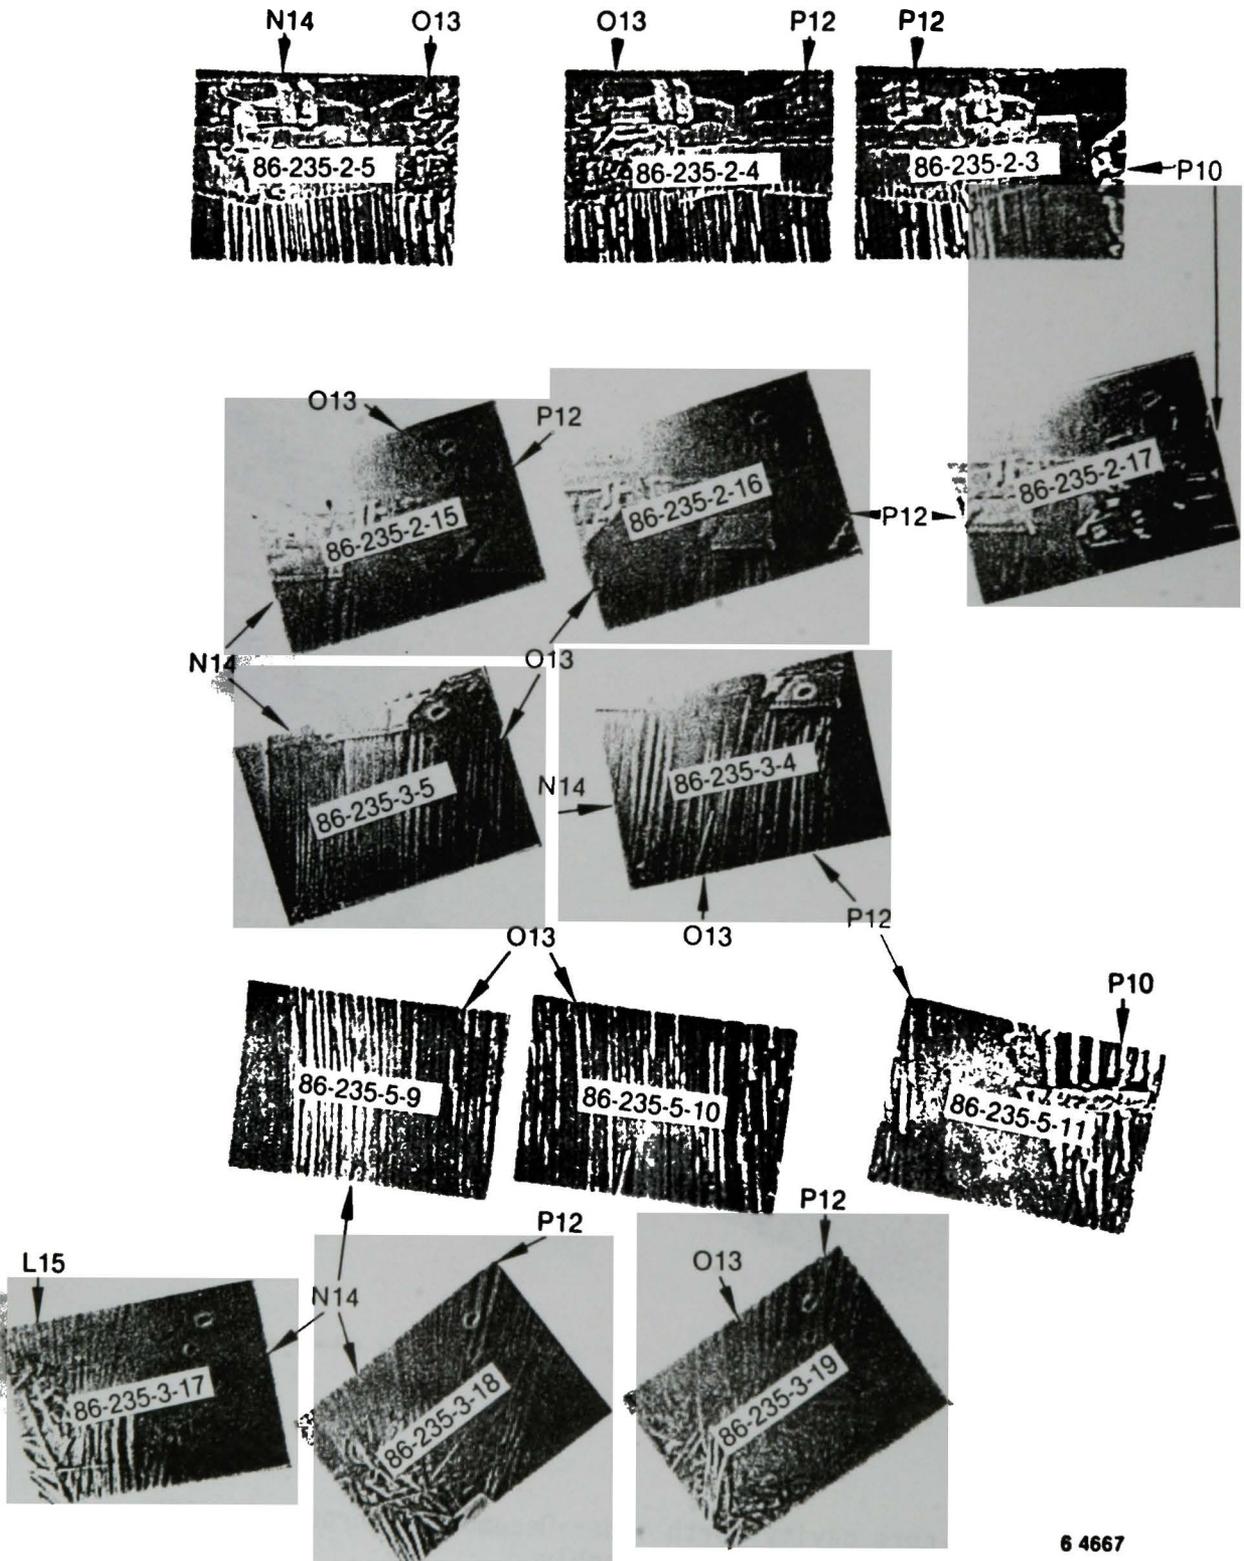
Plate 2. TMI-2 core cavity northeast side--December 6 through 21, 1985 core position N14, O13, and P12 fuel assemblies.

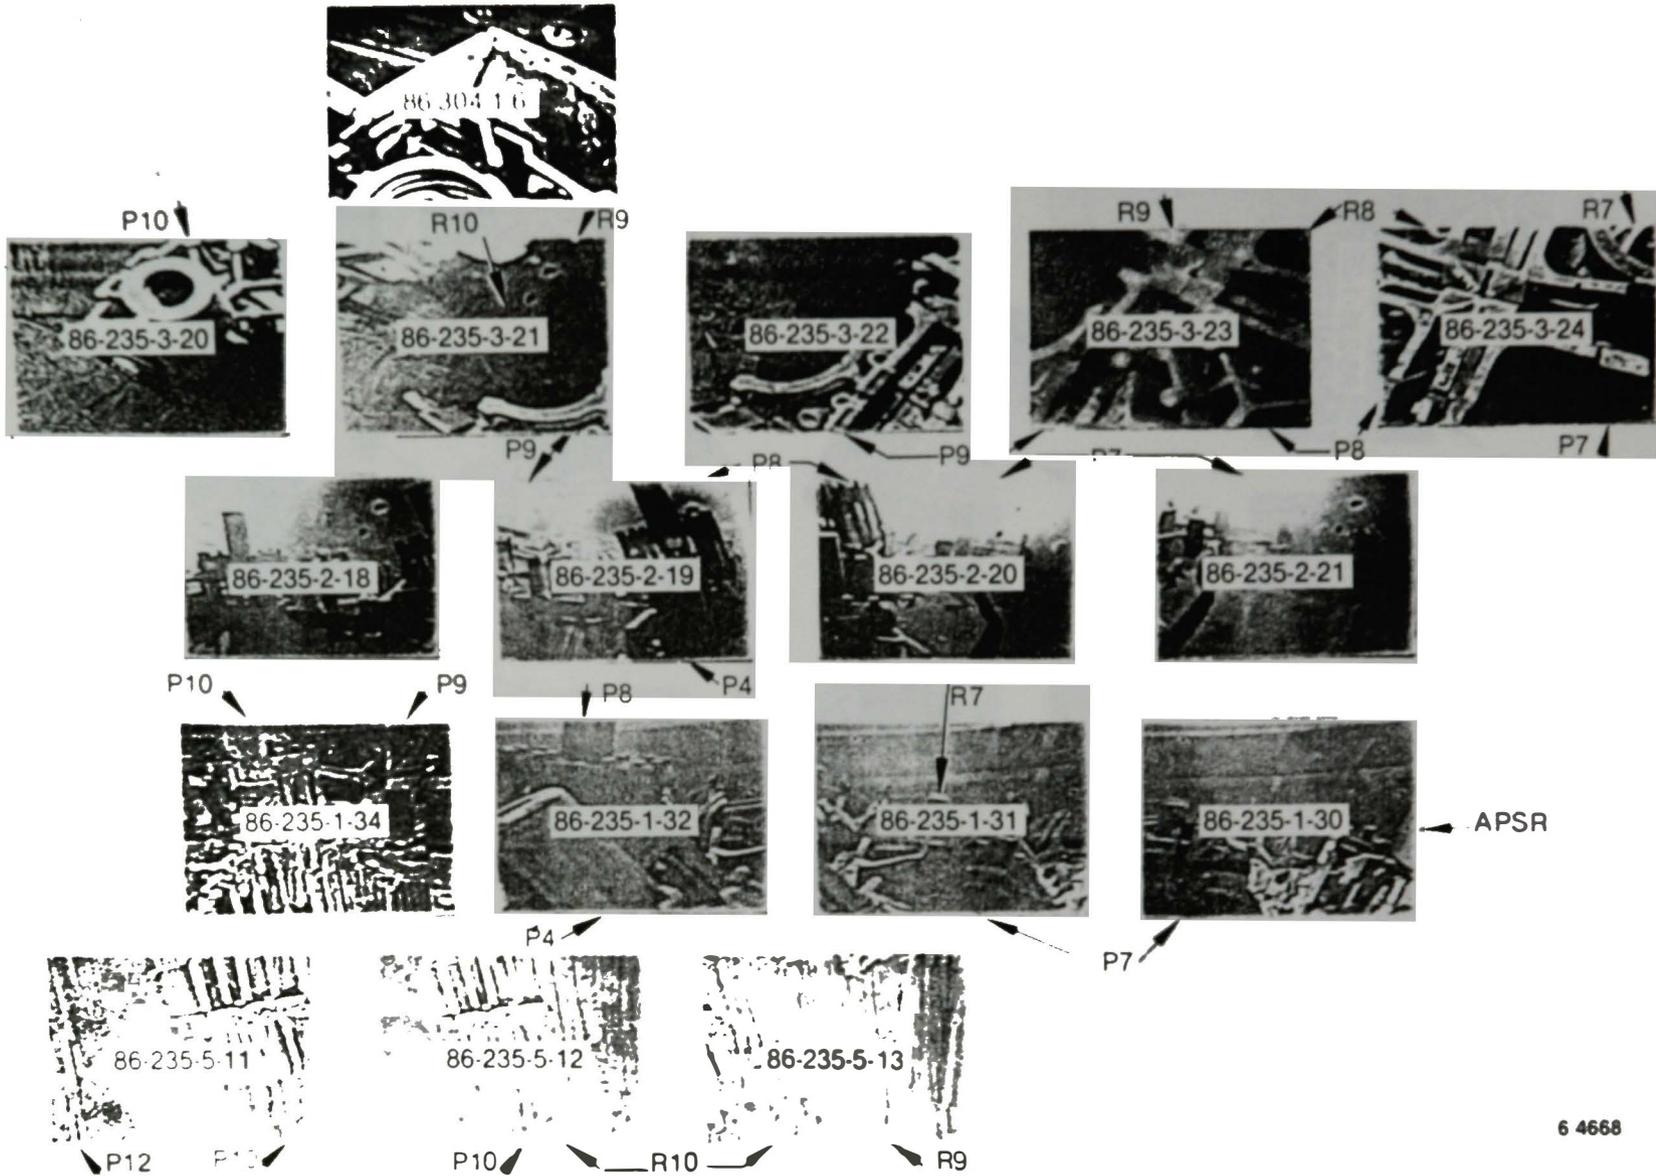
Plate 3. TMI-2 core cavity east side--December 6 through 21, 1985 core position P10, P9, P8, P7, R10, R9, R8, and R7 fuel assemblies.

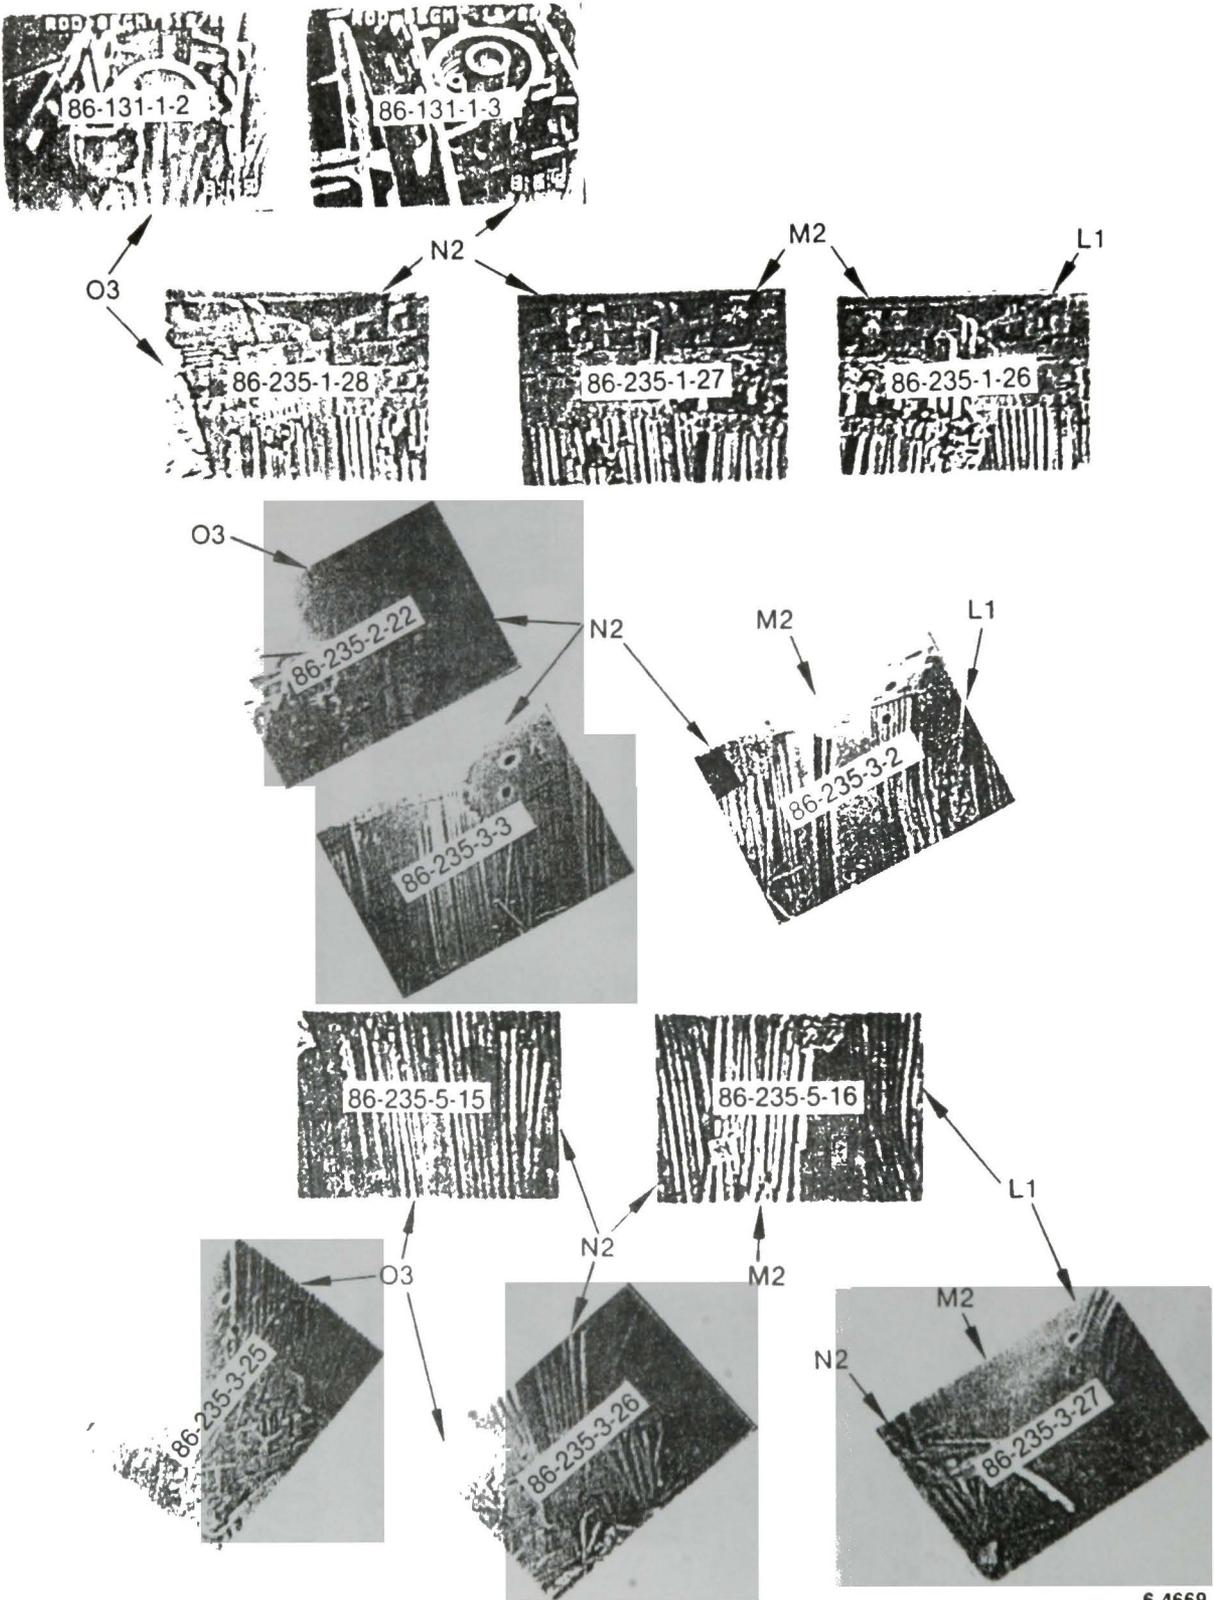
Plate 4. TMI-2 core cavity southeast side--December 6 through 22, 1985 core position O3, N2, and M2 fuel assemblies.

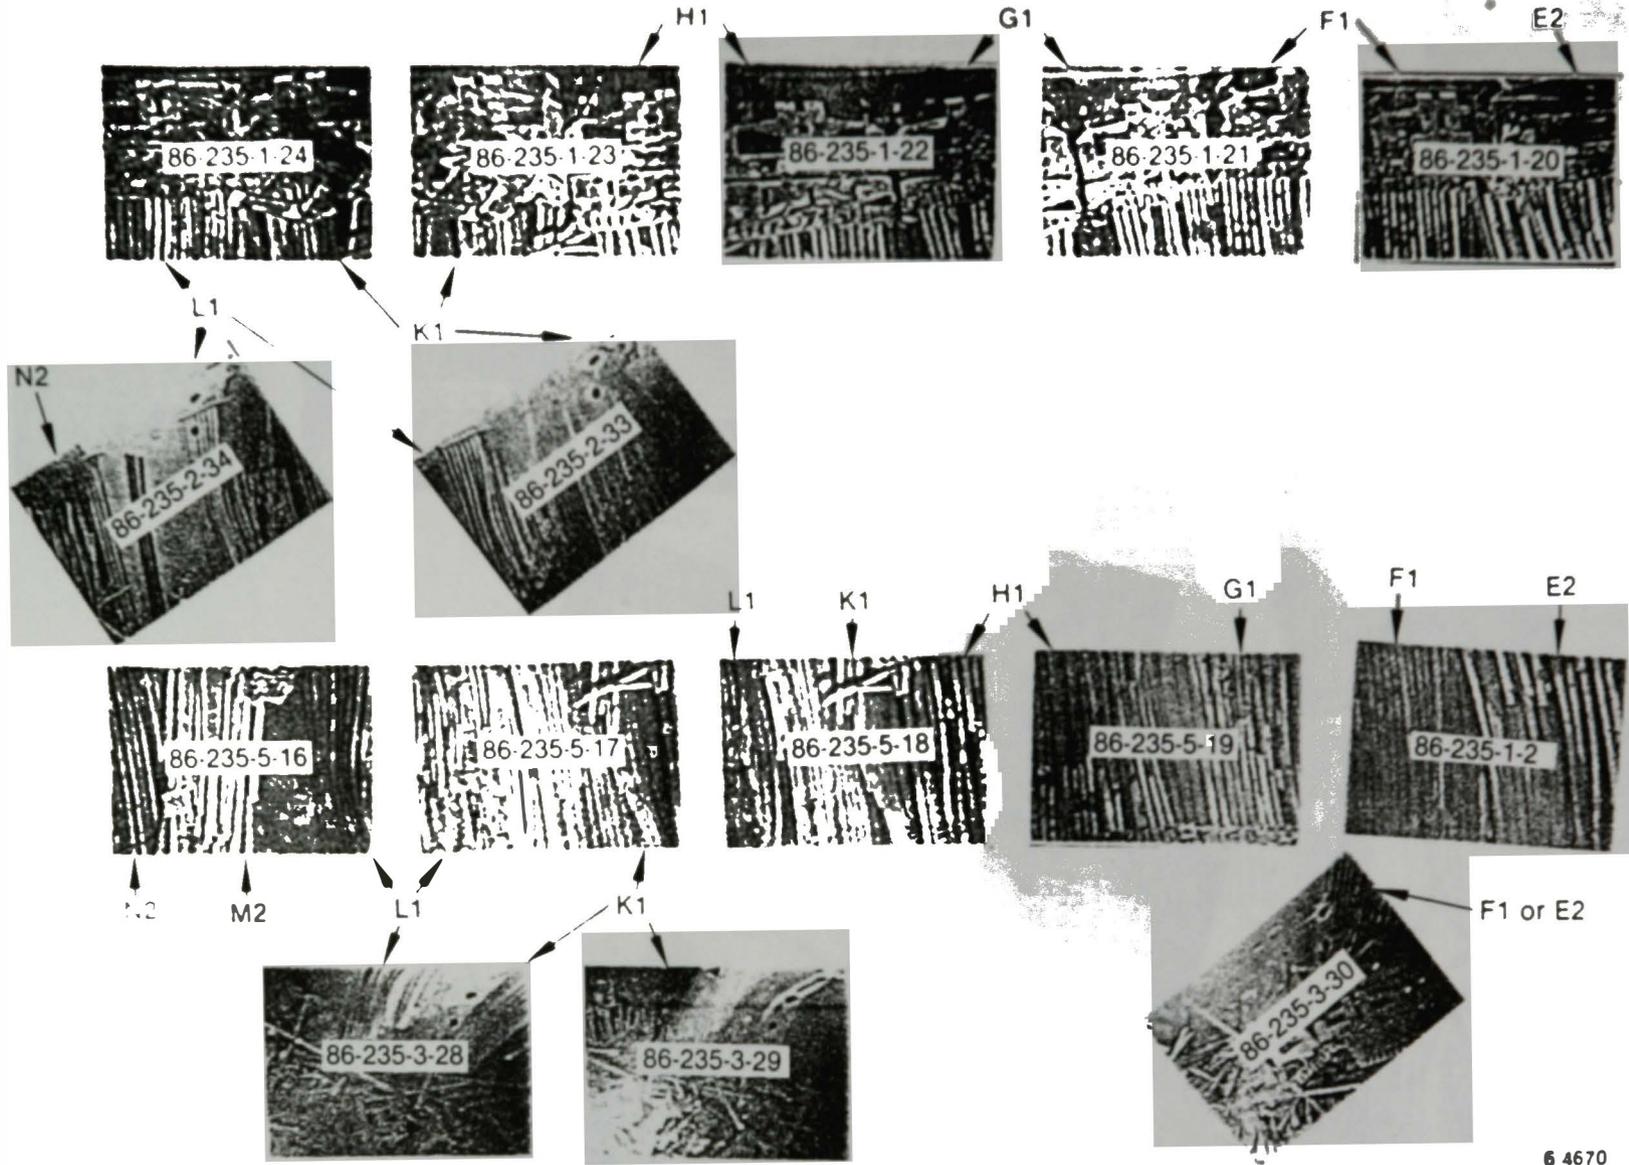
The fuel assembly upper region damage is consistent with other peripheral fuel assemblies including the bow on the rod bundle that exists above spacer grid 5. The rod bundle bowing appears to have occurred also at core south (Plates 5 and 10), southeast (Plate 6), east (Plate 7), and northeast (Plate 8) locations. Because the bow appears to occur between only one set of spacer grids, it may be an artifact of fuel assembly buckling from differential thermal expansion between the fuel assembly and the core support structures during the core heatup.

Plate 5. TMI-2 core cavity south side--December 6 through 21, 1985 core position L1, K1, H1, G1, and F1 fuel assemblies.

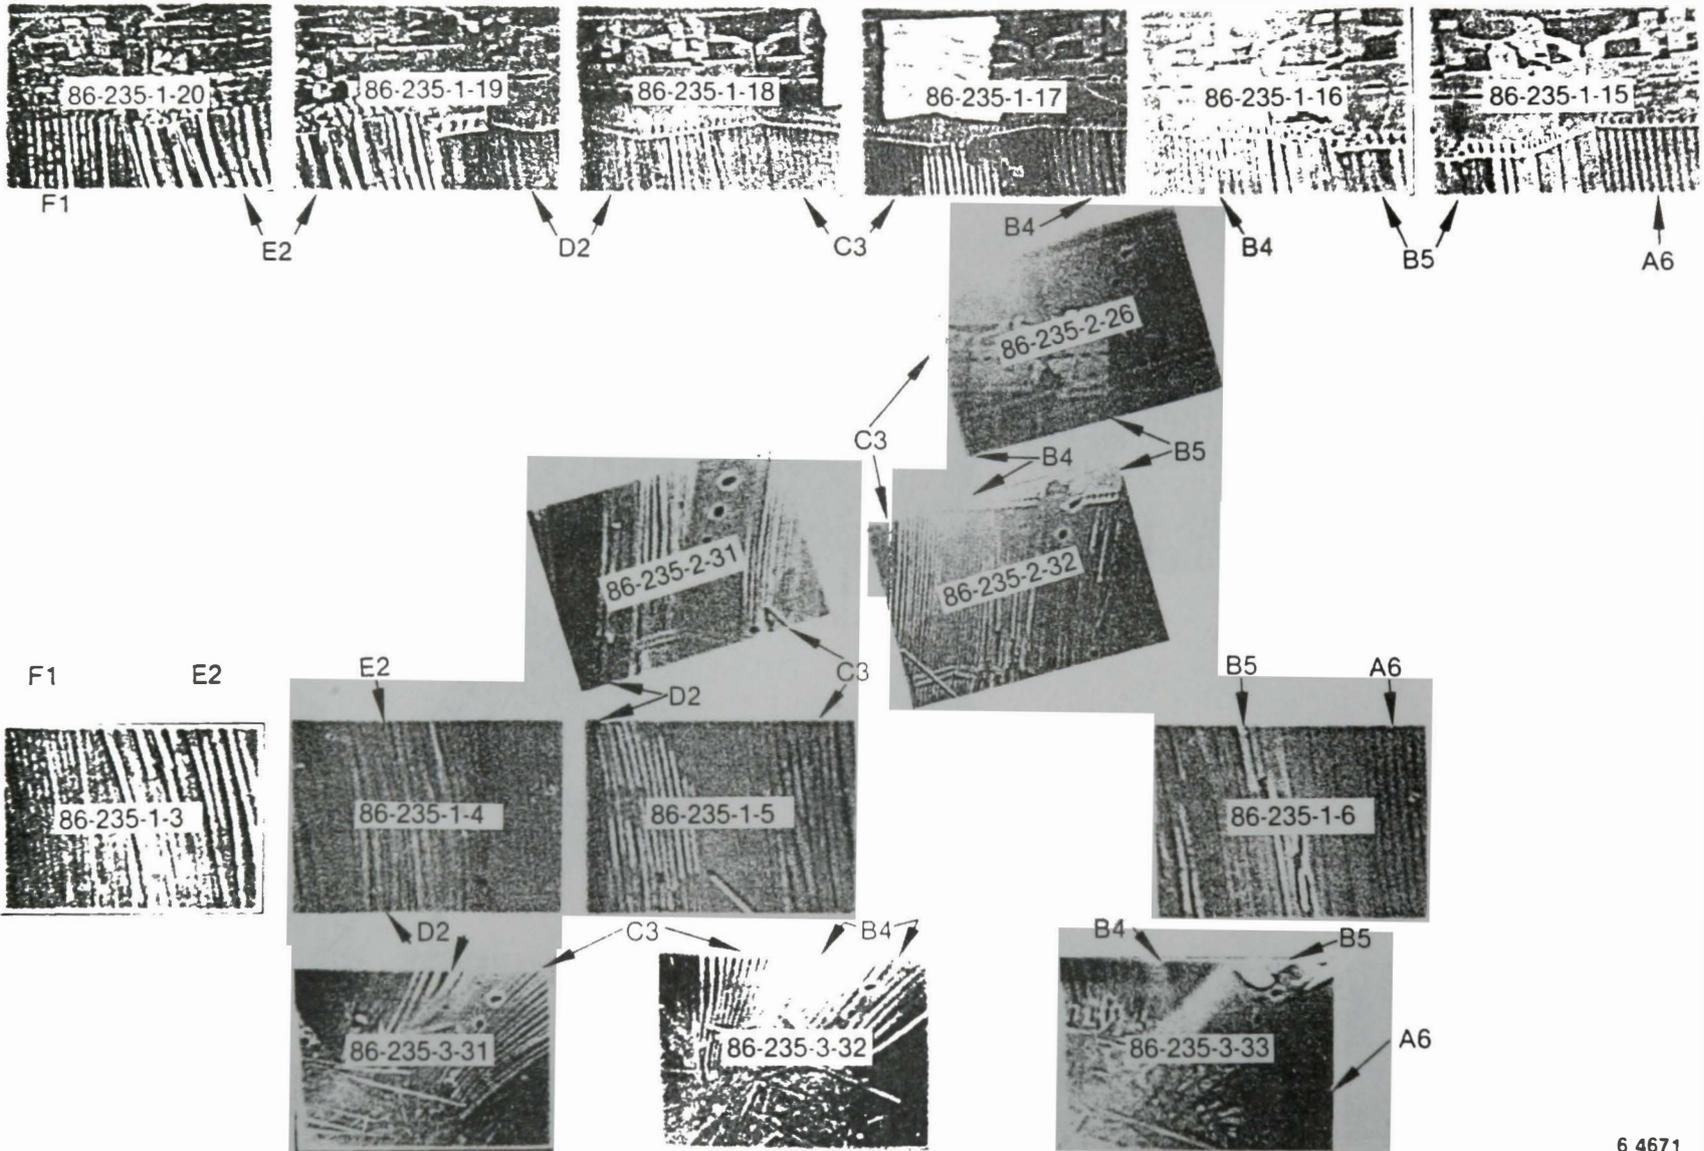
Plate 6. TMI-2 core cavity southwest side--December 6 through 21, 1985 core position E2, D2, C3, B4, and B5 fuel assemblies.

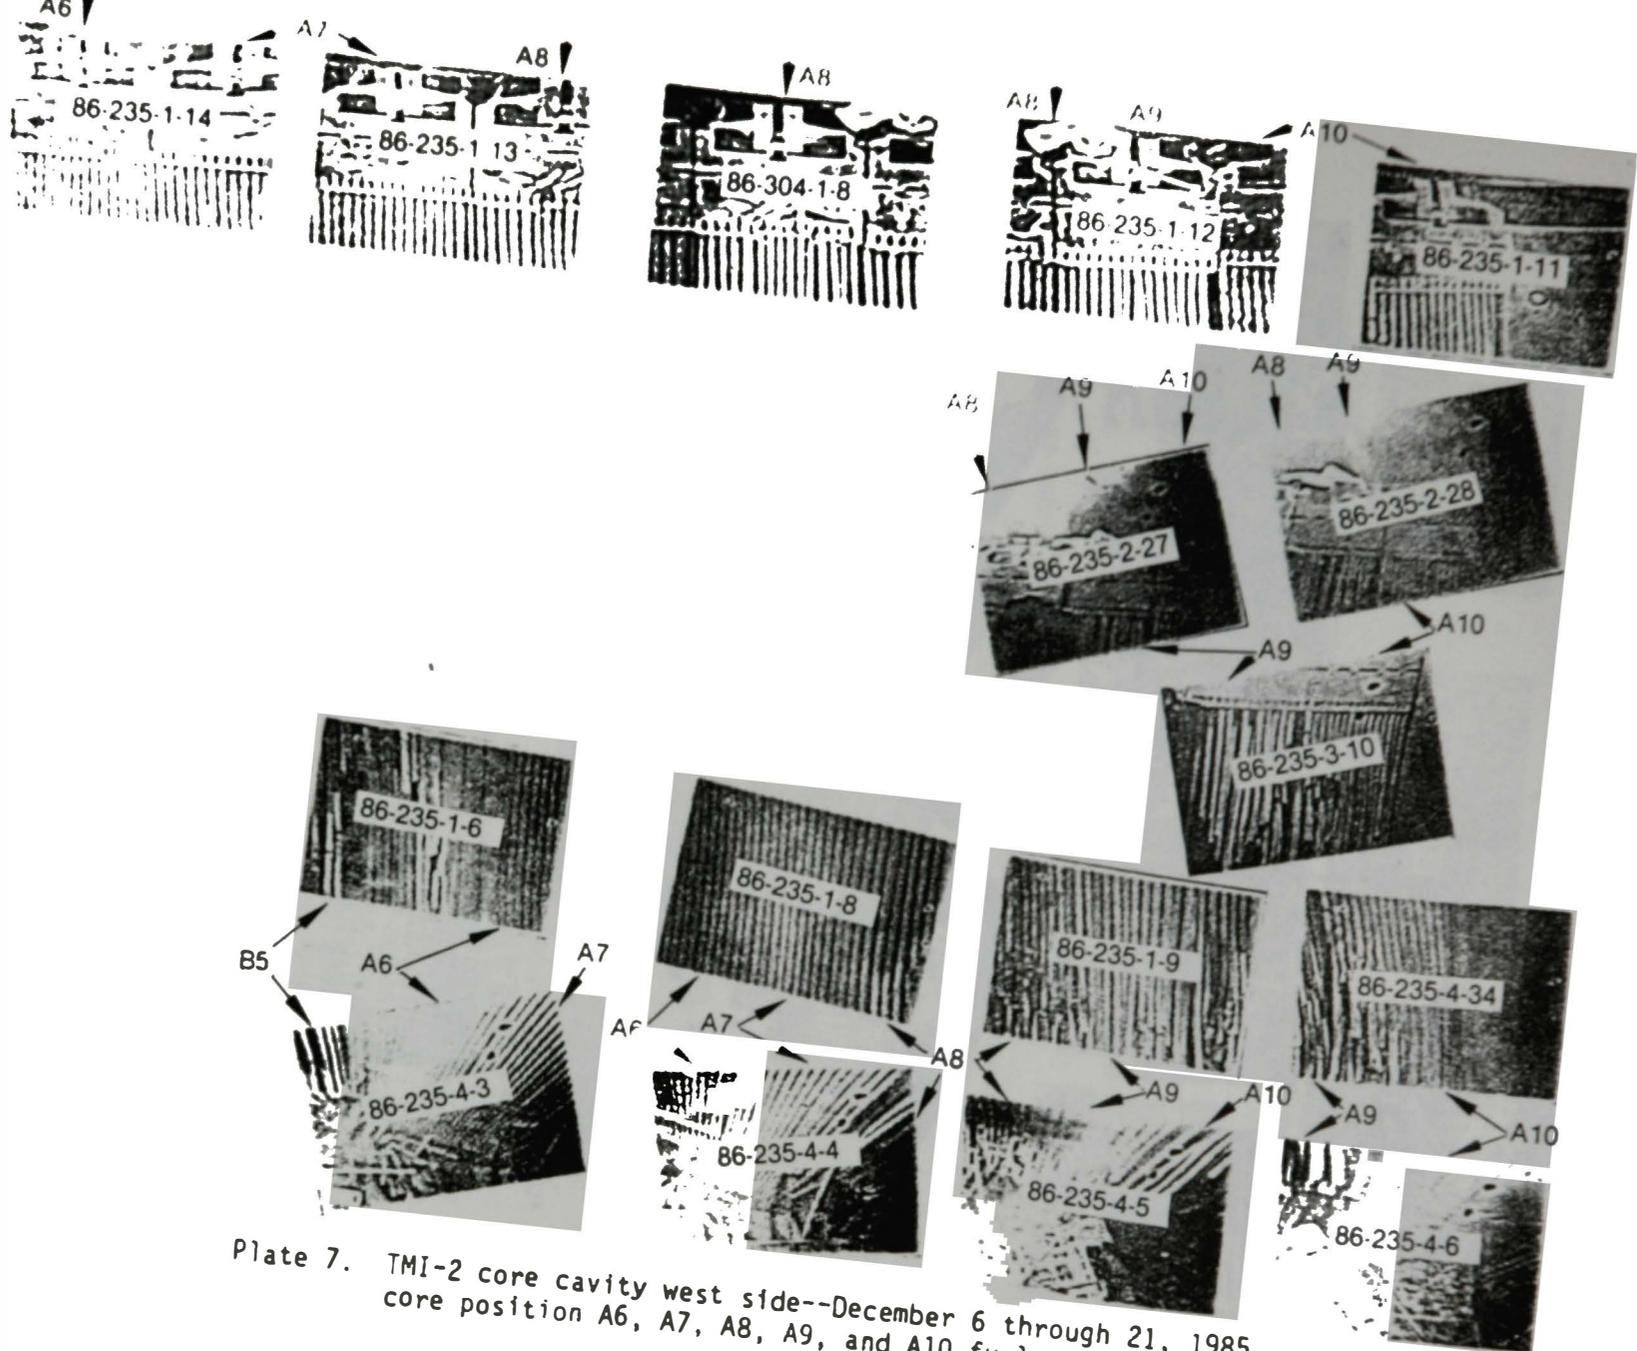
Plate 7. TMI-2 core cavity west side--December 6 through 21, 1985 core position A6, A7, A8, A9, and A10 fuel assemblies.

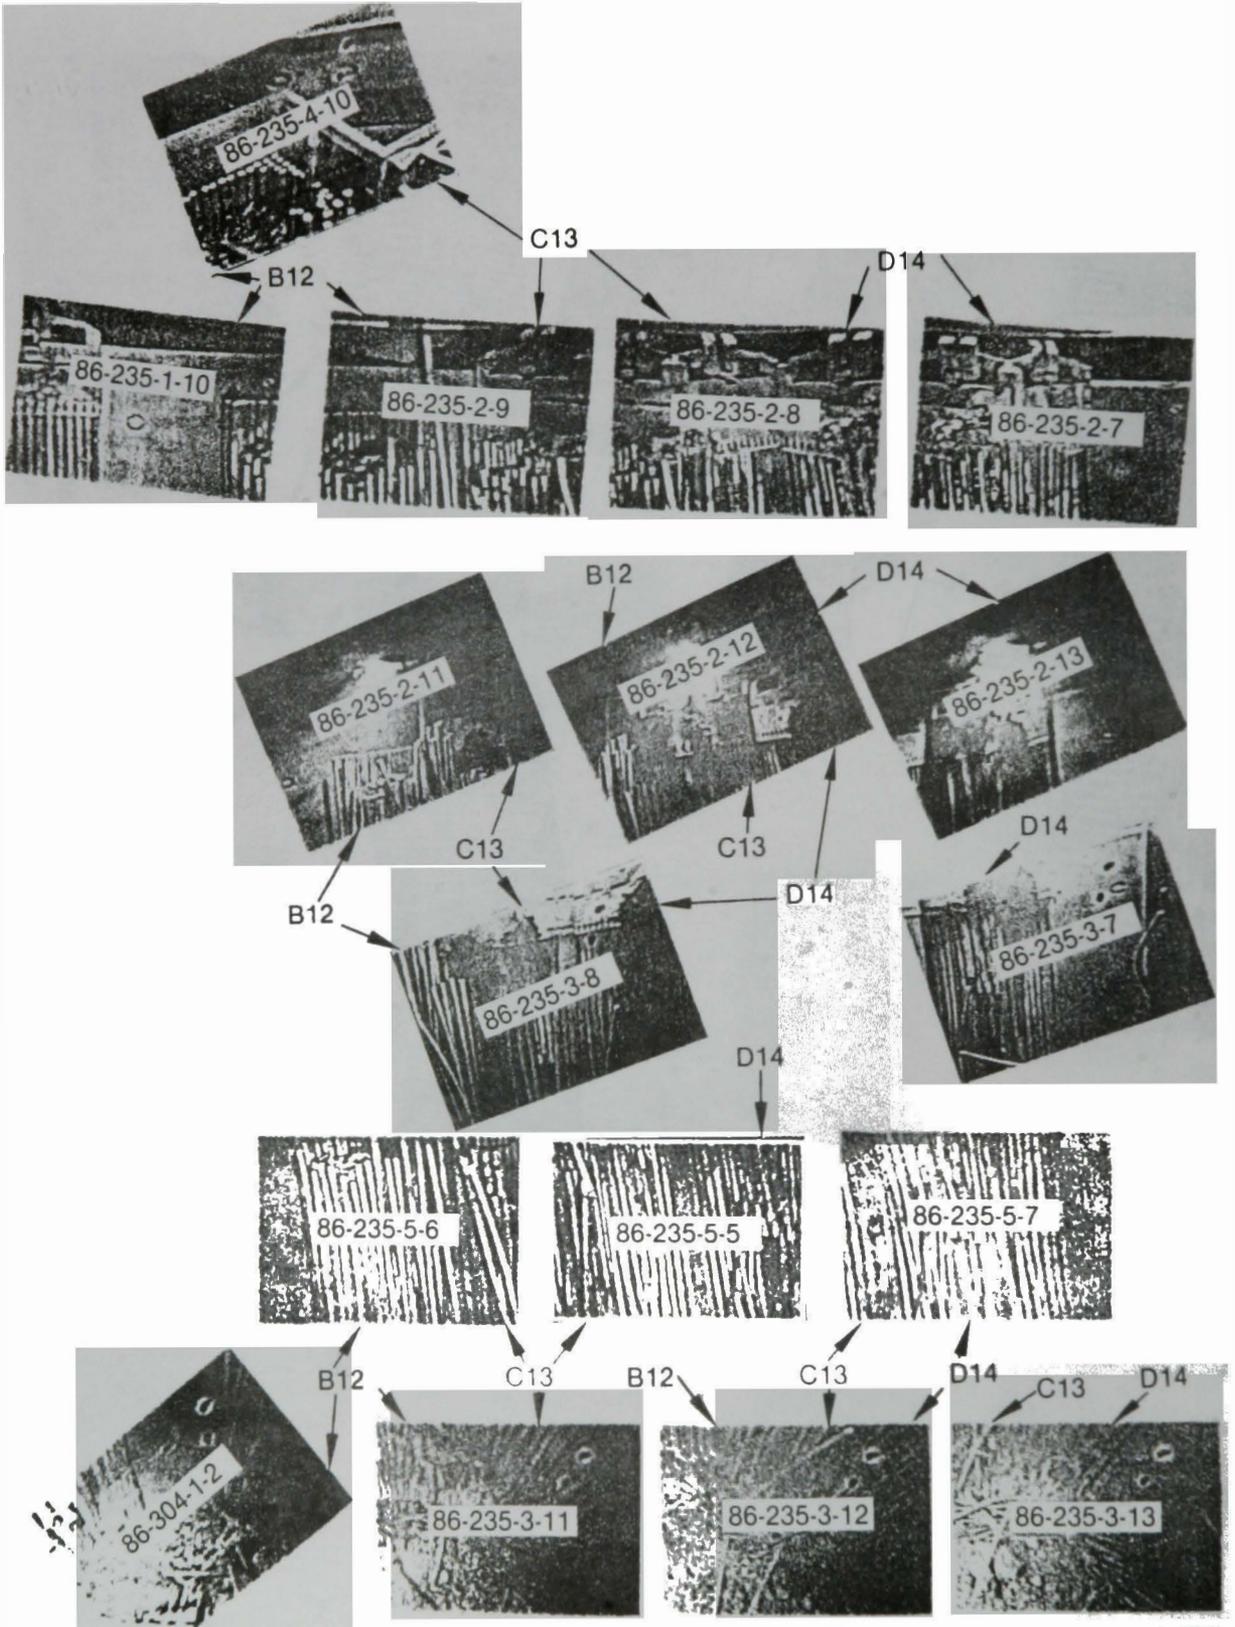
Plate 8. TMI-2 core cavity northwest side--December 6 through 21, 1985 core position B12, C13, and D14 fuel assemblies.

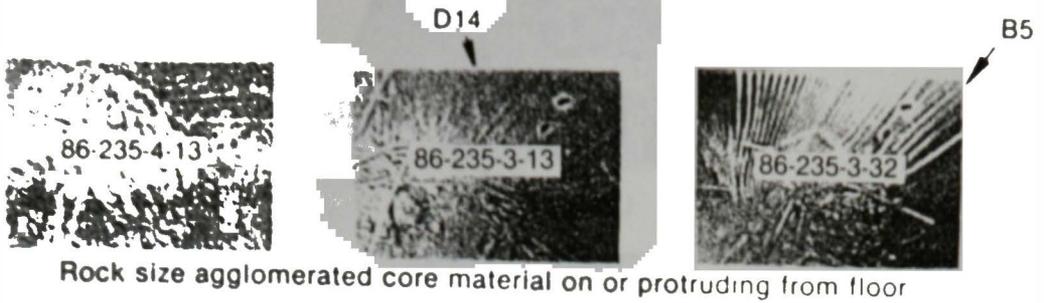
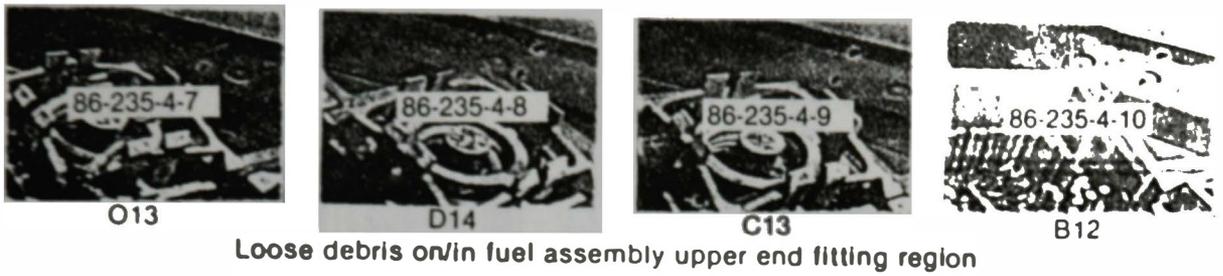
Loose debris on/in fuel assembly upper end fitting region

Core position C4, C5, D4 and D5 upper end fitting damage

- o Loose Debris In Fuel Assembly Upper End Fitting Region--Deposits of small, irregular-shaped particles have collected on upward facing surfaces and cup-like areas of the fuel assembly upper rod fittings.
- o Other Identifiable Upper End Fittings--The damaged upper end fittings from core positions B10, C4, C5, D4, and D5 were identified during the video surveys in the loose debris on the core cavity floor.
- o Fuel Rod Damage in Pellet Stack Holddown Spring Region--A still-image photograph of fuel rod damage from interaction between the stainless steel fuel pellet stack holddown spring and the zircaloy fuel rod cladding is at the bottom of Plate 9. The fuel rod bundle section was lying on the core cavity floor; its original core location is unknown.

Fuel rod damage in pellet stack holddown spring region

Plate 9. TMI-2 core cavity floor and sides--December 6 through 21, 1985 miscellaneous distinct component details.

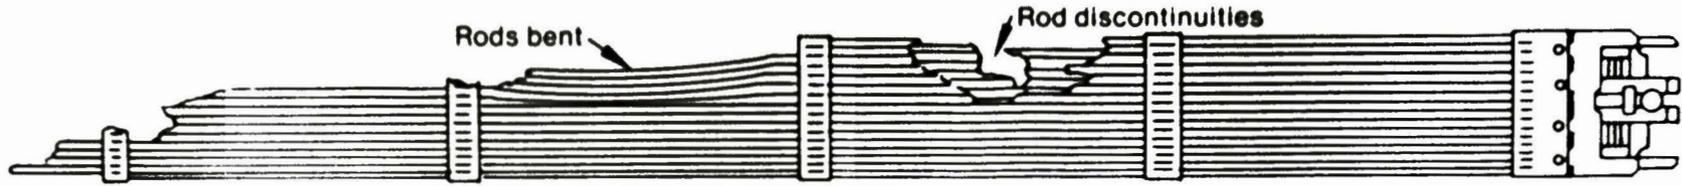
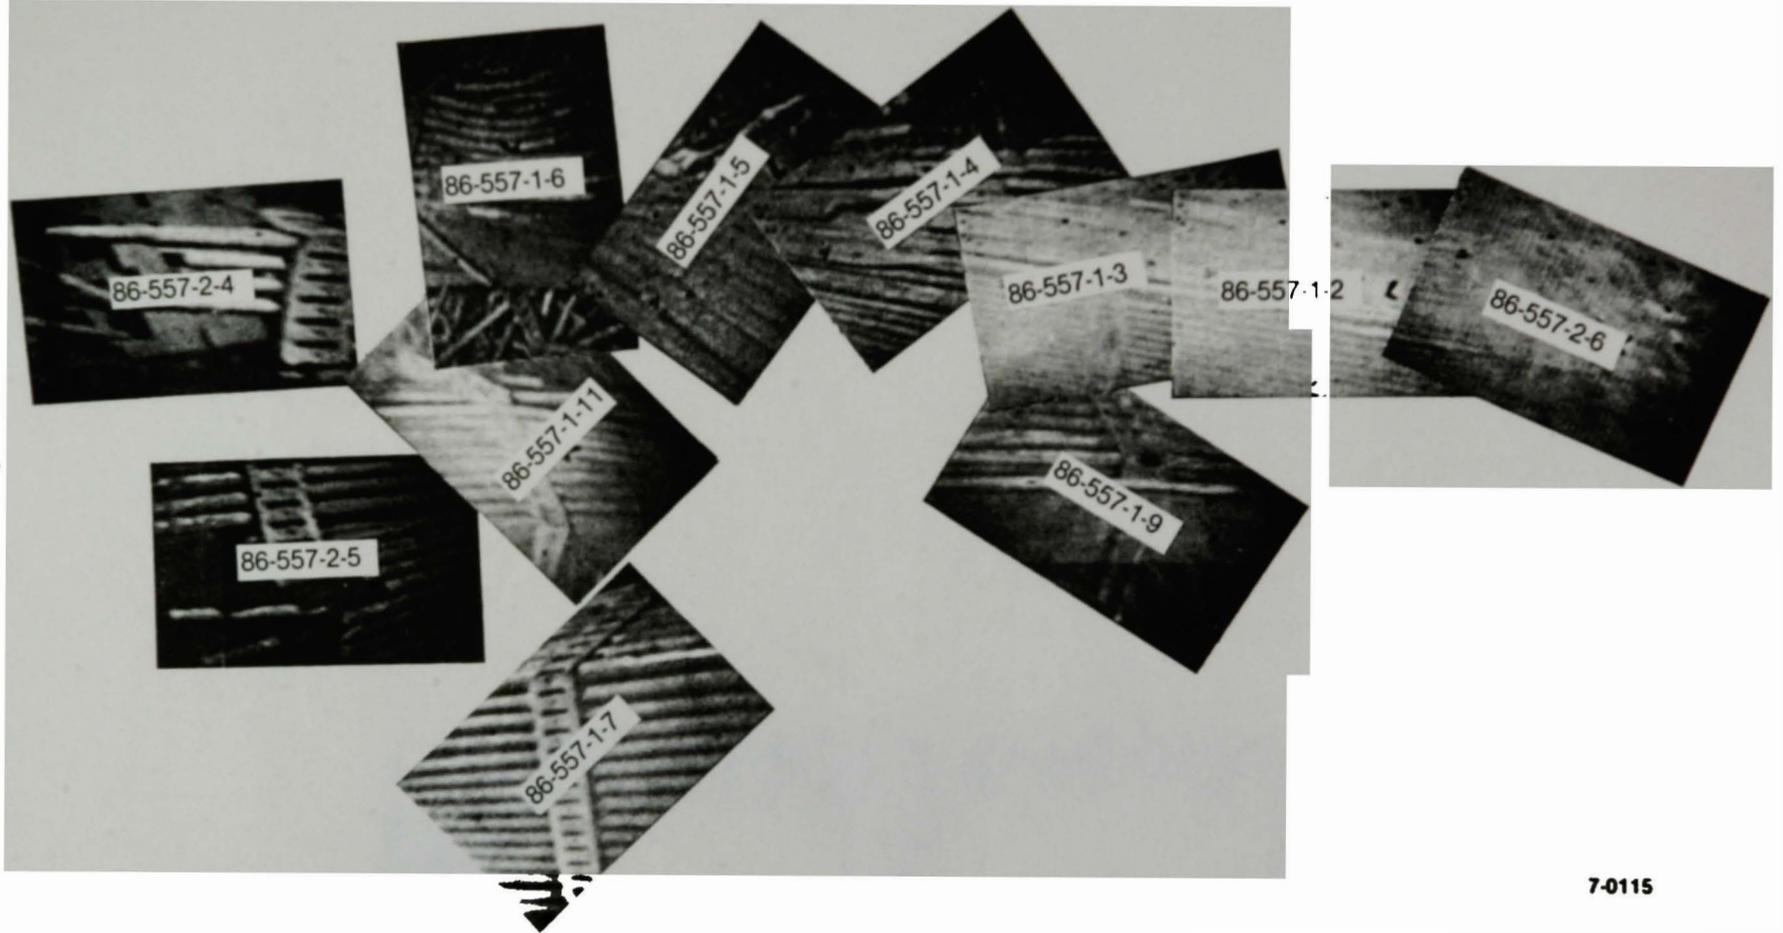
Plate 11 shows some detailed still-image photographs of the core position P4 fuel assembly south and east sides and a sketch of the fuel assembly's south face. The quality of the still images is poor due to distortion of the tape recording video signal and water turbidity. The video survey was conducted on January 21, 1986, after the peripheral fuel assembly had toppled completely to the core cavity floor. In the December 1985 surveys, the fuel assembly was leaning from its core southeast side position and obstructing the survey of the core eastside core positions (see Plate 3).

Core position P4 fuel assembly south face diagram (not to scale)

Plate 11. TMI-2 core position P4 fuel assembly.
