EXAMINATION OF THE TMI-2 CORE
DISTINCT COMPONENTS

EXAMINATION OF THE TMI-2 CORE DISTINCT COMPONENTS

**S. M. Jensen
D. W. Akers
R. W. Garner
G. S. Roybal**

September 1987

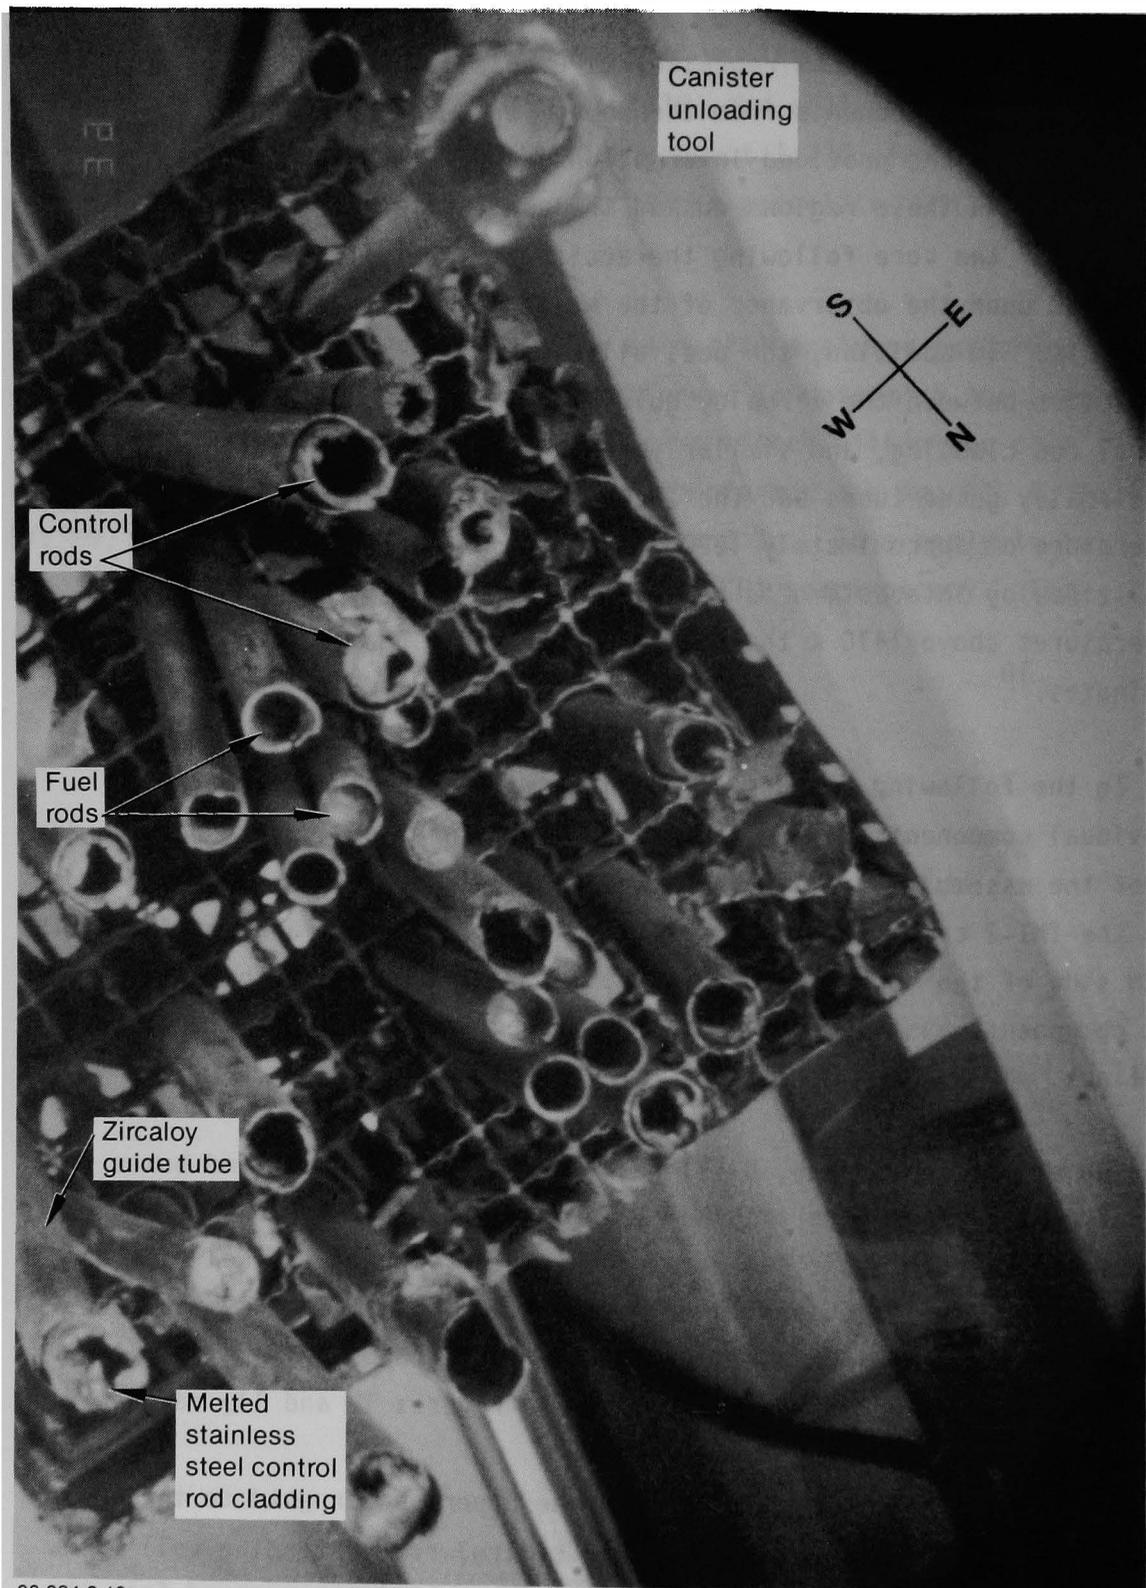
Two of the components, D-141-3 and D-153-9, were upper end boxes from fuel assemblies that were originally in core positions C7 and B8, respectively. Both these components contained remnants of fuel rods and control rods, from which additional samples were obtained for detailed metallurgical and radiochemical analyses. Photographs of components D-141-3 and D-153-9 are shown in Figures 13 and 14, respectively.

Component D-141-3 was intact from the upper spacer grid to the top of the control rod spider and had fuel and control rods extending well below the upper spacer grid. Most of the fuel rods were later removed from the assembly and had lengths ranging from approximately 47 cm (19 in.) in the

Figure 13. Bottom view of component D-141-3 after removal of most fuel rods.

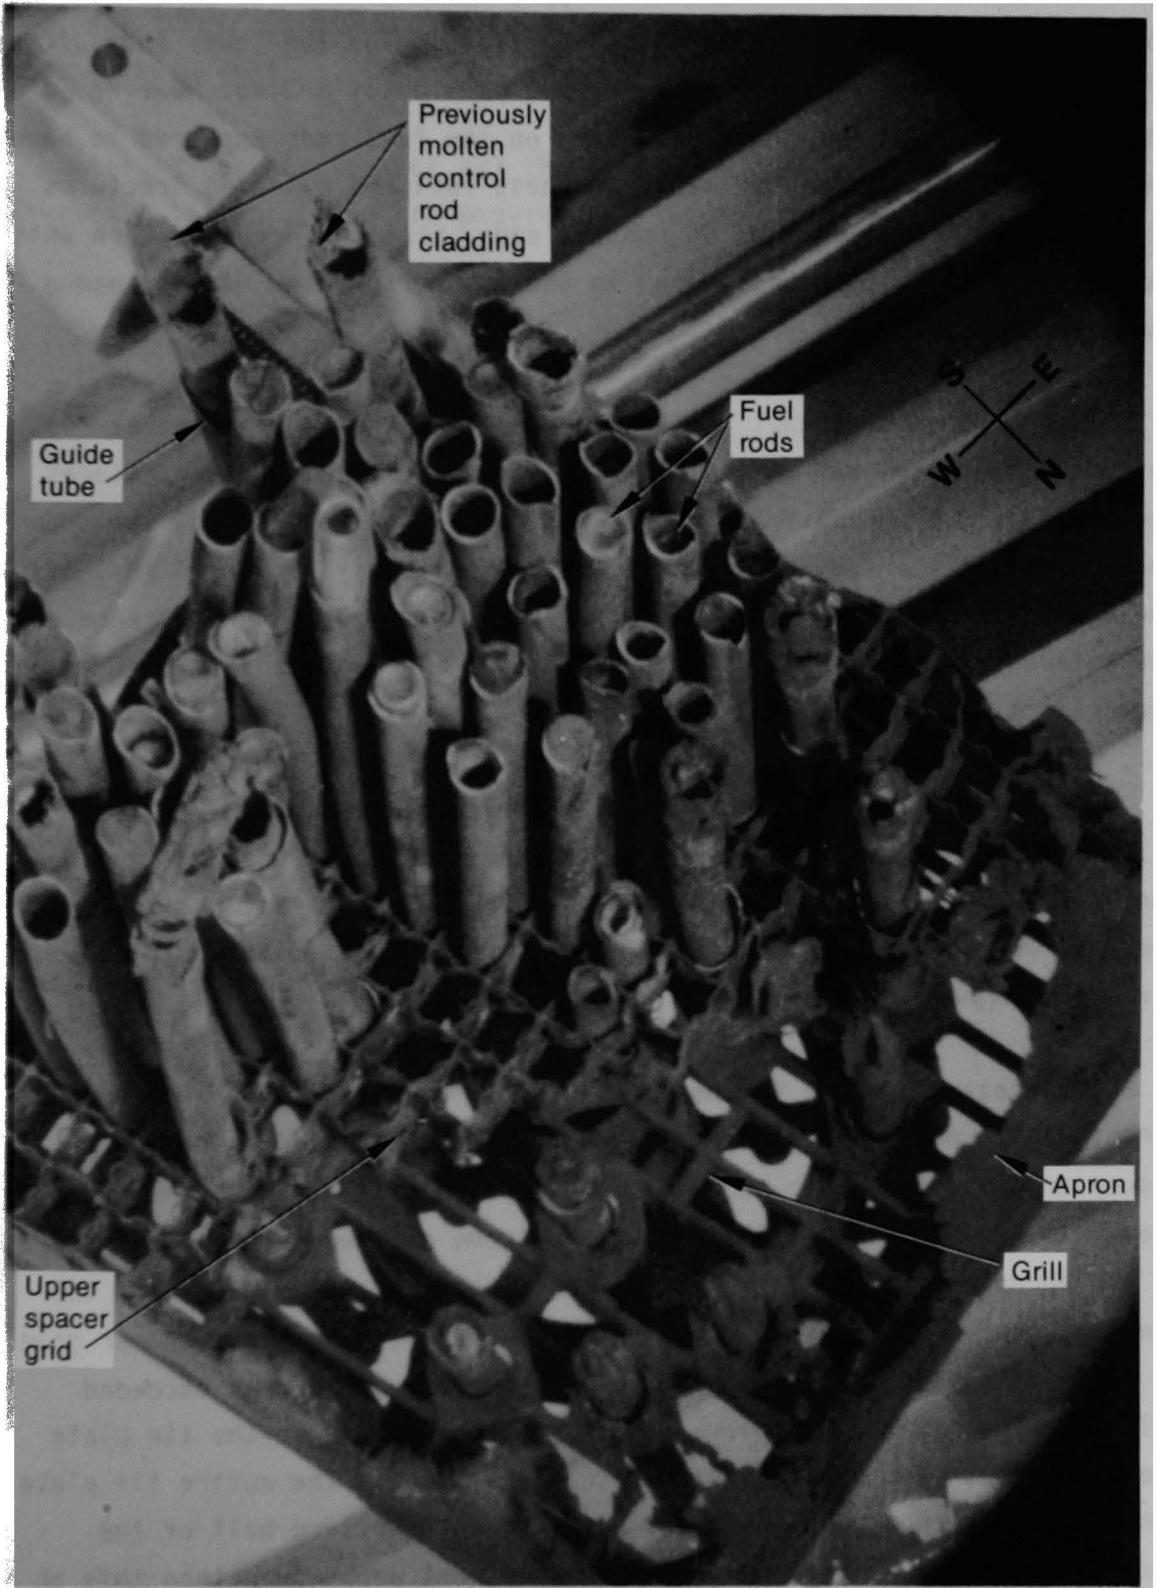
86-384-9-2

Figure 14. Bottom view of component D-153-9.

the southeastern side. In the extreme southeastern corner, approximately 25 cm below the upper spacer grid, the peak temperatures were near 1673 K. These peak temperatures were evidenced by partially melted control rod cladding (Figure 14).

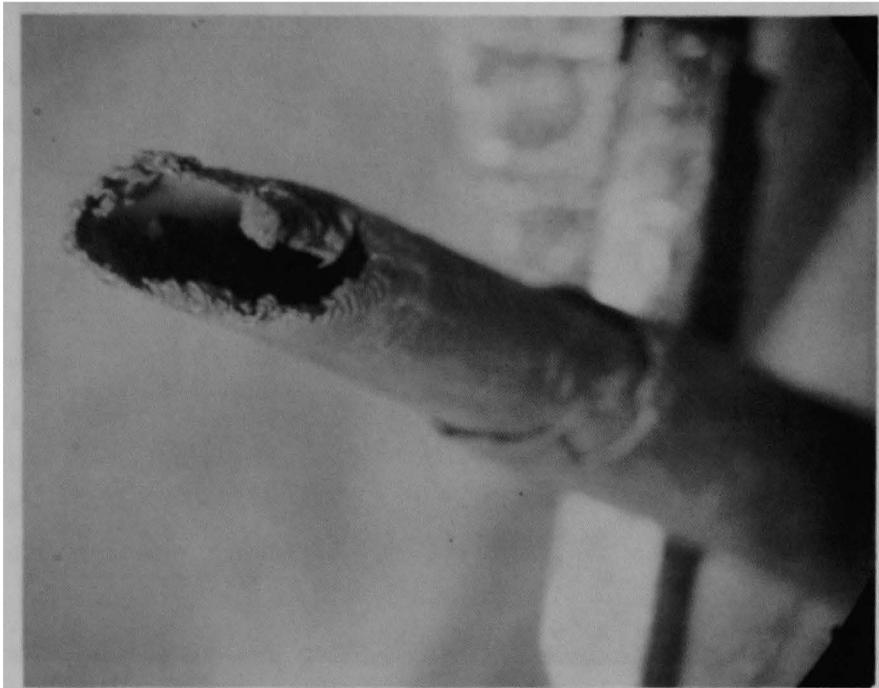
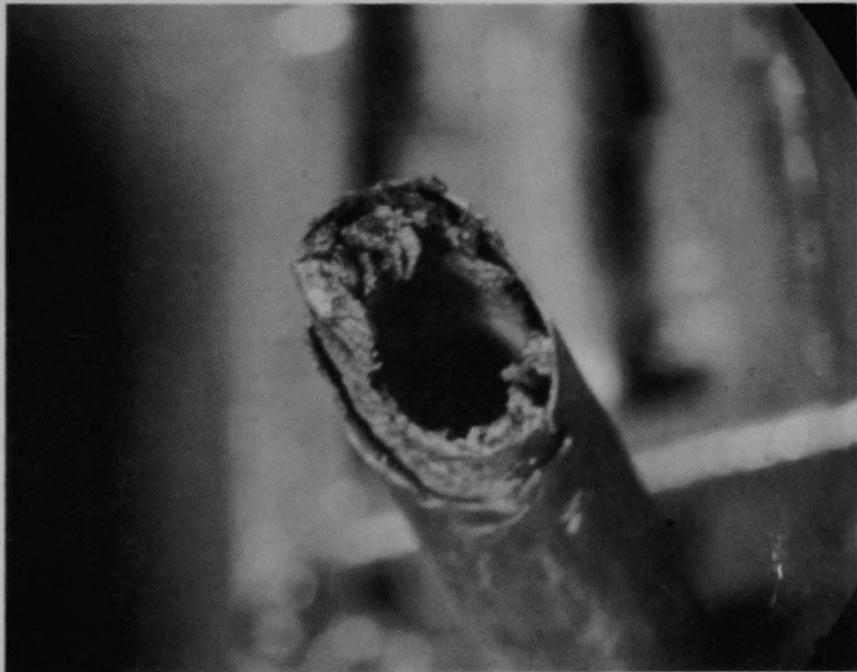
The endtips of all the fuel rods examined appeared to have been snapped off in a brittle manner, possibly due to handling damage or as a result of falling to the debris bed in the reactor. Some typical examples are shown in Figure 20. Similarly, the zircaloy guide tubes surrounding the control rods also appeared to have been broken off. However, in many cases the stainless steel control rod cladding appeared to have been previously melted, as typified in Figure 21. Some of these control rod/guide tubes were bent on the endtips (see Figure 22).

a) Control rod/guide tube 3-3C/G

b) Control rod/guide tube 3-4C/G

Figure 21. Melted stainless steel cladding on control rod endpoints.

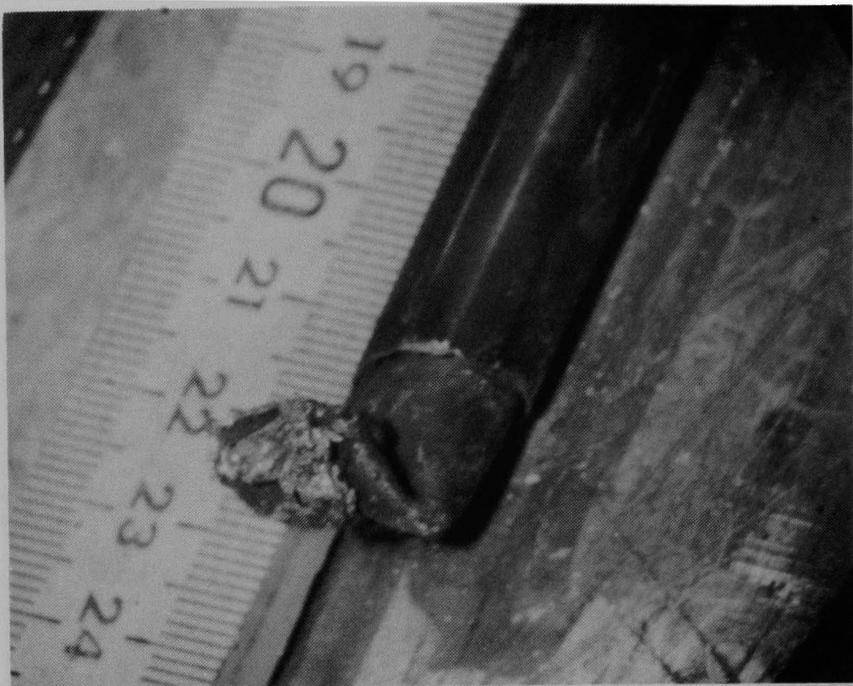
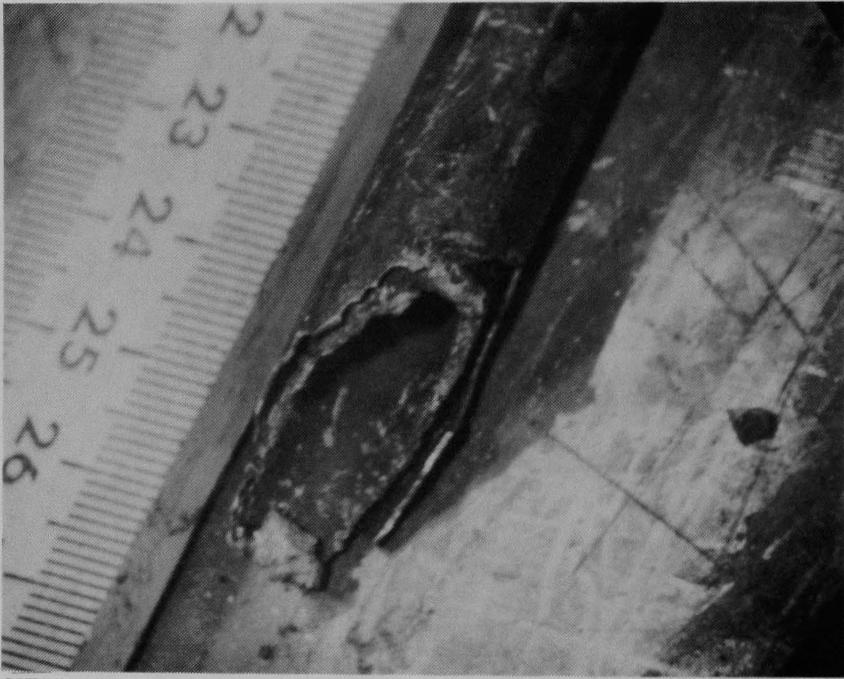
a) Control rod/guide tube 3-6 C/G

b) Control rod/guide tube 3-7 C/G

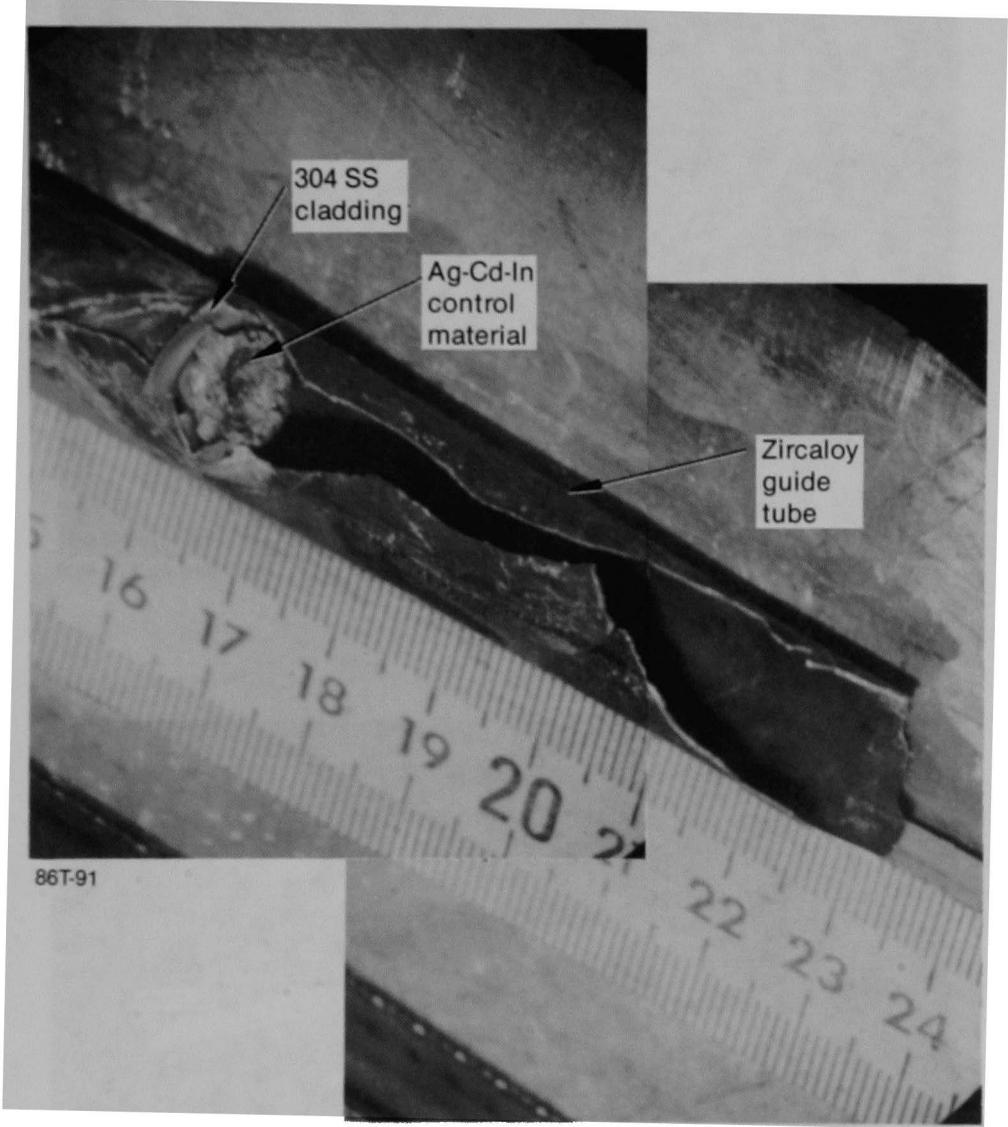
upper core debris bed or as a result of handling damage in inserting and removing the assembly from the shipping canister. A photomosaic of the 3-14C/G endtip is shown in Figure 25.

Figure 25. Bottom endtip of control rod 3-14C/G.

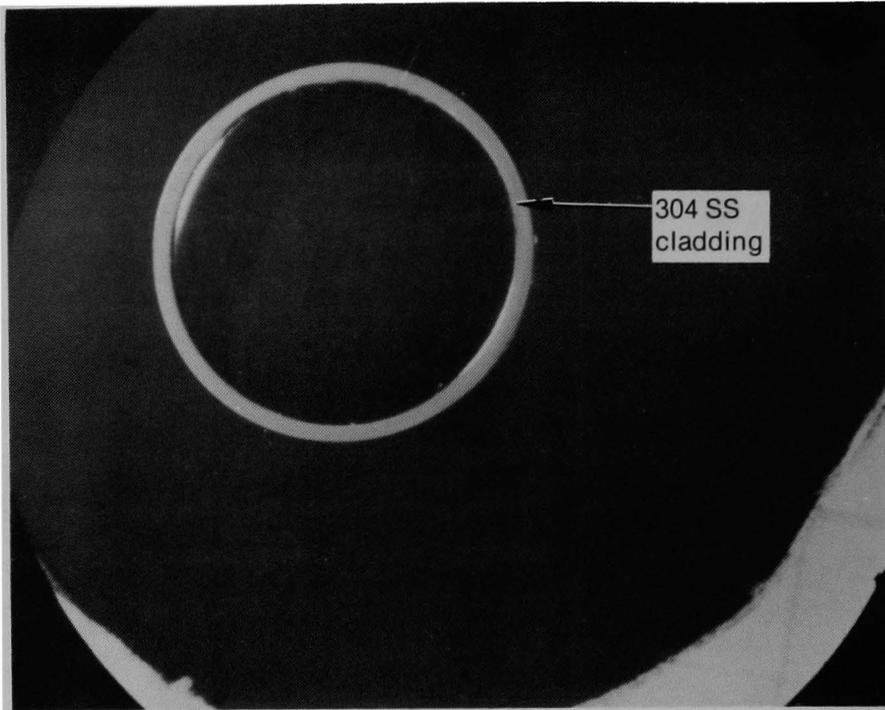
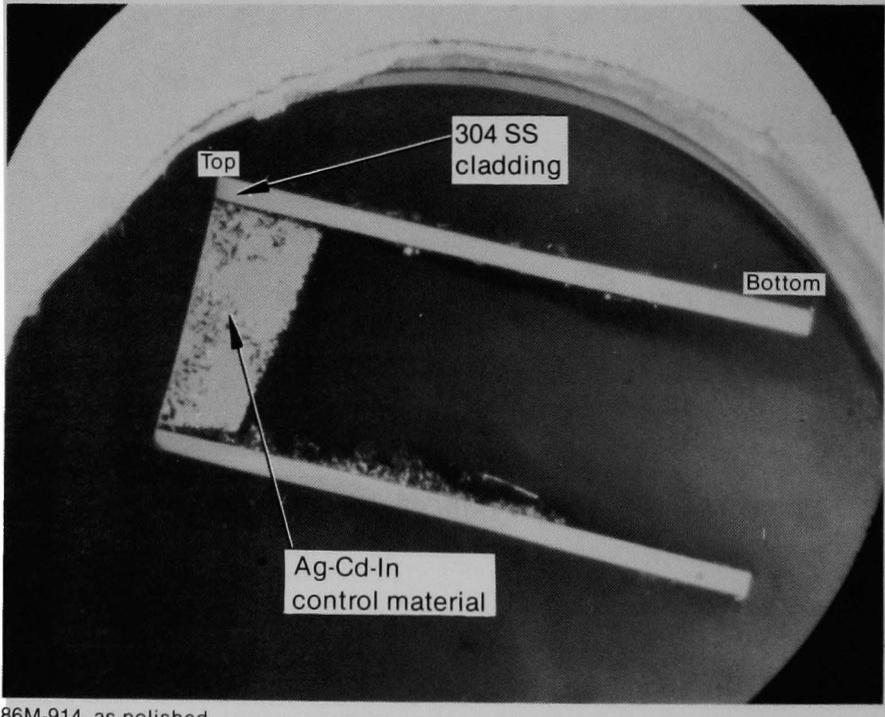
Figure 26. Metallographic samples from control rod 3-1C.

included with the ceramic material, as shown in Figure 28. The metallic material was not affected by zircaloy and stainless steel etchants. As shown in the photograph of sample M-10B in Figure 26, this debris was preferentially deposited on a cladding inner and outer surface, which suggests that it may have settled out of the water while this component was lying horizontal on the upper debris bed after plenum assembly removal.

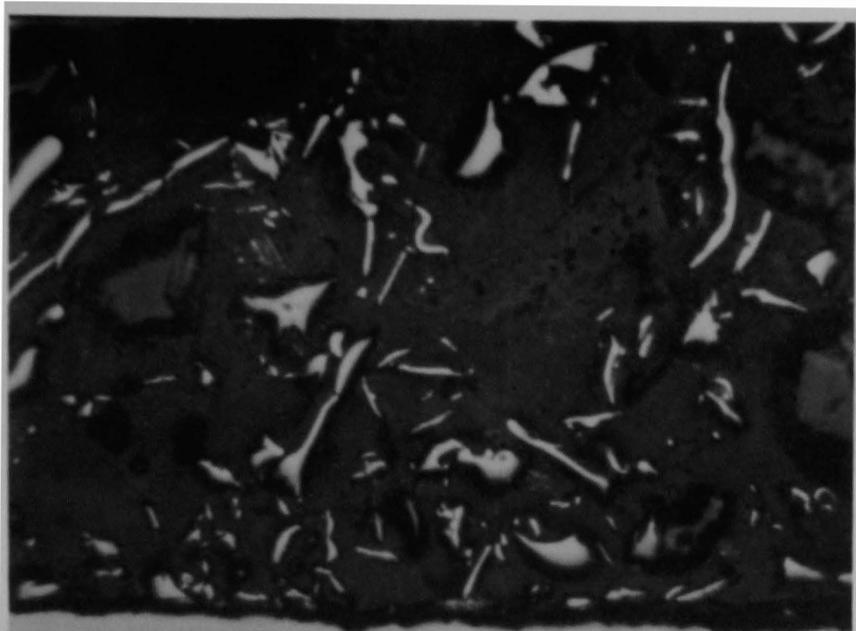
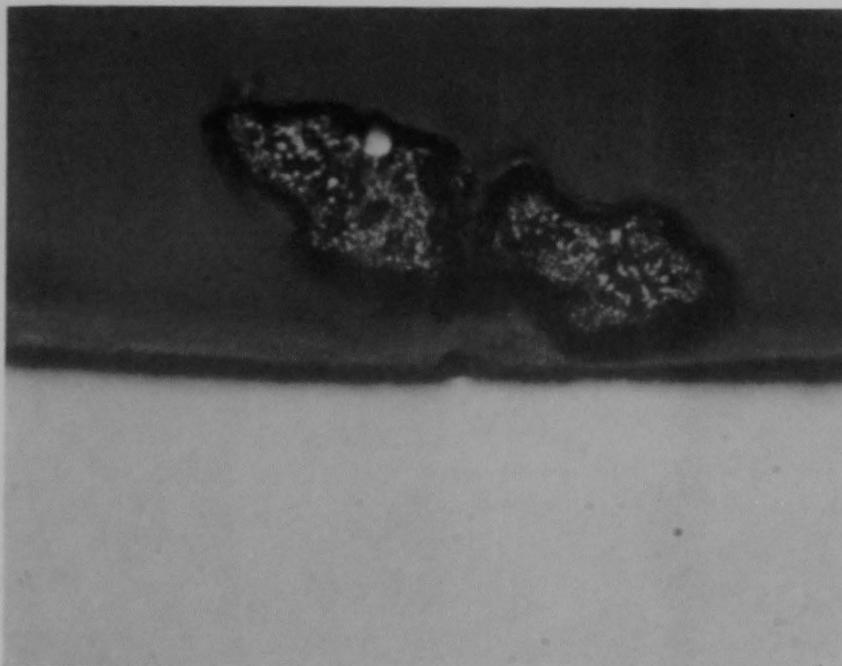
a) Metallic debris
(Sample M-10B)

b) Ceramic debris with metallic inclusion
(Sample M-10A)

Figure 28. Debris near the broken endtip of control rod 3-1C.

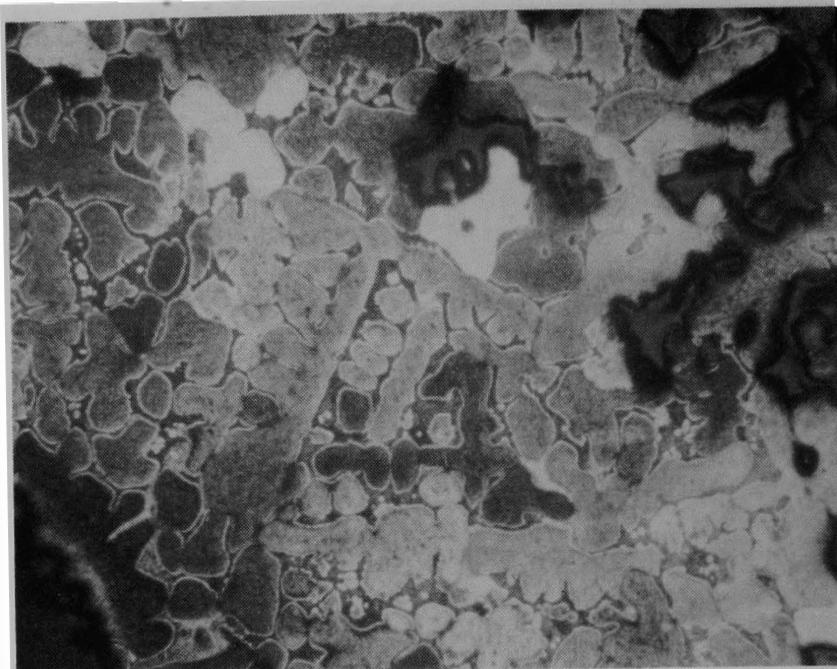
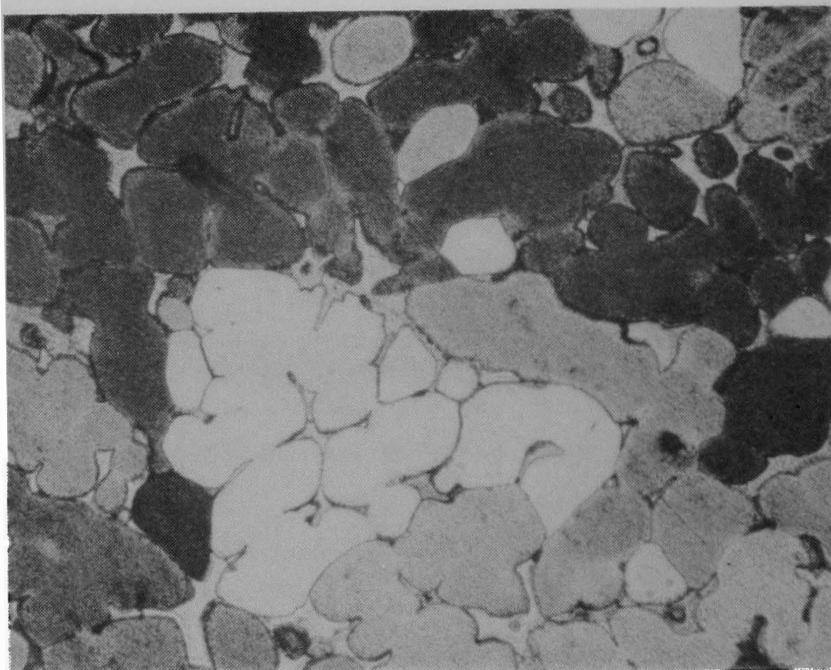
All of the Ag-Cd-In control rod material that was examined had a dendritic structure. This indicates that this material was previously melted. Representative photomicrographs of the control rod material at the endtips of the two control rods are shown in Figure 29. A photomosaic of the previously melted control rod material in the plenum spring region of 3-14C/G is shown in Figure 30. The dendrites in this region are much finer than those located near the endtip, approximately 13 cm below this location (see Figure 31). This indicates that the control rod material in the plenum cooled somewhat faster than the lower control rod material and exemplifies the changes in material behavior that occurred over relatively short distances. The presence of previously melted Ag-Cd-In control material adjacent to unmelted 304 stainless steel cladding indicates that peak temperatures in the plenum spring region were between 1073 K and 1673 K. There was no interaction between the melted control rod material and either the cladding or the spring.

a) Control material in Rod 3-1C
(Sample M-10B)

b) Control material in Rod 3-14C/G
(Sample M-13)

Figure 29. Dendritic structures in previously melted Ag-Cd-In control material.

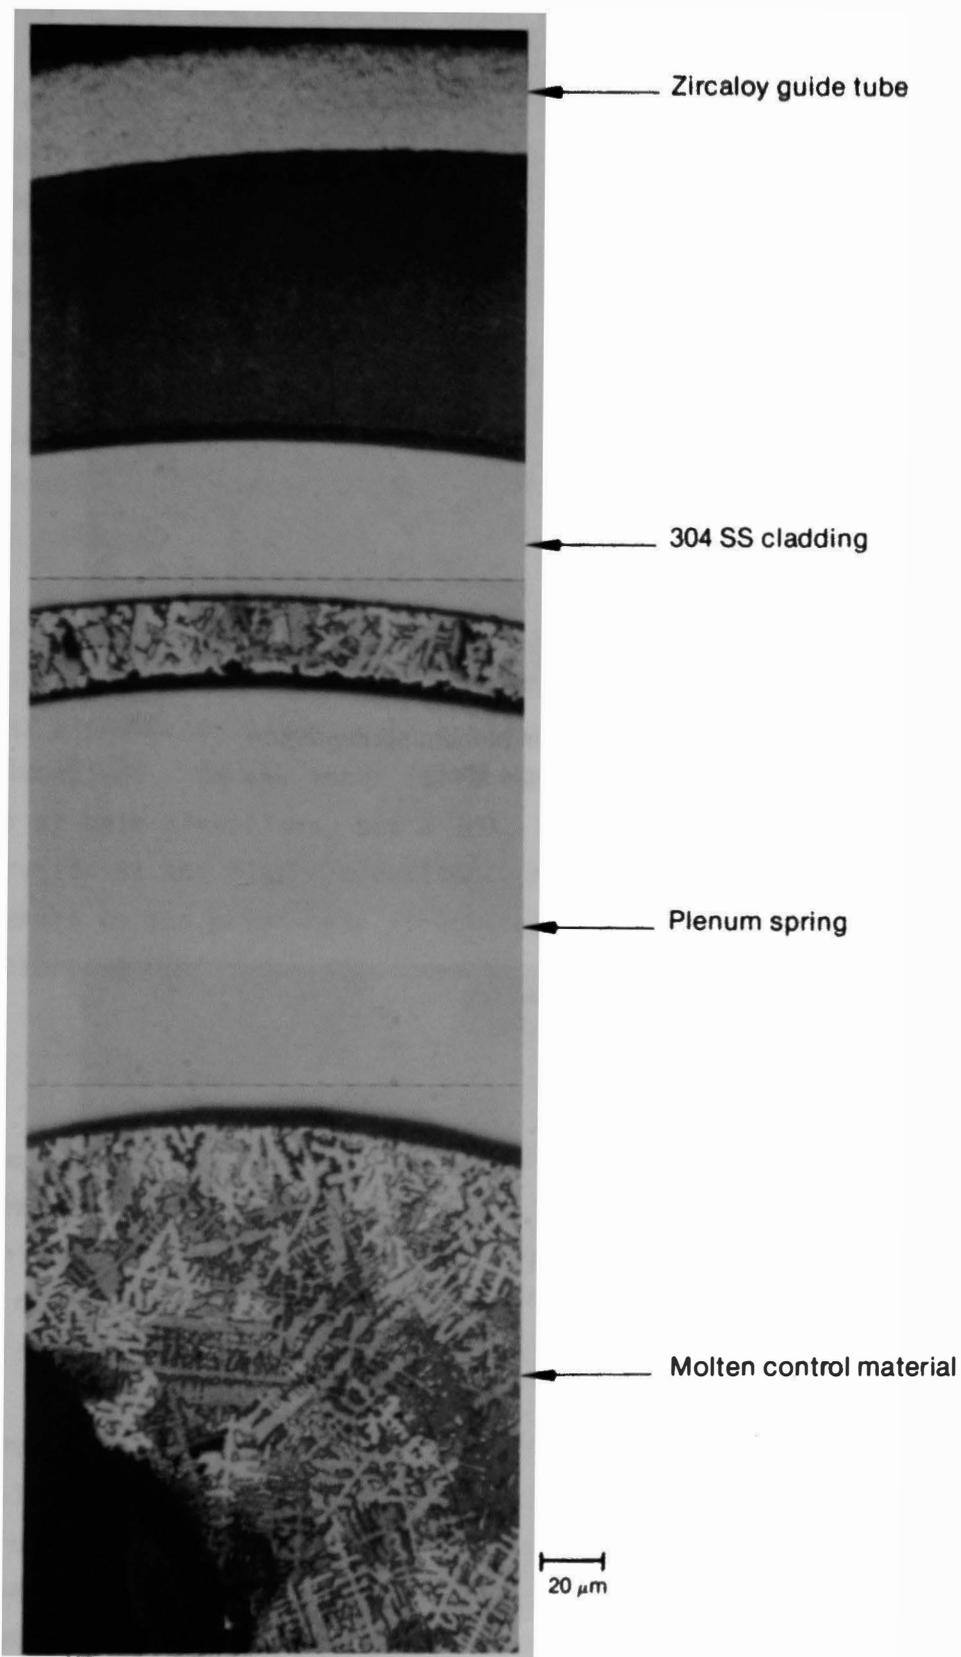
SEM-938, 939, 940, etched

Figure 30. Previously melted Ag-Cd-In control material in plenum spring region of sample M-15.

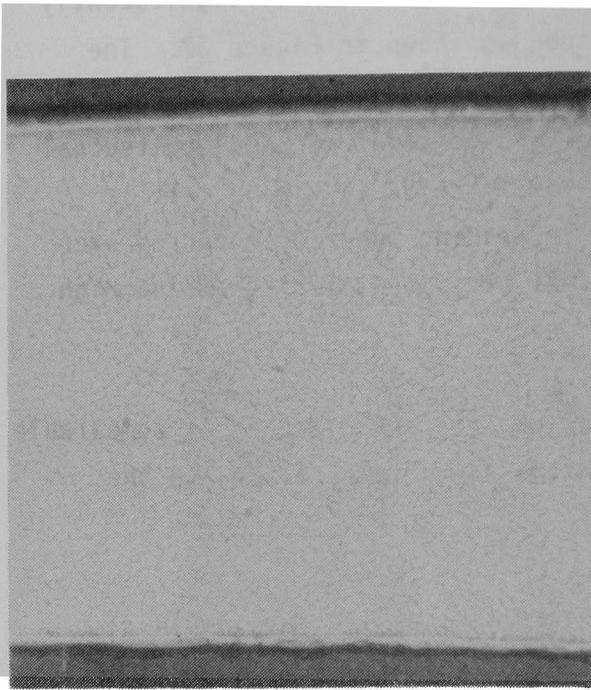
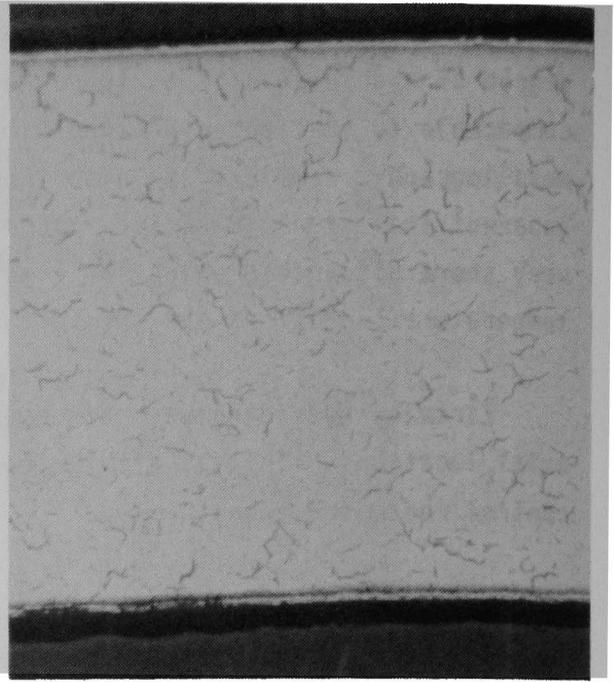
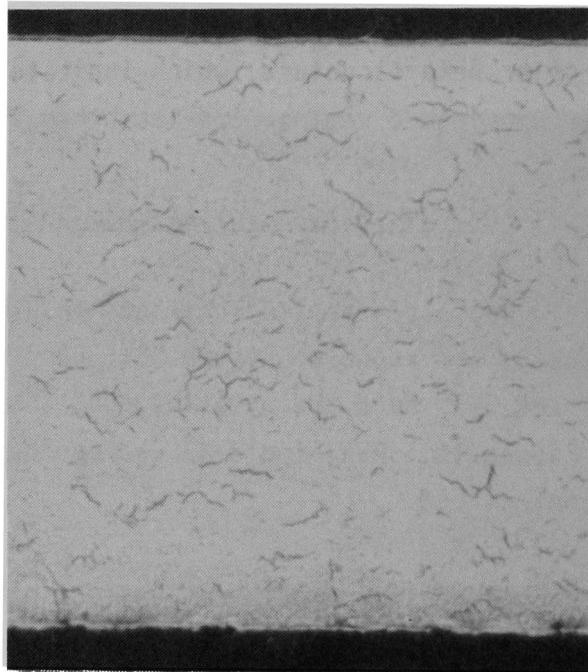
hydriding in the sample from the upper plenum region varied significantly around the circumference of the guide tube as shown in Figure 32. The degree of hydriding at the 270-degree orientation in the upper plenum was comparable to that observed approximately 13 cm lower on the longitudinal metallographic sample M-13, also shown in Figure 32 as view c. It is apparent that significant variations in hydriding behavior occurred over very short distances, which indicates that very localized steam and high temperature conditions existed in the core.

(a) Hydriding in plenum region at 90°

(b) Hydriding in plenum region at 270°

Figure 32. Zircaloy hydrides in the guide tube of control rod 3-14C/G.

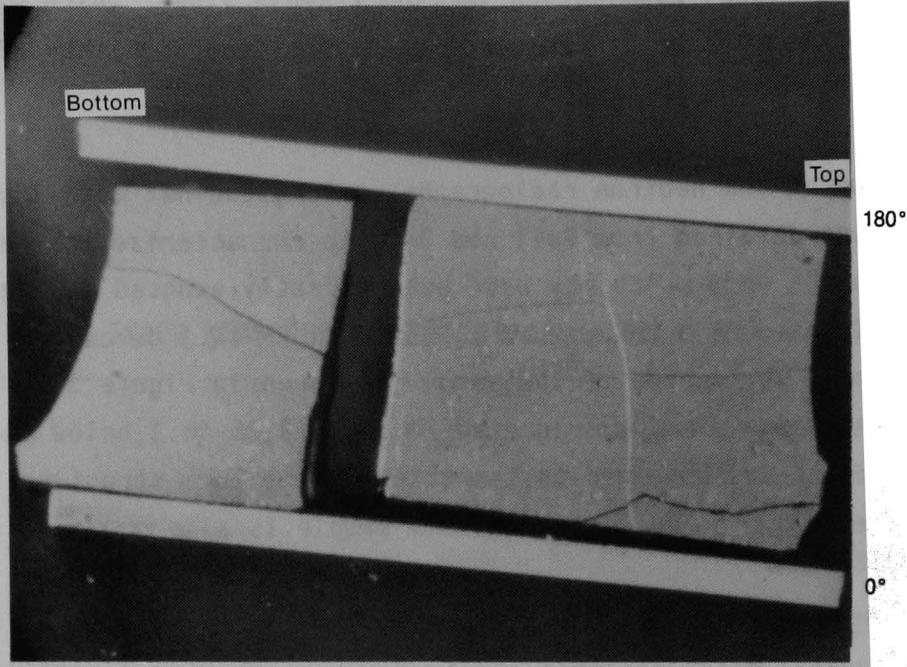
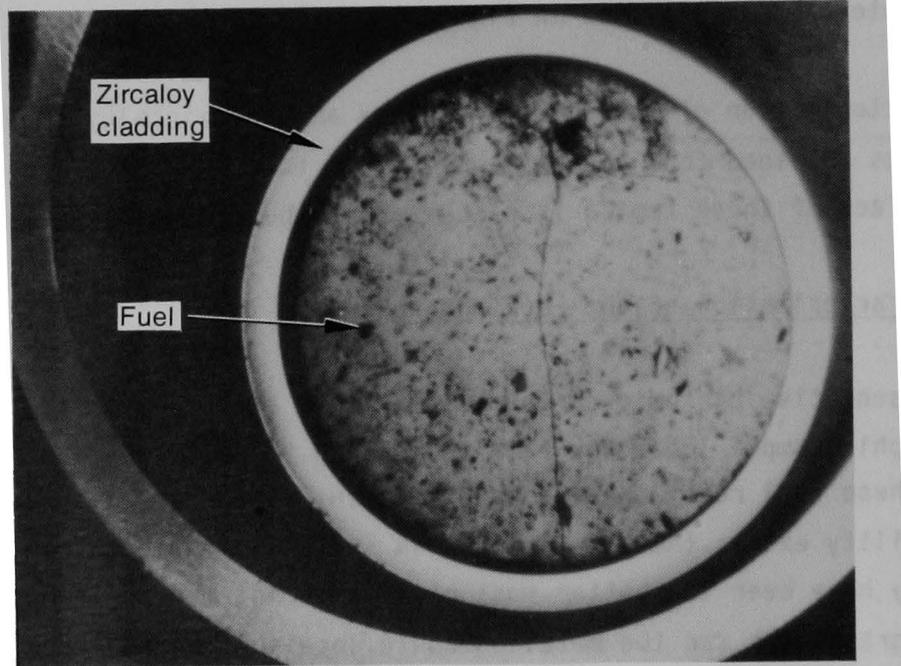
Figure 34. Metallographic samples from fuel rod 3-30.

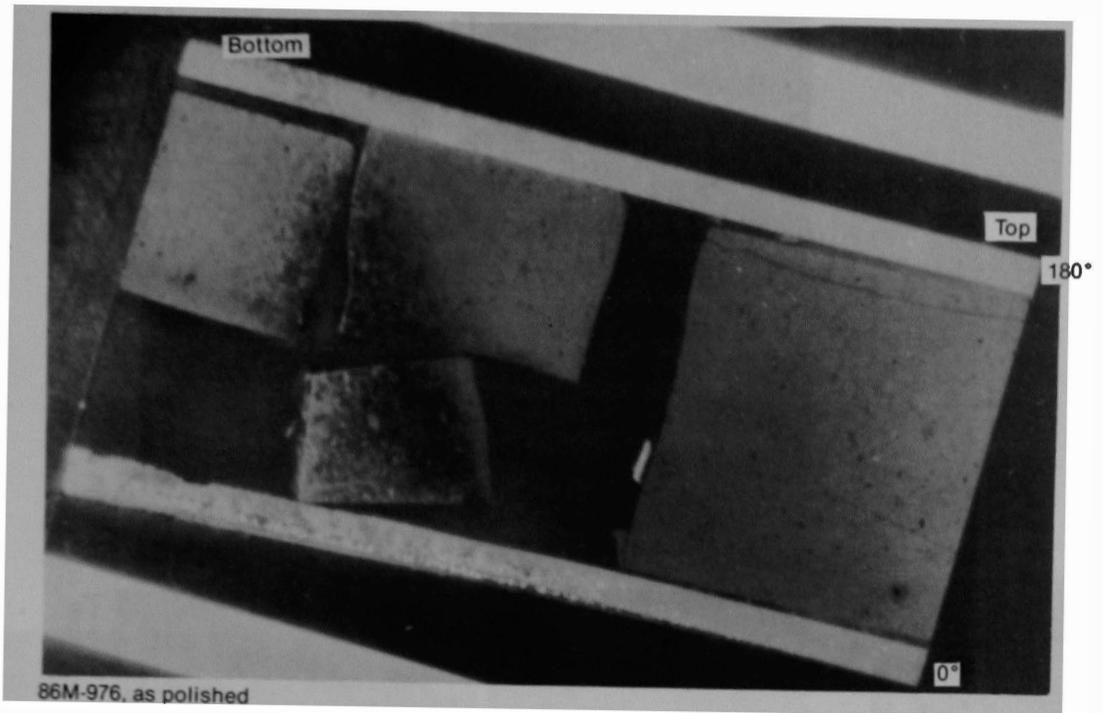
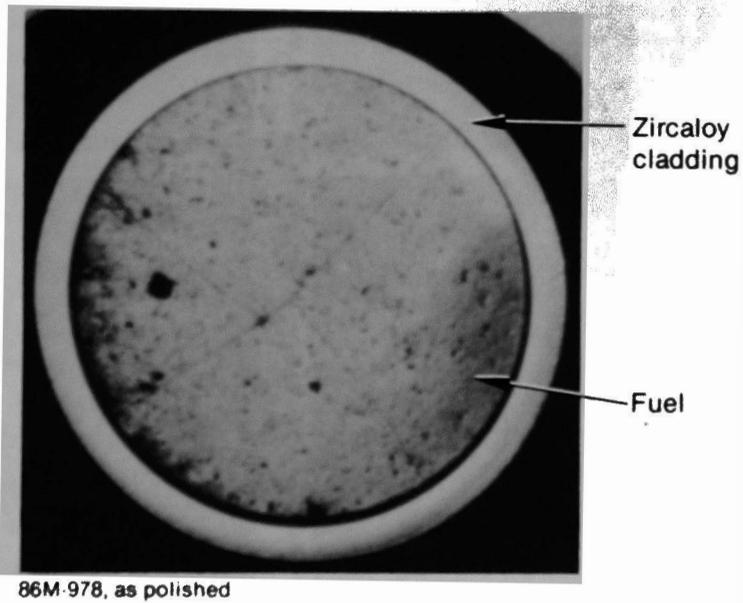
Longitudinal metallographic sample M-5 was obtained from fuel rod 3-42 to characterize the fuel structure near the endtip. This sample was located 26.0 to 27.9 cm (10.25 to 11.0 in.) below the top of the fuel rod, and photographs are provided in Figure 35. Transverse metallographic sample M-7 was sectioned to provide fuel structure information away from the broken endtip. It was located 16.5 cm (6.5 in.) below the top of the rod. A photograph is provided in Figure 35.

Figure 35. Metallographic samples from fuel rod 3-42.

Small, intermittent ZrO_2 layers and a continuous $\alpha\text{-Zr(O)}$ layer were observed on the cladding inner surface of fuel rod 3-42 near the bottom end. At the higher axial location of sample M-7, both of these inner surface layers were continuous. On fuel rod 3-30, only a small continuous $\alpha\text{-Zr(O)}$ layer was observed on the cladding inner surface near the bottom end. These results indicate that zircaloy oxidation continued to occur after these fuel rods ruptured.

All of the unoxidized zircaloy cladding in sample M-5 from the bottommost end of fuel rod 3-42 had transformed to the prior-beta structure. Approximately 10 cm above this elevation, at the M-7 location, temperatures were not hot enough to cause this transformation. The minimum temperature for this phase change is 1133 K. Sample M-1 from the bottom

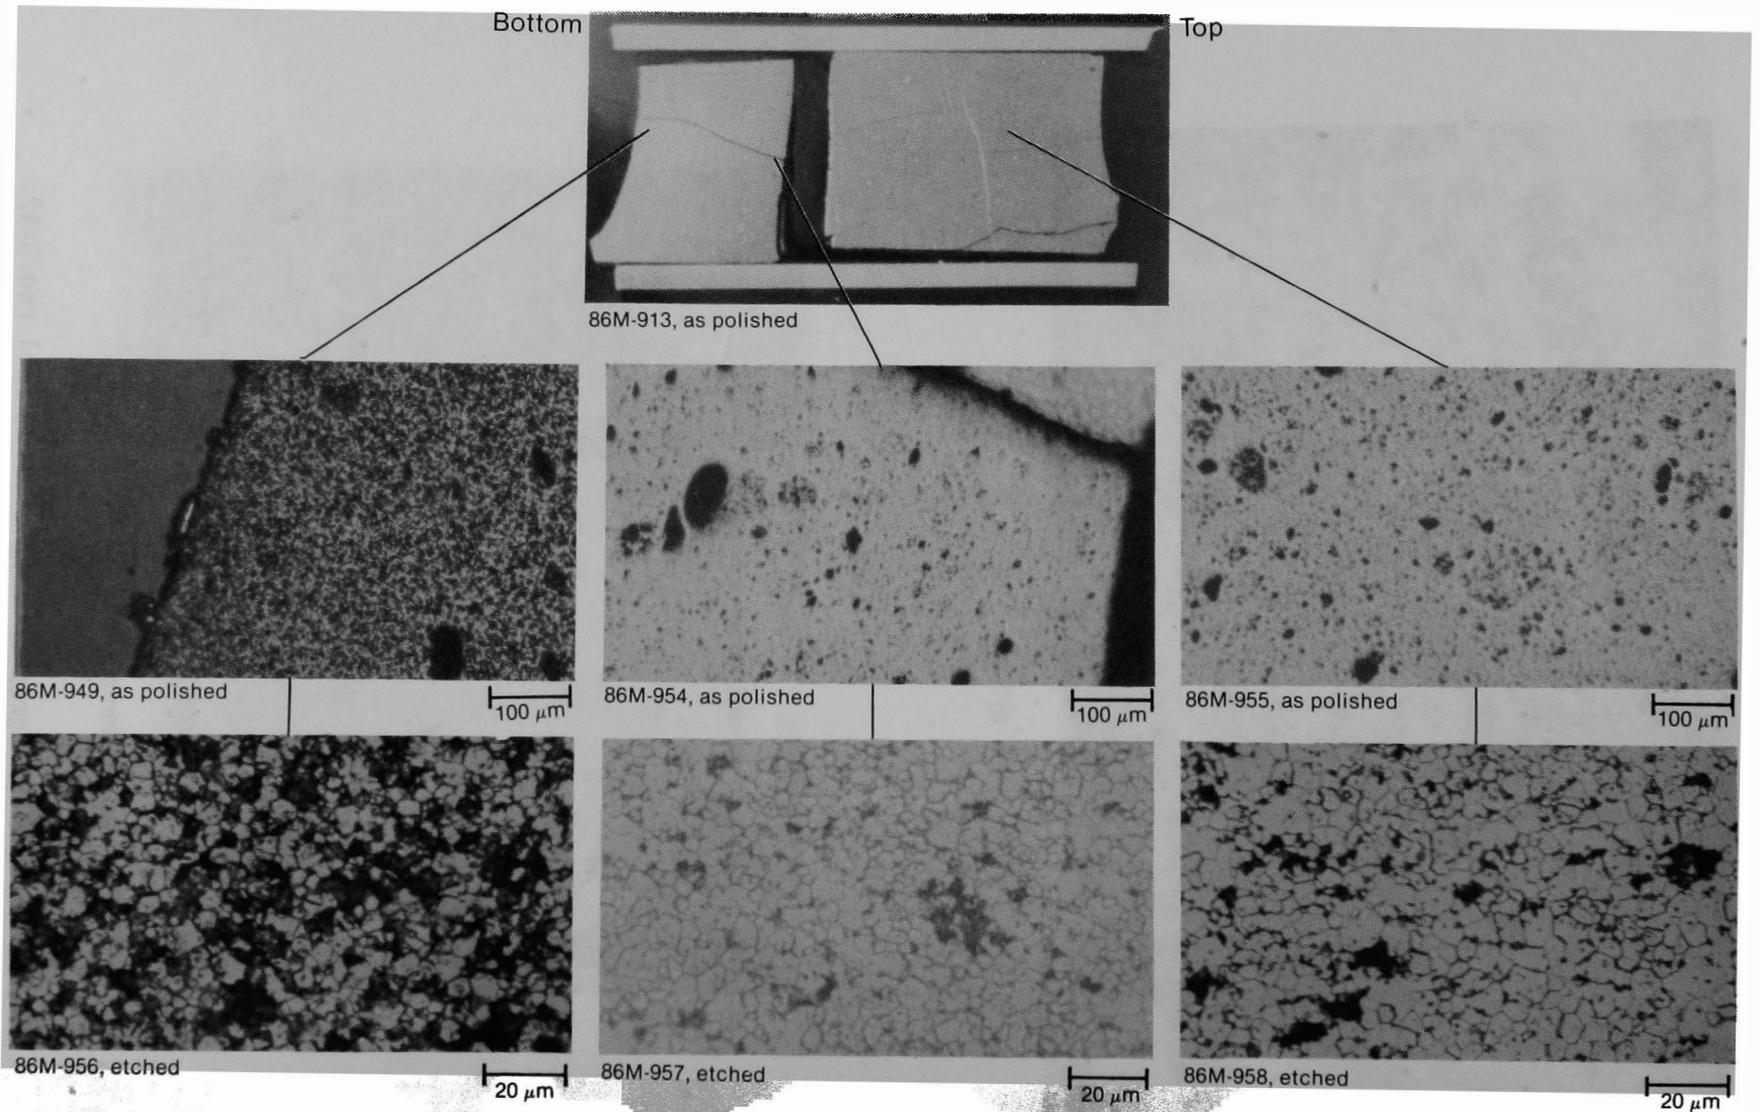
Representative photomicrographs of the fuel structure at the two metallographic sample locations from fuel rod 3-30 are shown in Figures 36 and 37. These fuel rods appeared to have been broken off at some time, and the possibility exists that the pellets in the bottom of each rod may not necessarily have been the bottom-most pellets during the accident. Similar photomicrographs for the two metallographic locations on fuel rod 3-42 are shown in Figures 38 and 39. None of the fuel structures exhibited any

Figure 36. Fuel morphology in sample M-1 near broken end of fuel rod 3-30.

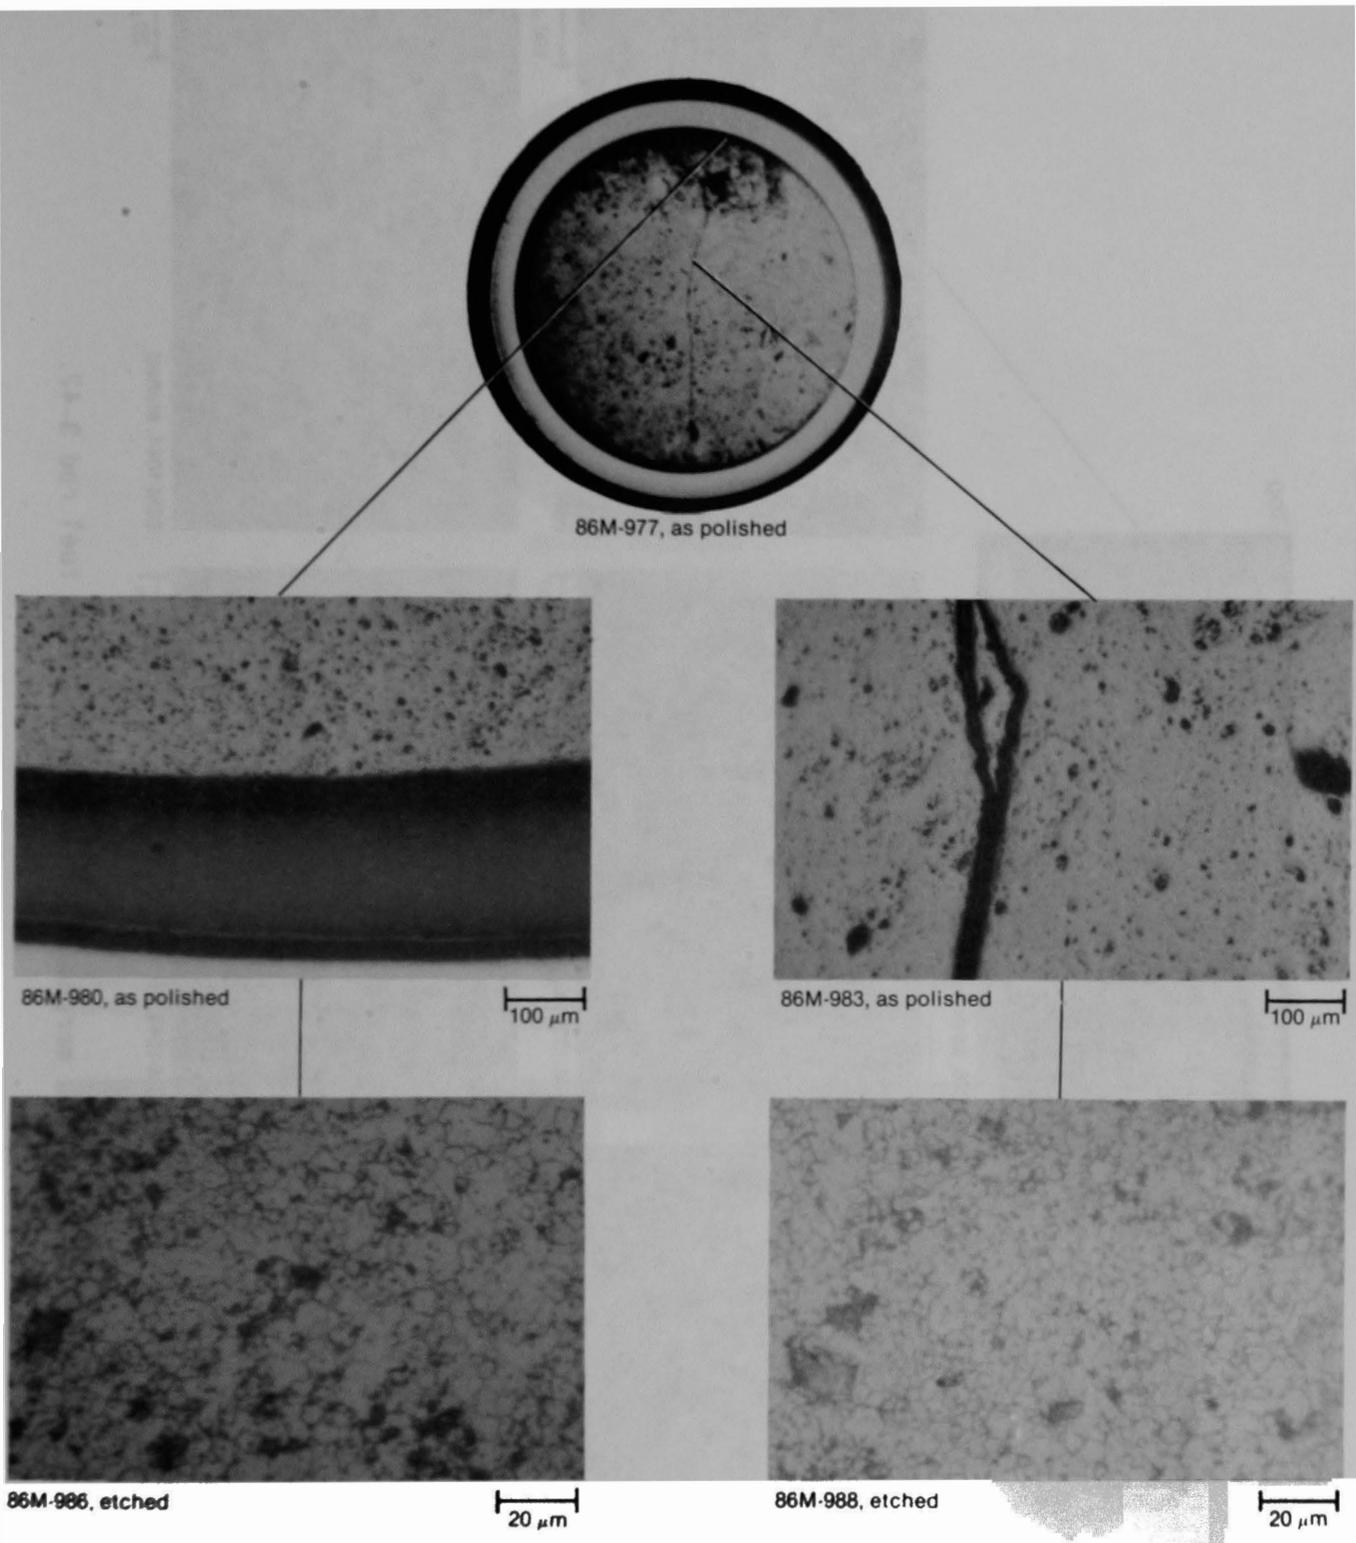
Figure 37. Fuel morphology in sample M-3 from fuel rod 3-30.
