EXAMINATION OF THE TMI-2 CORE
DISTINCT COMPONENTS

EXAMINATION OF THE TMI-2 CORE DISTINCT COMPONENTS

**S. M. Jensen
D. W. Akers
R. W. Garner
G. S. Roybal**

September 1987

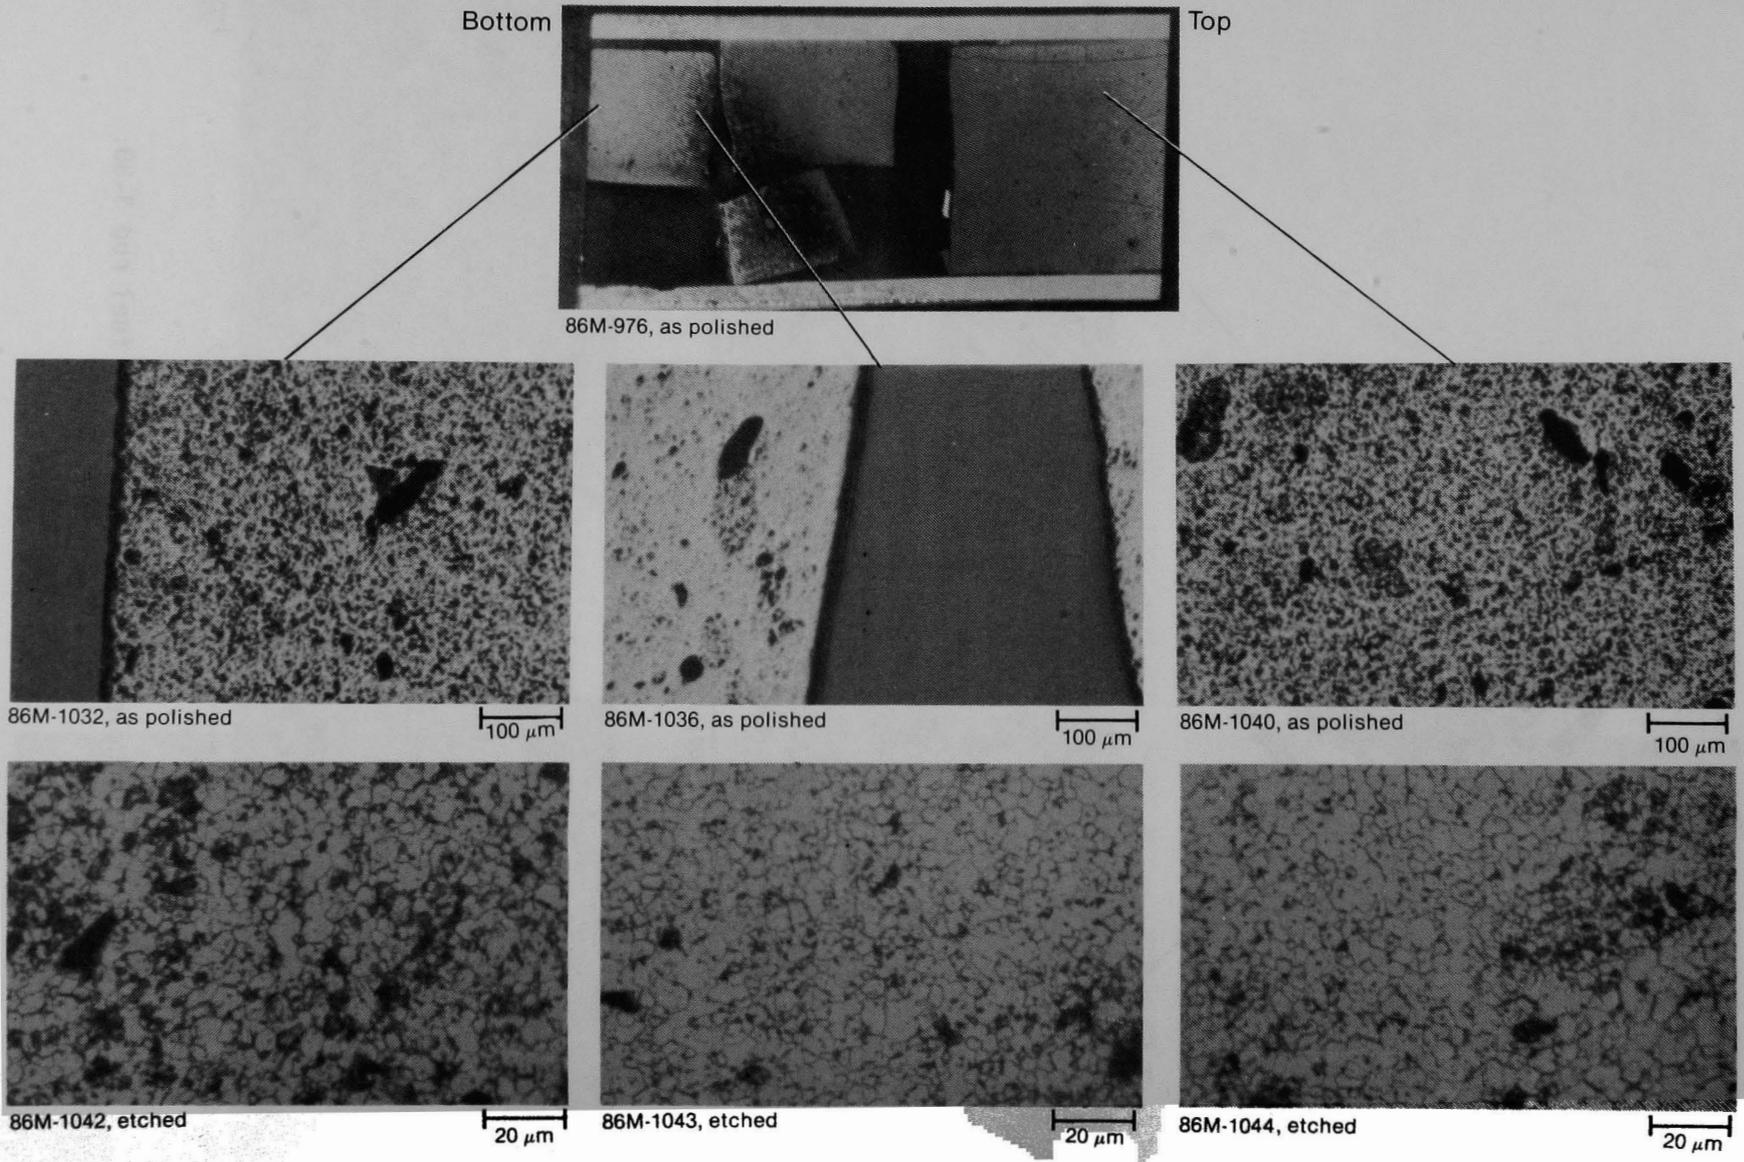
Figure 38. Fuel morphology in sample M-5 from fuel rod 3-42.

unusual characteristics or any definite evidence of fuel oxidation. The typical grain size of the fuel was 5-7 μm , however isolated regions where the grain size approached 10 μm were observed as shown in Figure 40. It is possible that these isolated regions were present in the as-fabricated condition.

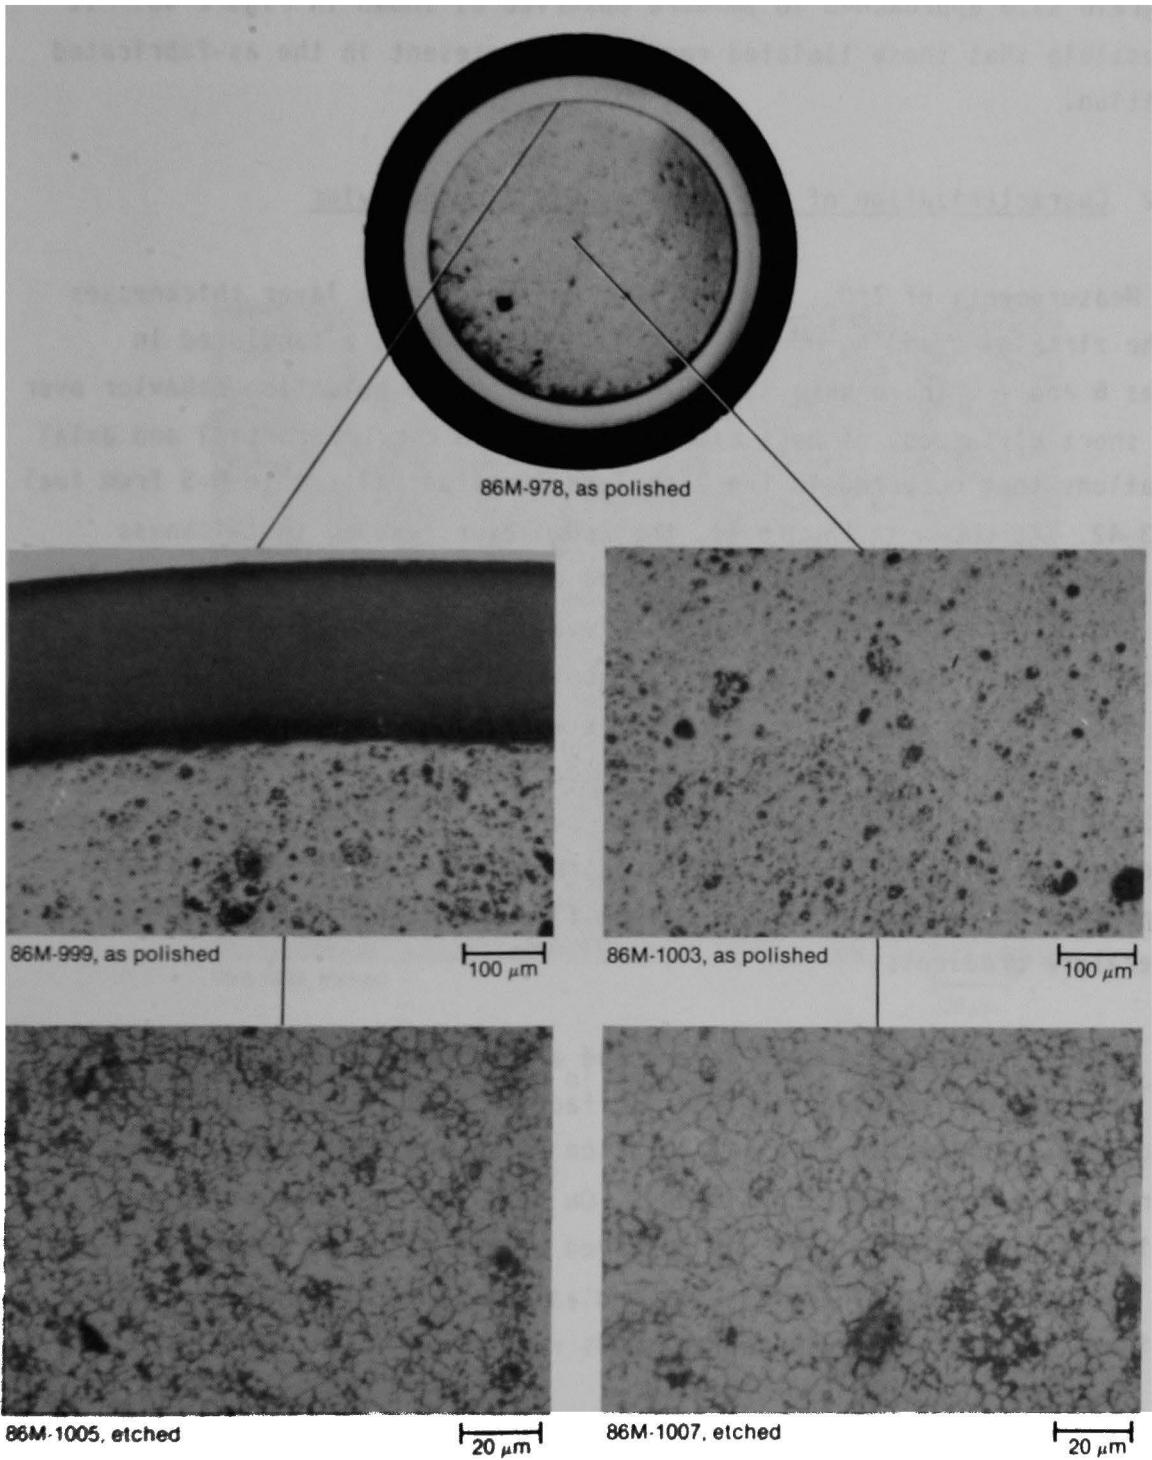
Figure 39. Fuel morphology in sample M-7 from fuel rod 3-42.

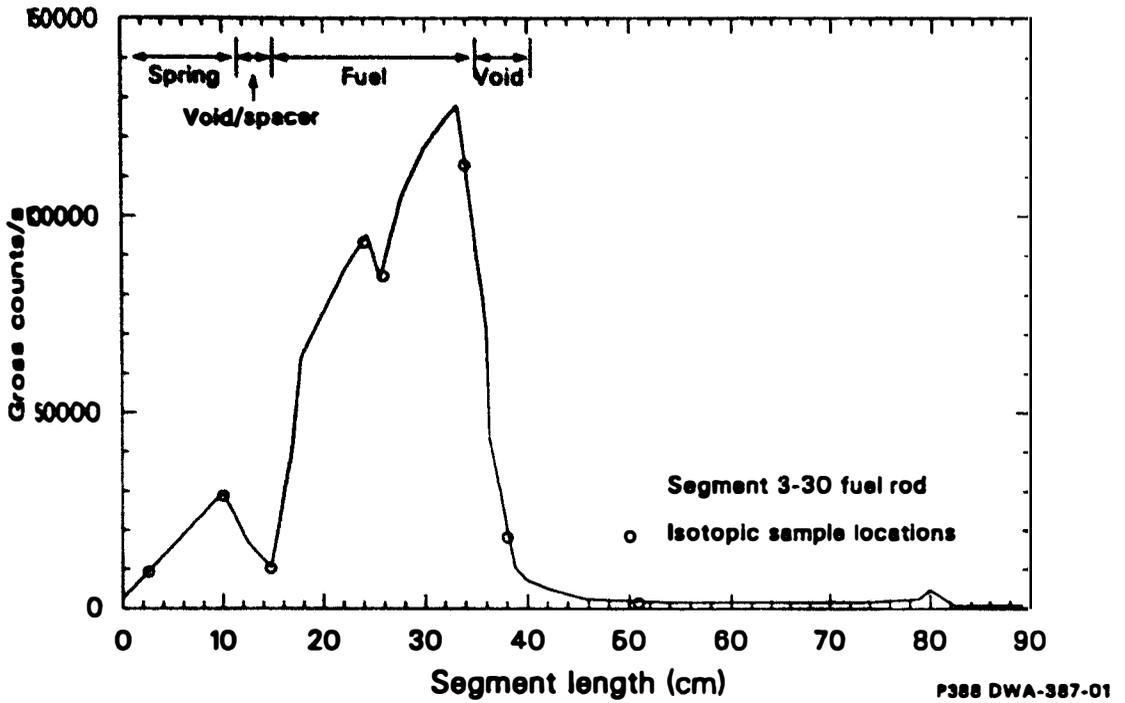
Rod 3-30. Rod 3-30 was obtained from rod position N11 in assembly C7. This location is next to a control rod and is approximately 2.9 cm from the edge of the assembly. From the neutron radiograph in Appendix Figure A-6, the total rod length is 40.4 cm of which the first 11.5 cm is the 304 SS spring region followed by a spacer and gap (3.5 cm), a fueled region of 19.4 cm, and 6 cm of empty cladding. This is the same total length of rod indicated in Figure 42, the gross gamma scan of this rod.

In Figure 42, a relatively small activity peak is present between 0 and 14 cm. The neutron radiograph of this sample indicates that the only rod components in this region are cladding, the 304 SS spring, and the zircaloy spacer. The isotopic analyses listed in Table 9 indicate that at 2.5 cm most measurable fission products (including Ce-144) were detected; however, the predominant radionuclides are Cs-137 and Co-60. The presence of Ce-144, a nonvolatile fission product, on a portion of the rod which does not contain fuel suggests the presence of particulate fuel material

Figure 42. Gross gamma scan of segment 3-30 fuel rod.

The reduction in activity from 12 to 15 cm (see Figure 42) is due to the void and zircaloy spacer as shown in the neutron radiograph of this portion of the rod. Below 15 cm is the fueled portion of the fuel rod. The visible increase in activity in Figure 42 from 15 to 35 cm is due to the increased neutron flux causing more fissions at lower locations in the assembly. The isotopic data indicate corresponding increases in activity from 15-34 cm for the measurable fission products. Also, Co-60 is measurable at most locations due to the activation of a component of the fuel rod cladding. The measured activities in the clad fuel region are 10^1 - 10^2 less than those measured in the spring region, which is to be expected because of the substantially smaller amount of Co-59 present in the cladding than in the 304 SS spring.

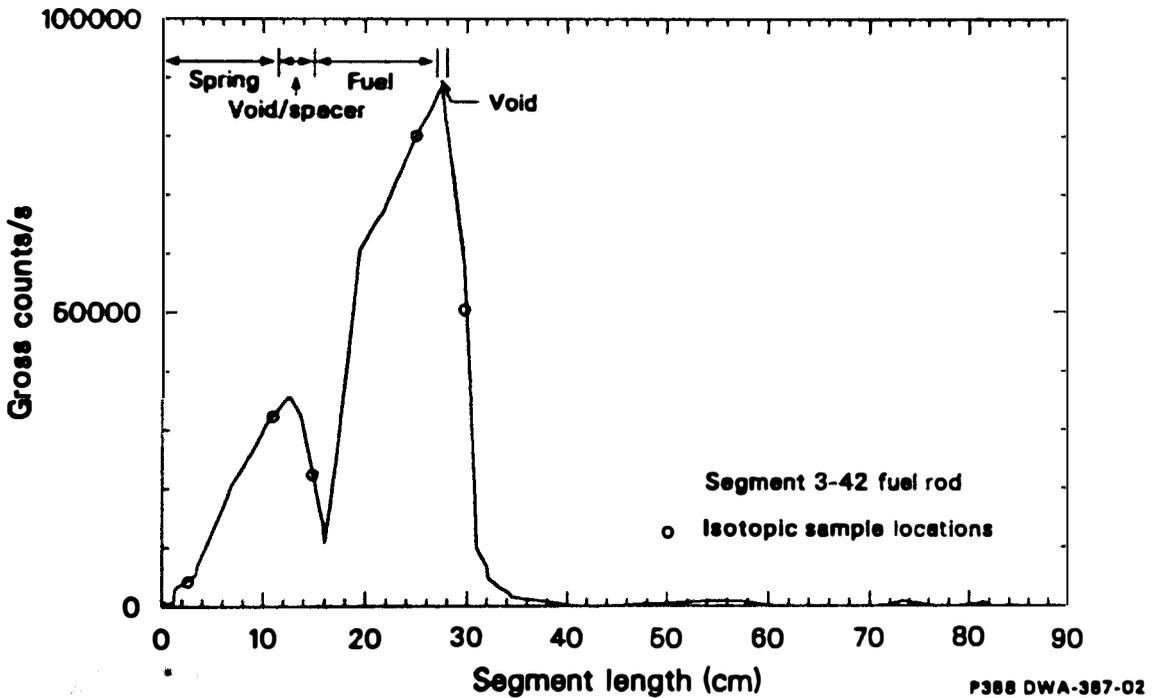
Figure 43. Gross gamma scan of segment 3-42 fuel rod.

Inspection of Figure 43 indicates a very similar gross gamma scan to that observed for fuel rod 3-30 (Figure 42) except that the rod (3-42) is located at about 2 cm from the bottom of the tube, thereby offsetting the rod components. As shown in Figure 43, a high activity peak is associated with the spring region (0-11.5 cm) of the rod. This peak is similar in shape to that observed for rod 3-30; however, higher count rates (15 to 20%) were measurable for this rod than were observed on rod 3-30. This would be expected as there is no adjoining control rod to reduce the available neutron flux at the location of rod 3-42. The isotopic data for the spring/spacer region of rod 3-42 (Table 9) indicates lower activities than those observed on rod 3-30 for all fission products; however, the Co-60 activities are substantially higher and would account for the increase in gross activity (Figure 43) over rod 3-30. Neither Ce-144 nor

The fueled region for rod 3-42 is from 15-25 cm from the top of the rod as determined from the neutron radiographs. The gross scan data in Figure 43 show expected increases in radionuclide activity due to increases in the neutron flux at lower locations in the core and consequential increases in fissioning of the fuel material.

The isotopic data at 30 cm from the top end of the rod are from the end of the fuel column (as indicated in the neutron radiograph) and show the presence of significant amounts of Cs-137, Sb-125 and Co-60. This activity may be due to the presence of loose fuel material in the end of the rod.

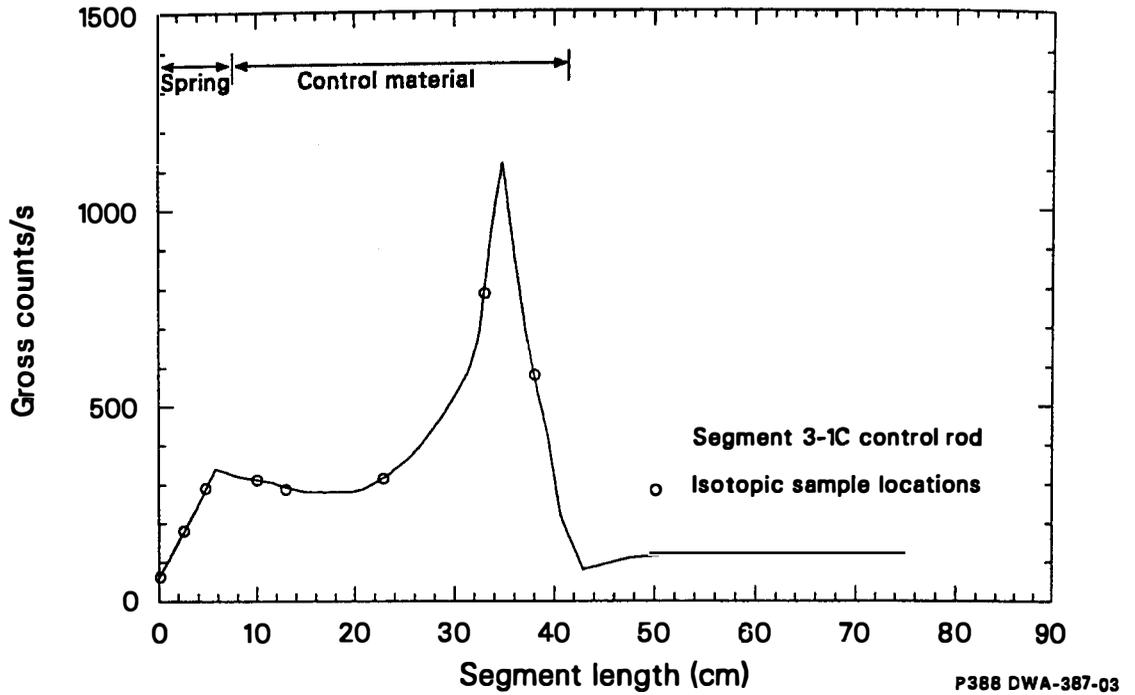
Figure 44. Gross gamma scan of segment 3-1C control rod.

Control Rod 3-1C and Guide Tube 3-1G. Control rod 3-1C and guide tube 3-1G were obtained from the N10 position next to fuel rod 3-30. This control rod/guide tube combination was located 2.9 cm from the edge of the assembly. Control rod 3-1C is 37 cm in length of which 31 cm contains control material, and the associated guide tube (3-1G) is about 36 cm in length. The control rod was separated from the guide tube, and each section was analyzed separately. The gross gamma scan results for the 3-1C control rod are shown in Figure 44 and indicate a relatively low concentration of fission products on the rod, with the greatest activity located approximately 35 cm from the end of the rod, which corresponds to the end of the guide tube. Isotopic data for the control rod 3-1C indicate a relatively similar concentration of Cs-137 along the length of the rod. The Cs-137 could have been deposited by coolant which flowed into the guide tubes through holes in the cladding after the accident. Sb-125 was only measurable on the control rod at the bottom end of the section. These data suggest possible surface deposition of Sb-125 at this location as there is no indication of particulate fuel (i.e., Ce-144), and the control rod cladding is 304 SS.

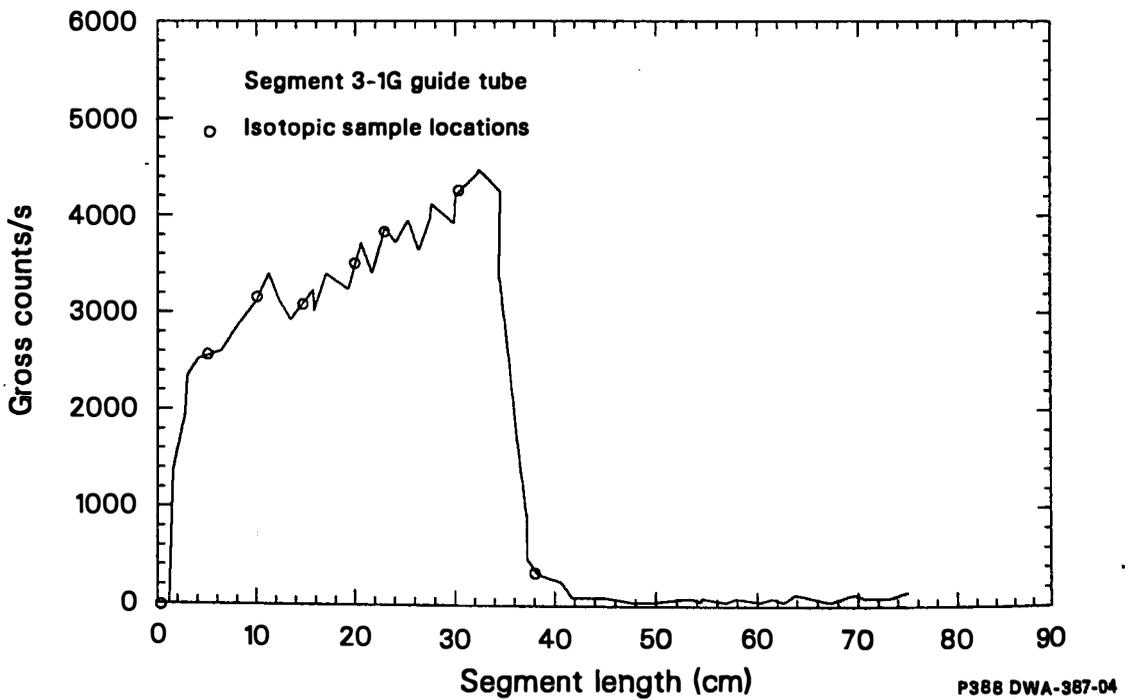
Figure 45. Gross gamma scan of segment 3-1G guide tube.

Guide tube 3-1G has a substantially different gross activity profile (shown in Figure 45) than that observed on the associated control rod. These data indicate a general increase in total activity from the top end of the guide tube to lower locations in the core. Based upon the isotopic data, the principal radionuclides present are Cs-137, Co-60, and Sb-125. The Cs-137 appears to be evenly deposited over the surface of the tube at concentrations approximately similar to those observed on the control rod. The Co-60 and Sb-125 concentrations increase from the top end of the tube to the broken end at about 35 cm. This increase is probably due to neutron activation of the iron (Fe) and tin (Sn) constituents of the zircaloy guide tube.

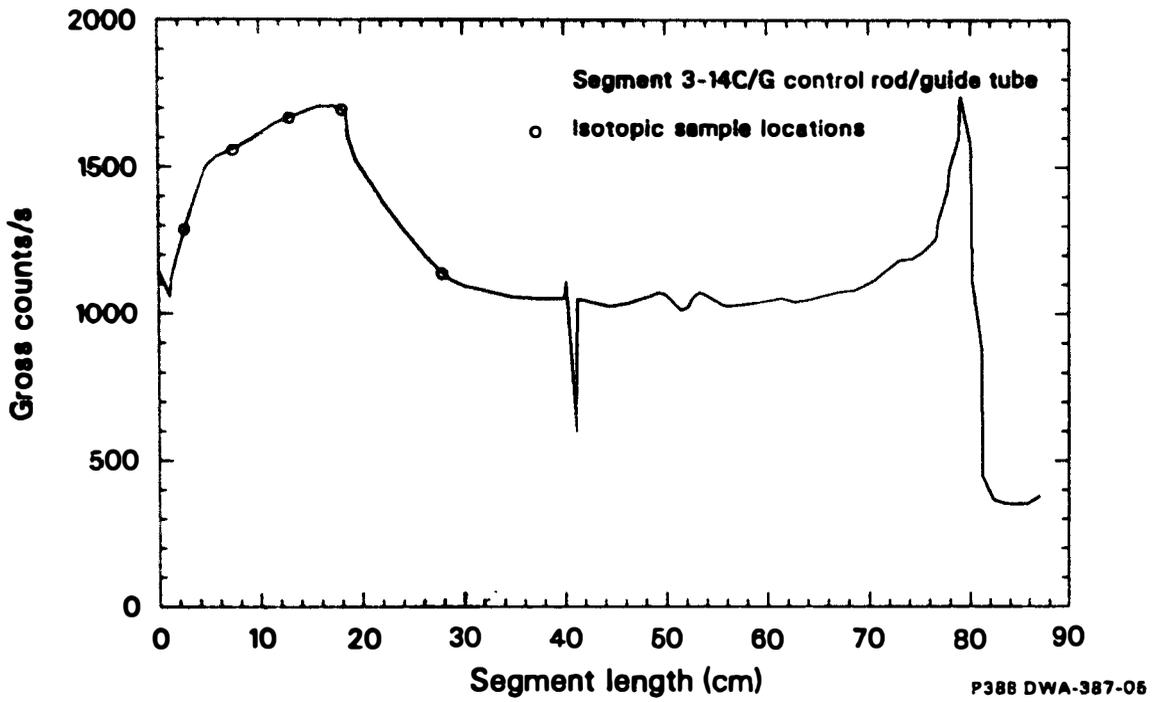
Figure 46. Gross gamma scan of segment 3-14C/G control rod/guide tube.

Control rod and guide tube 3-14C/G. The 3-14C/G was obtained from position C6, approximately 2.9 cm from the edge of the assembly. The control rod and guide tube were not separated for this analysis. The guide tube section is approximately 24 cm long and the control rod is about 17.8 cm long, as shown in the neutron radiograph in Appendix Figure A-30. The gross gamma scan (Figure 46) indicates a relatively constant distribution of activity along the length of the rod. This activity ends at the approximate end of the guide tube (about 25 cm). Beyond 25 cm, the activity measured is due to background in the tube from loose debris and surface contamination of the tube interior during handling. The isotopic data in Table 9 indicate similar activities for all radionuclides to those observed for guide tube 3-1G.

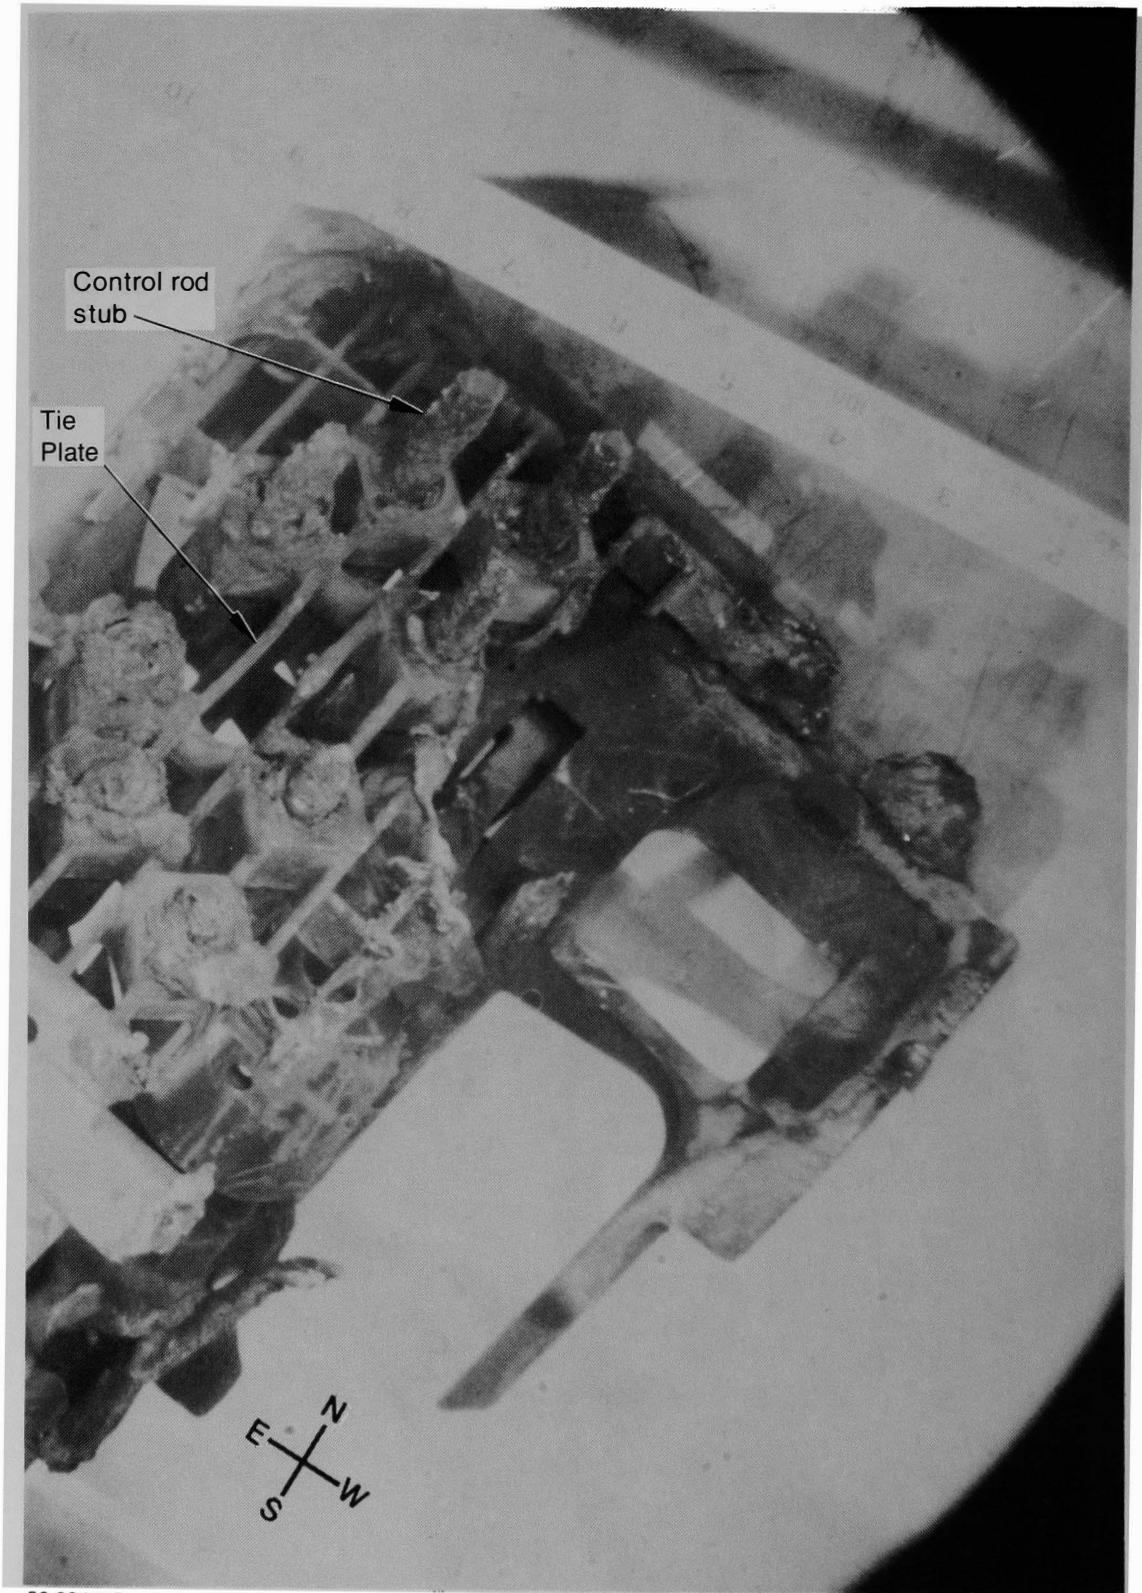
86-384-1-5

Figure D-2. Bottom view of component D-141-1.

The apron and all material below the tie plate are missing from component D-141-1 except for a few small stubs of control rod material. The heaviest damage occurred in the southwest corner where the tie plate, mixing cup, upper regions of the end fitting, the spring retainer, and the control rod spider have melted away. Drips of previously melted material are present on portions of the end fitting and spider. The holddown spring is completely missing. The tie plate is generally intact on the eastern half of the assembly, while the upper end fitting (above the tie plate elevation) is, with the exception of the southwest corner, generally intact.

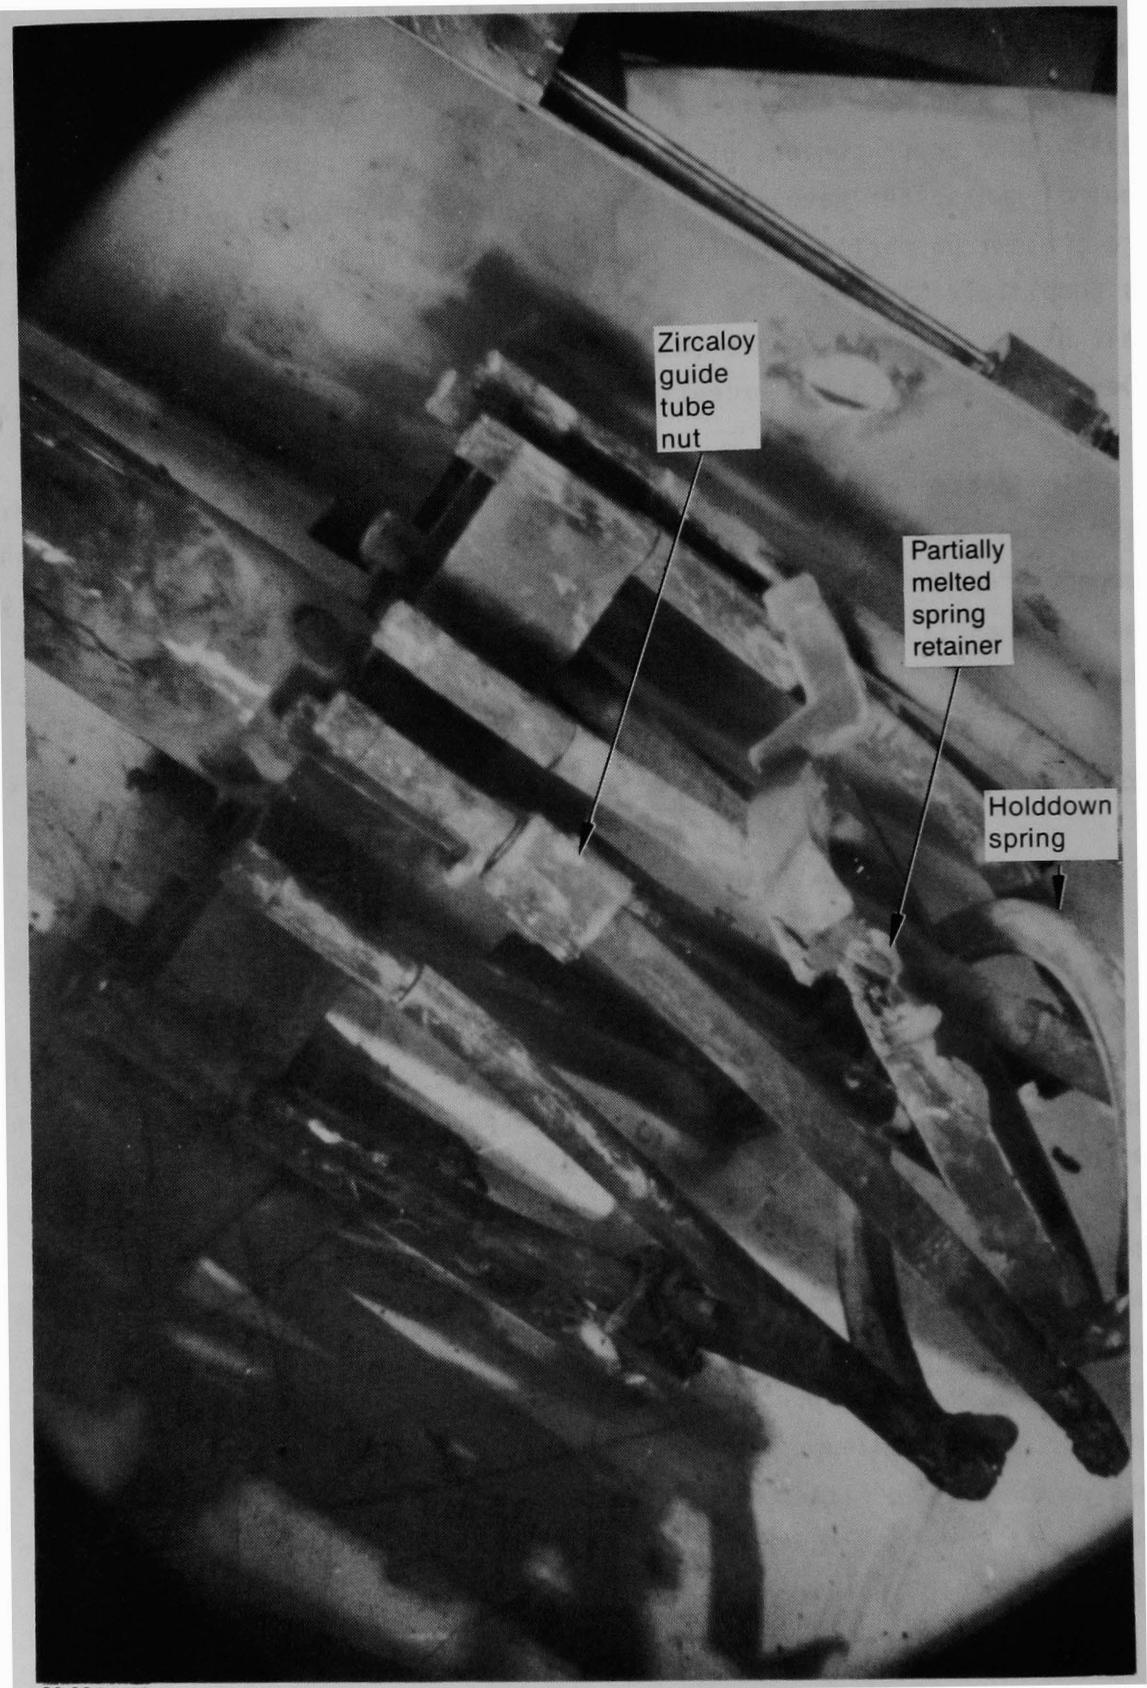
86-384-1-13

Approximately 15 to 20 cm (6 to 8 in.) of control rod cladding still remains on component D-141-2. This corresponds to the approximate length to the tie plate when the spider is fully inserted. Some of the zircaloy guide tube nuts have slipped upward and most, if not all, were partially melted. The melting could have occurred as a result of a Fe-Zr eutectic reaction between the zircaloy guide tube nuts and either the 304 SS tie plate or the control rod cladding at a minimum temperature of approximately 1220 K. However, the presence of prior-molten regions on the spring retainer indicates temperatures were in excess of 1673 K near the upper portion of the end fitting. The presence of prior-molten endpoints on the remaining portion of the holddown spring further supports temperatures in excess of 1666 K in this region.

Figure D-3. Component D-141-2. Partially melted control rod spider.

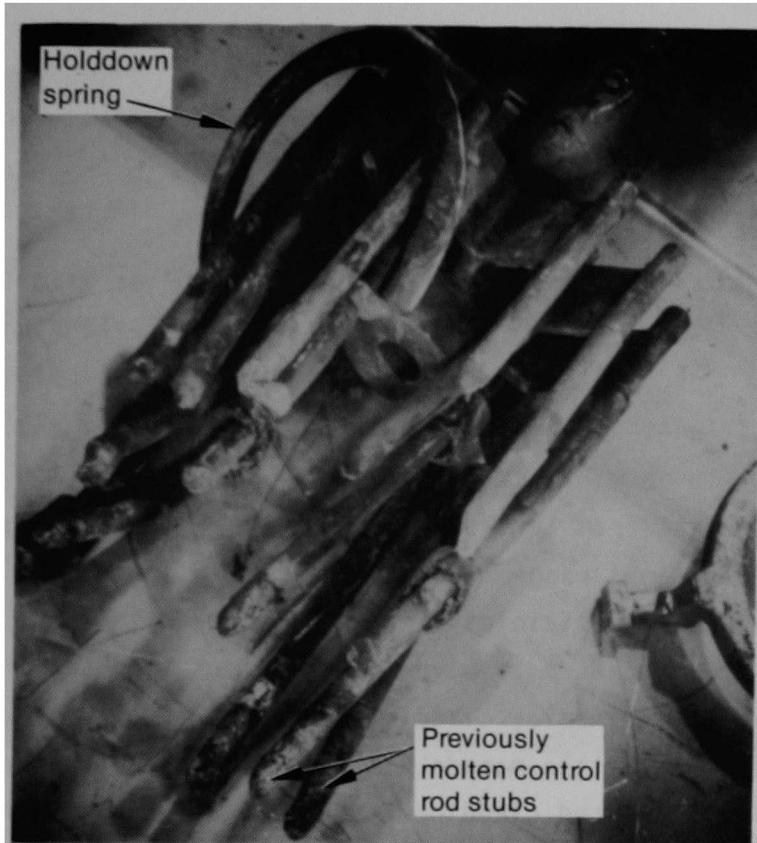
86T-6

Figure D-4. Bottom view of component D-141-2. Control rod spider.

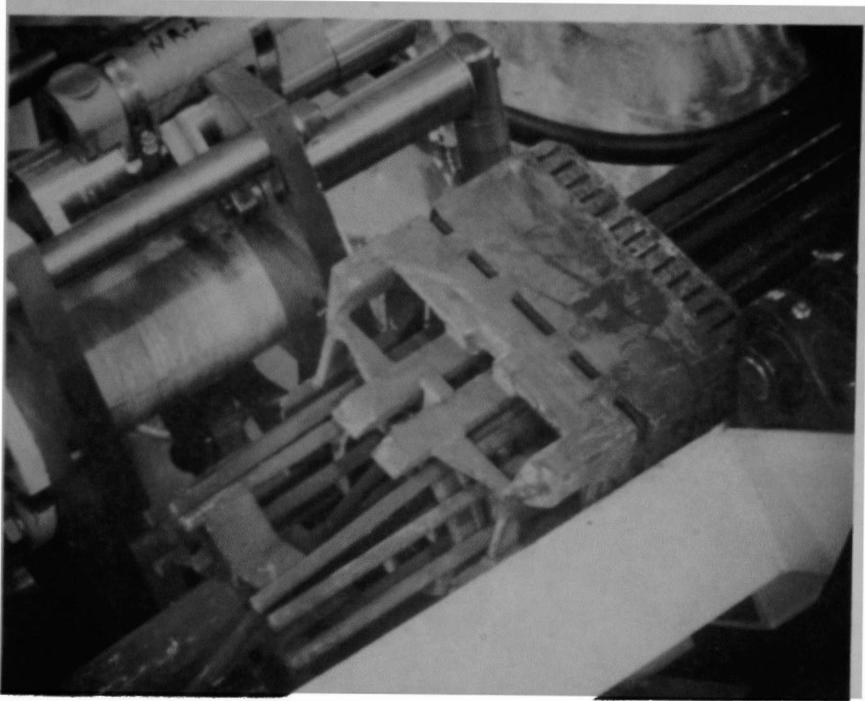
86T-49

Component D-141-3 was intact from the upper spacer grid to the top of the control rod spider and had fuel and control rods extending well below the upper spacer grid. Most of the fuel rods were later removed from the assembly and had lengths ranging from approximately 47 cm (19 in.) in the southwest corner to about 20 cm (8 in.) in the northeast corner. The control rods were cut from the assembly just below the upper spacer grid, and the removed sections ranged from approximately 15 to 38 cm (6 to 15 in.) in length. The stainless steel cladding on the lower ends of some of the control rods appeared to have been previously melted; however, all the lower ends of the zircaloy cladding on the fuel rods appeared to have been broken off in a brittle manner. Typical examples are shown in Figure D-6. These fuel rod cladding fractures, along with some bent endtips on control rods (Figure D-7), probably occurred when this component fell to the debris floor in the reactor or during loading into the canister. The small region of damage to the apron and spacer grid on the northwest corner (Figure D-8), and similar damage on the southeast corner, may have occurred in getting the component in and out of the shipping canister.

The presence of intact stainless steel cladding on the control rods, which in some cases was melted near the endtips, indicates temperatures were near 1673 K, approximately 20 to 25 cm (8 to 10 in.) below the upper spacer grid in the southeast corner, and approximately 35 cm (14 in.) below

Figure D-5. Component D-141-3. Partial fuel assembly in disassembly trough.

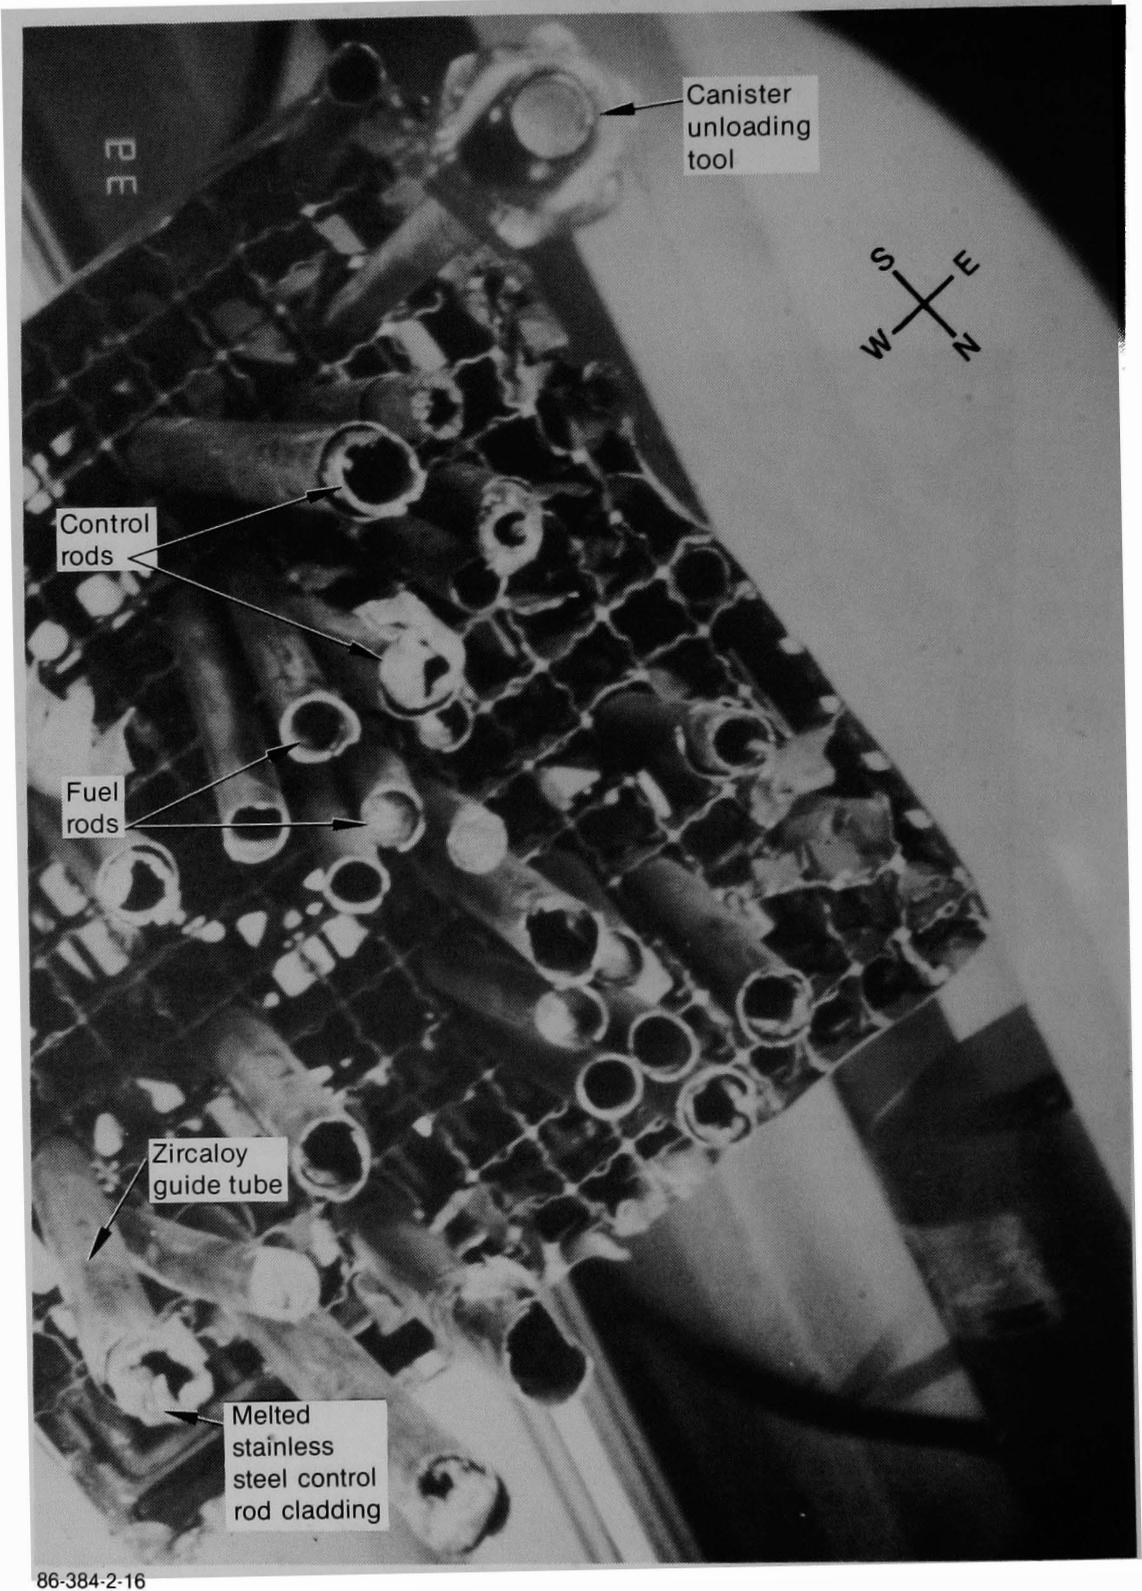
Figure D-6. Bottom view of component D-141-3 after removal of most fuel rods.

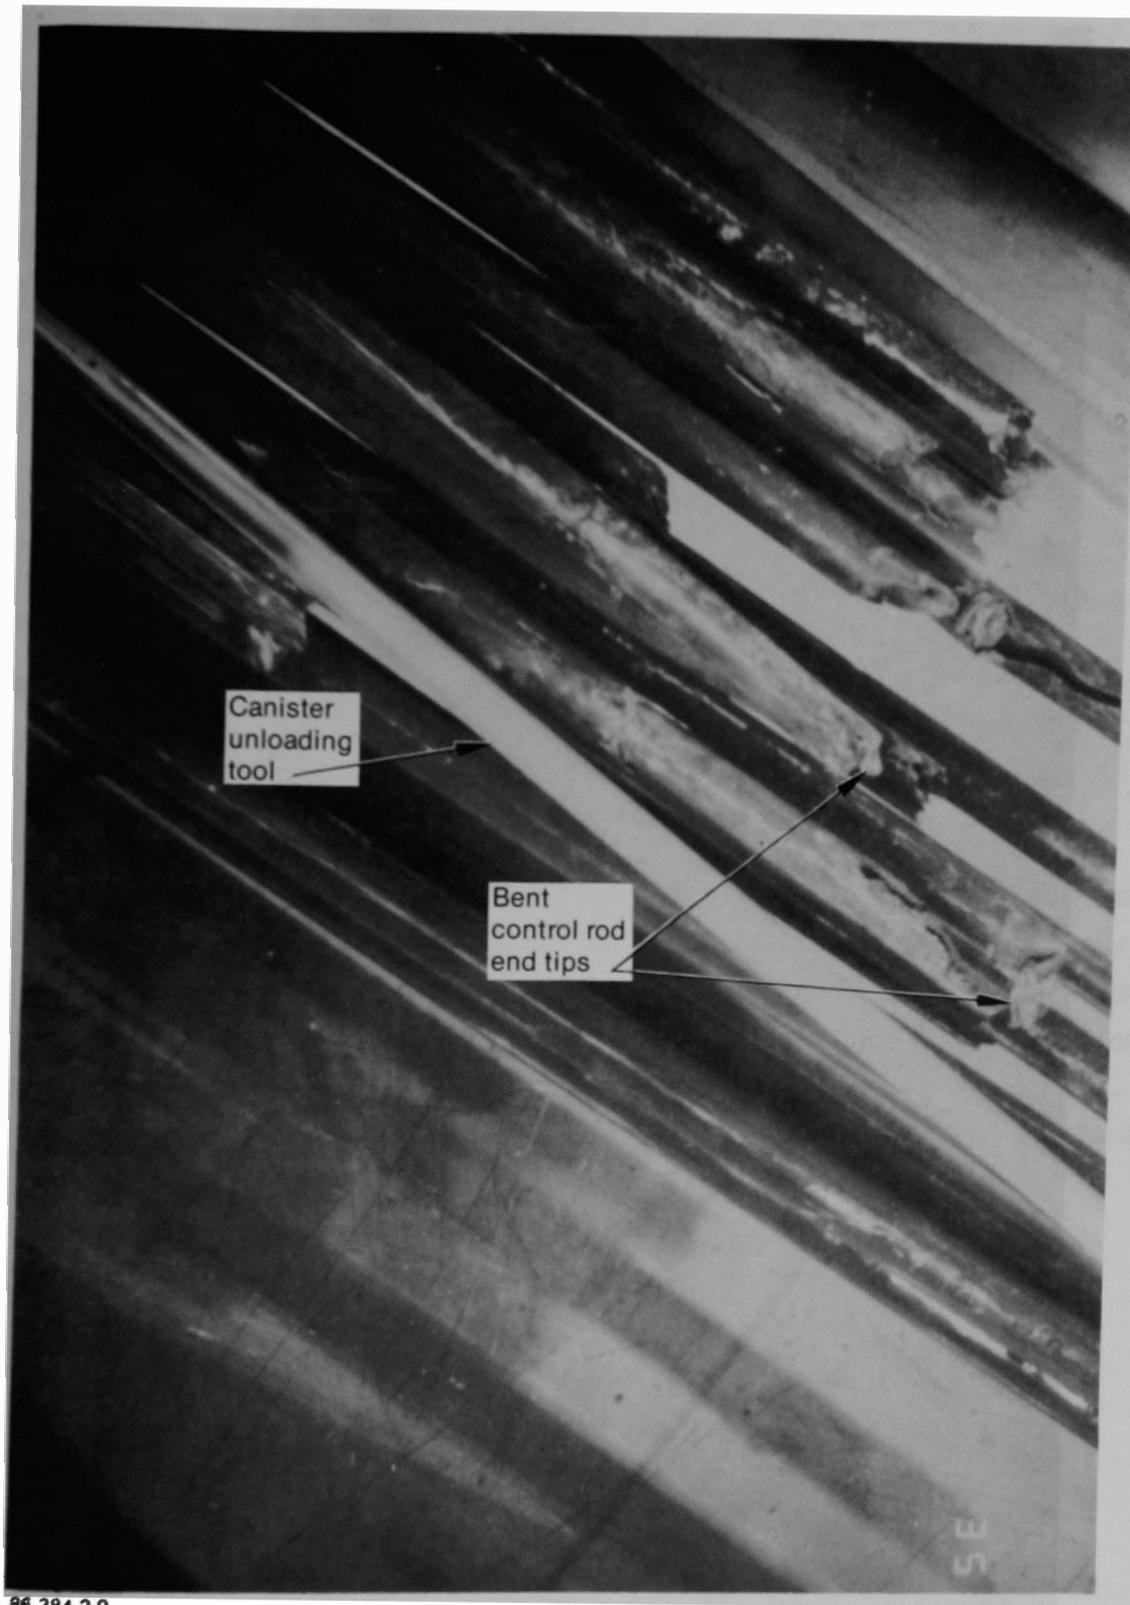
Figure D-7. Control rod stubs of component D-141-3 after removal of most fuel rods.

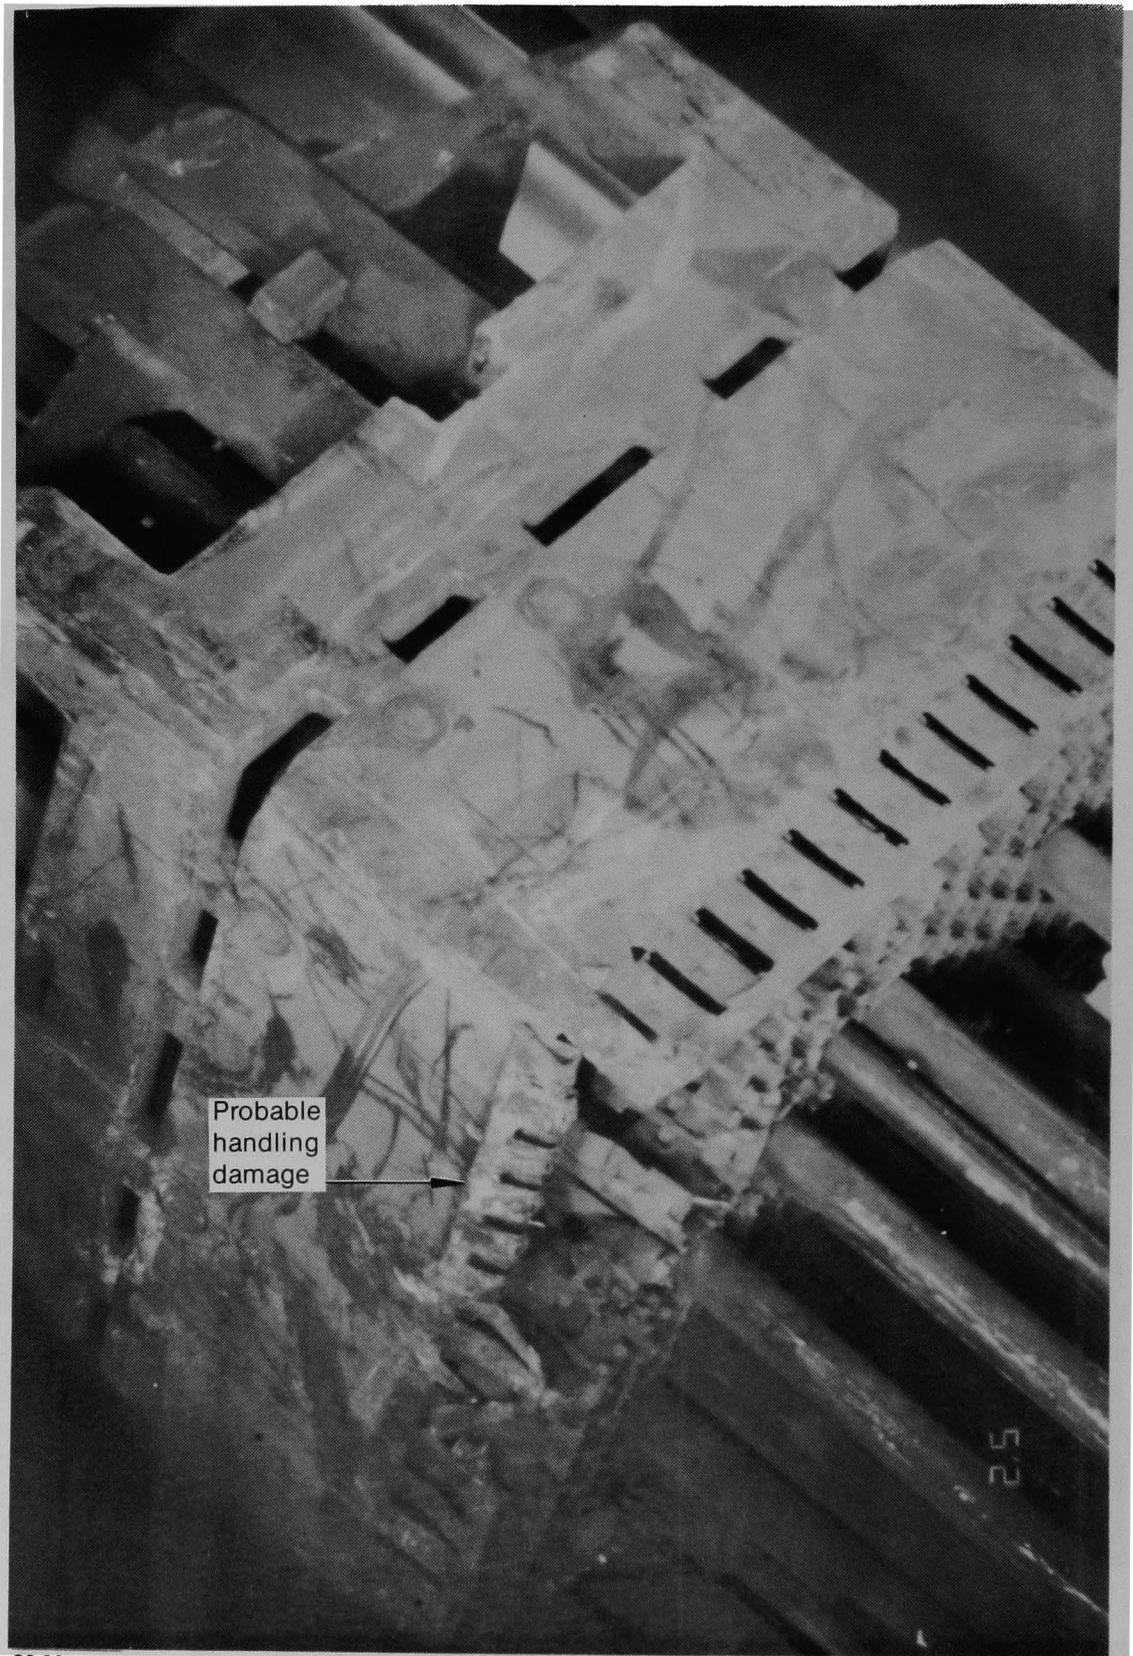
86-384-2-2

Figure D-8. Northwest corner of component D-141-3 showing damaged apron.
