EXAMINATION OF THE TMI-2 CORE
DISTINCT COMPONENTS

EXAMINATION OF THE TMI-2 CORE DISTINCT COMPONENTS

**S. M. Jensen
D. W. Akers
R. W. Garner
G. S. Roybal**

September 1987

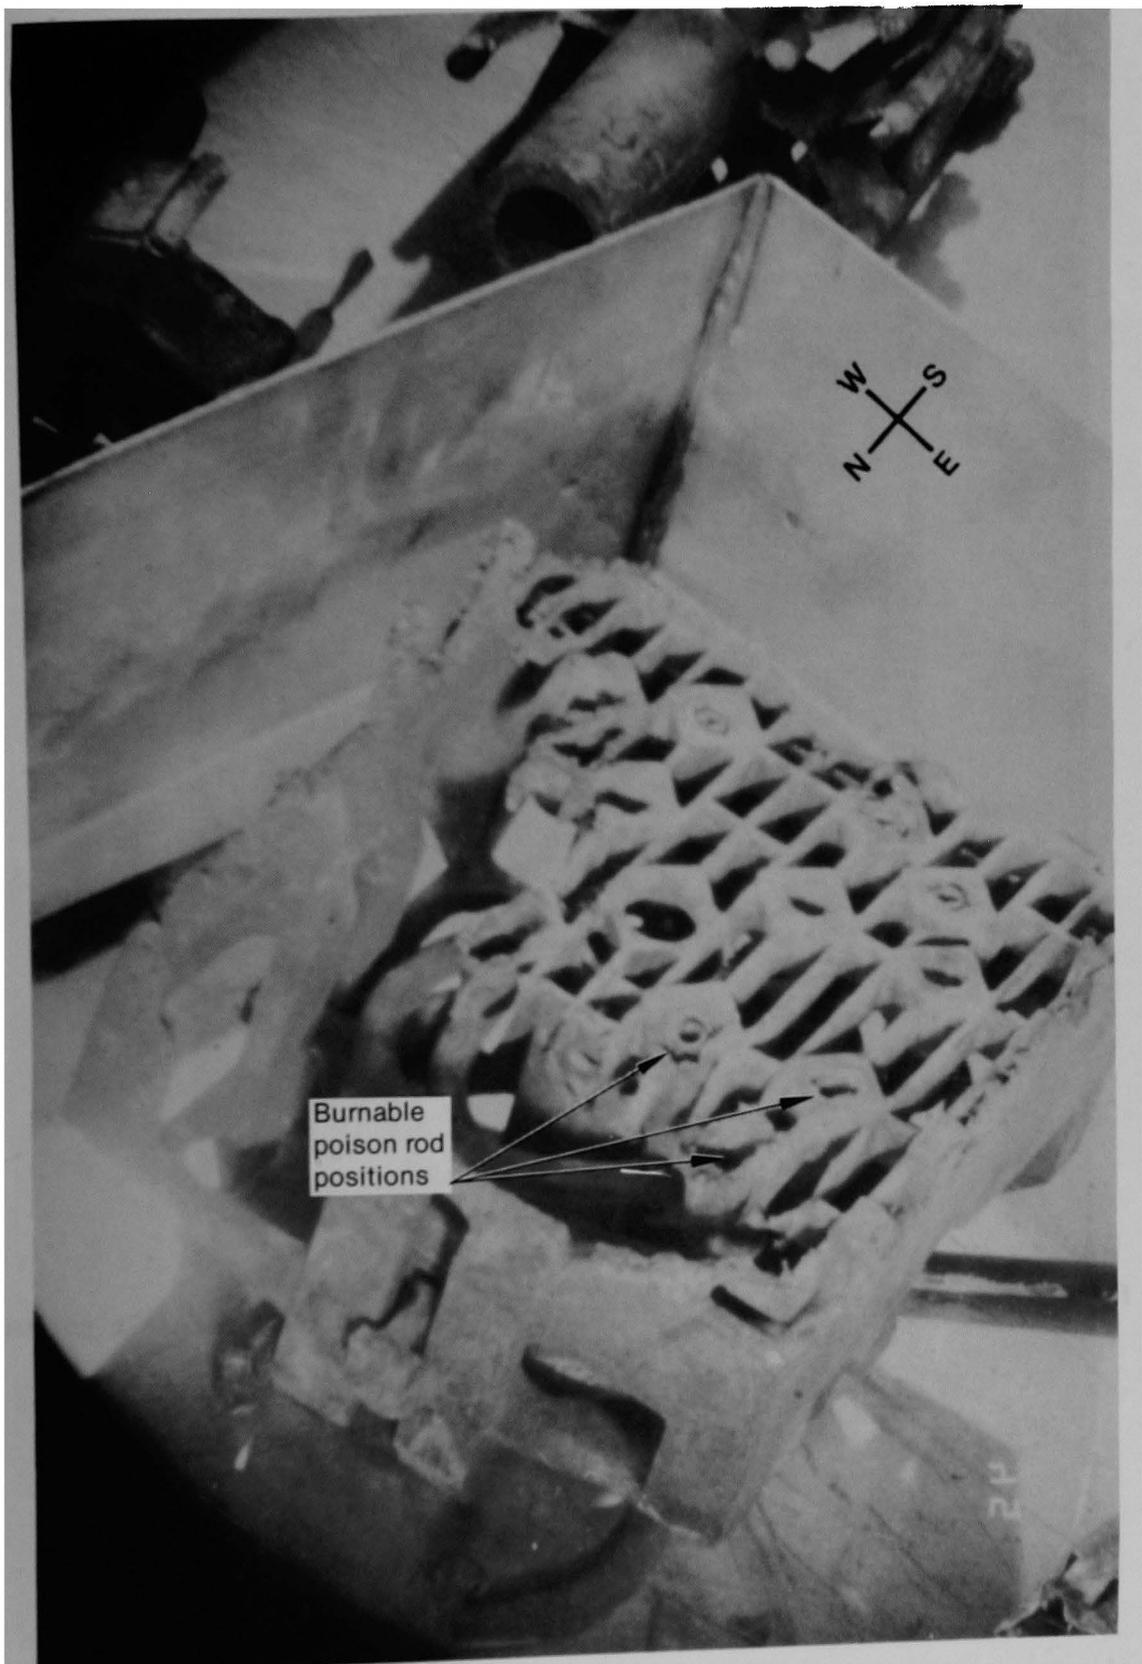
The greatest damage to component D-141-4 occurred on the north side where the prior-molten region included the tie plate and the upper sides of the end fitting. On the west side, the tie plate had partially melted away and some minor melting of the sides of the end fitting above this elevation also occurred. Figure D-11 shows details of the melted/unmelted transition zone around the burnable poison rod/guide tube positions in the tie plate. The damage immediately surrounding the guide tube positions may be due to a Fe-Zr eutectic reaction, however this is uncertain unless detailed examinations are performed. In the regions on the north and west side where the tie plate and end fitting sides were melted, peak temperatures were greater than 1673 K.

Figure D-10. Bottom view of component D-141-4.

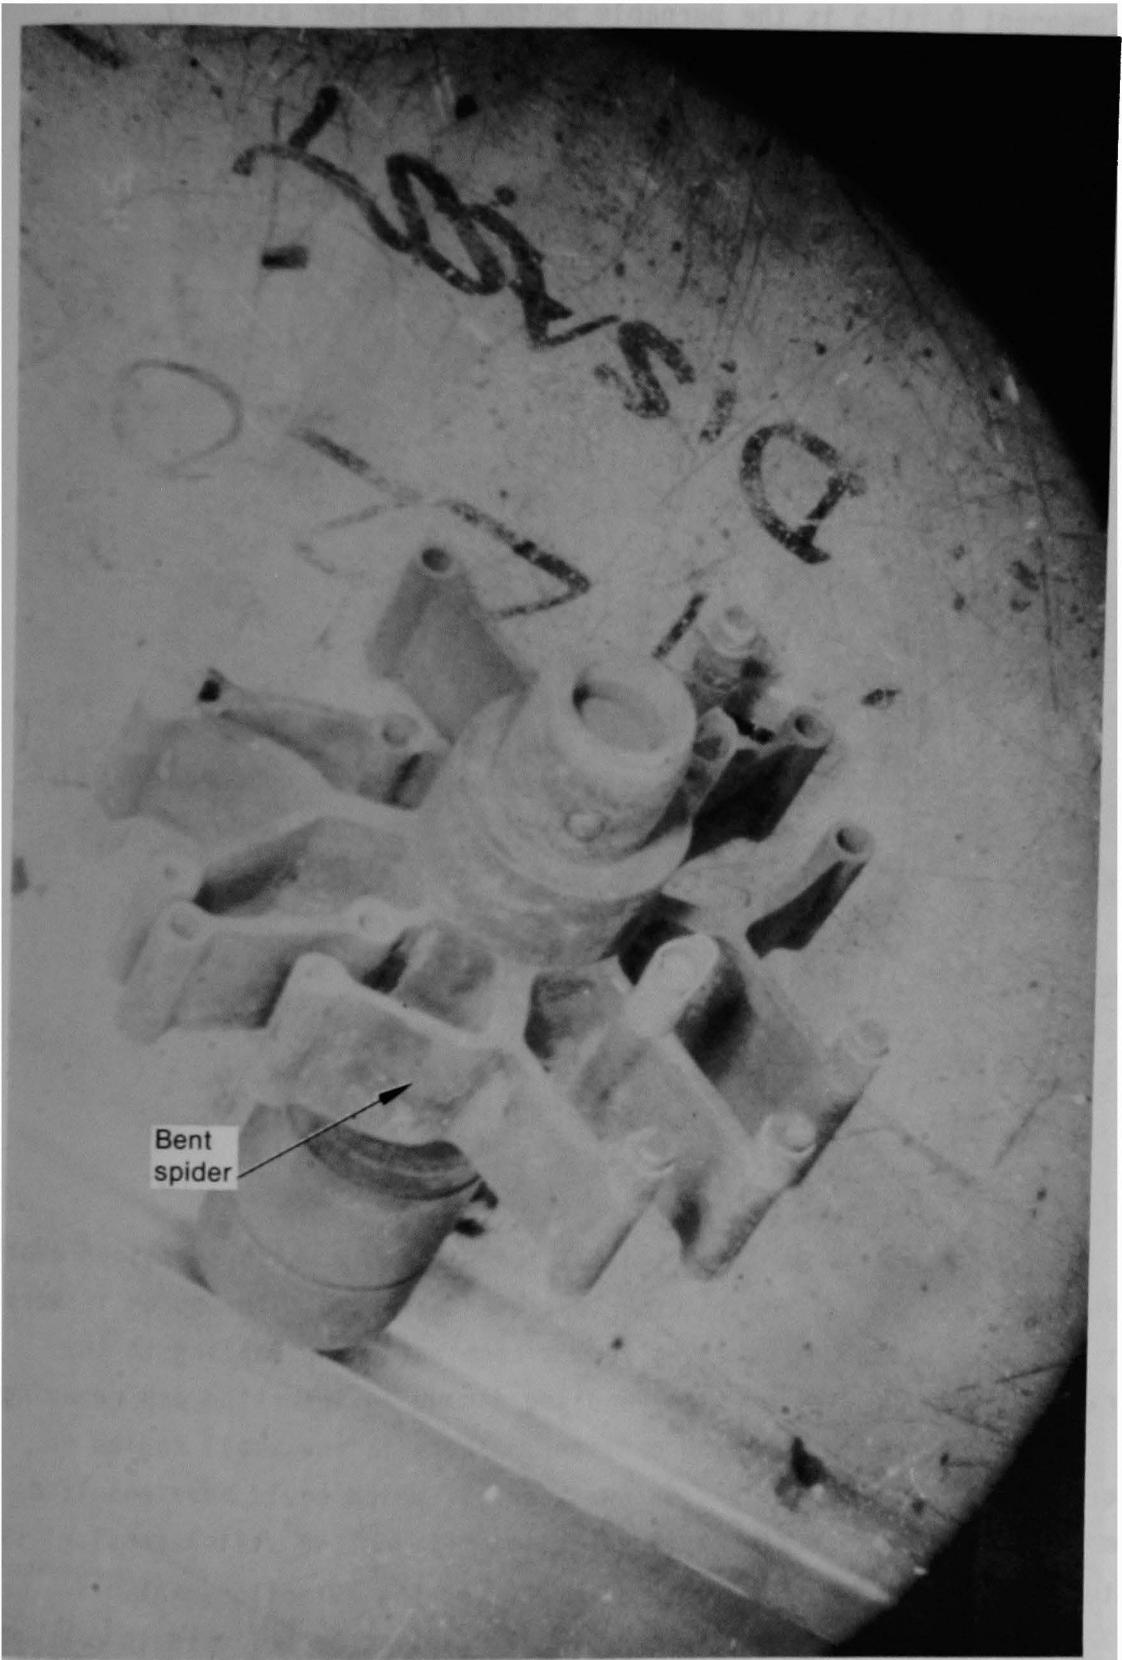
86-384-3-3

Figure D-12. Component D-141-5. Burnable poison rod spider from end fitting component D-141-4.

Component D-141-5 is the burnable poison rod spider assembly corresponding to the upper end fitting identified as component D-141-4. The arms on the spider are bent and only 8 of the 16 burnable poison rod stubs are present. No melted regions are apparent and the rod stubs appear to have been broken off. The bending of the spider arms may have occurred during loading into the fuel canister. The condition of this component further indicates that temperatures were lower than 1673 K in the upper regions of core position N9 where this and component D-141-4 were originally located.

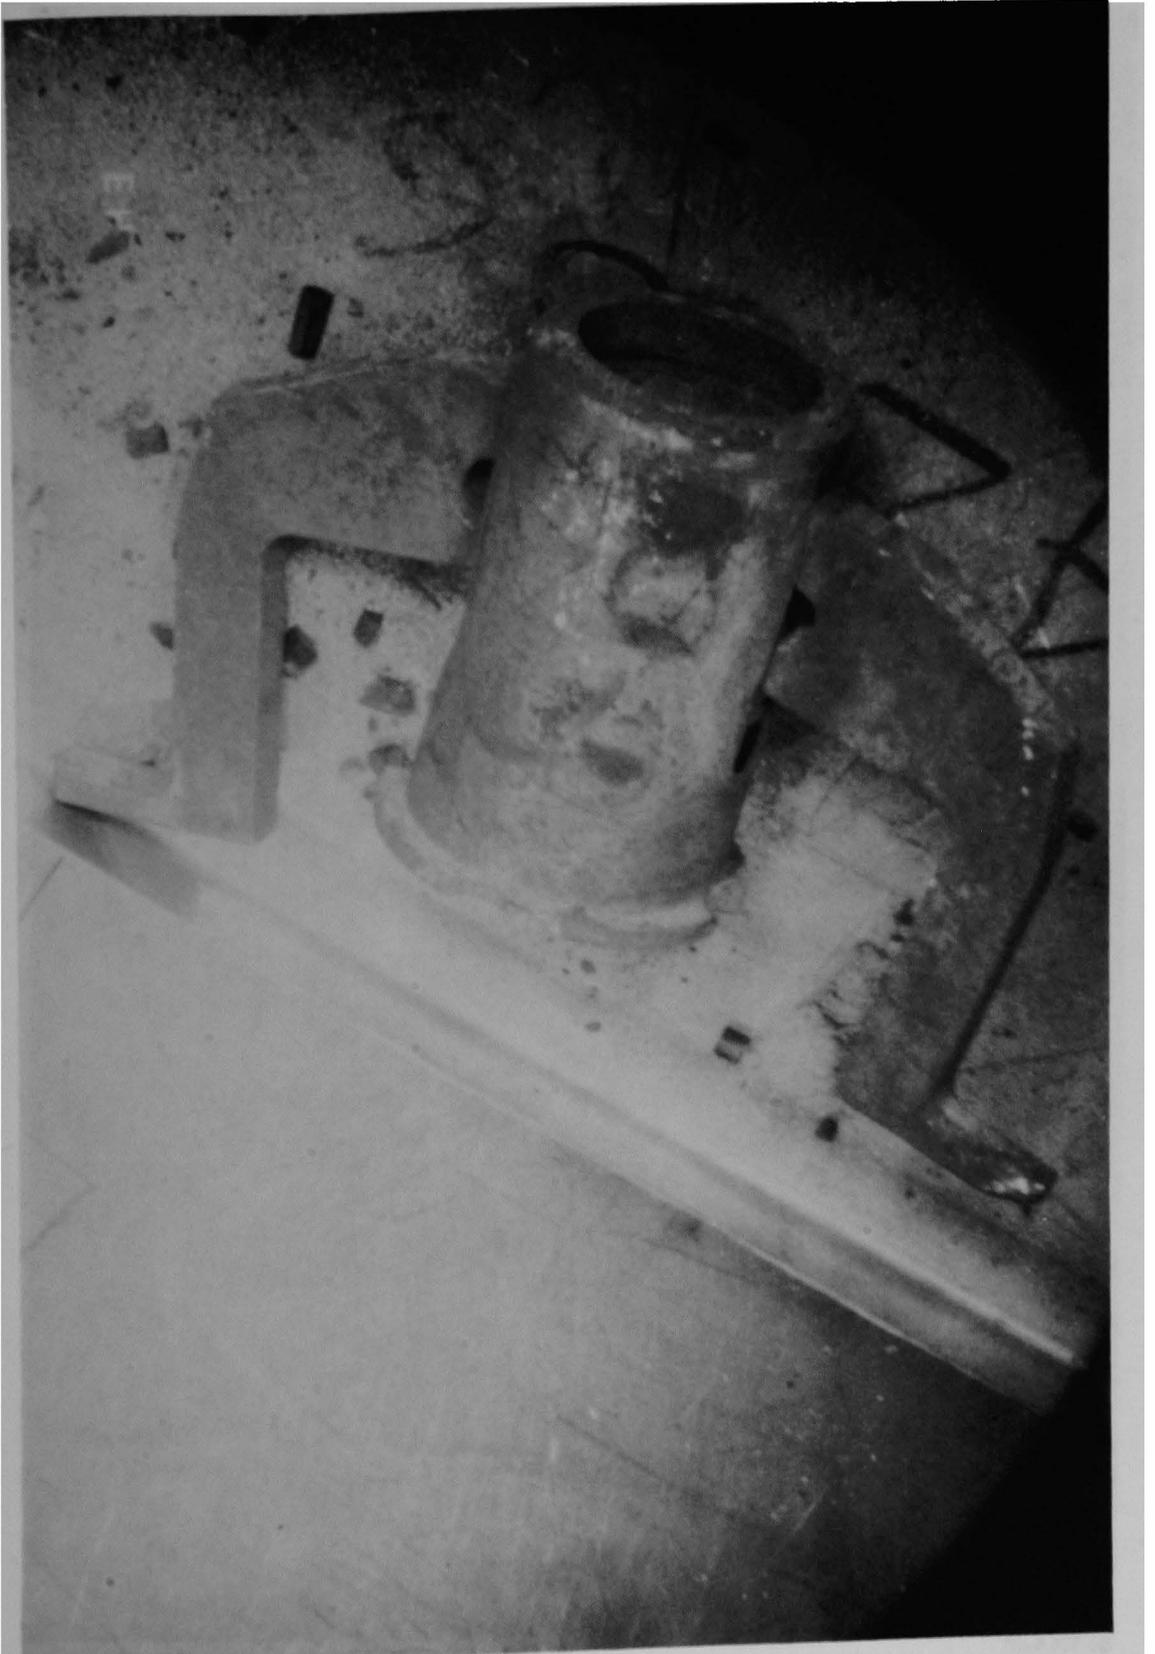
86-384-3-4

No prior-molten regions or damage were observed on component D-141-6. This component fits over the top of the spider and presses down on the spring retainer.

Figure D-13. Component D-141-6. Burnable poison rod assembly retainer.

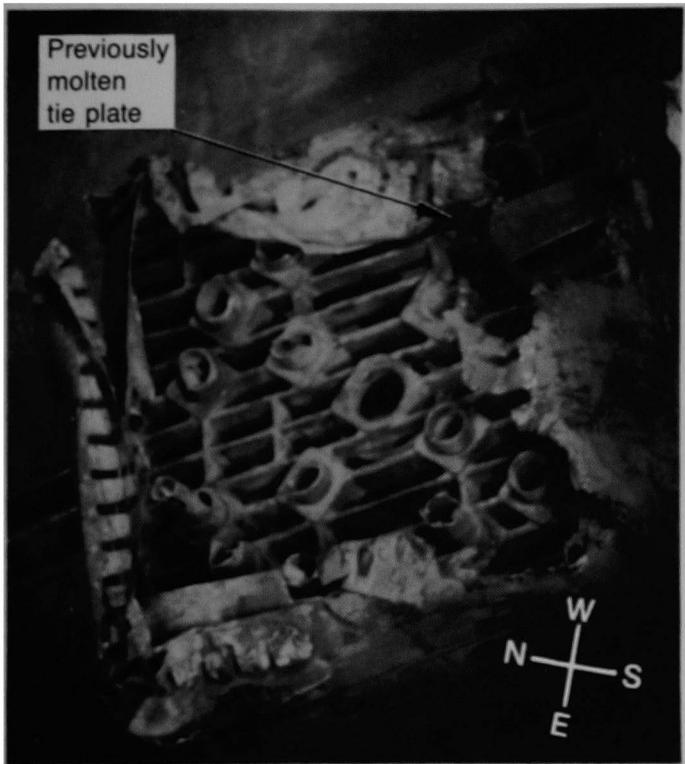
86T-112

Component D-141-7 was a peripheral fuel assembly which contained empty guide tubes. No rod assembly spider was ever attached. The apron is very bent and torn, probably resulting from a combination of falling to the debris floor in the reactor, and handling damage in inserting and removing the component from the shipping canister. There is one small region of prior-molten tie plate in the southwest corner which could have resulted from a localized Fe-Zr eutectic interaction between the stainless steel tie plate and the zircaloy guide tube sleeves. At the eutectic point (~1220 K), the stainless steel-zircaloy interaction is believed to proceed very slowly; however, at temperatures above 1470 K the reaction approaches

Figure D-15. Bottom view of component D-141-7.

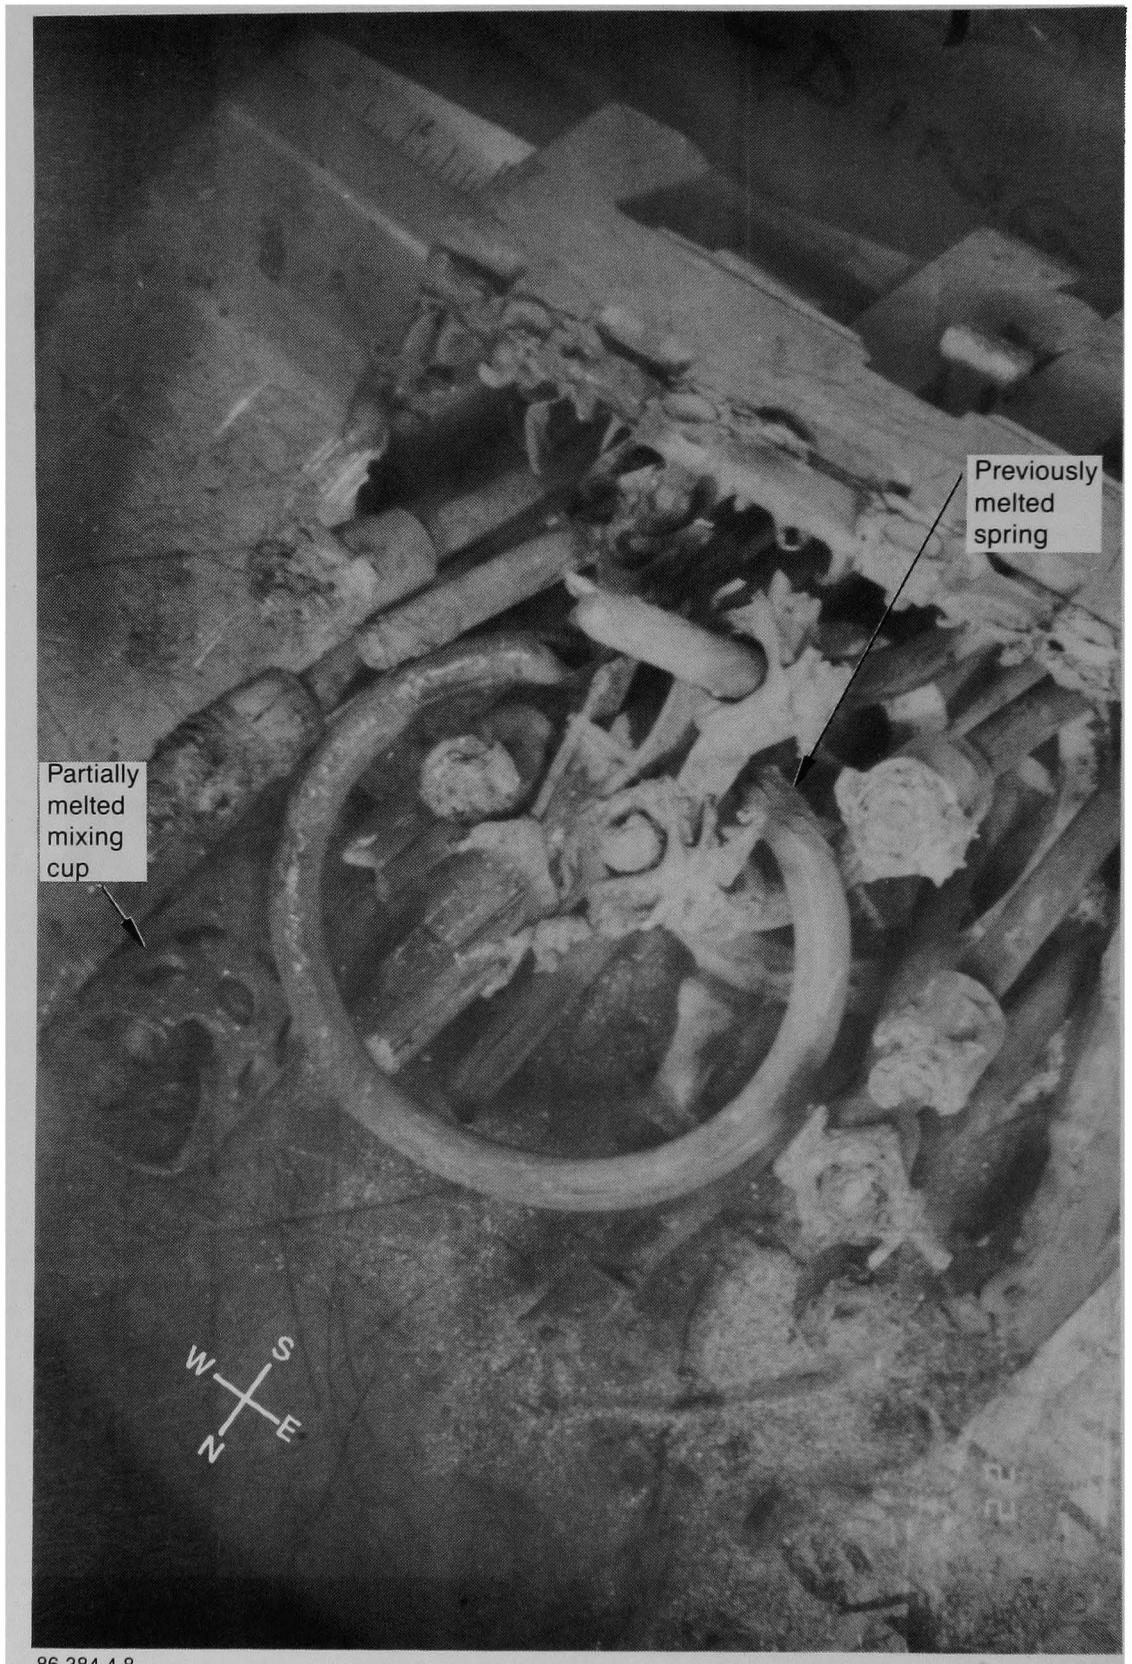
The greatest damage to component D-141-8 occurred on the north side where the upper end fitting is completely gone. There is also a small region of incipient melting on the spring retainer on this side of the assembly. The control rods on the north side were melted above the tie plate elevation and the guide tube nuts are gone. In contrast, the control rods are intact down to the guide tube nuts on the south side of the assembly. The tie plate and apron are completely gone over the entire assembly, and the one remaining spring coil was melted on at least one end. The bottom portion of the mixing cup was also partially melted (this fell out of the end fitting after it was removed from the canister).

Figure D-17. Bottom view of component D-141-8.

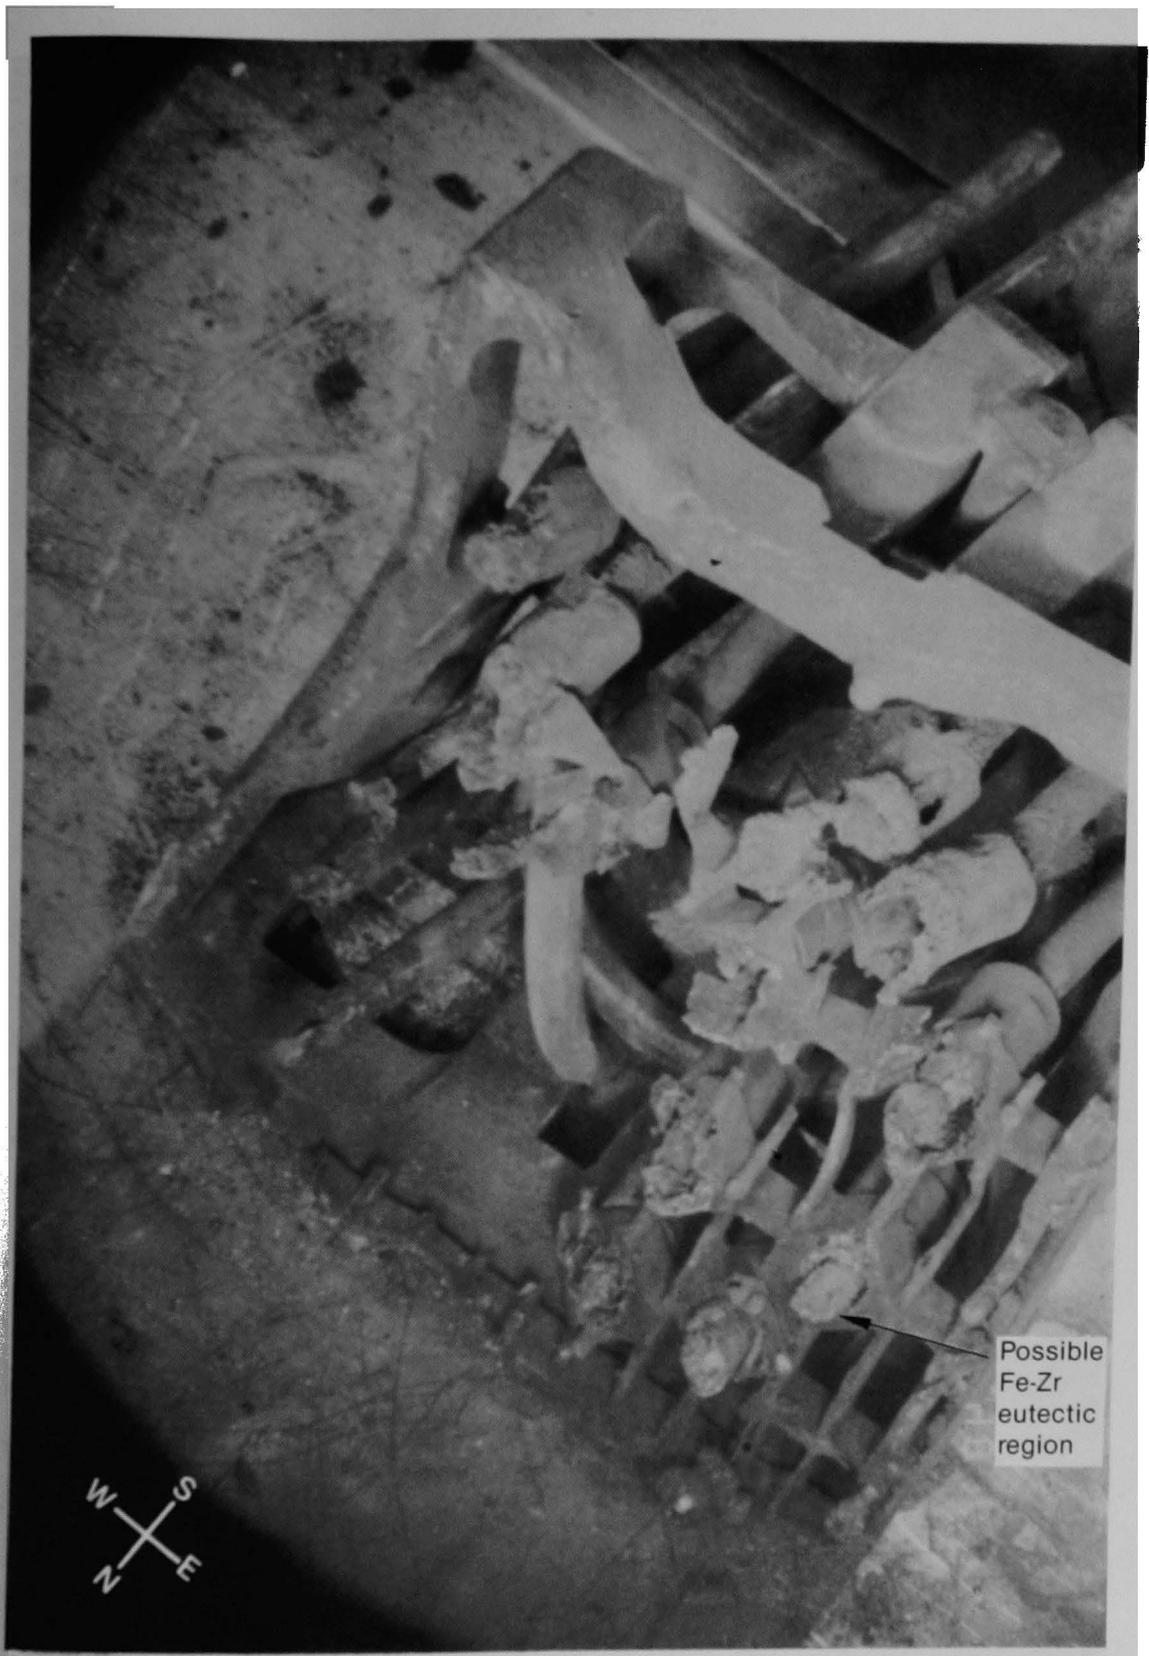
86-384-4-1

The outer edges of component D-141-9's upper end fitting show drips of partially melted stainless steel on the south and west sides above the tie plate elevation. Bent identification markings and slumping in the upper portions of the end fitting near the southwest corner are further evidence of near melting temperatures in this region. The tie plate is completely gone except in the northeast corner. There is some indication of a possible eutectic interaction between the zircaloy guide tube and stainless steel grill in one area (Figure D-19). Peak temperatures were generally greater than 1673 K near the grill elevation except in the northeast corner.

Figure D-19. Bottom view of component D-141-9.

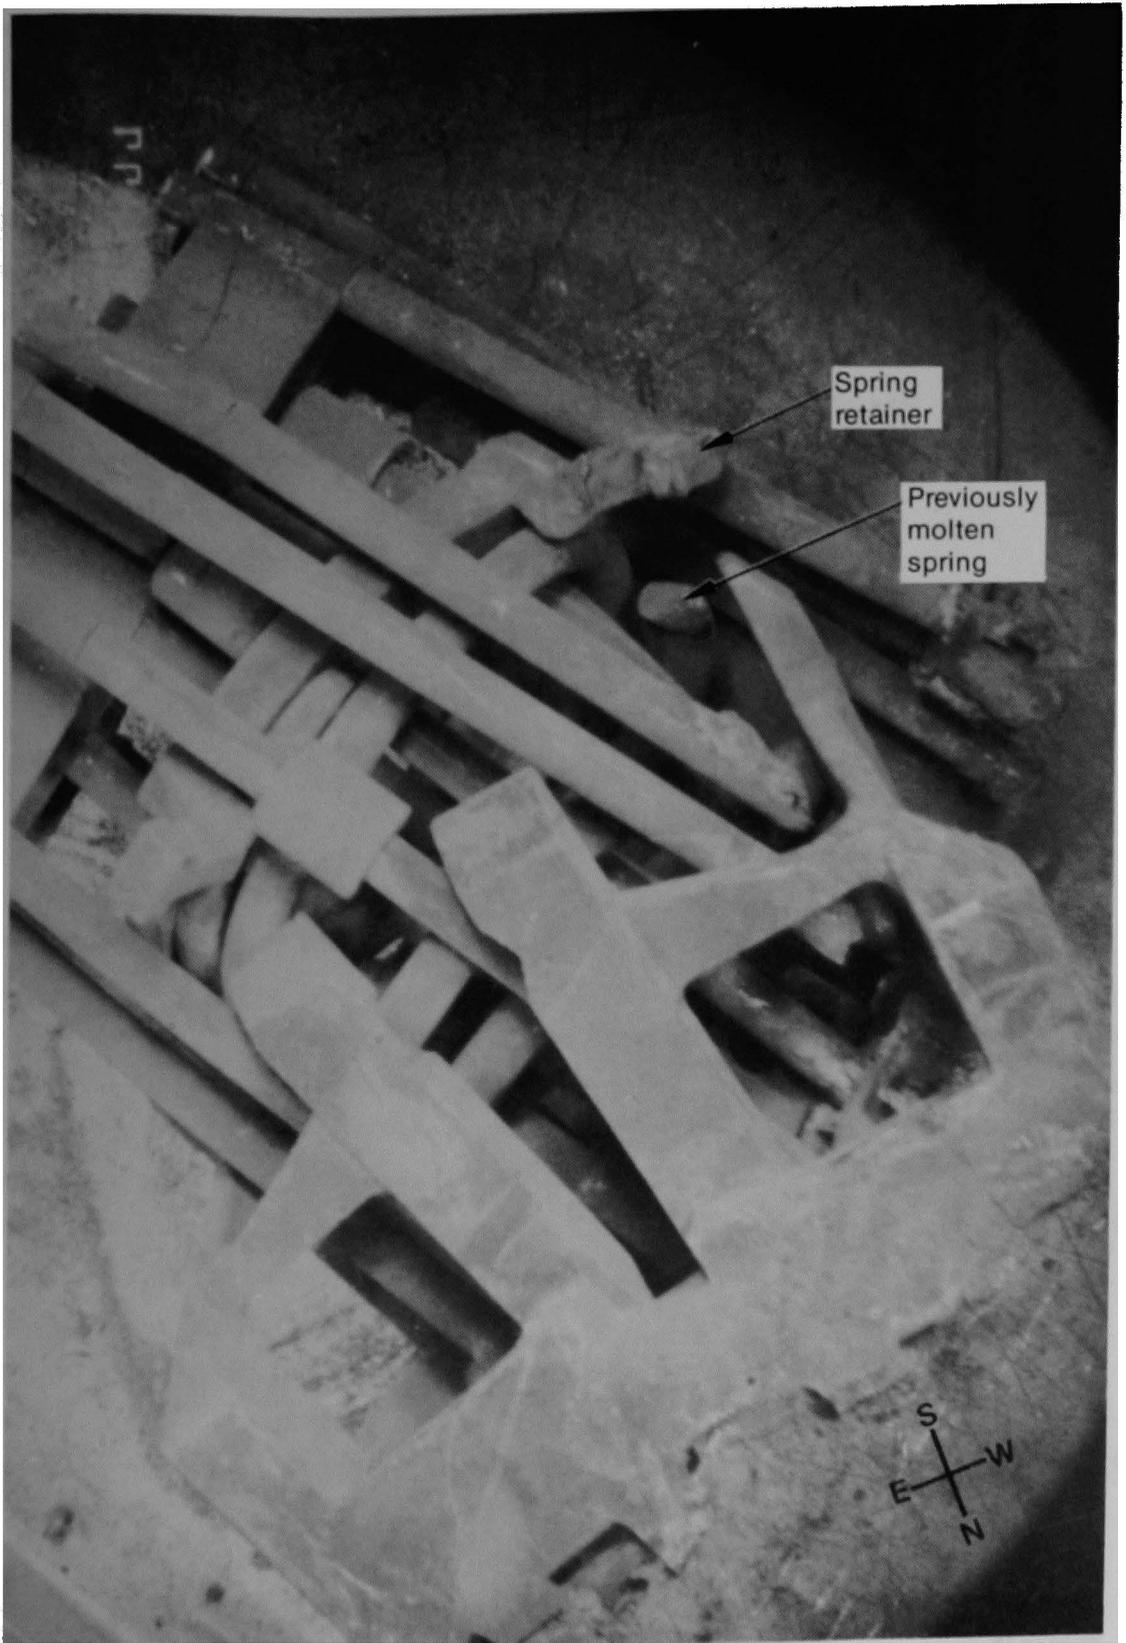
86 384 5 12

Figure D-21. Northwest corner of component D-141-10.

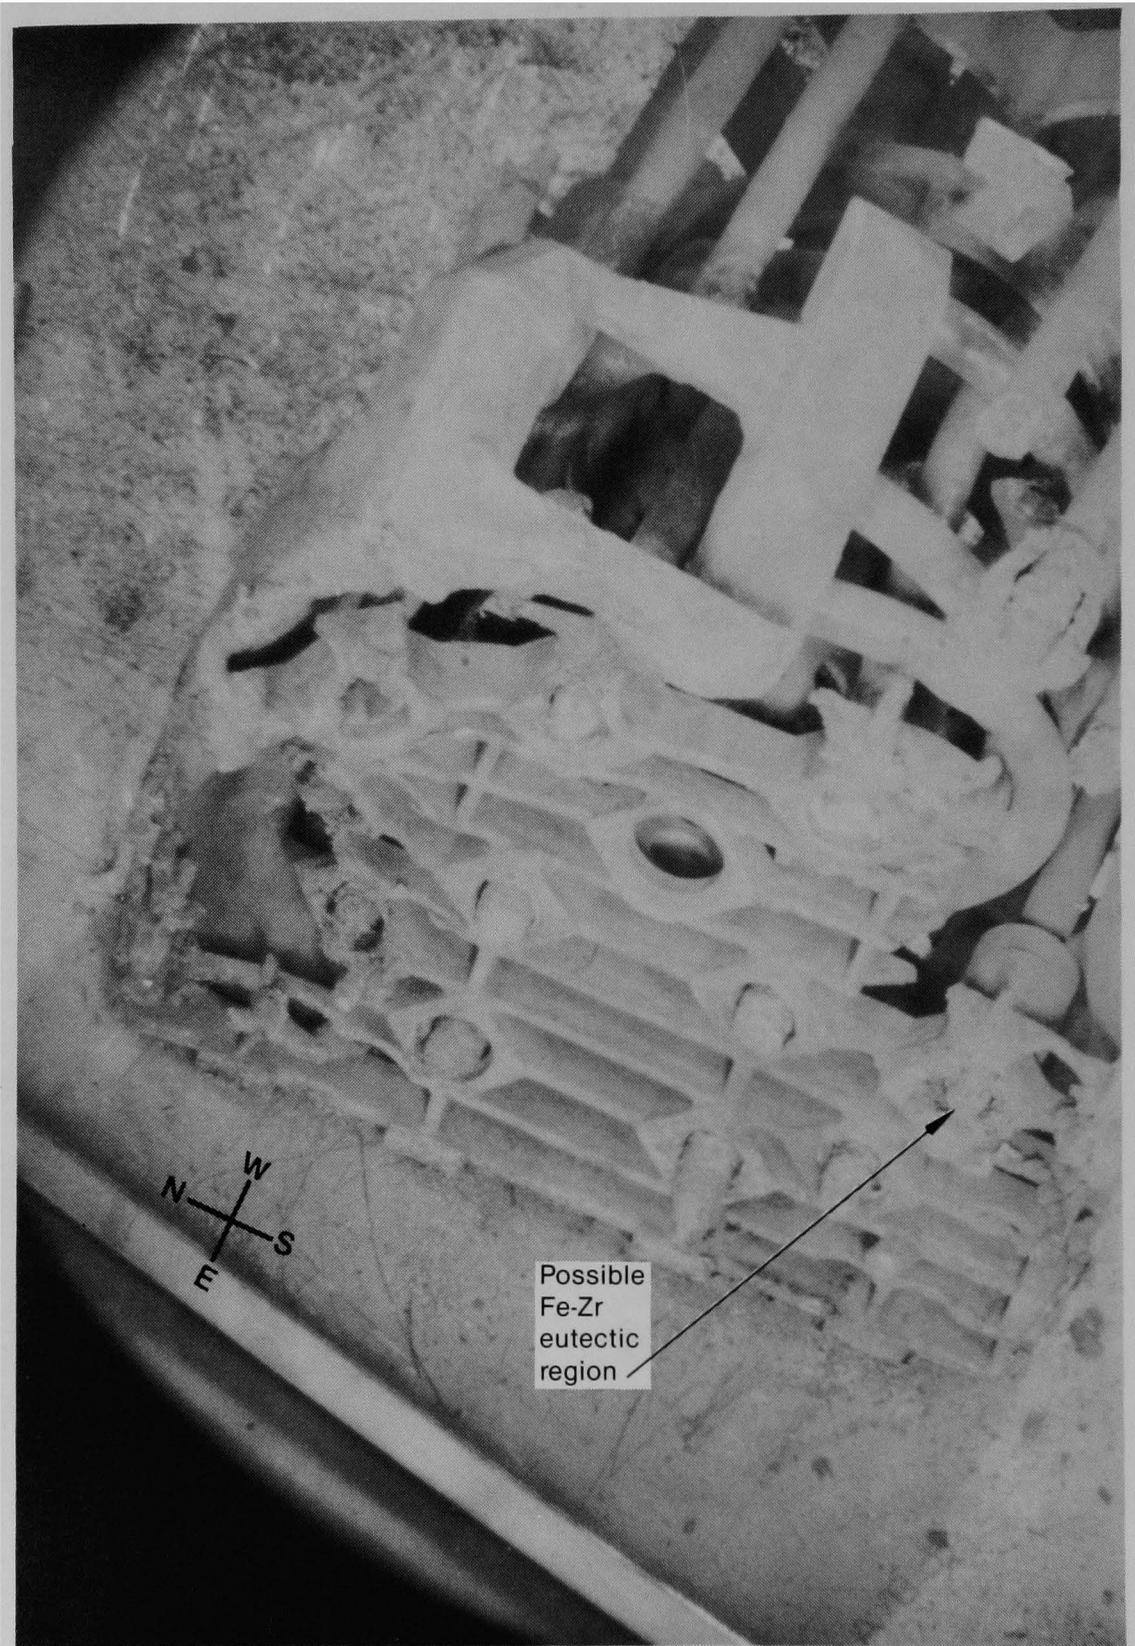
86-384-5-10

Figure D-22. Bottom view of component D-141-10.

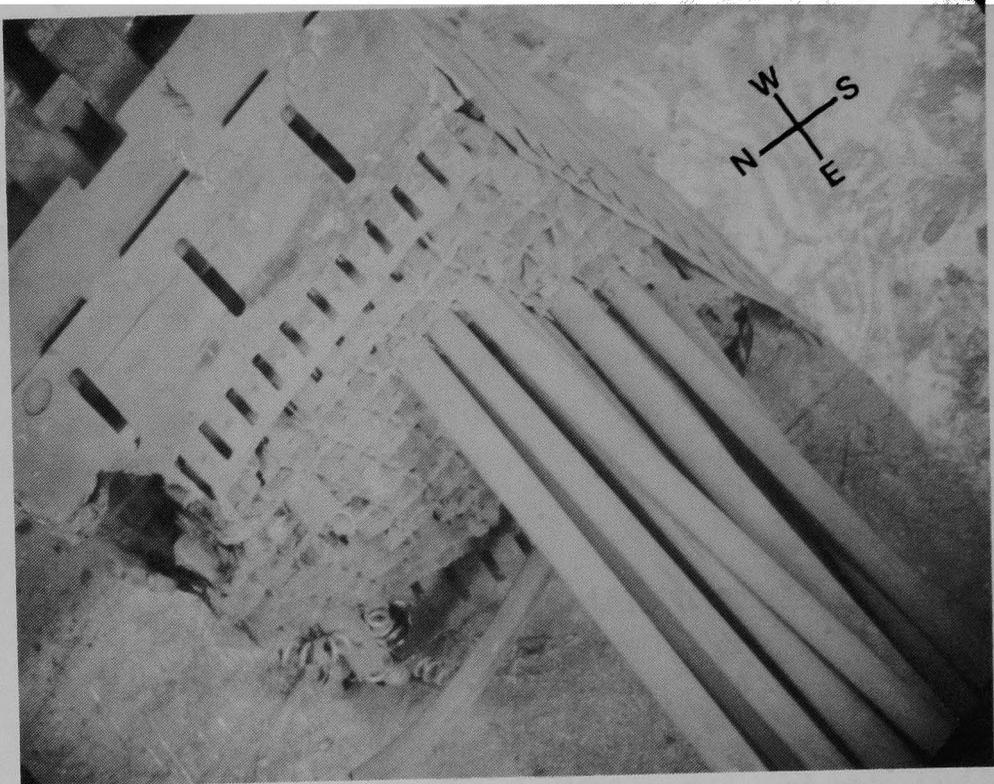
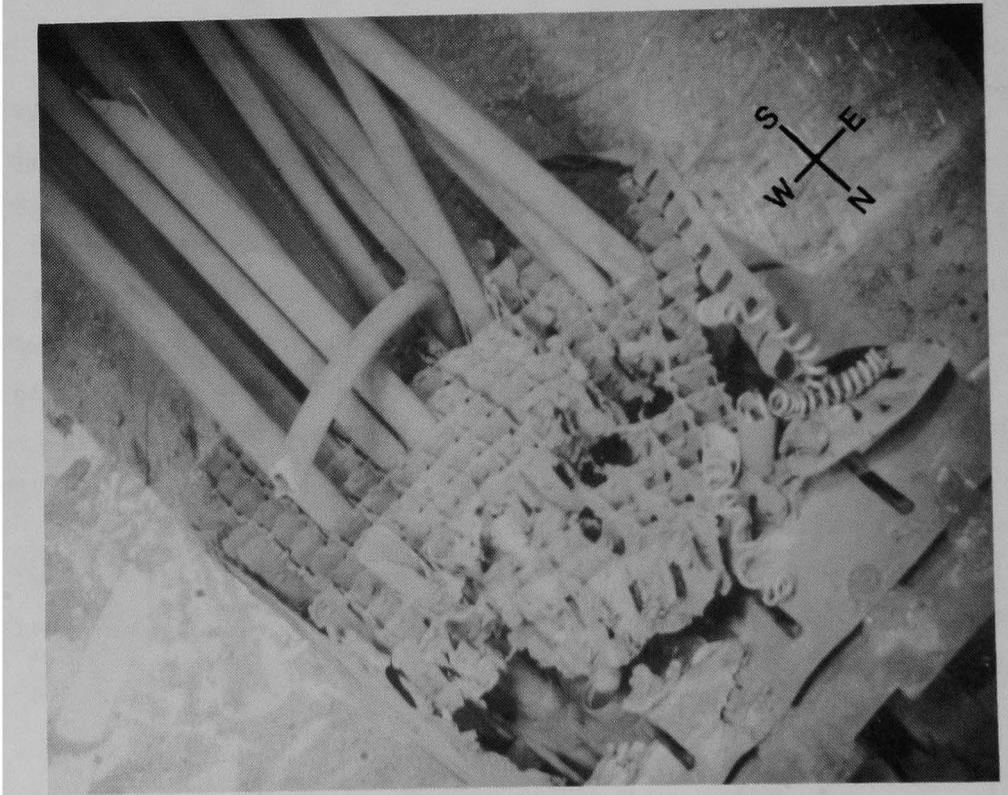
Fuel rods extended well below the upper spacer grid in component D-141-11. Eleven fuel rods, which were subsequently removed, ranged from 40 to 60 cm (16 to 24 in.) in length and appeared to have been broken off when the fuel assembly toppled over after removal of the plenum assembly. This fuel assembly, still standing, is shown in the still-image video survey described in Reference D2. Neutron radiographs of some of these fuel rods are presented in Appendix A of this report. Some empty guide tubes were also still present. The apron and upper spacer grid were badly deformed in some areas, some of which probably occurred when the component was loaded into the shipping canister. There may possibly be some previously melted apron and upper spacer grid material in the northwest corner, but most of these materials remained intact. Peak temperatures can generally be considered to have been lower than 1533 K at the upper spacer grid location.

a) Southwest corner

b) Bottom view

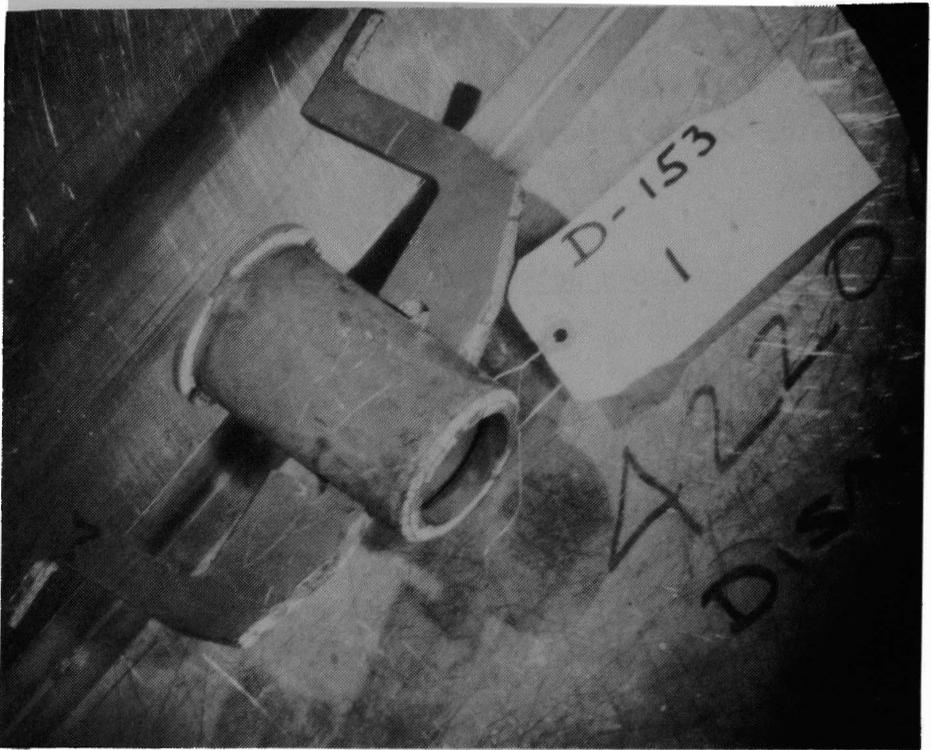
86T-164

As shown in Figure 11, in the main body of this report, core position K4 was in a highly damaged region. However, no melted or damaged regions were present on component D-153-1. This indicates that damage did not penetrate into the plenum assembly.

Figure D-24. Component D-153-1. Burnable poison rod assembly retainer.

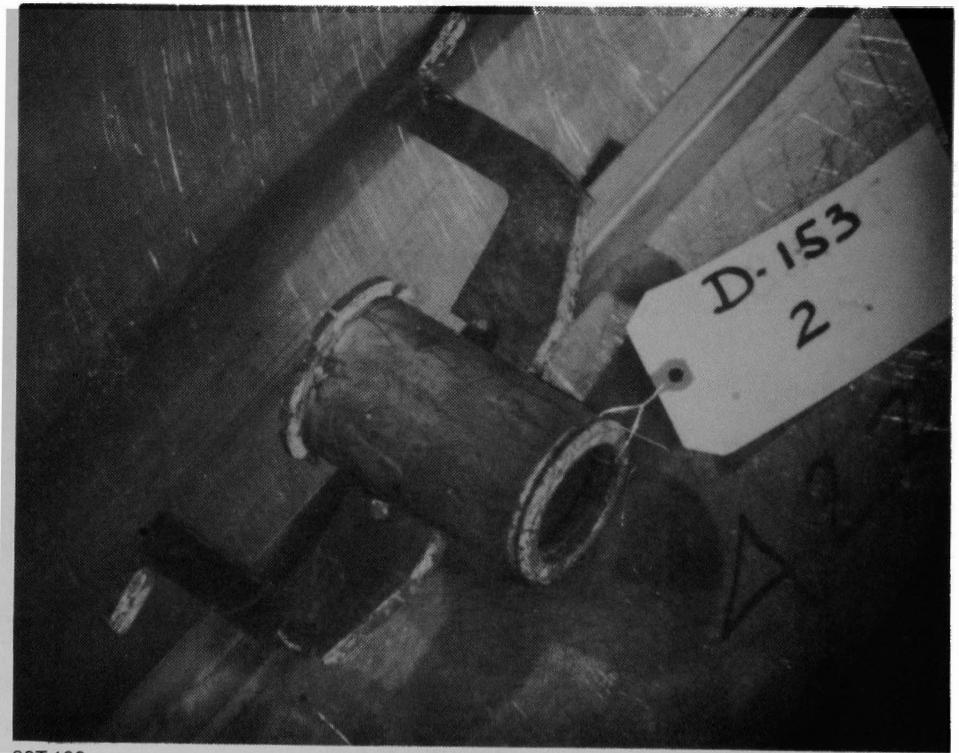
86T-166

No melted or damaged regions were present on component D-153-2.

Figure D-25. Component D-153-2. Burnable poison rod assembly retainer.

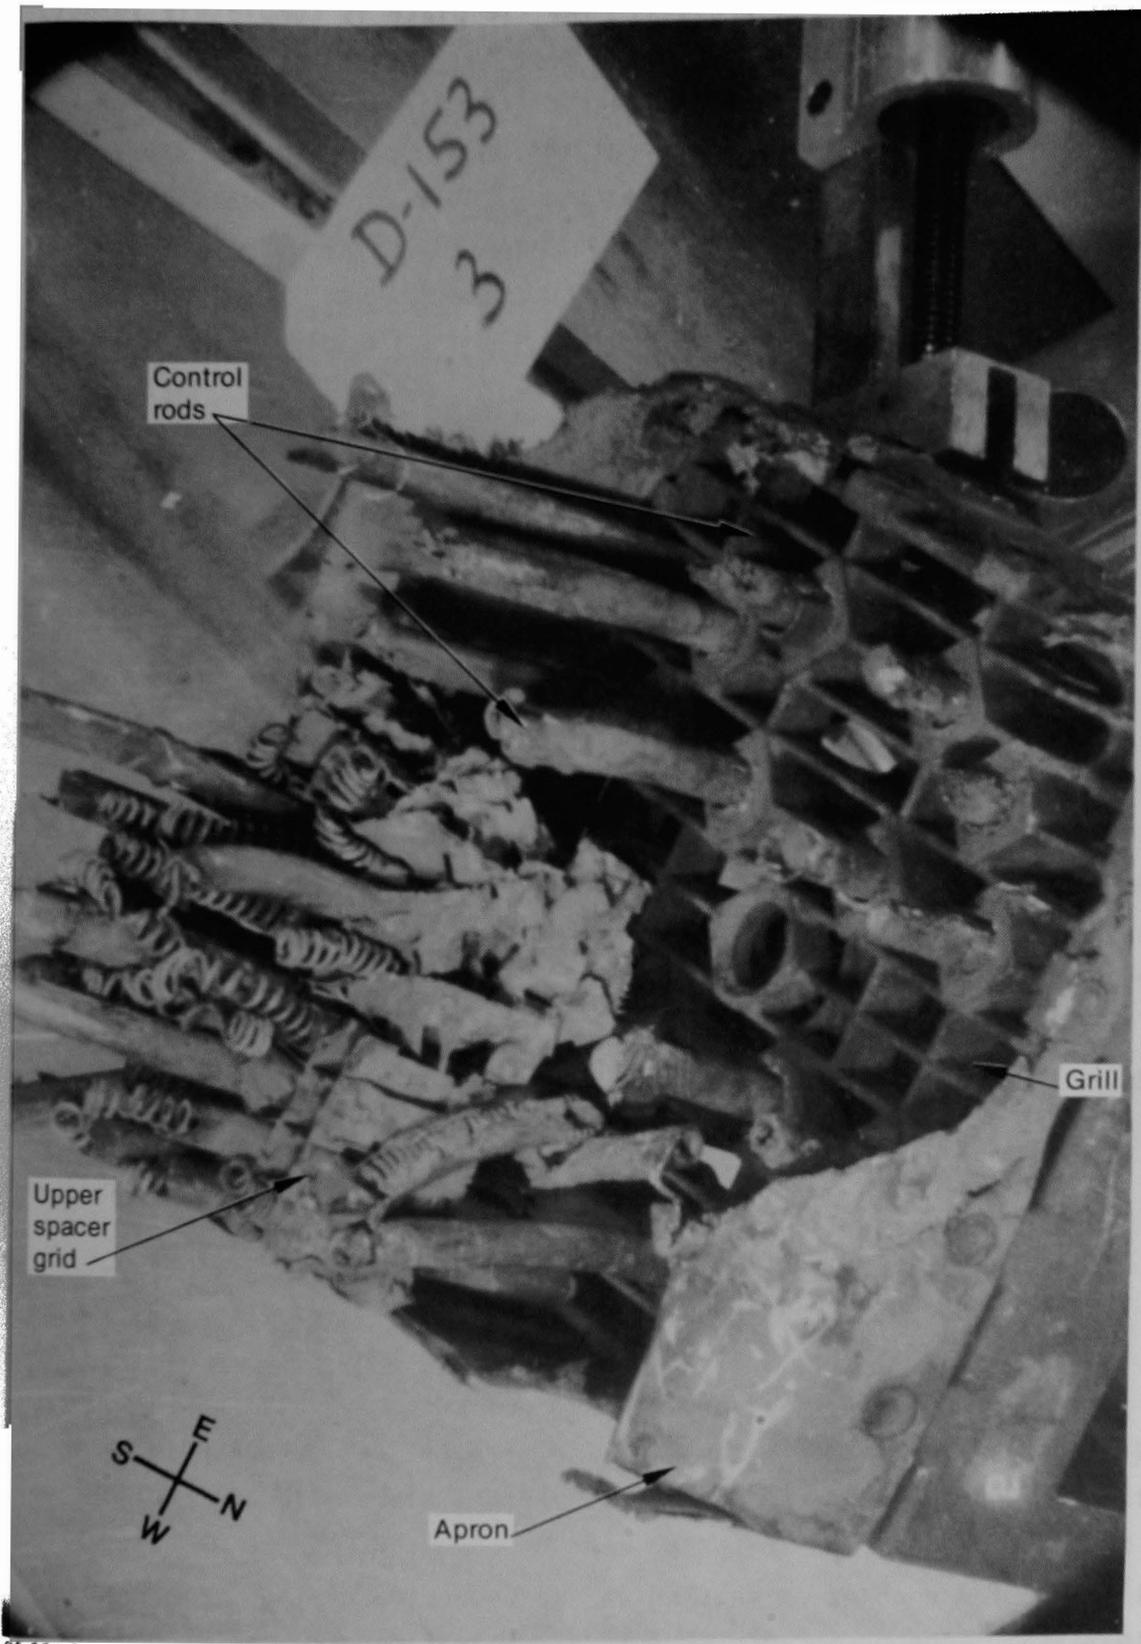
86-384-7-5

The most damage to component D-153-3 occurred on the east side where the apron has melted away, and this prior-molten region extends around to the midpoint of the north side. The least damage occurred in the southwest corner where the apron, fuel rods and springs, and deformed pieces of the

Figure D-26. Component D-153-3. Partial gadolinium poison rod fuel assembly.

upper spacer grid are still present. The tie plate is completely intact, and there is no apparent damage to any material above this elevation. Peak temperatures were lower than 1673 K across the tie plate and were lower than 1533 K in the southwest corner at the upper spacer grid elevation. However, peak temperatures were in excess of 1533 K over most of the assembly at the upper spacer grid elevation.

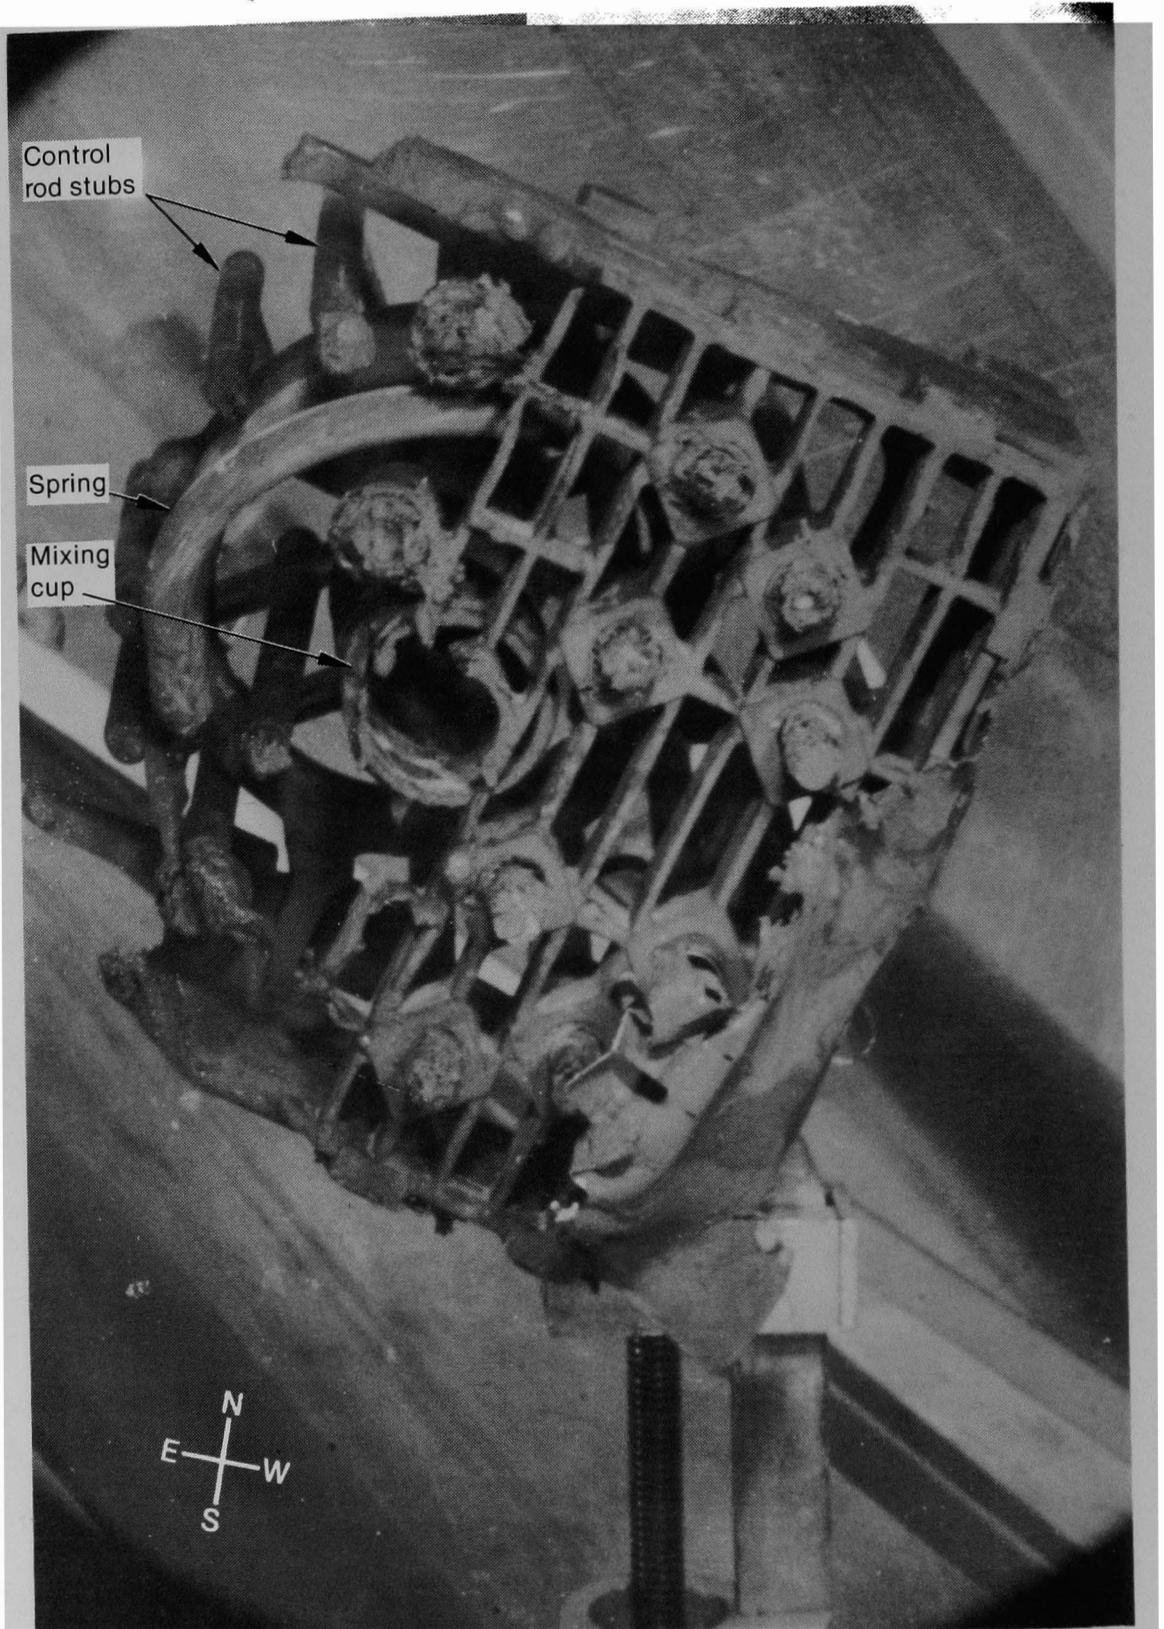
86-384-7-8

The most damage to component D-153-4 occurred on the east side where the tie plate, sides of the end fitting, control rod cladding, and portions of the holddown spring, spring retainer, and mixing cup were once melted. On the west side, the tie plate and even portions of the apron were still intact. Peak temperatures were generally higher than 1673 K on the east side of this assembly. On the western half of the assembly temperatures were lower than 1673 K at the tie plate elevation.

Figure D-28. Bottom view of component D-153-4.
