EXAMINATION OF THE TMI-2 CORE
DISTINCT COMPONENTS

EXAMINATION OF THE TMI-2 CORE DISTINCT COMPONENTS

**S. M. Jensen
D. W. Akers
R. W. Garner
G. S. Roybal**

September 1987

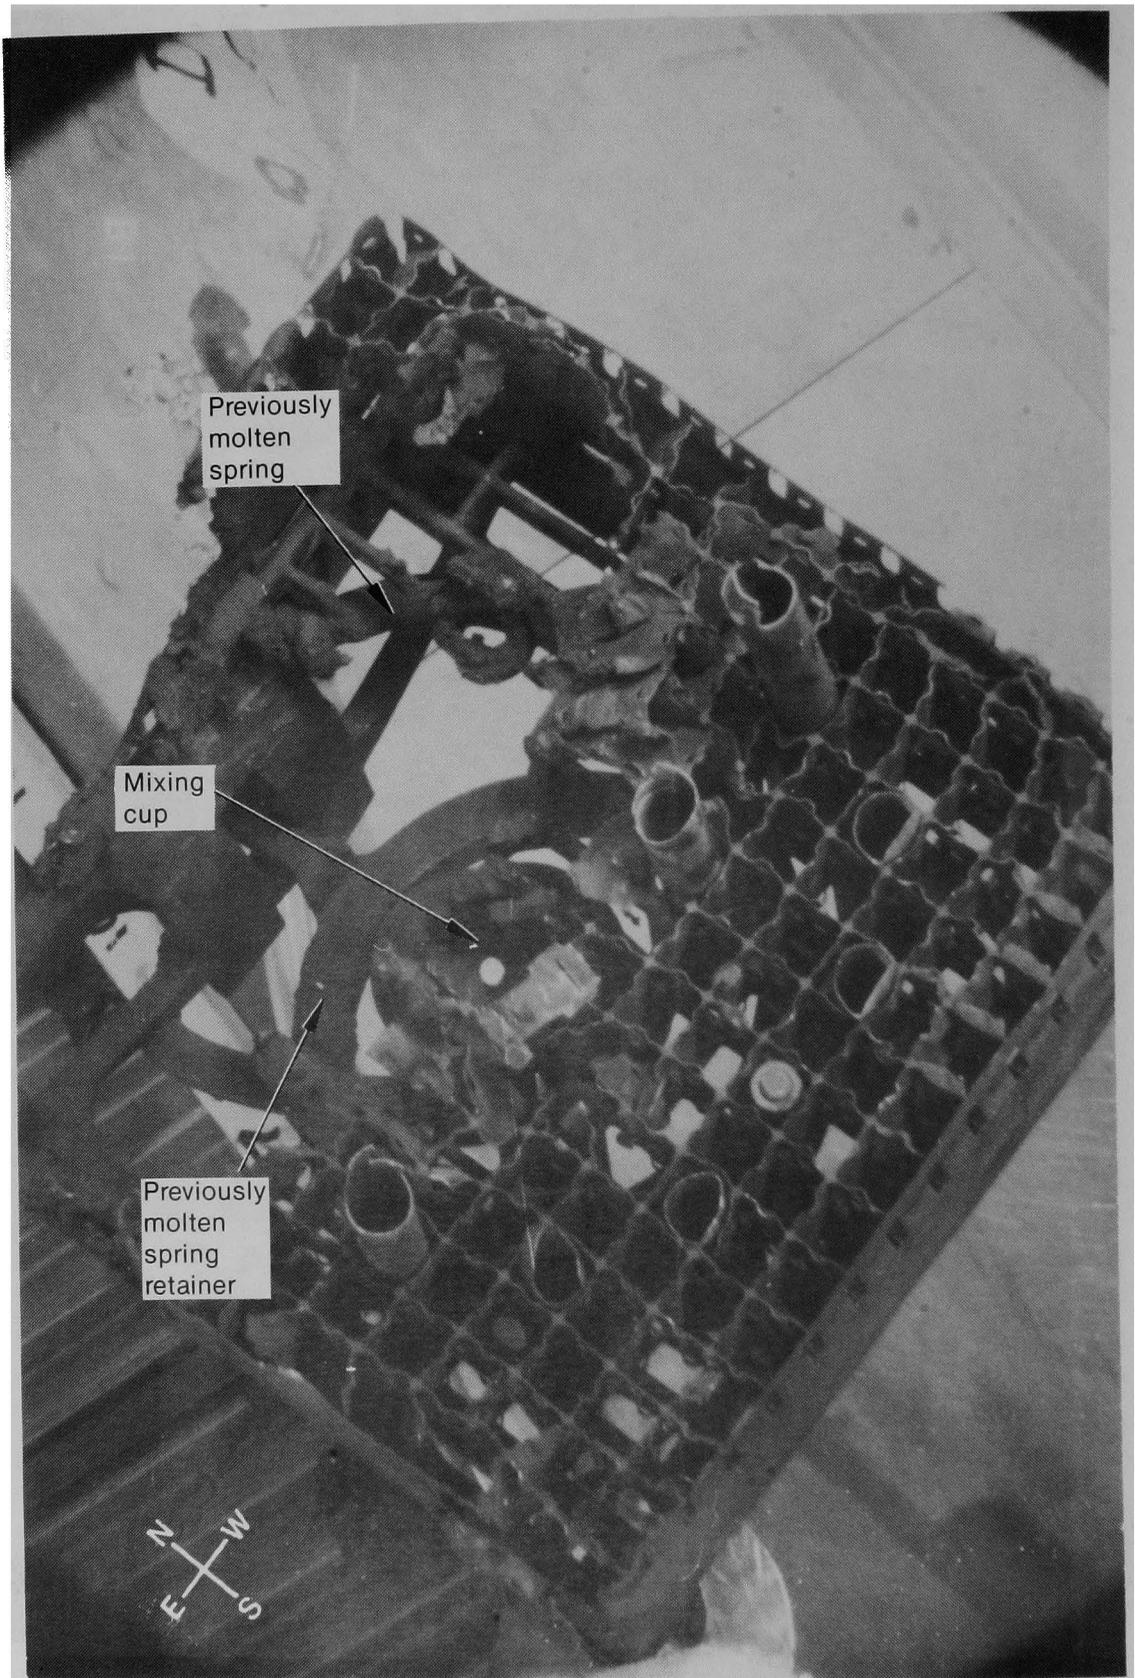
86-384-7-14

Component D-153-5 was a peripheral fuel assembly which contained empty guide tubes and no spider assembly. The greatest damage occurred on the north side where the upper spacer grid, apron, tie plate, and portions of the mixing cup and holddown spring were once melted. There was also an indication of the onset of melting on the underside of the spring retainer on this side. The north side of this assembly faced towards core center, and the postaccident condition indicates steep temperature gradients

Figure D-30. Bottom view of component D-153-5.

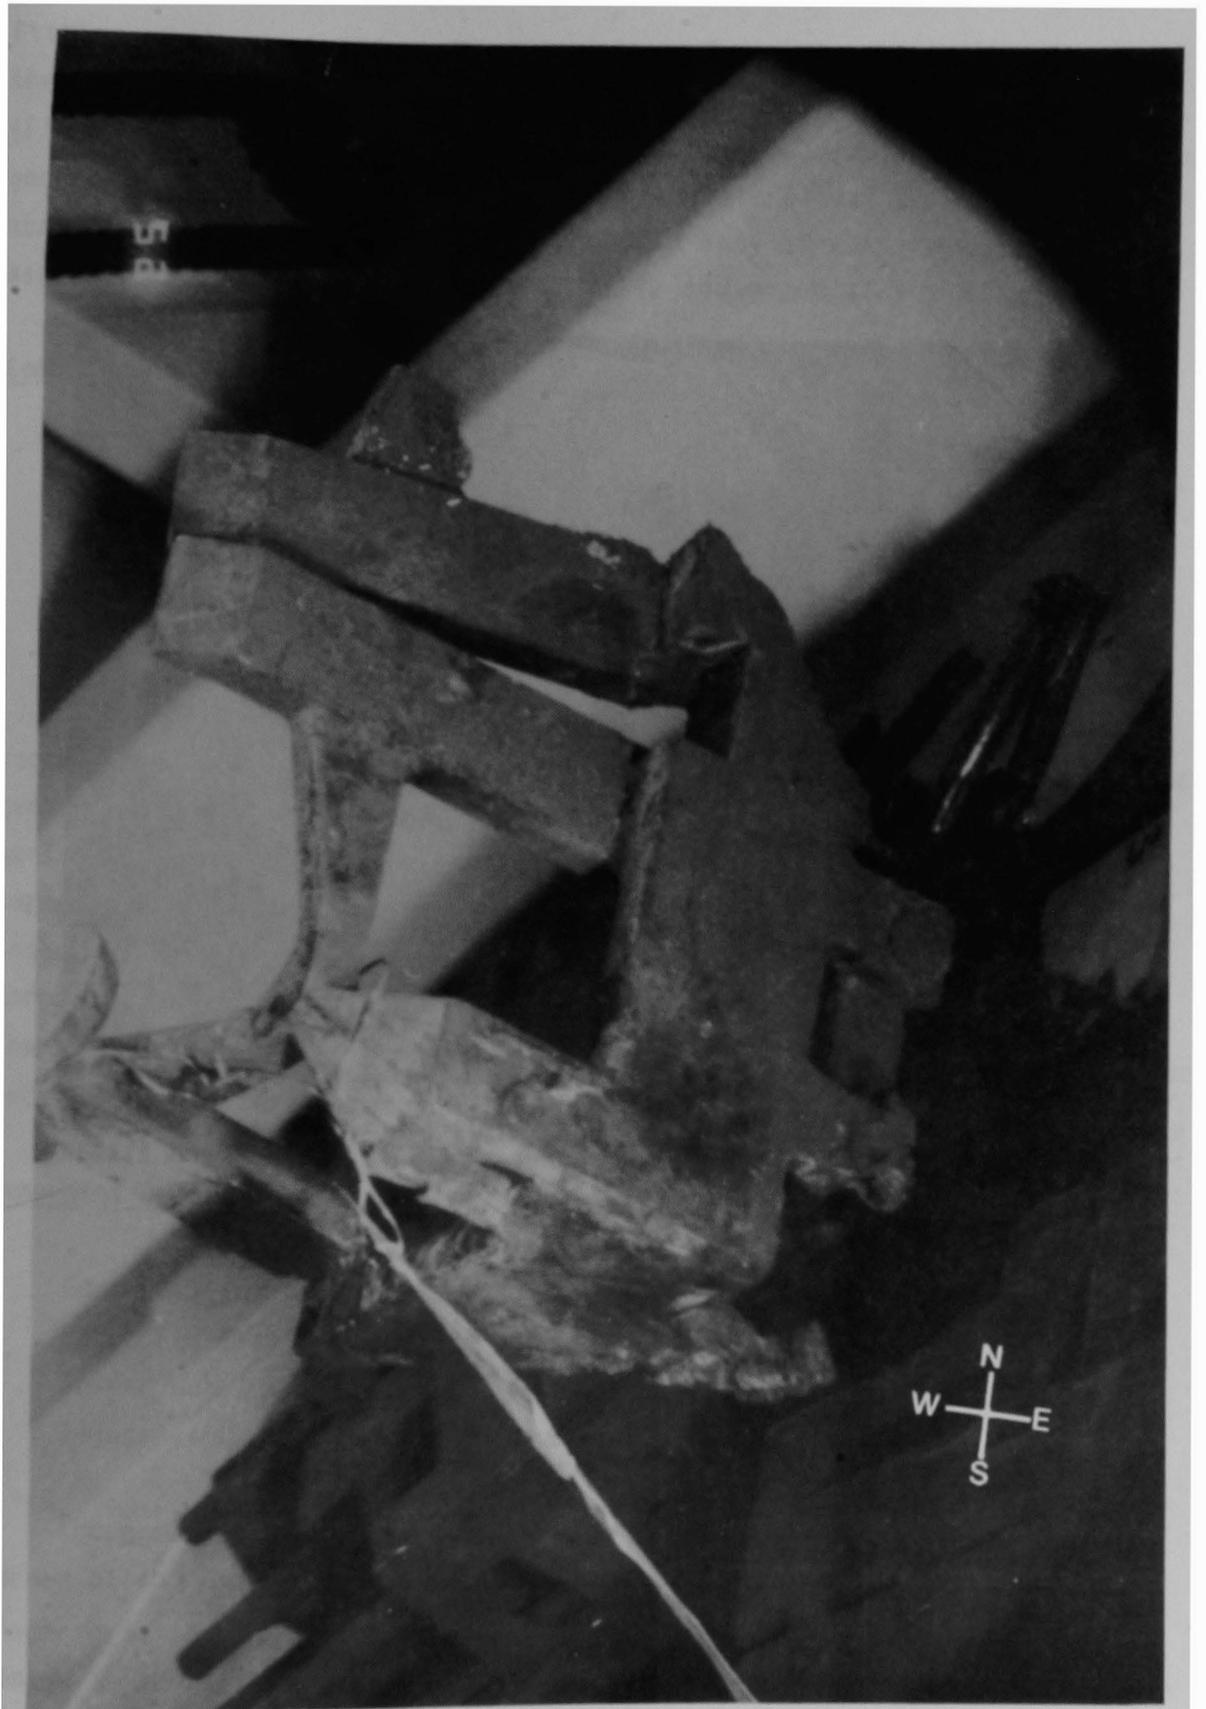
86-384-8-8

Component D-153-7 actually consisted of two pieces that had broken apart while in the shipping canister. The larger piece was a partially melted corner of an upper end fitting with the partial identification letters of NJ stamped on it (Figure D-32). The melted regions extended from the tie plate elevation in the corner to the upper regions of the end

Figure D-32. Portion of component D-153-7. Corner of peripheral fuel assembly upper end fitting.

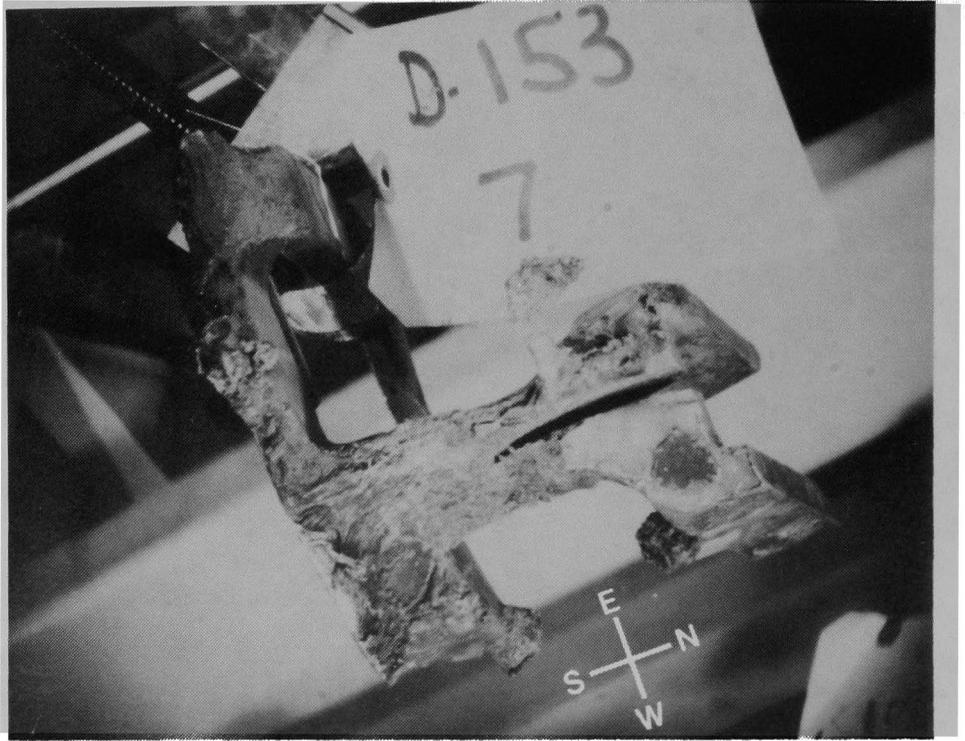
86T-238

Figure D-33. Portion of component D-153-7. Upper end fitting.

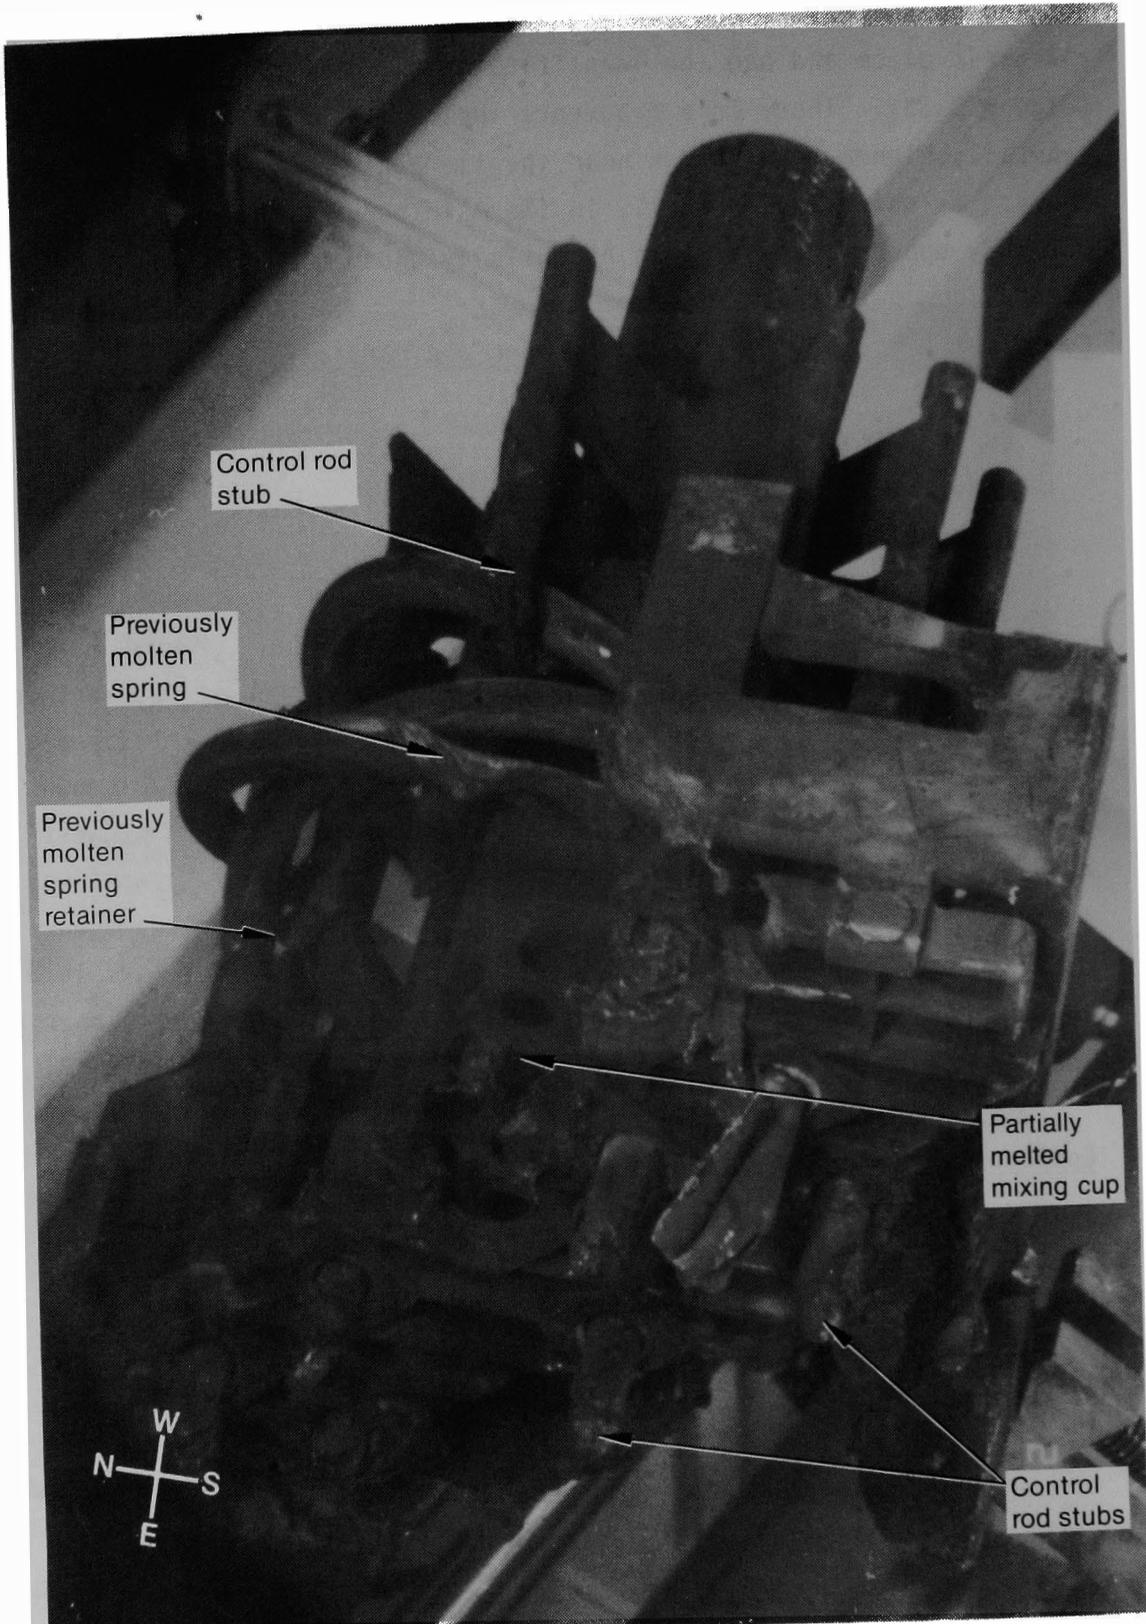
86-384-10-36

The greatest damage to component D-153-8 occurred in the northwest corner, and to a lesser extent in the southeast corner. The tie plate was generally intact except in these corners. The mixing cup, holddown springs, and spring retainer were partially melted in the northwest corner. Control rod stubs extended below the tie plate where it was intact, but were melted above the tie plate in the heavily damaged corners. Peak temperatures were generally either near or above 1673 K at the tie plate elevation, but reached 1673 K in the northwest corner at the location of the spring retainer.

Figure D-34. West side of component D-153-8. Control rod spider and partial upper end fitting.

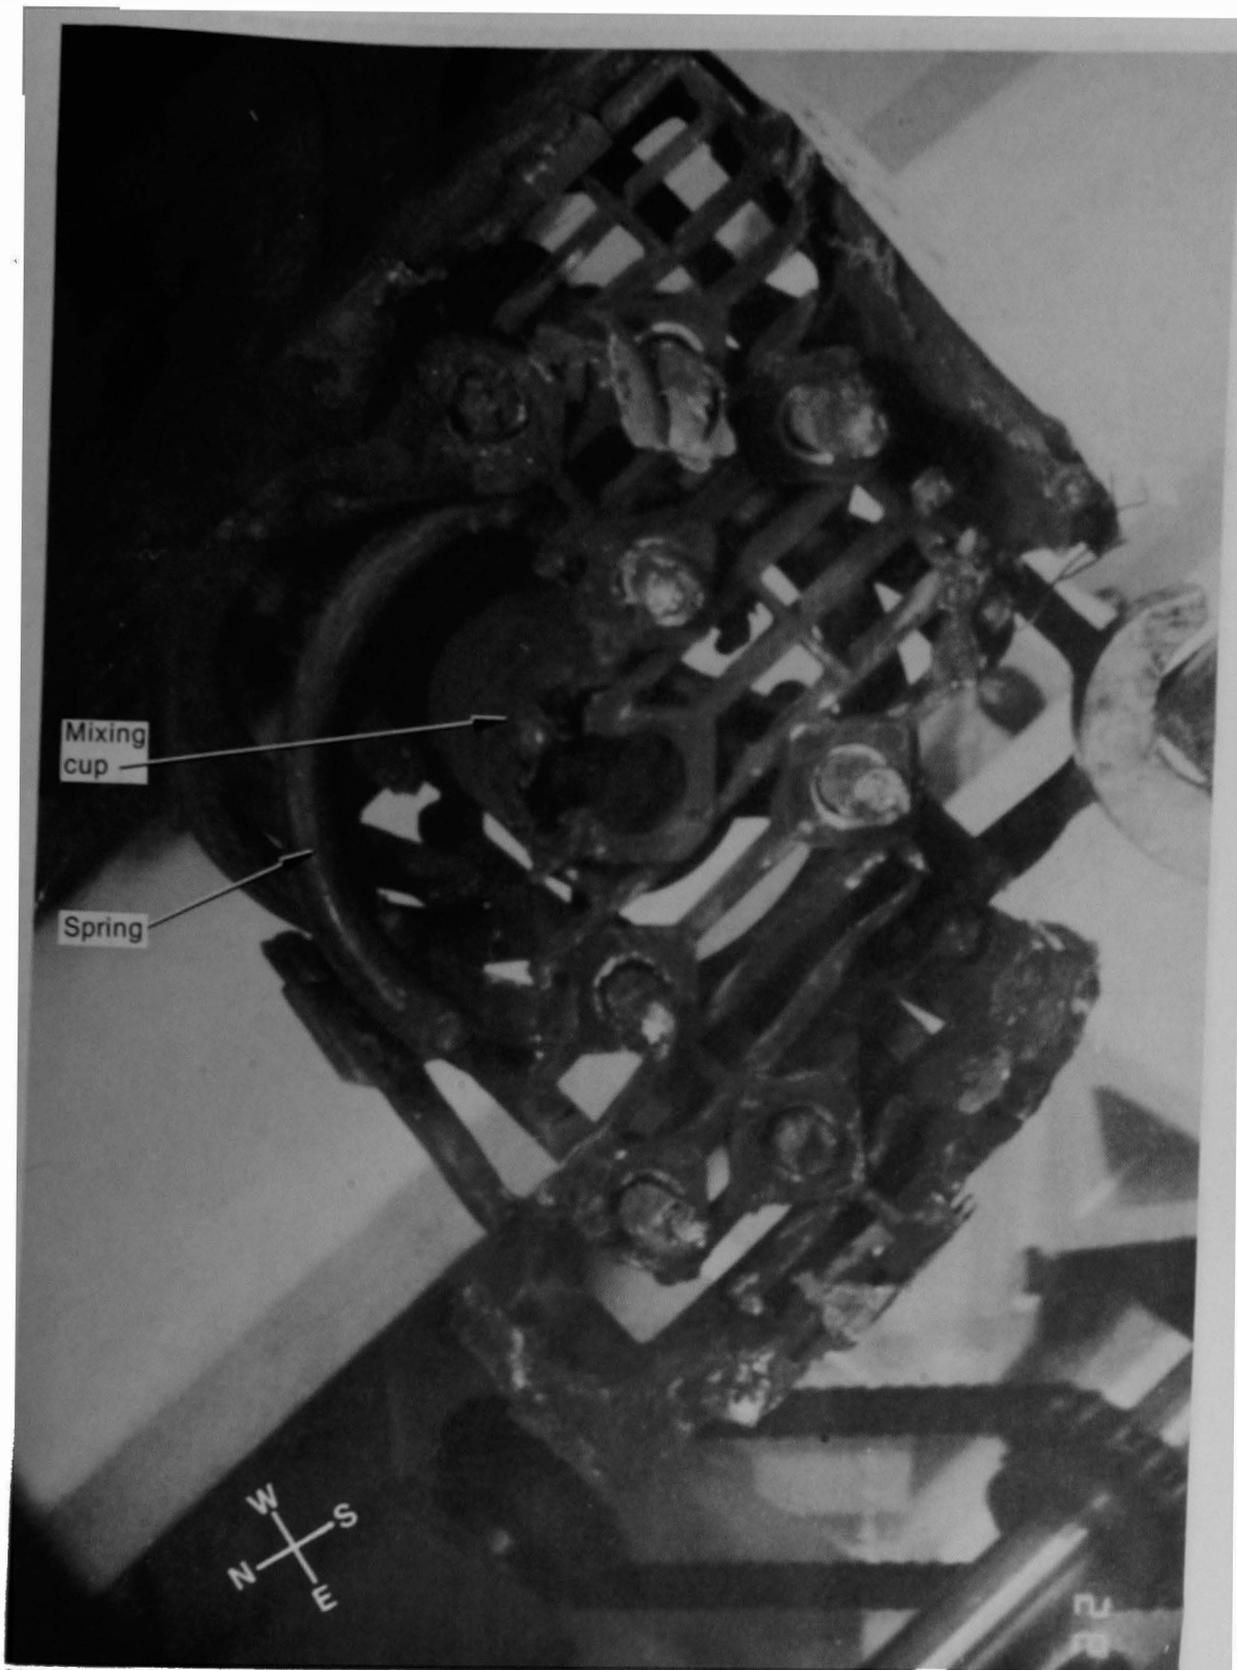
Figure D-35. Bottom view of component D-153-8.

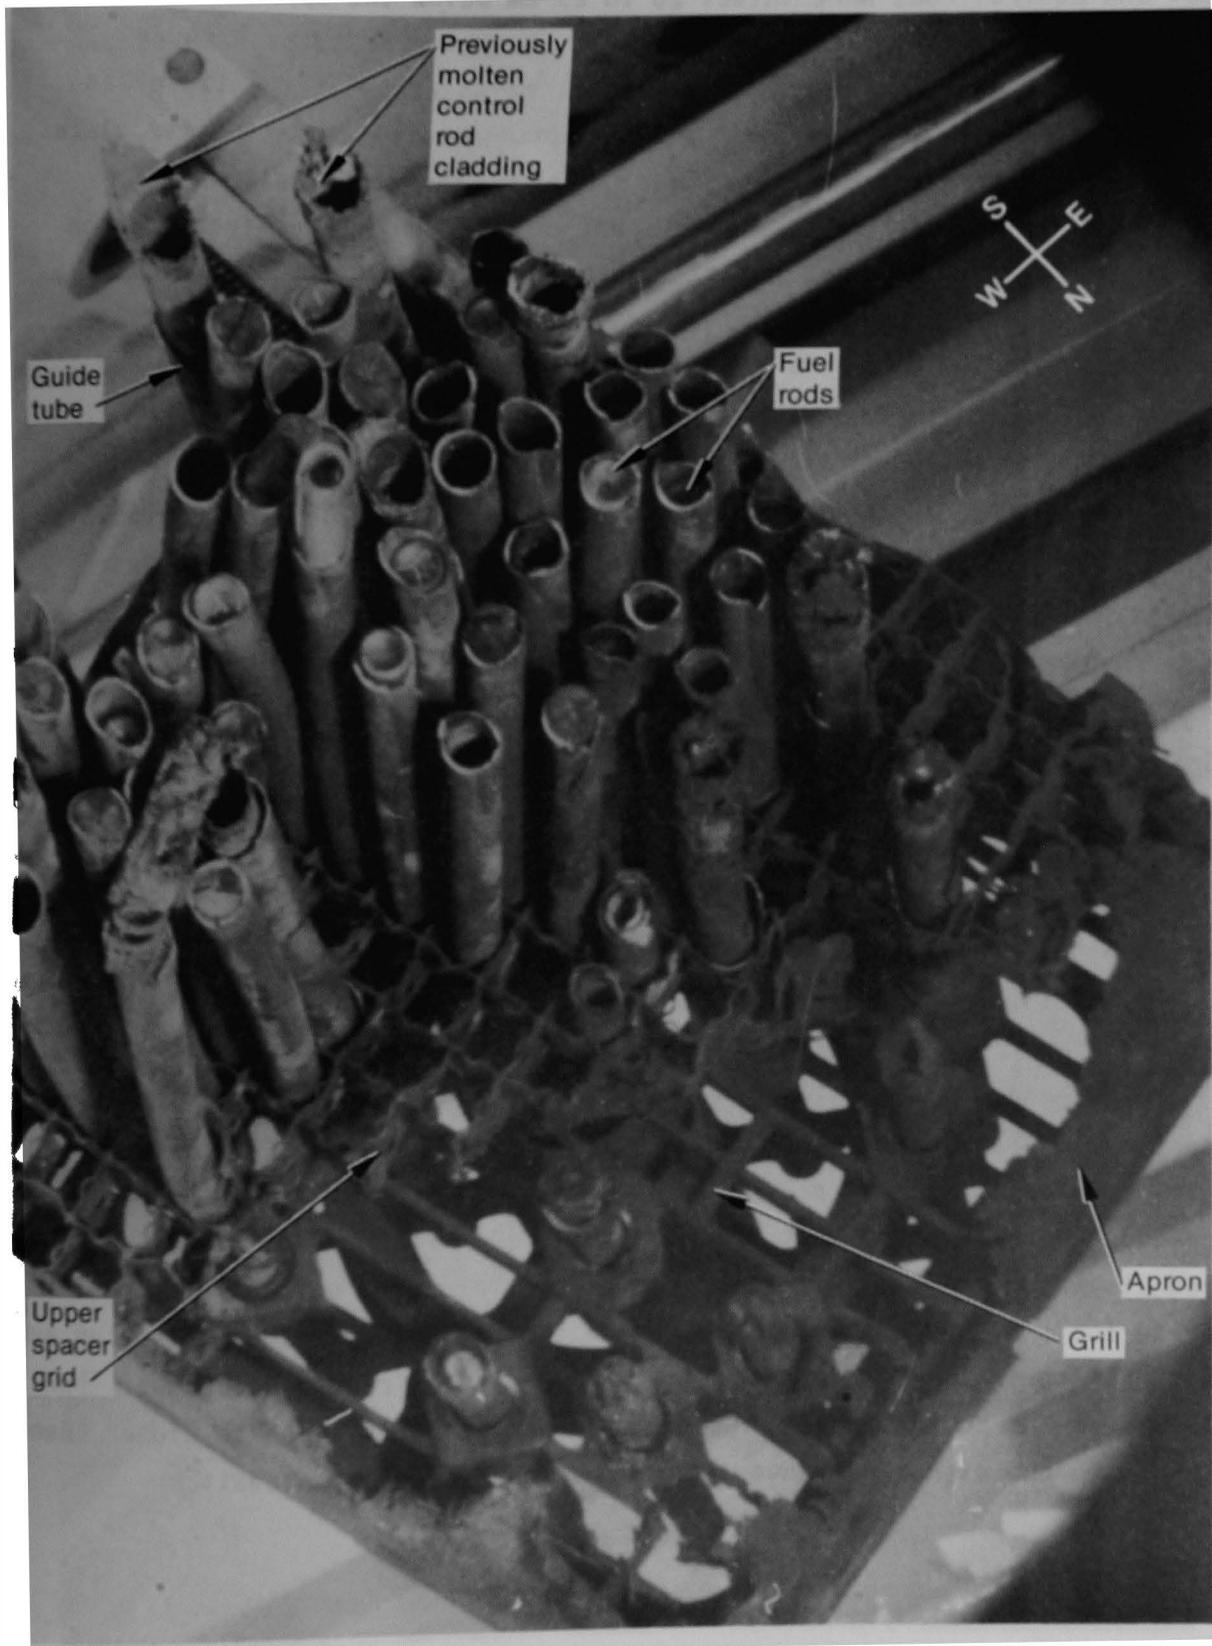
06-154-92

The greatest damage to component D-153-9 occurred in the northwest corner of the assembly, and particularly along the north side. The upper spacer grid and tie plate were intact except in this region, with the damage to the tie plate limited to the extreme northwest corner. Portions of the apron were also melted on the north and west sides. Most of the

Figure D-37. Bottom view of component D-153-9.

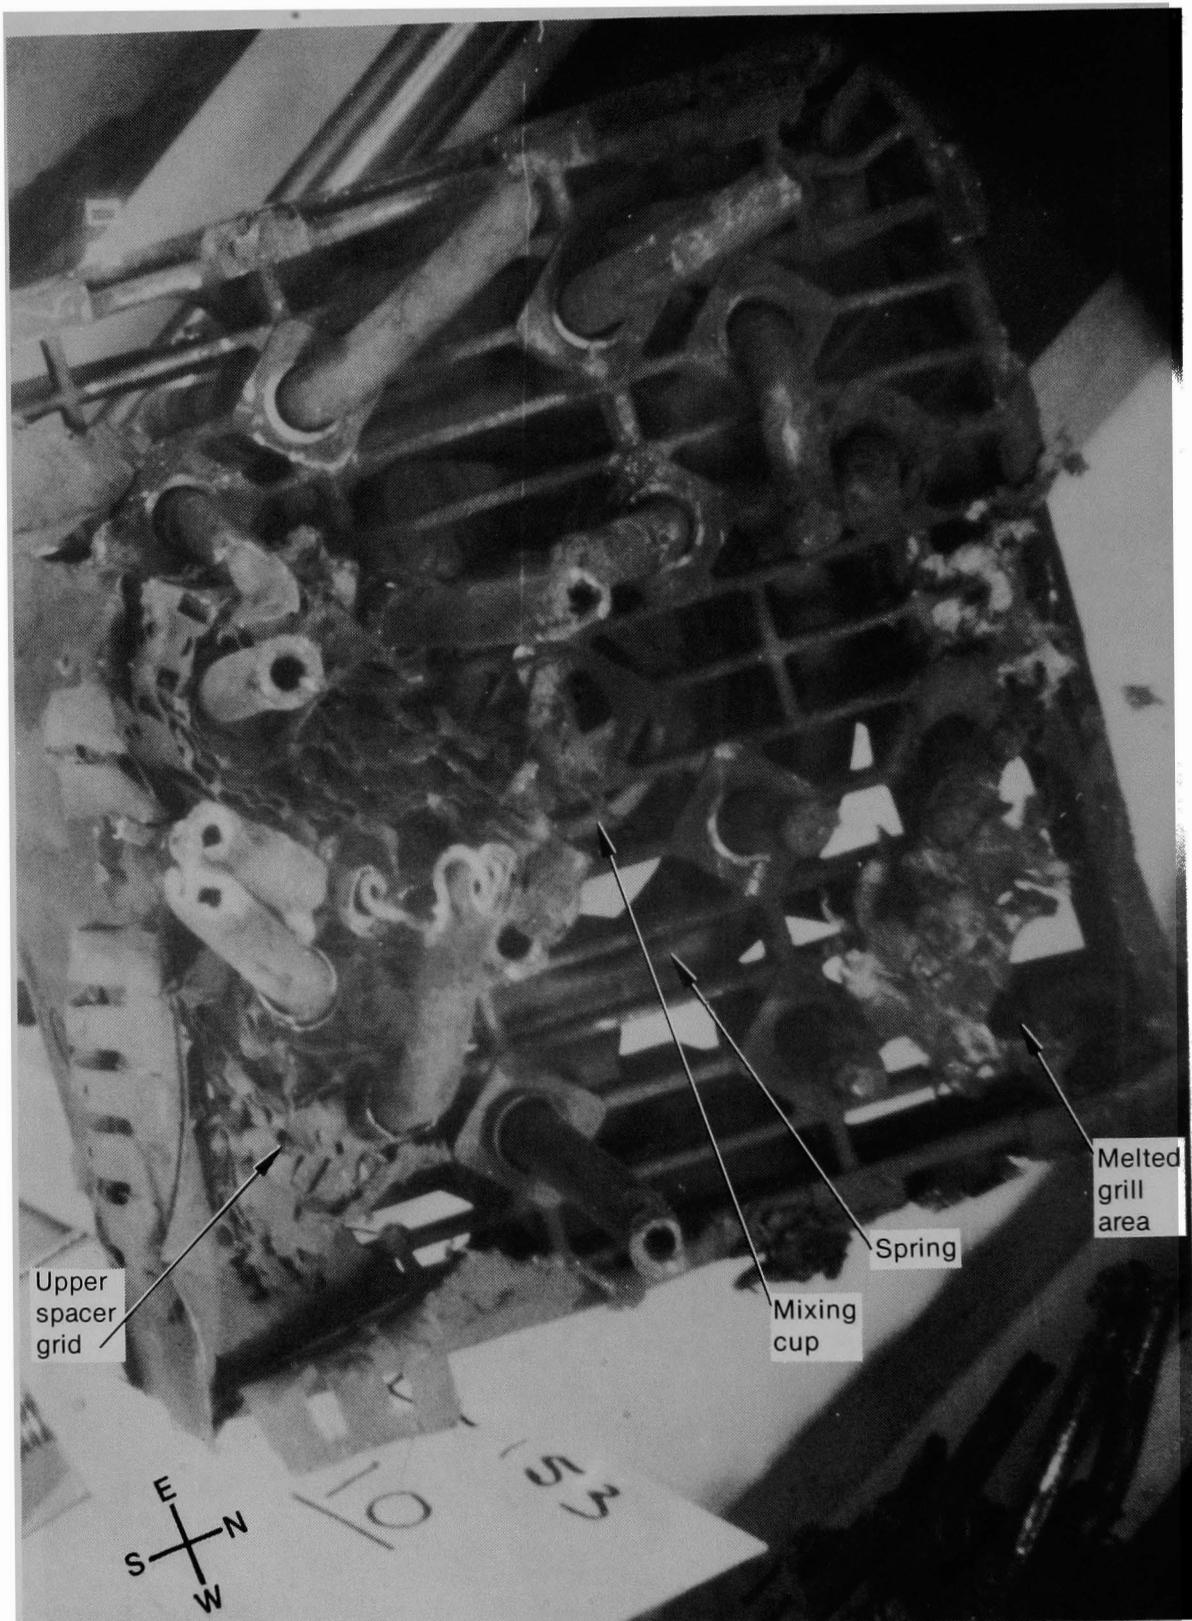
86-384-9-28

Figure D-39. Bottom view of component D-153-10.

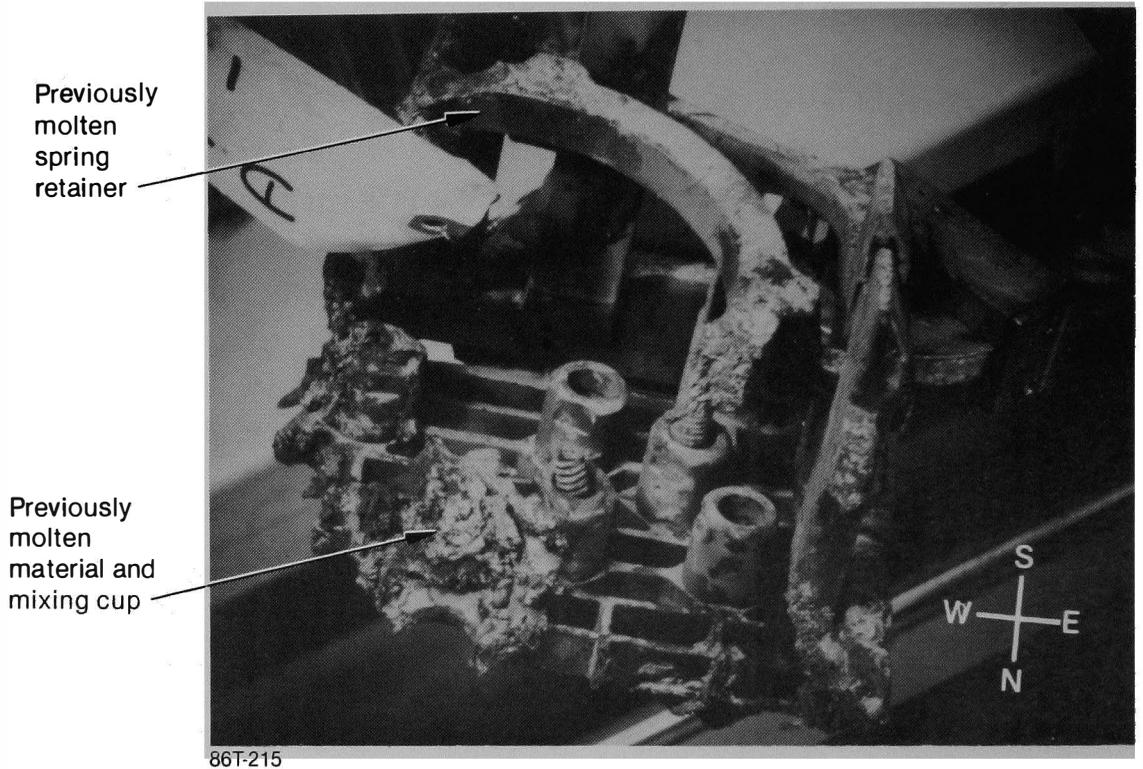
Figure D-40. Component D-153-11. Partial control rod upper end fitting.

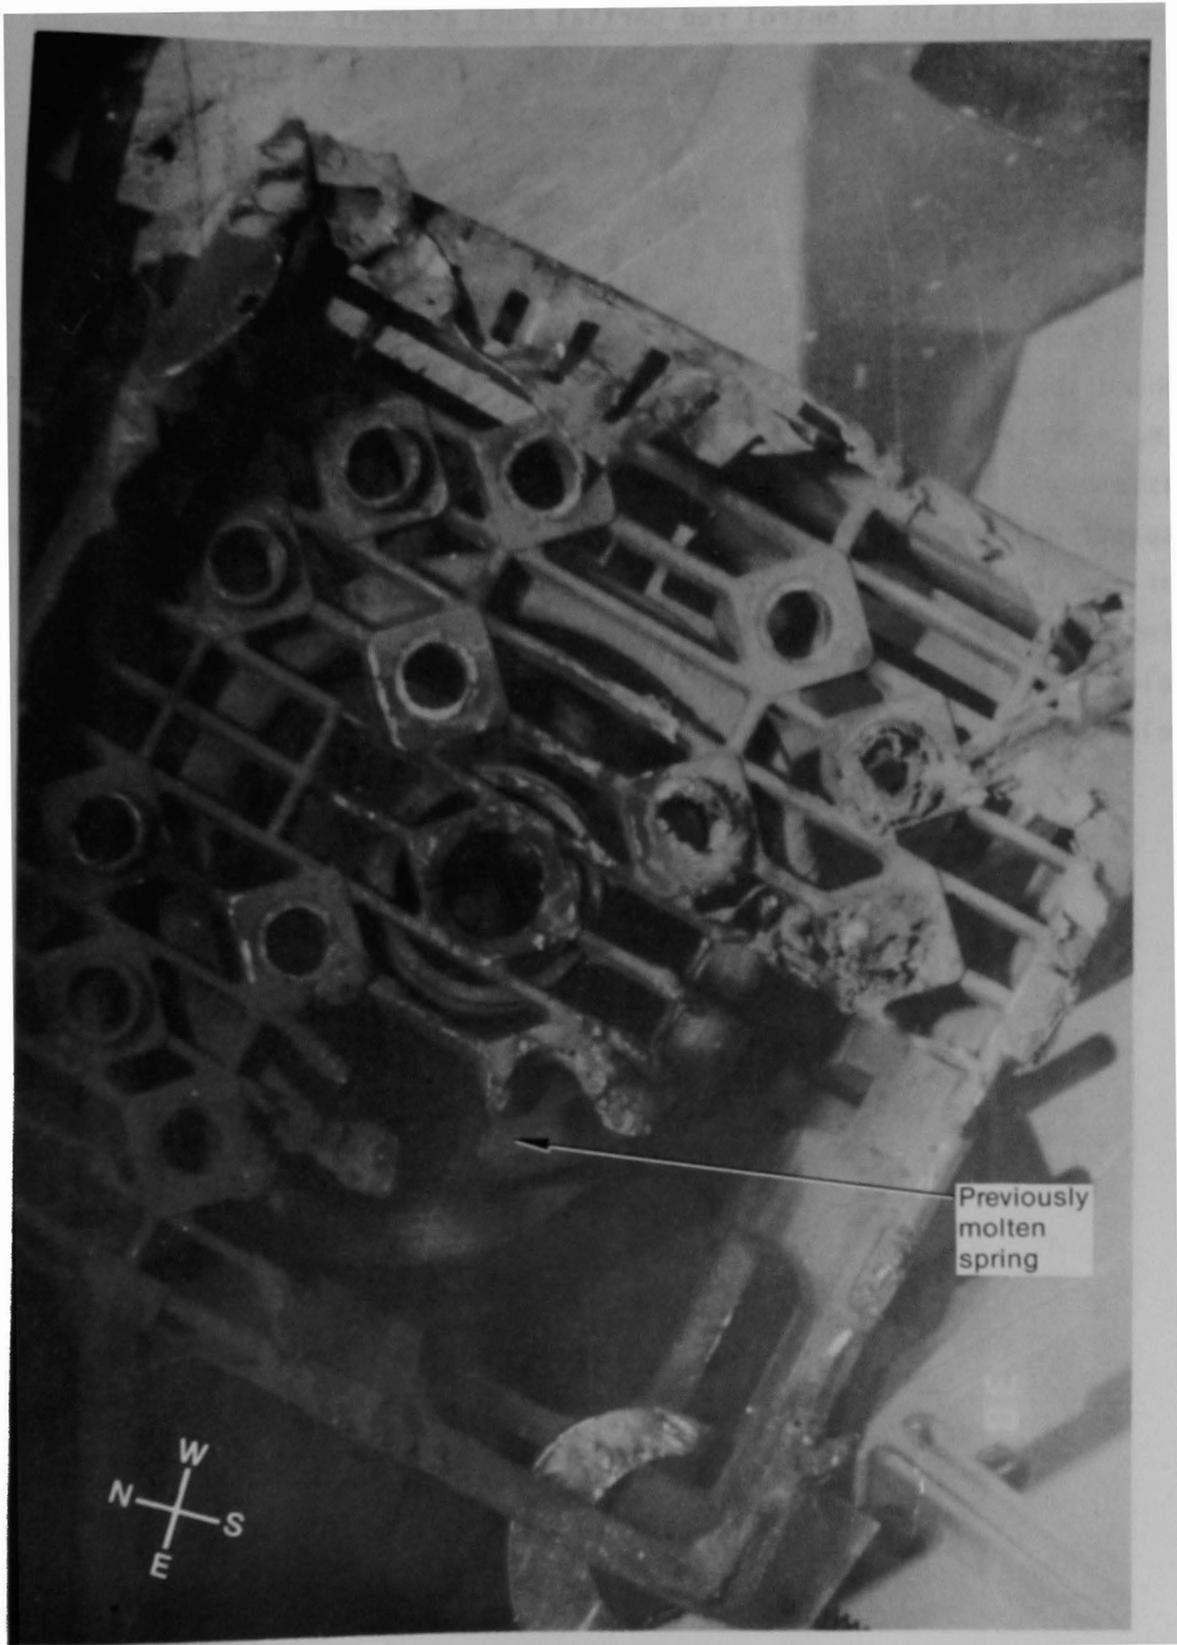
88-384-9-8

Component D-153-12 was most heavily damaged in the southeast corner where the tie plate and portions of the sides of the end fitting above the tie plate elevation were melted. A small portion of the lower part of the holddown spring in the southeast corner was also melted. Portions of the remaining apron on the north and west sides were also melted. Peak temperatures were in excess of 1673 K in the southeast corner at the tie plate elevation and were higher than 1666 K where the holddown spring melted just above the tie plate. Temperatures were lower than 1673 K across the remainder of the assembly at the tie plate elevation.

Figure D-43. Bottom view of component D-153-12.

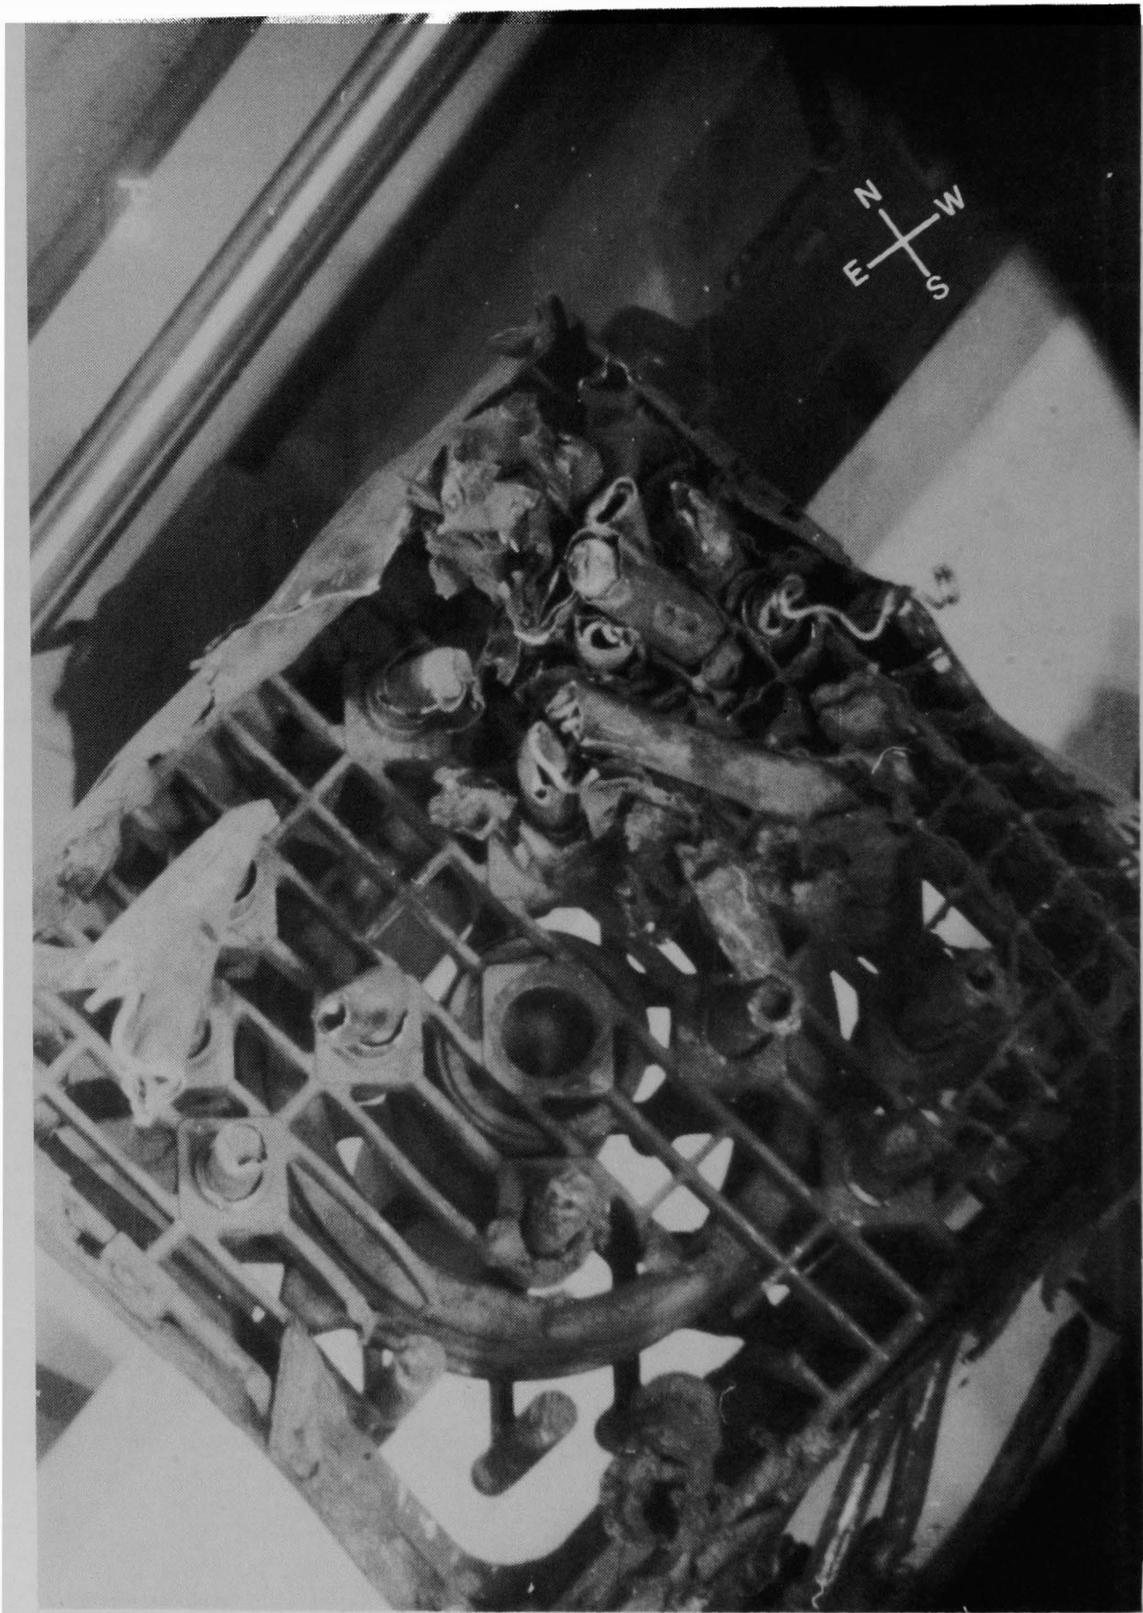
86-384-8-6

Component D-153-13 was most heavily damaged in the southeast corner where the melted region included the tie plate and portions of the sides of the upper end fitting. This corner faced core center in this peripheral assembly. The least damage occurred on the west side where the upper spacer grid is still present. This side faced a fuel assembly on the edge of the core. The mixing cup and holddown spring were undamaged. Peak temperatures ranged from 1673 K in the southeast corner at the tie plate elevation and slightly above to less than 1533 K at the upper spacer grid elevation on the west side.

Figure D-45. Bottom view of component D-153-13.
