TMI-2 CORE HORSESHOE RING EXAMINATIONS

M. L. Russell

Published October 1987

**EG&G Idaho, Inc.
Idaho Falls, Idaho 83415**

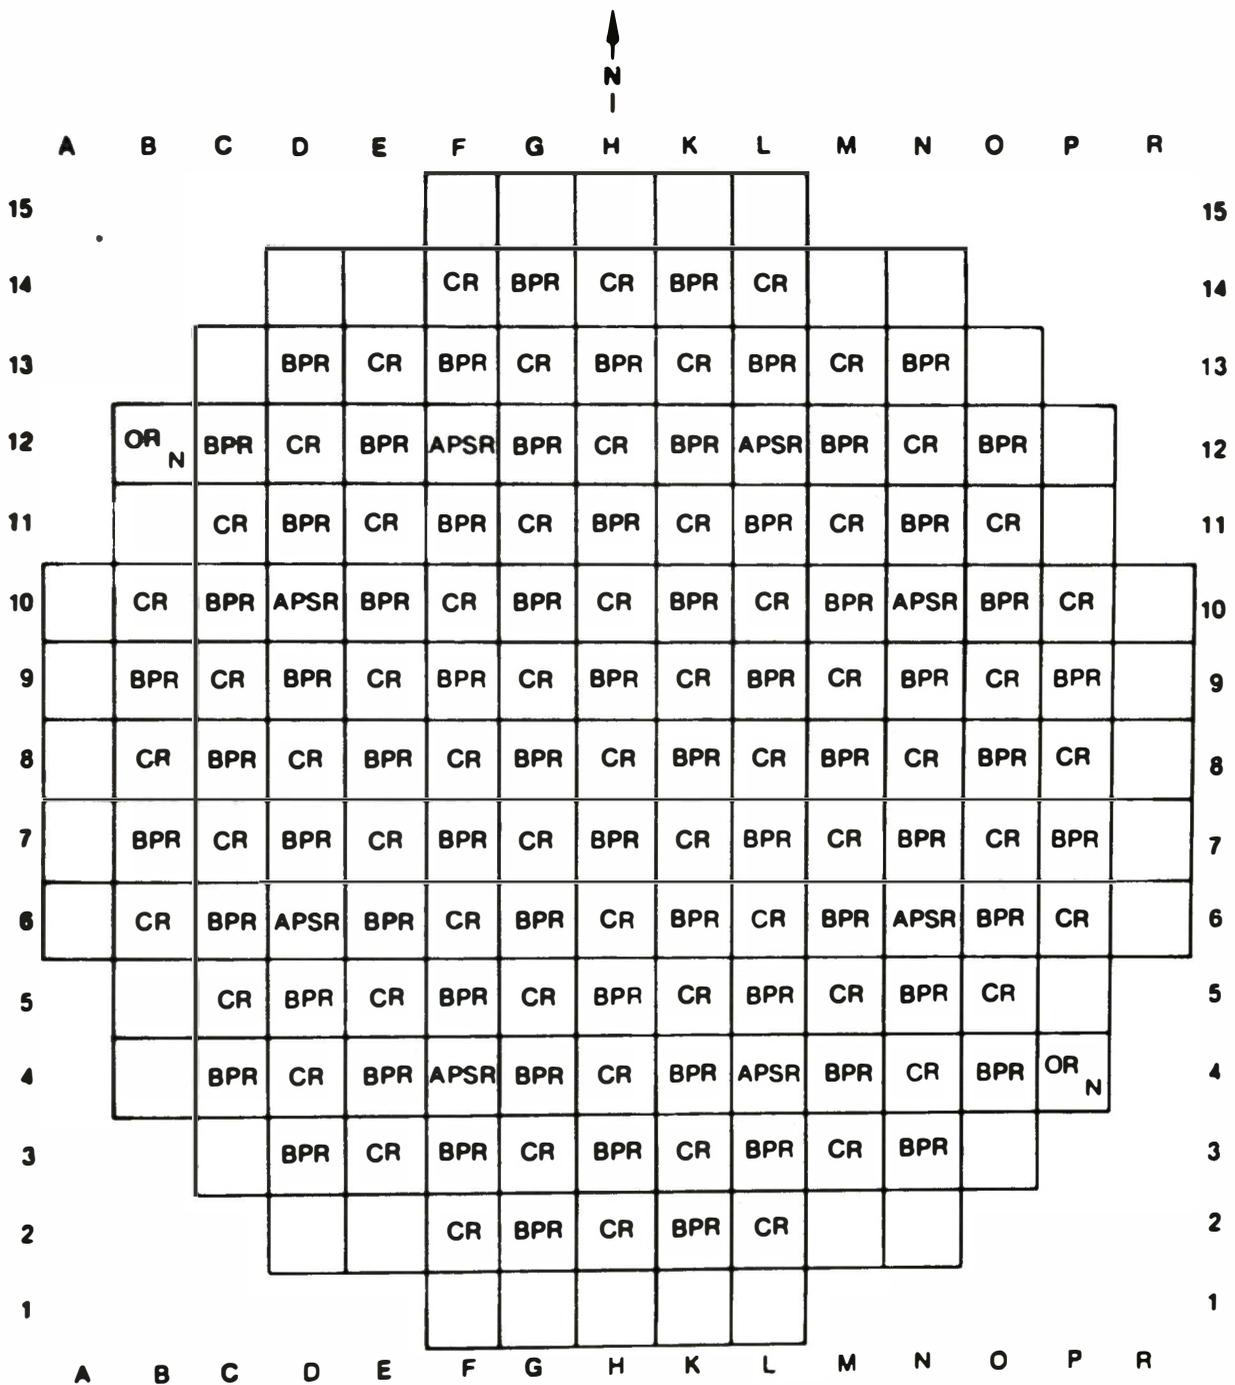
Figure 8-1. TMI-2 core loading diagram.

At accident initiation, the TMI-2 core was in the initial fuel cycle at 95% of full power with 3175 MWD/MTU average core burnup. The core loading consisted of 177 fuel assemblies and 139 rod assemblies arranged in the core positions as shown in Fig. B-1.

All interior and two of the 40 peripheral core positions also had rod assemblies consisting of 16 rods connected together at the top by arms extending from a central hub. The rods fit into the fuel assembly guide tubes. The two peripheral fuel assemblies (core position B12 and P4, next to the core former wall) contained a stationary orifice rod assembly with 12-in.-long stainless steel rods extending into the guide tubes to restrict coolant flow, of which one in each assembly is assumed to be modified to include a neutron source rod. Interior fuel assemblies contained one of three types of rod assemblies as follows:

- Burnable Poison Rod (BPR) Assembly (see Fig. B-3)--The stationary burnable poison rod assemblies were located in 72 core positions as show in Fig. B-1. Each BPR rod contained a 126-in.-long stack of Al_2O_2 (0.95)- B_4C (0.01)-impurities (0.04) ceramic pellets clad in zircaloy, except for core position N13, which is assumed to have contained 8 rods with boronated graphite instead of Al_2O_3 - B_4C .
- Control Rod (CR) Assembly (Fig. B-4)--The CR assemblies were located in the 61 core positions shown in Fig. B-1. The rods

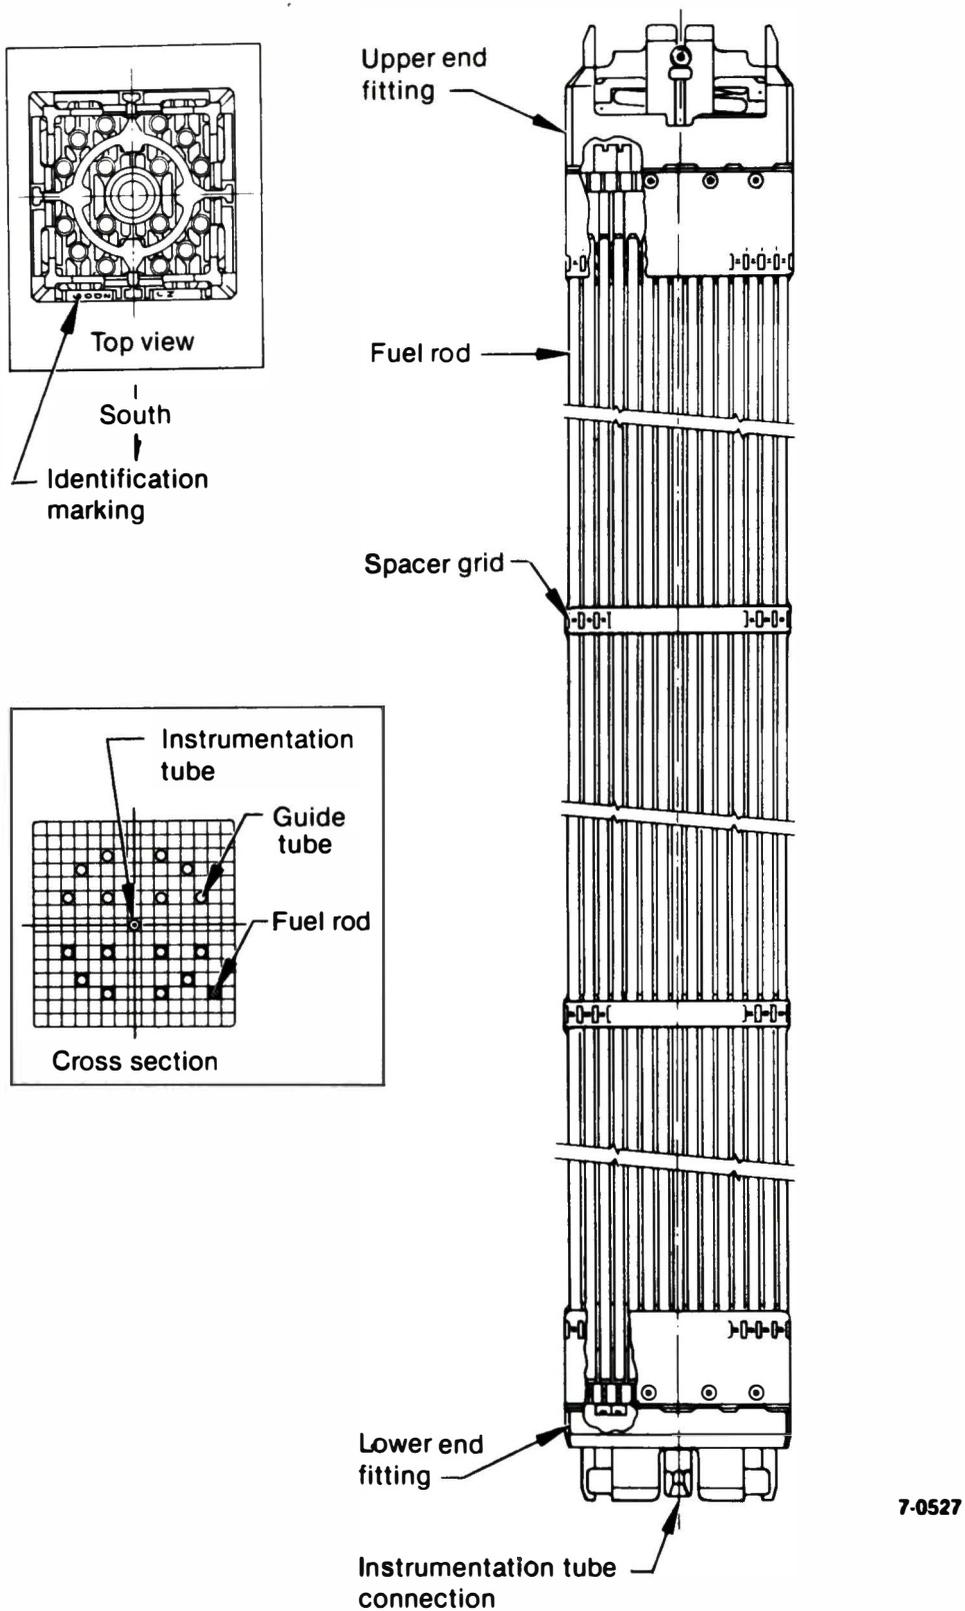
Figure B-2. Side, top, and cross-sectional views of TMI-2 fuel assembly (from Ref. B-1).

Each of the fuel assemblies (see Fig. B-2) was a 15 x 15 array of 208 fuel rods, 16 zircaloy guide tubes, and 1 center-position zircaloy instrument tube. The entire array was connected to and supported by eight Inconel spacer grids and 304L stainless steel upper and lower end fittings. An Inconel, coil-type holddown spring was located in the upper end fitting.

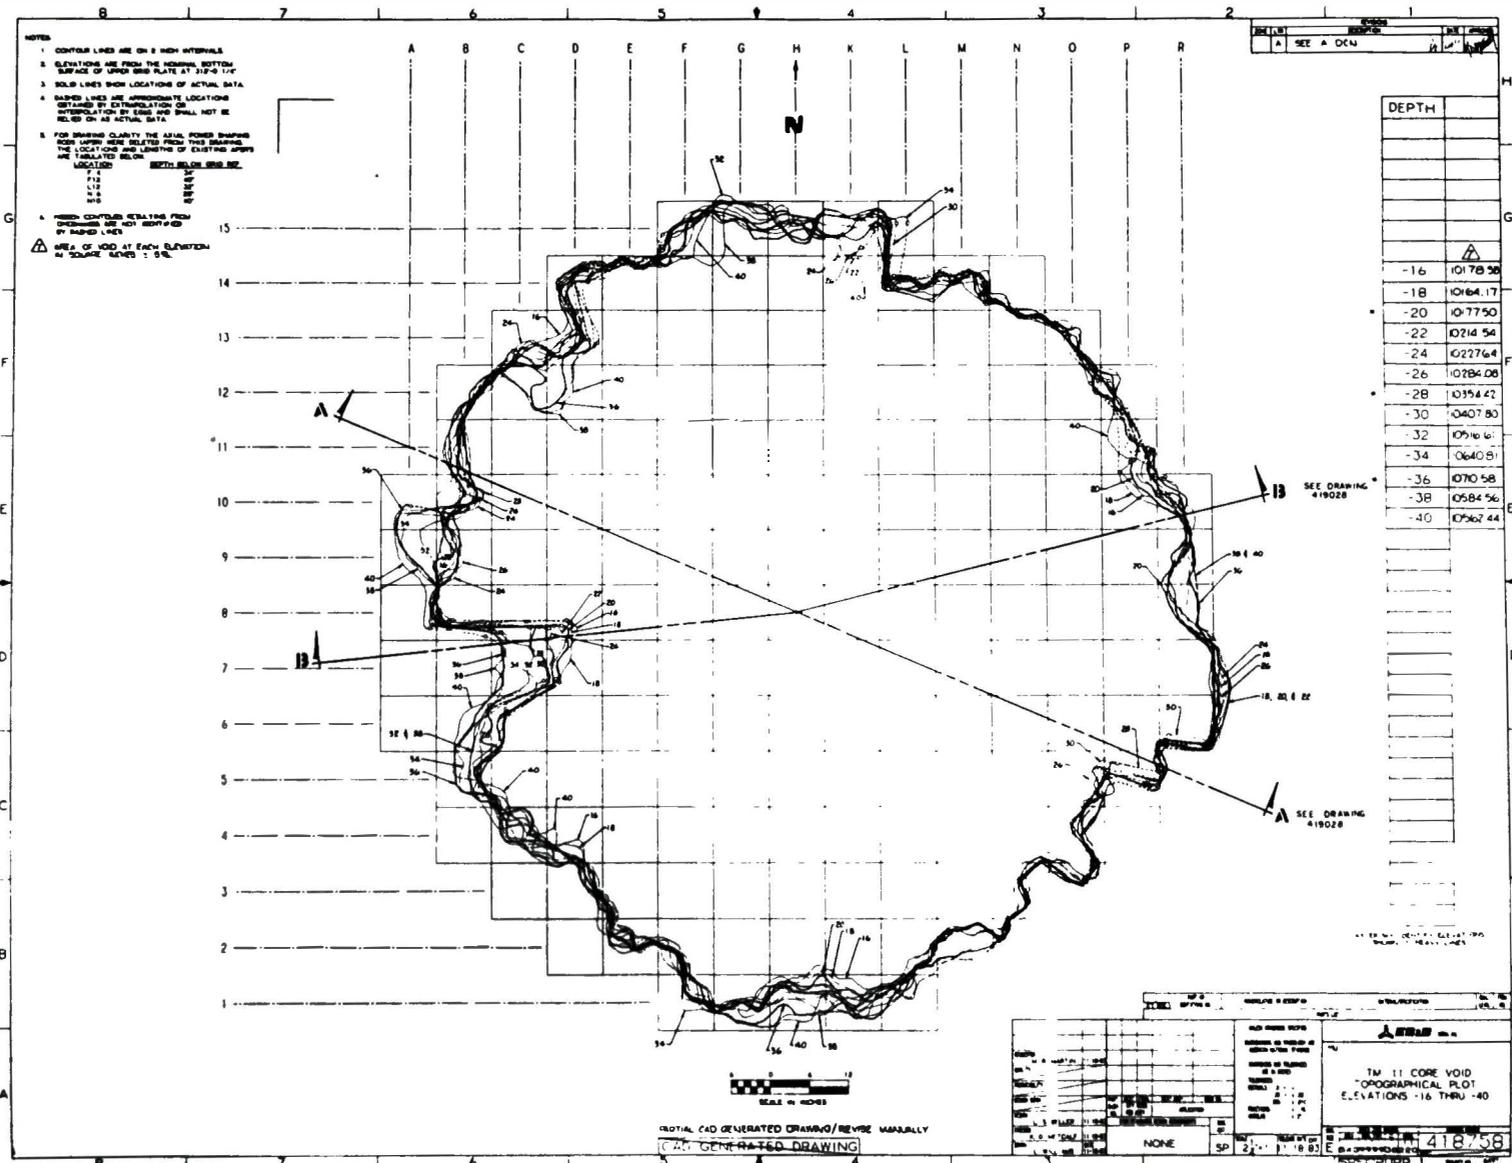
Figure B-7. TMI-2 core void topographical plot elevations -16 through -40.

On August 31, 1983, an ultrasonic scanner survey was made to determine the shape and dimensions of the core cavity. Figures B-6 through B-9 are the resulting topographical maps of the core cavity. The core topographical features included the following:

- The cavity extended from the bottom of the upper grid-plate downward to approximately 7.5 ft above the core bottom and radially to the core baffle plates in some places
