GENE-INF-023
Vol. V

ANALYSIS OF THREE MILE ISLAND UNIT 2 REACTOR COOLING SYSTEM TRANSIENTS

Published August 1983

Rockwell International
Rockwell Hanford Operations
Energy Systems Group
Richland, Washington
Idaho Falls, Idaho 83415

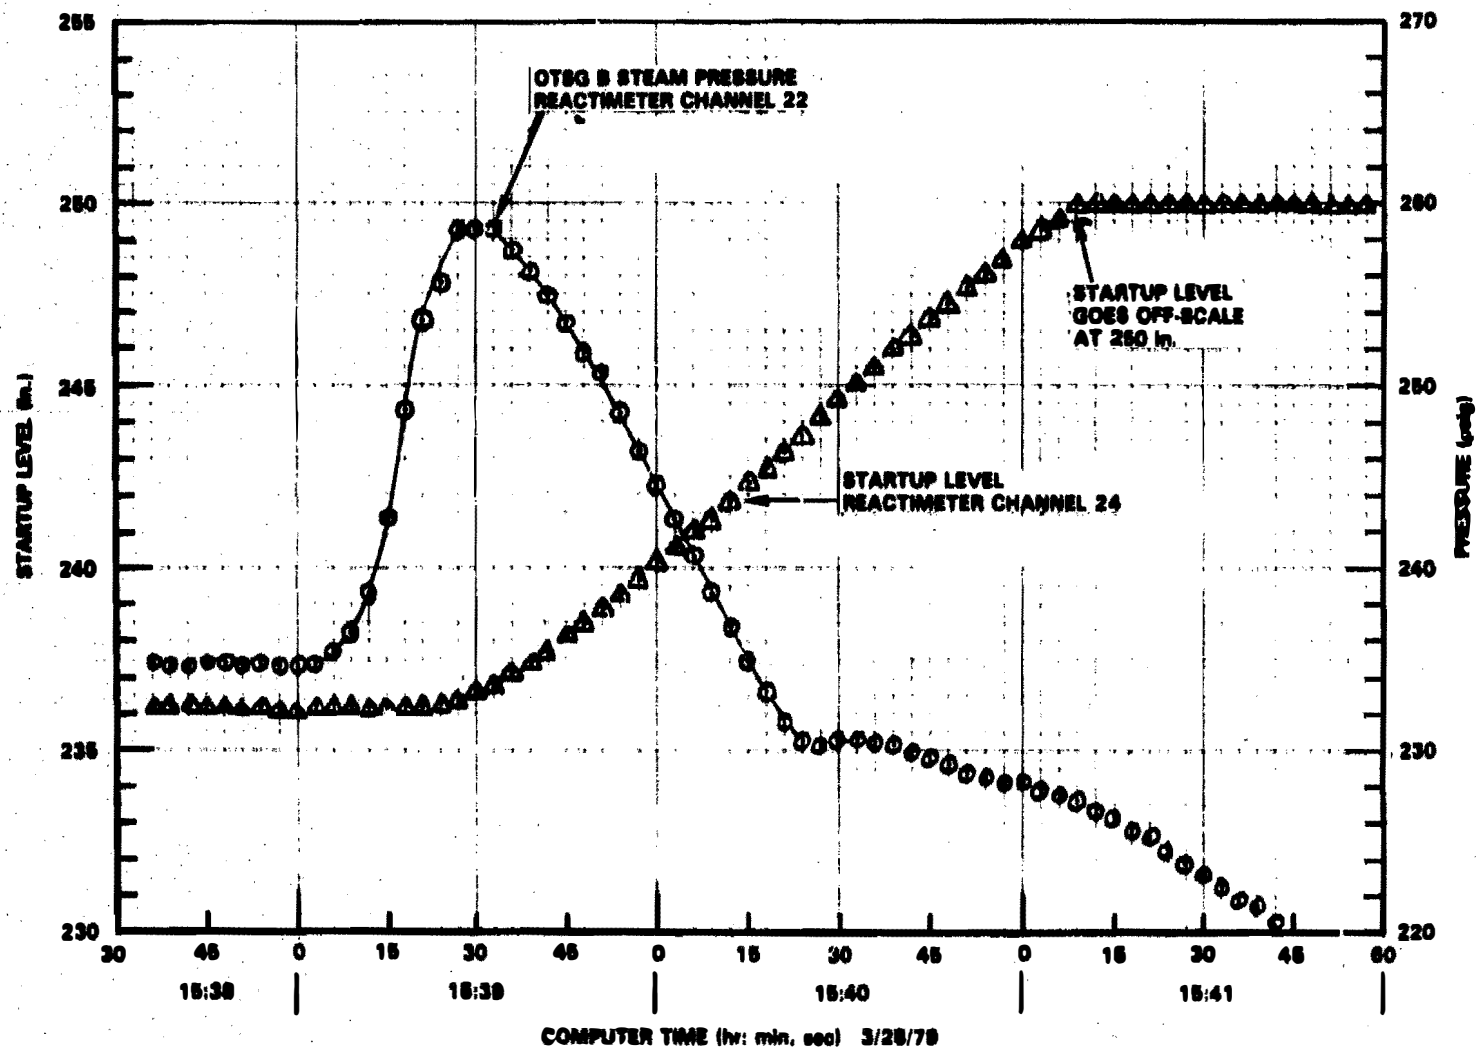
Feed water began spraying into OTSG B at 15:39:06. This is indicated by the beginning of a sharp rise in steam pressure in OTSG B that began at that time. This timing is illustrated in Figure 5. Also plotted on Figure 5 is the water level in OTSG B. As indicated, water level begins to increase at 15:39:27, 21 sec after the pressure spike began. Essentially all of the water entering the steam generator during that lag period apparently flashed into steam or was held up in the steam space.

FIGURE 5. Response of OTSG B to Emergency Feed-Water Flow at 15:39.

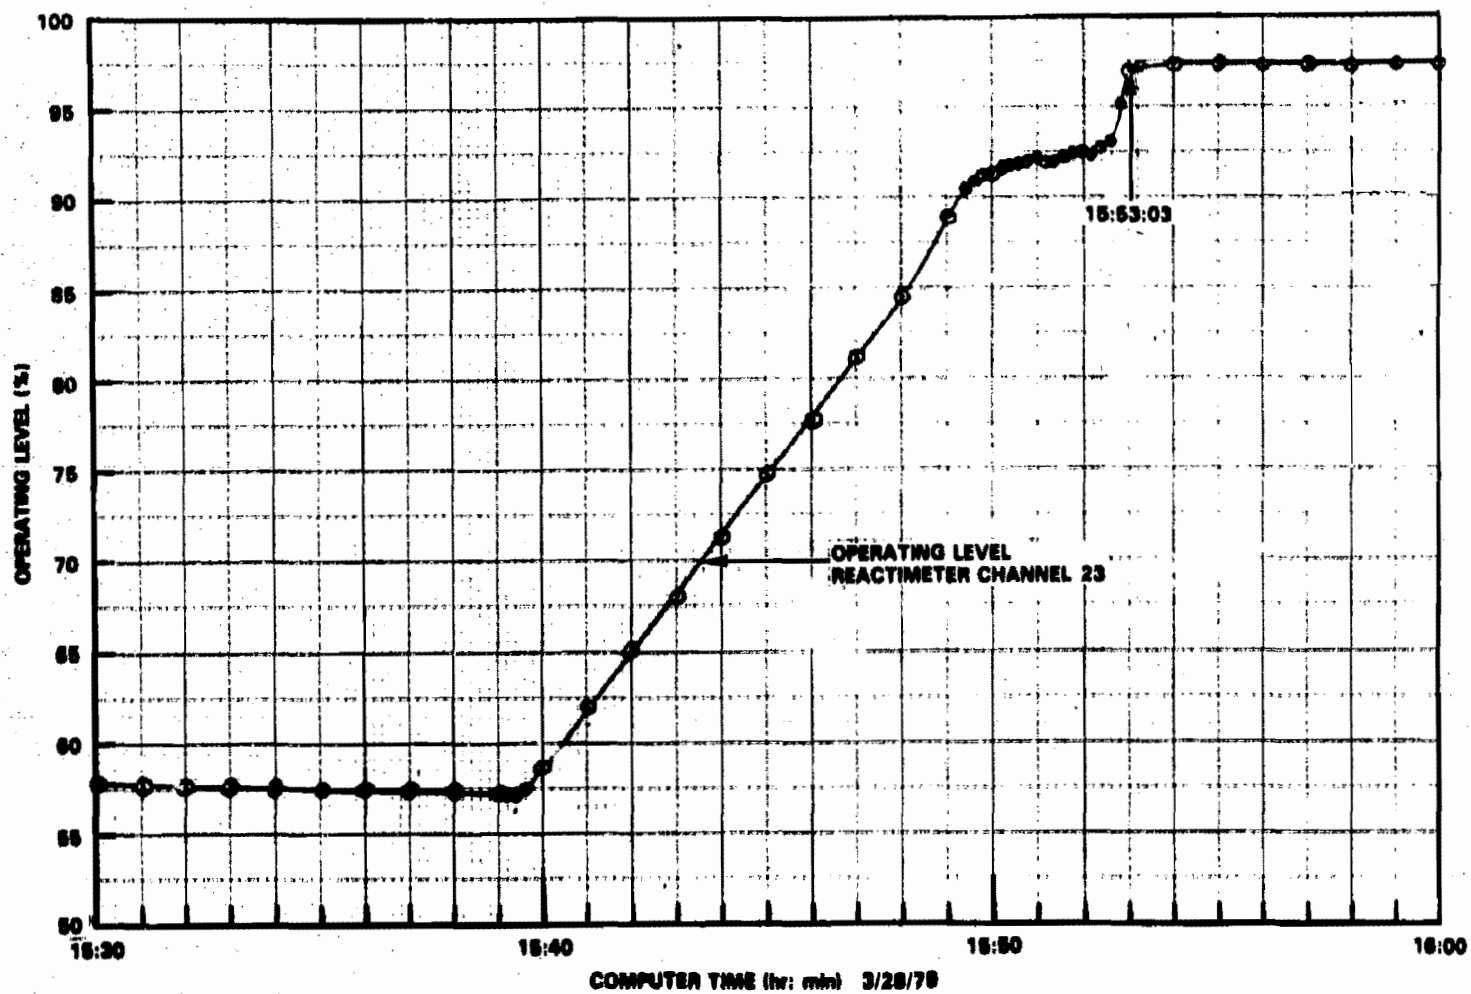
Feed-water flow continued until 15:52:41. This is indicated by the time that the feed-water pump tripped (alarm printer record). Feed-water termination is also indicated by the graph of water level versus time (see Fig. 6). The water level stops increasing at 15:53:03, some 20 sec after pump trip. This short delay between pump trip and the time for maximum water level is reasonably accounted for by pump coast-down, by the draining of water held on the surfaces of tubes, and by other inertias in the systems.

FIGURE 6. Increase in Water Level in OTSG B Due to Emergency Feed-Water Flow at 15.39.
