INVESTIGATION OF HYDROGEN-BURN DAMAGE IN
THE THREE MILE ISLAND UNIT 2 REACTOR BUILDING

N. J. Alvares and D. G. Beason
Lawrence Livermore National Laboratory
and
G. R. Eidam
EG&G Idaho, Inc.

Published June 1982

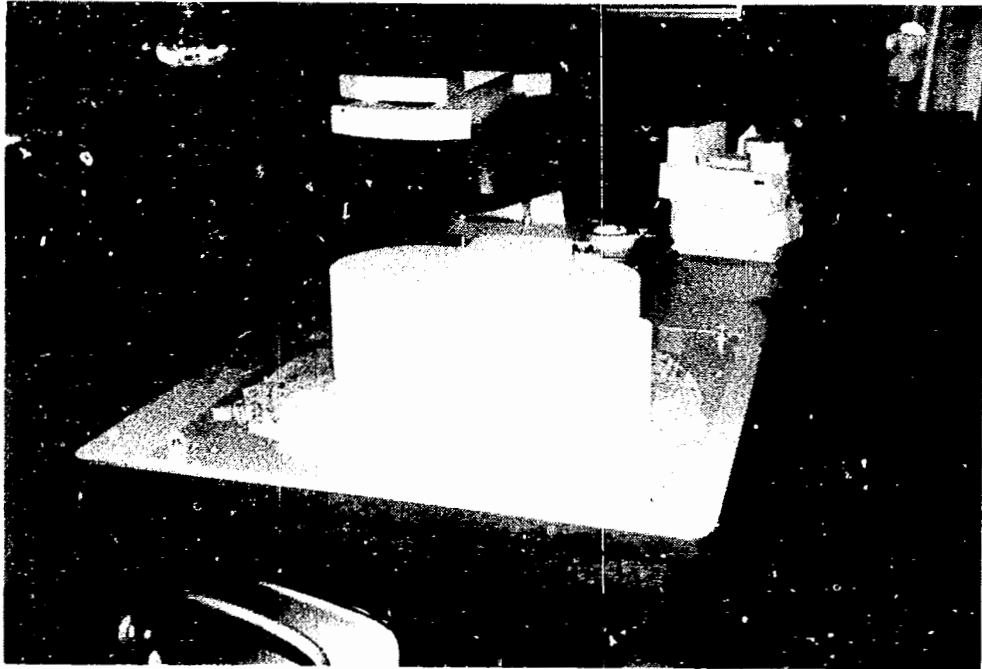
Figure 31. Building model south view--305 level.

Figures 31 through 33 are photographs of the styrofoam model on which damage patterns were plotted according to photographs from the first 15 reactor building entries. This model currently resides at the EG&G Idaho site office at TMI. New information about thermal and overpressure damage recorded during subsequent reactor building entries is being added to the model to increase the accuracy of the damage pattern.

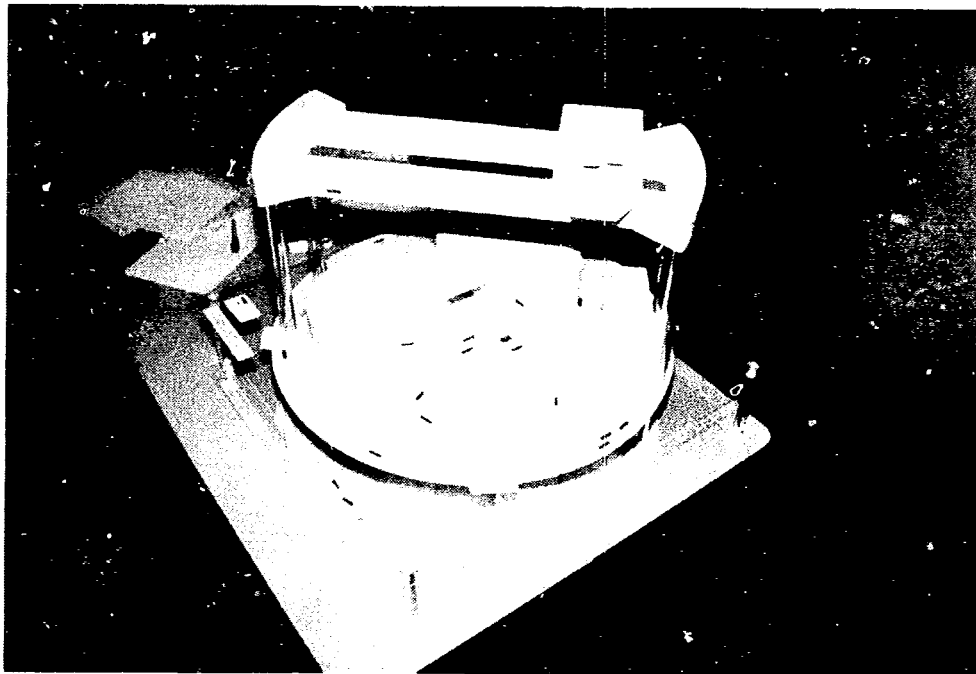
Figure 34. Building model top view--crane and 347 level.

Figures 31 through 34. Model of the TMI-2 reactor building showing damage locations.
