## ASSESSMENT OF EXTENT AND DEGREE OF THERMAL DAMAGE TO POLYMERIC MATERIALS IN THE THREE MILE ISLAND UNIT 2 REACTOR BUILDING

GEND-INF--023-Vol.6

Published February 1984

Lawrence Livermore National Laboratory  
Livermore, California

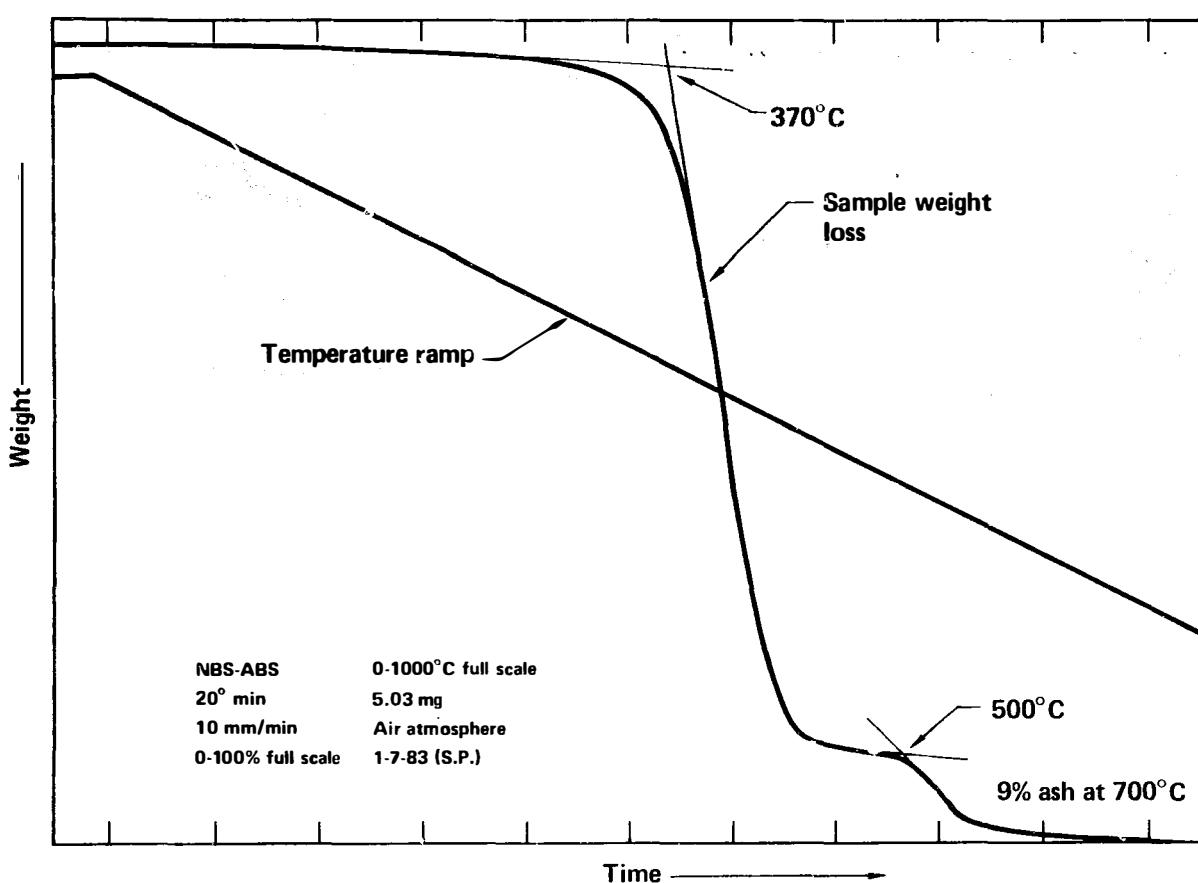
Figure 7. Thermogram of NBS-ABS.

These figures are included to illustrate how different TGA records can be used to analyze performance of exposure materials. Figure 7 shows that NBS-ABS commences major weight loss at 370<sup>0</sup>C and terminates at 500<sup>0</sup>C. Most flammable pyrolyzates are emitted in this range, leaving about 20% inert material as residue. This material is flammable and, with an external ignition source, it will ignite within this range. Figure 8 shows two major weight-loss periods, the first occurring at 265<sup>0</sup>C and the second at 365<sup>0</sup>C. This ABS formulation included bromine- and antimony-containing fire retardants that release upon pyrolysis to inhibit flaming combustion.

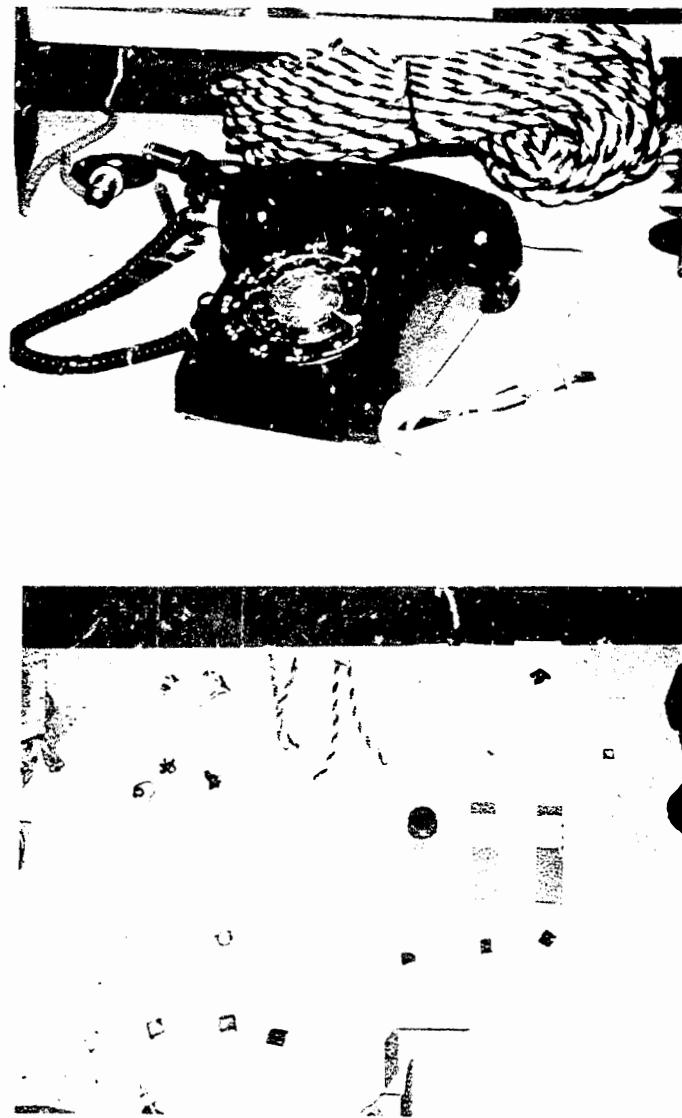
Figure 15. Small-scale materials and test apparatus for TMI exemplar materials. Hydrogen flame output was 6 W.

Figure 15 shows the simple experimental setup. In Figs. 16 through 24, materials subjected to the experimental fire are compared directly to similar materials extracted from the TMI-2 reactor building. Table 4 gives details of the experimental exposure and descriptions of thermal damage to exposed samples.
