Examination Results of the Three Mile Island Radiation Detector HP-R-211

October 1981

EXAMINATION RESULTS OF THE THREE MILE ISLAND RADIATION DETECTOR HP-R-211

Sandia National Laboratories
Albuquerque, New Mexico 87185
and
Livermore, California 94550

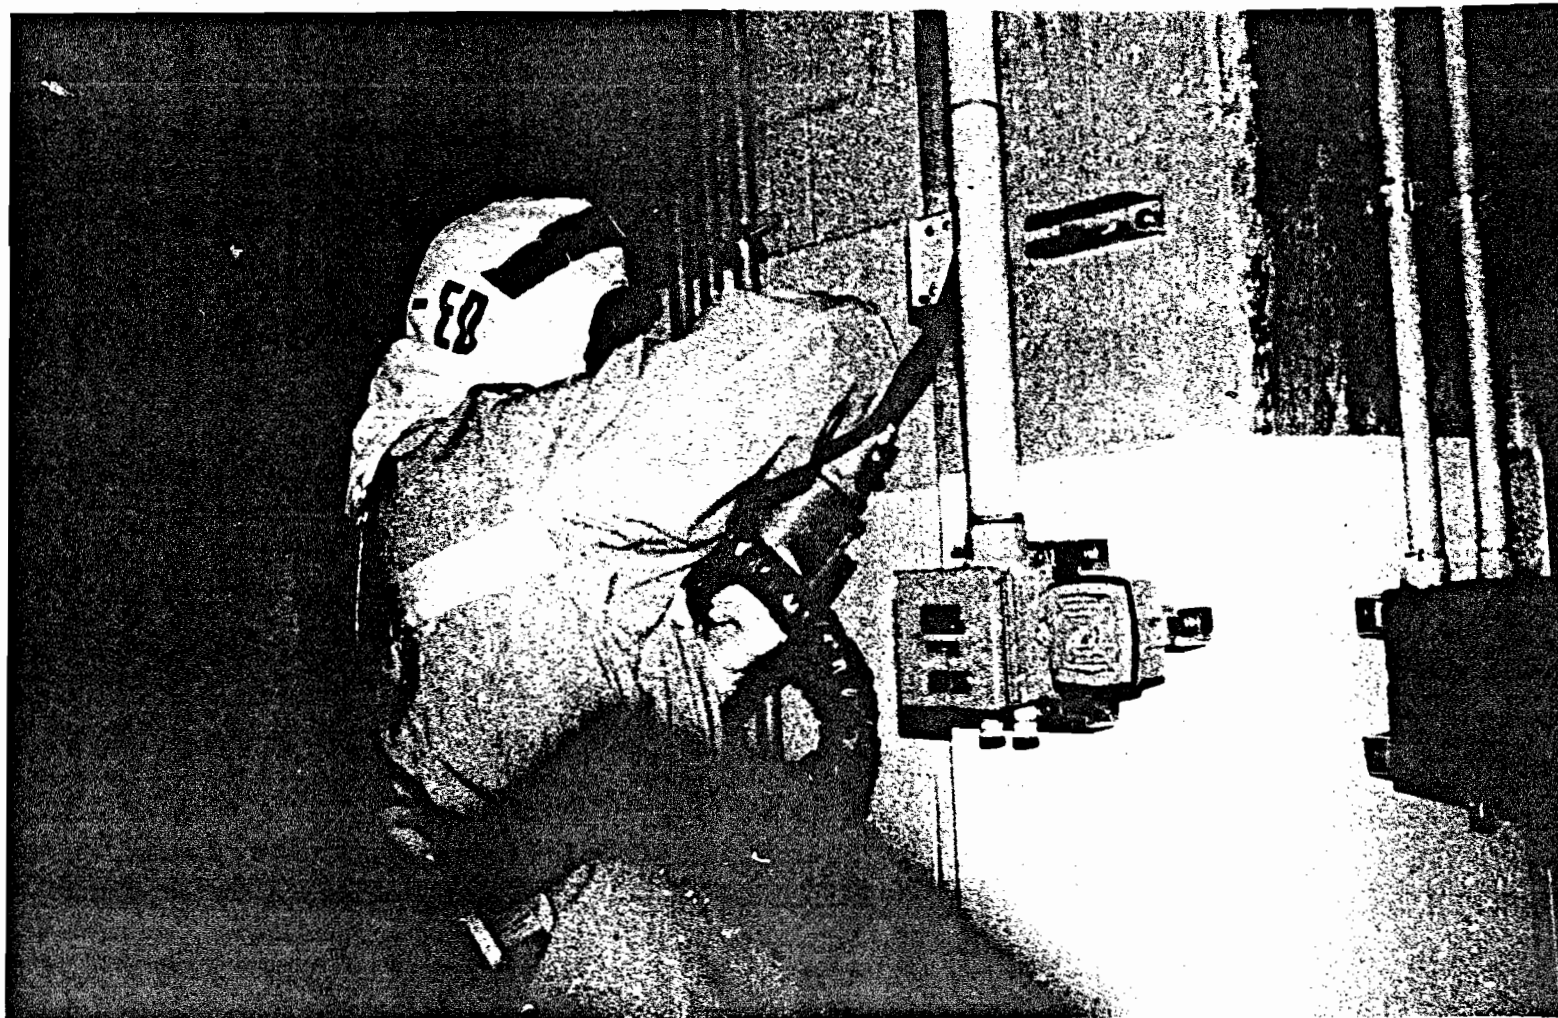
Extensive preparations were made prior to removal to minimize the time spent by the GPU staff inside the containment building. This included practice on a full scale mock-up assembled by the TIO staff. The plan was to remove the faulty detector and replace it with a functional one. Unfortunately, during removal (Figures 3 and 4) the cable was detached from the connector backshell at the point where solder connections are made. The result of this was to make it impractical to install the replacement.

FIGURE 3. Detector Removal. The detector has been removed from the wall slide bracket and the cable is being disconnected.

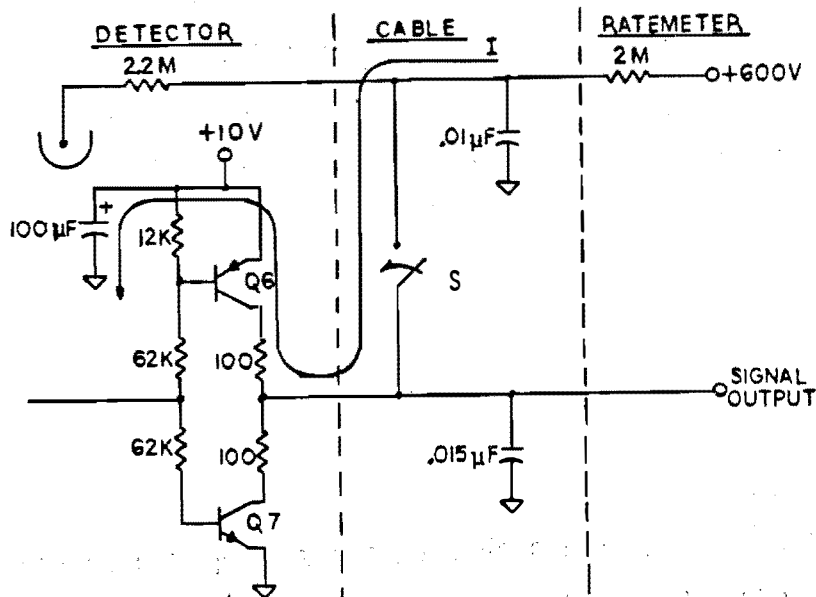
FIGURE 16. Test Circuit Showing Energy Discharge Path

To investigate this postulated mode of failure, several laboratory simulations were conducted and will now be discussed. The presence of the 100 ohm current limiting resistors in the signal output line preclude Q6 from being destroyed by a short of the signal line to ground. In fact, DC shorts were made from each connector pin to the next, using the test channel, and a failure could not be induced. The 600 Volt line has a 2 Megohm current limiting resistor at the ratemeter; even though the transistor can break down, the steady-state current is limited to only 300 Microamperes. No discharge paths were found on the circuit board. Recall however, that some 152 M (500 ft.) of cable connects the detector to the power source. We found that the energy stored in the line capacitance was sufficient to cause punch-through. This was found by conducting the following experiment (refer to Figure 16): Capacitors of 0.015 μ F and 0.01 μ F were connected to the signal output and 600 Volt lines going to the test detector to simulate the charges stored in the 50 Ohm and 75 Ohm cable capacitances. A switch was then thrown to discharge the capacitor on the 600 Volt line into the signal output. This results in a surge current of approximately 6 amperes. The circuit diagram shows a possible current path, I.

We opened and closed Switch S repeatedly while constantly monitoring the signal output line. After approximately 40 closures the "O" level voltage had increased to 6.65 Volts. After 80 closures, the transistor in slot Q6 was removed, tested and found to exhibit a 96 Ohm collector-to-emitter resistive path, similar to that in the failed detector. No other circuit defects were observed. Tests have been conducted on four other 2N 3906 transistors from a different manufacturer and on two higher current 2N 2904's. All could be made to fail with a single discharge, but only if the 100 Ohm current limiting resistor was decreased. One 2N 3906 failed when the resistor was 72 Ohms, however, all others required lower resistance. The capacitive model of the cable does not simulate exactly the cable characteristic impedance of 75 Ohms and stored charge, since the cable is a transmission line and will appear to have a 75 Ohm source impedance. Since the line is not

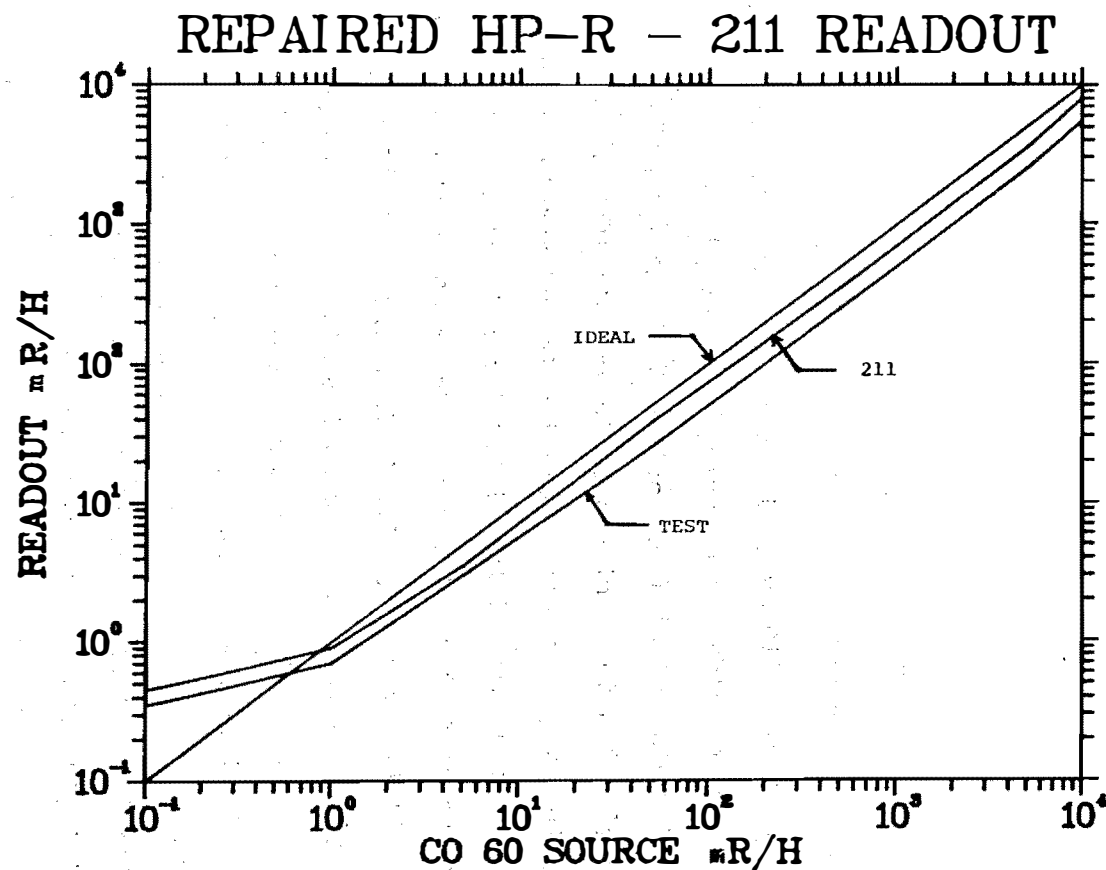
FIGURE 19. Repaired Detector Characteristics. The curve labeled 211 is a plot of the HP-R-211 readout versus Co-60 source level using the test channel ratemeter. The ideal input vs output is shown. The two curves differ by a calibration factor associated with each GM tube. So that there be no mistake that HP-R-211 is operating properly, the test detector is included for comparison. This curve also shows the need for ratemeter calibration. The changes in slope at low radiation levels are due to normal background radiation.

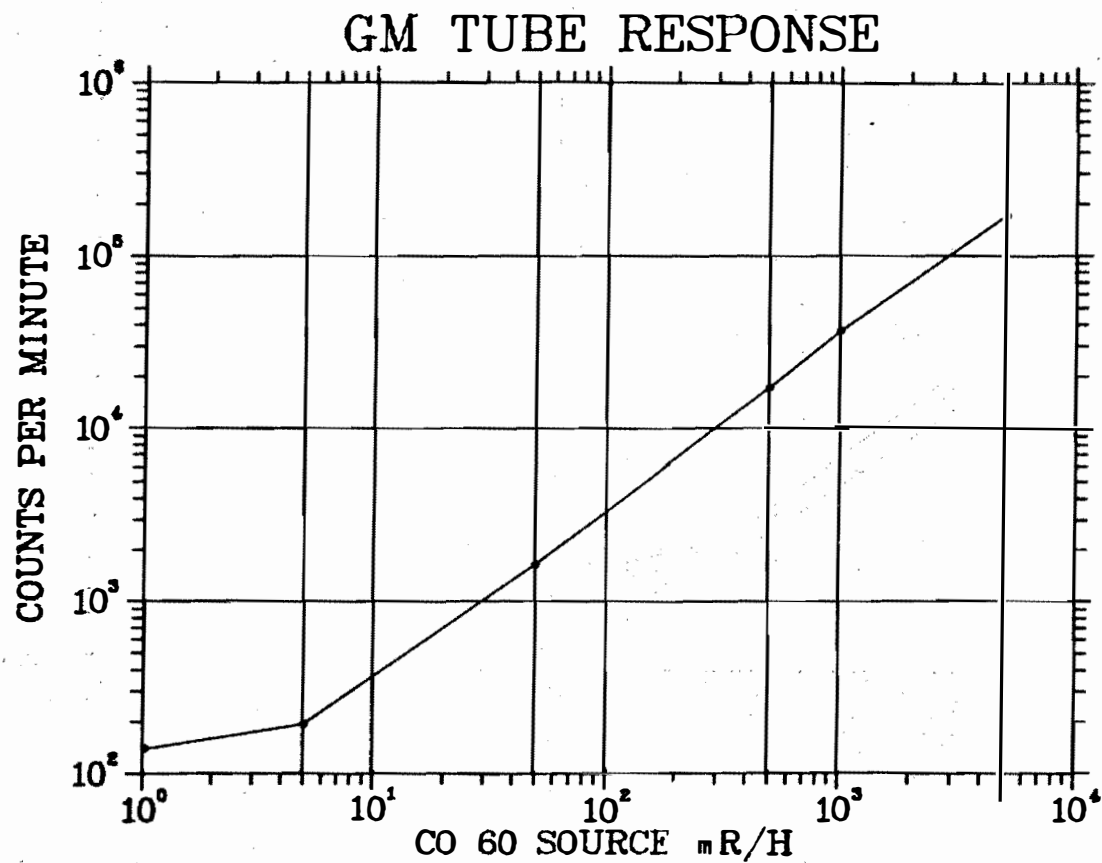
FIGURE 20. GM Tube Characteristics. The detector counts-per-minute are plotted vs gamma source level as measured with a frequency counter. Since the detector was contaminated, the lower end of the curve has a slope change.

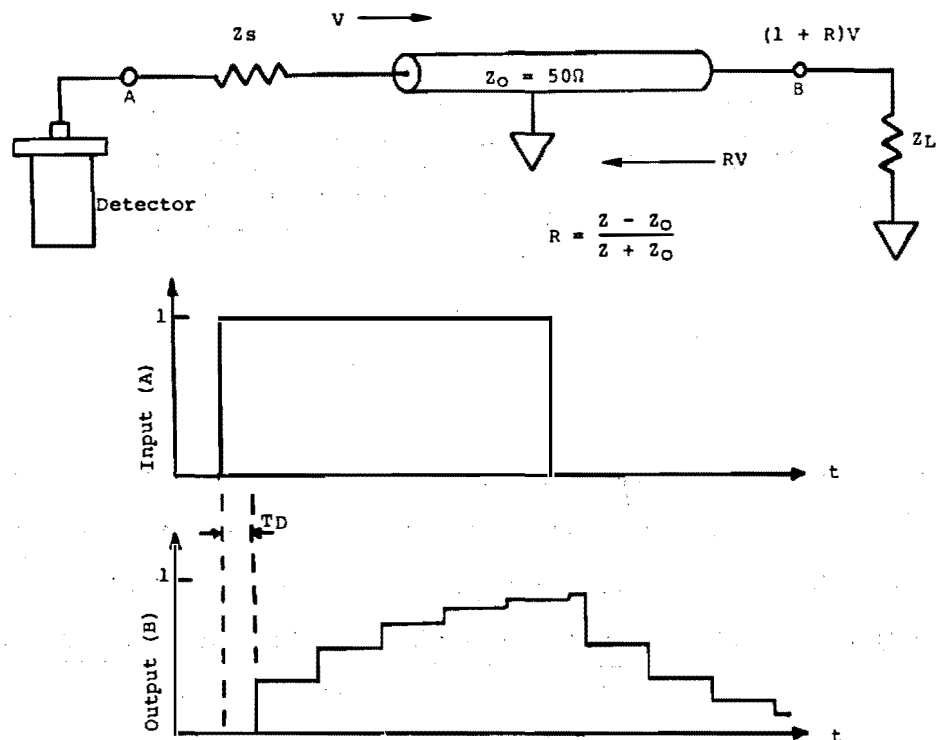
The dip has, in fact, been determined to be due to two items: impedance mismatches between the coaxial cable and both the detector and ratemeter circuits, and GM tube circuit interactions above the antijam point. First, and probably most importantly, the detector output circuit is not designed to properly match in impedance the 50 ohm cable attached to it. The normal output impedance of the detector is approximately 100 ohms rather than 50 ohms. Further, the ratemeter input appears as an open circuit for the steady-state signal. This open circuit combined with the mismatched driver sets up reflections in the cable which have the same effect as filtering the signal. Since the ratemeter circuit is a linear log pump, both the amplitude and the frequency of the signal affect readout accuracy. Figure 22 illustrates the effects on the waveform of the mismatch. For a voltage V propagating down a coaxial cable of characteristic impedance Z_0 , the voltage across the load impedance Z_L is equal to $(1 + R)V$, where R is the reflection constant. If Z is the termination impedance, R is given by:

FIGURE 22. Input and Output Waveforms for a Mismatched Transmission Line ($Z_s = 250\Omega$, $Z_L = \infty$)

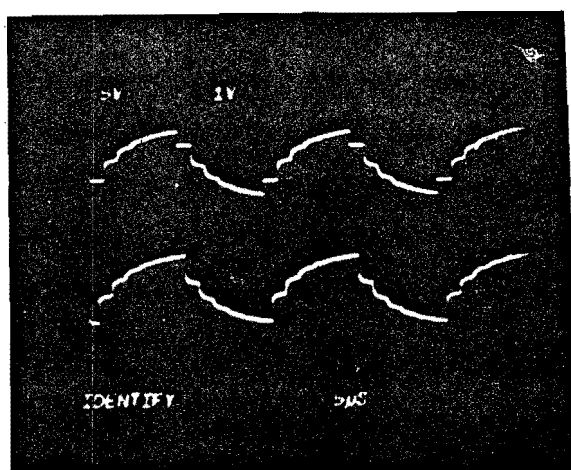
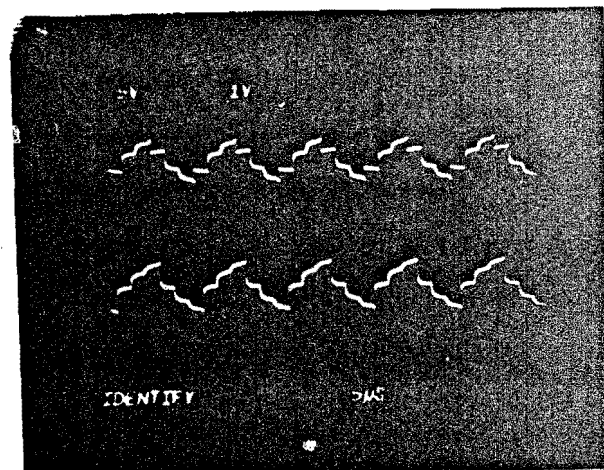
FIGURE 23. Mismatch Filtering. For both photographs $Z_s = 250$ ohms and $Z_L = \infty$. The top trace is the transmission line input voltage and the bottom trace is the output voltage. The input frequencies for left and right photographs were 50 kHz and 100 kHz respectively.

length of the cable and impinges at the detector end where it is reflected due to the improper termination. The process continues, and a voltage step at the detector end, the resultant waveform at the rate-meter shows a series of upward (or downward) steps. The width of each step is equal to $2T_D$, where T_D is the time required for the signal to propagate the length of the cable. If the detector output squarewave reaches a frequency high enough to have a period which is of the order of T_D , a substantial rolloff of the waveform will result. Figure 23 shows oscilloscope pictures of this condition.

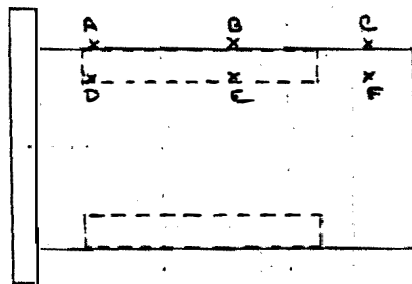
Position 4

Bottom view

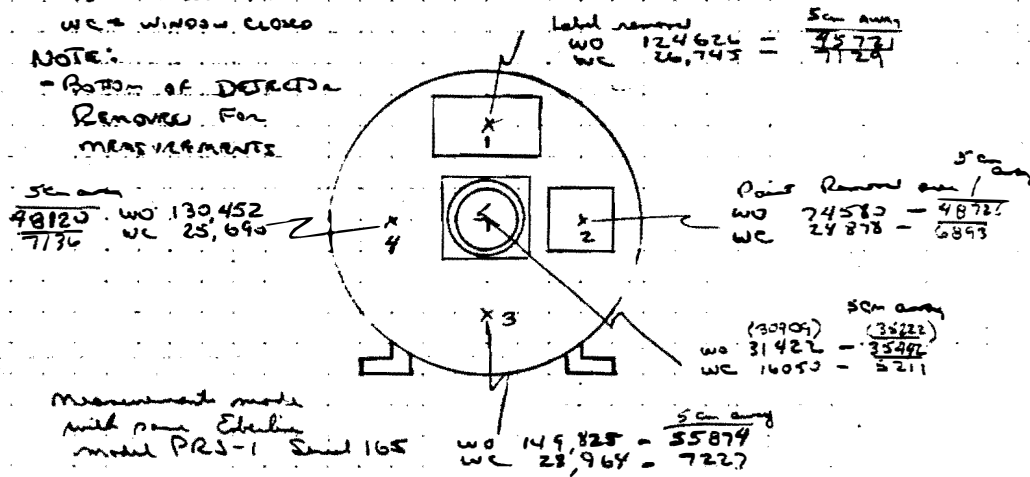
Measurements made
with same Etchlon
model PR3-1 Serial 165

WO - Window Open
WC - Window Closed
