GEND--019

EXAMINATION RESULTS OF THE THREE MILE ISLAND RADIATION DETECTOR HP-R-213

Sandia National Laboratories
Albuquerque, New Mexico 87185

November 1982

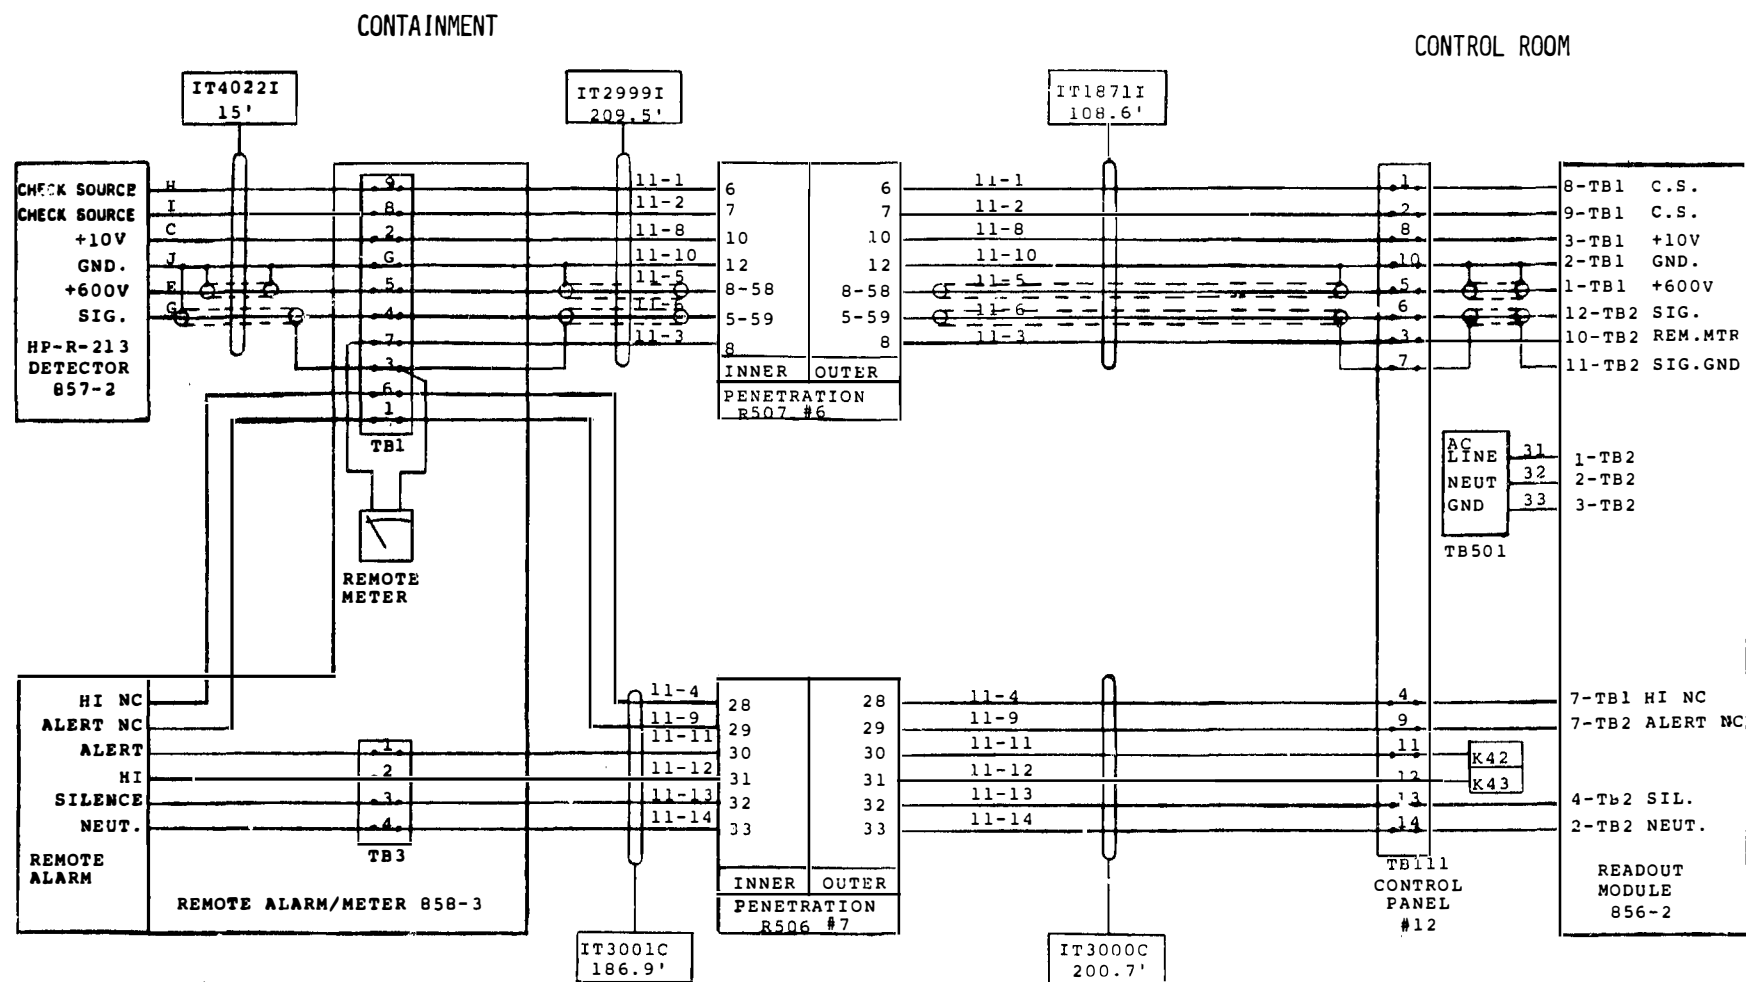
FIGURE 2. HP-R-213 WIRING DIAGRAM

HP-R-213 (SN326) is one of six containment building area radiation monitors. It was mounted on the D ring wall at the 347 foot elevation near the incore tube exit ports. The detector was connected to its ratemeter readout electronic module in the TMI-2 control room through about 104 meters (341 feet) of instrumentation cable. The wiring diagram for HP-R-213 is shown in Figure 2.

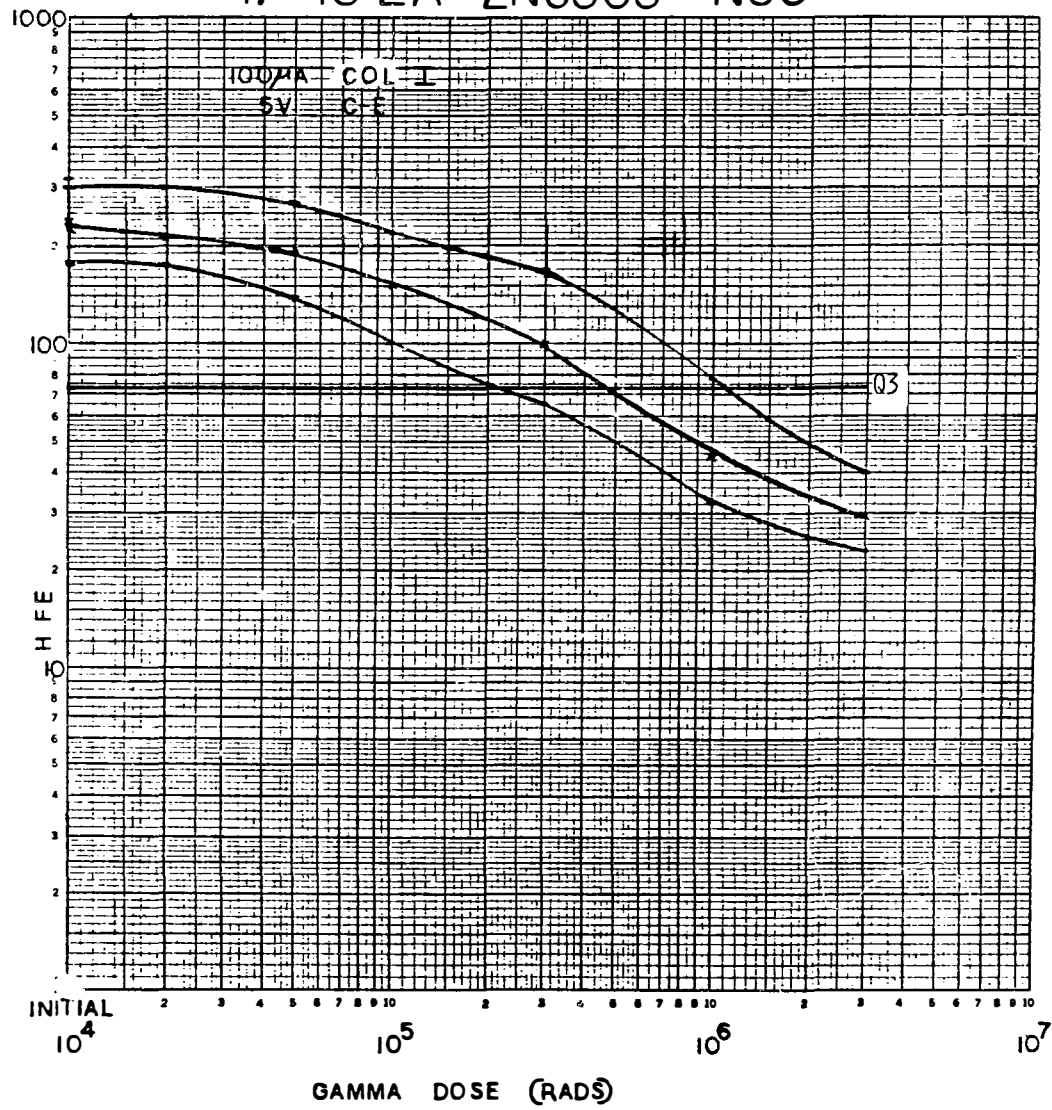
I. 10 EA 2N3565 NSC

Transistor current gain, HFE, degradation is plotted in the curves given here versus cumulative gamma radiation dose. Eighty-seven devices from four manufacturers were passively exposed to a ^{60}Co source in progressive steps, and the characteristics were measured after each step. Transistor HFE's are plotted for collector currents of 100 micro-amperes. The three curves shown for each device type represent HFE characteristics from the minimum device, the maximum device and the average of all the devices of that manufacturer. Also shown are the intersections of these curves with the HFE values measured for the devices removed from HP-R-213. The number of devices of each type as well as the manufacturer is listed on each graph.
