FINAL REPORT ON THE IN SITU TESTING OF ELECTRICAL COMPONENTS AND DEVICES AT TMI-2

Florante T. Soberano

Published June 1984

United Engineers & Constructors, Inc. Philadelphia, Pennsylvania

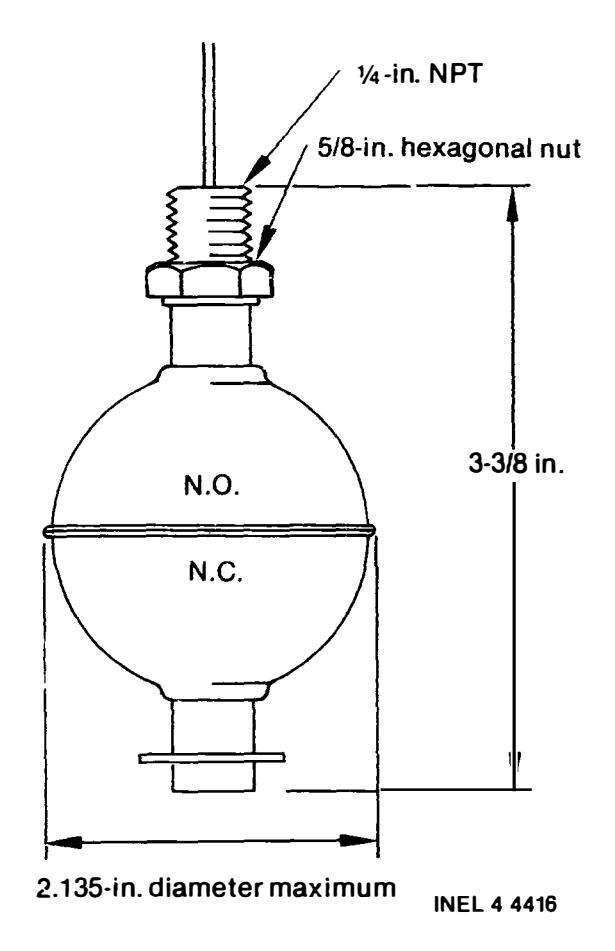
Figure 2. Level switch Delaval GEMS Model LS 1950.

The devices were tested before and after gross decontamination. In predecontamination testing, AH-LS-5007 and AH-LS-5008 were normal in all aspects while AH-LS-5006 exhibited an elevated real resistance of 554 ohms and a capacitive dip at the device end of its circuit TDR signature, as seen in Figure 3. This anomaly of AH-LS-5006 was attributed at the time to water in the circuit, specifically in the device proper or very close to the device. Postdecontamination testing revealed basically the same abnormality but with some changes.

AH-LS-5007 remained normal, as it performed in the initial test. In contrast, AH-LS-5008 exhibited a slight increase in its loop resistance from its initial value of 1.81 ohms to 12.2 ohms. The change was also apparent in the TDR trace, characterized by a less rapid decay at the end of the cable. The rise in resistance was suspected to be due to oxide buildup on the switch contact or on the field wire-instrument lead wire connection. The anomaly did not affect the device function.

Although the abnormalities of AH-LS-5006 and AH-LS-5008 did not affect their functions, their occurrence signifies failure of the devices if the point of high resistance is in the device. The switches are supposed to be hermetically sealed.

The cause of the failure of the two level switches can only be speculated, but it may be related to the accident. The devices are designed to operate in a wet, 400°F environment. During and after the accident, the radiation level was high and temperatures increased. The high radiation level persisted but the temperature decreased to lower than normal. The high radiation level may have deteriorated the device stem potting material and reed switch sealing material, causing them to crack and shrink and allowing moisture into the reed switch internal. If the point of fault is external to the reed switch, the extremely wet Reactor Building environment that existed since the accident could have caused oxidation to the circuit terminals.

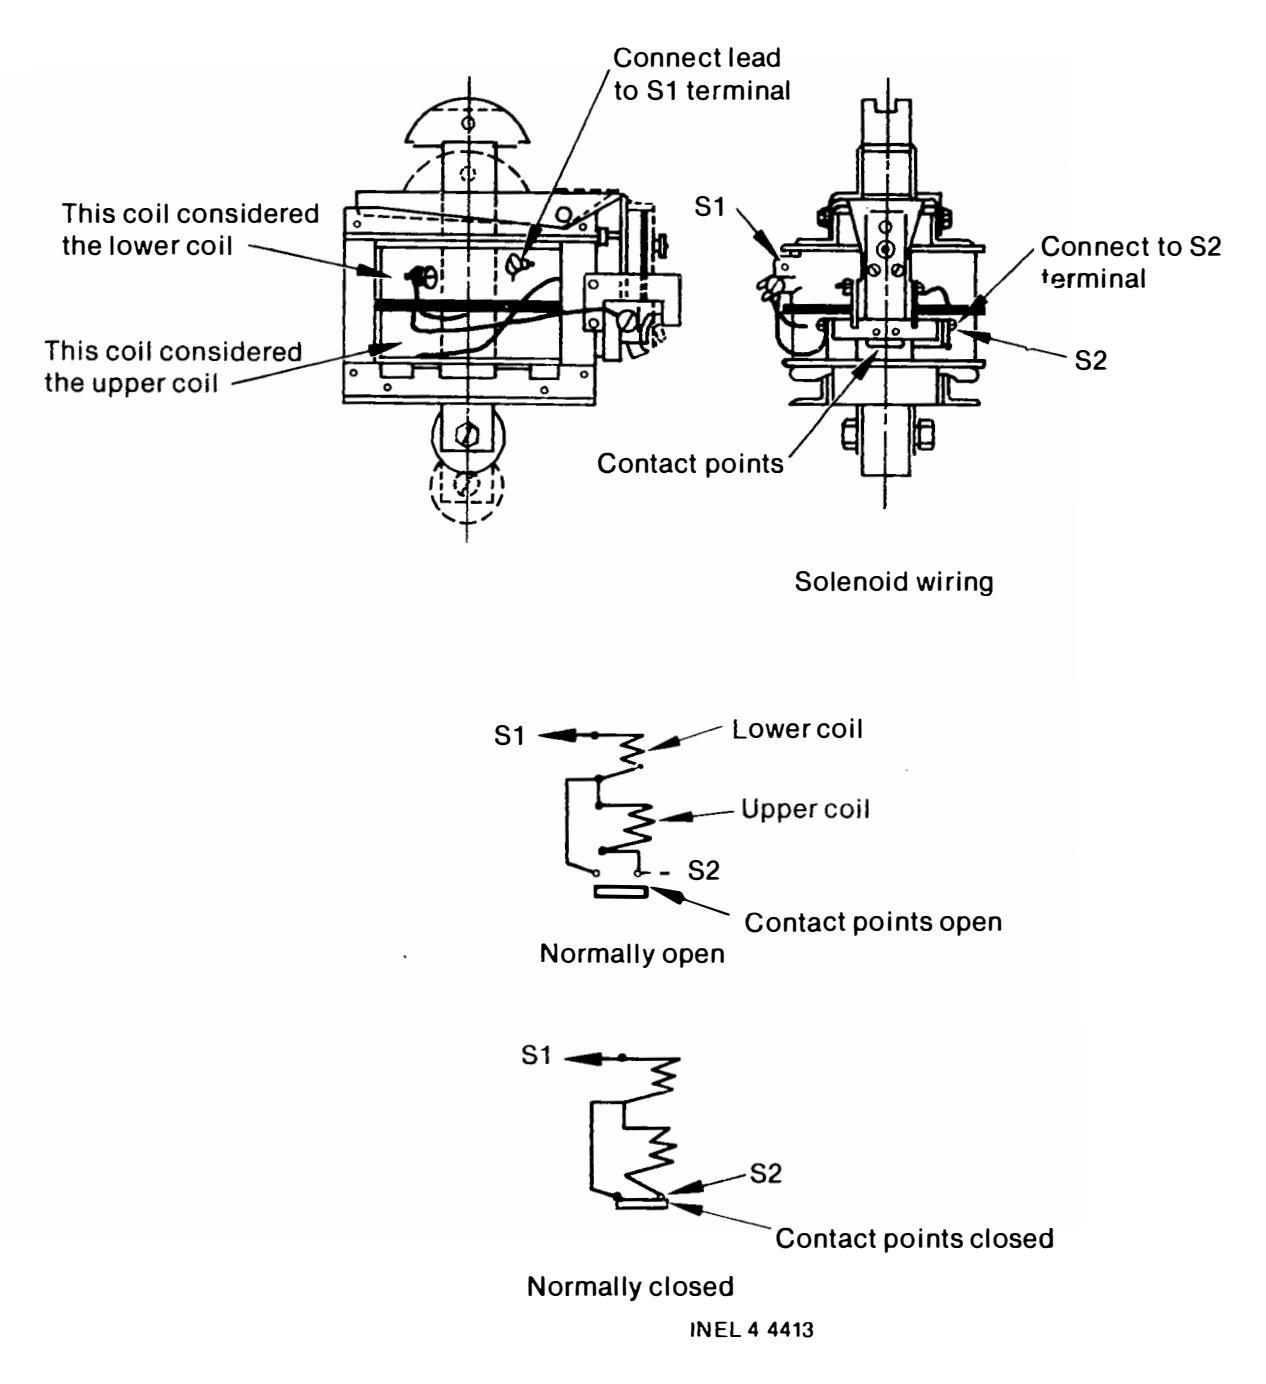
Figure 12. Circuit arrangement of the solenoid of RC-R2. One coil functions to open the valve, and both coils function to hold the valve in open position. When the lower coil is energized, current flows through the contact points following the path of least resistance, bypassing the upper coil. In full open position, contact points are broken, and current must flow through both coils. (This is a dc solenoid for a 31533VX-30 valve.) The test of the PORV solenoid and limit switches indicates the unit is intact. The electrical parameters are normal, and the insulation resistances are high. However, the inductance and resistance measured on the solenoid correspond to the two coils in series. The solenoid has a design inrush current of 26.3 amperes and holding current of 0.4 ampere. Since the coils are designed for 125-Vdc operation, the resistance of the solenoid in its deenergized condition should be 5.29 ohms, and in the solenoid's steady state condition, the resistance should be 312.5 ohms. Photographs from early Reactor Building entries show the solenoid plunger to be fully retracted; hence, the measured values for inductance and resistance suggest the cutout switch is open.

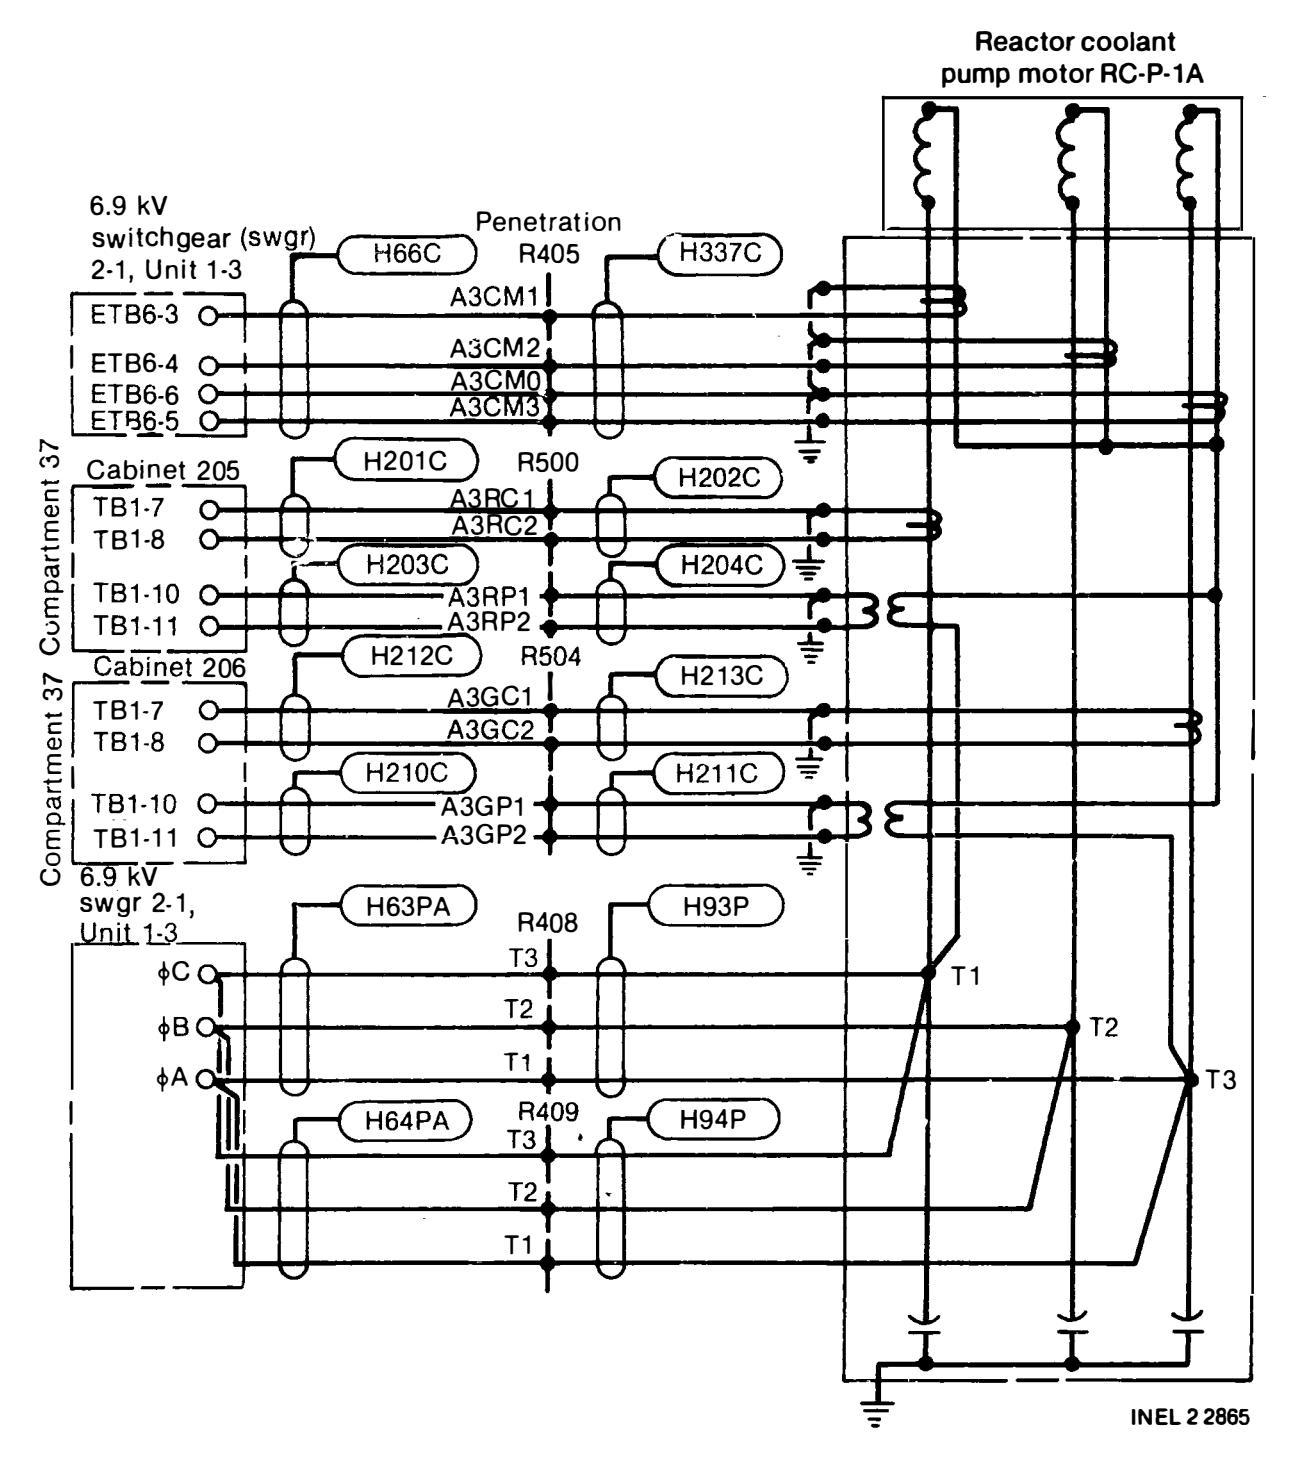
Figure 14. Interconnection wiring diagram of the RC-P-1A motor.

In contrast with the condition of the RC-P-2B differential CTs, those of RC-P-1A and RC-P-2A exhibited more severe abnormalities. The RC-P-1A CTs were broken on circuit A3CM1 (see Figure 14). The break is shown on the TDR traces (Figures 15 through 18) to be in the inner termination box of penetration R405. In addition, the test showed a slightly elevated resistance in circuit A3CMO, the high resistance point likewise being in the inner penetration box. Another anomaly that was observed on the RC-P-1A CT is the absence of the ground wire from the neutral of the transformers. No significant change in the characteristic impedance of the CTs' in-containment cable was observed. In the case of the RC-P-2A differential CTs, a circuit break on phases T2 and T3 CTs also exists. The TDRs show wires B4CM2 and B4CM3 broken in inner penetration box R405 (see Figures 19, 20, and 21).

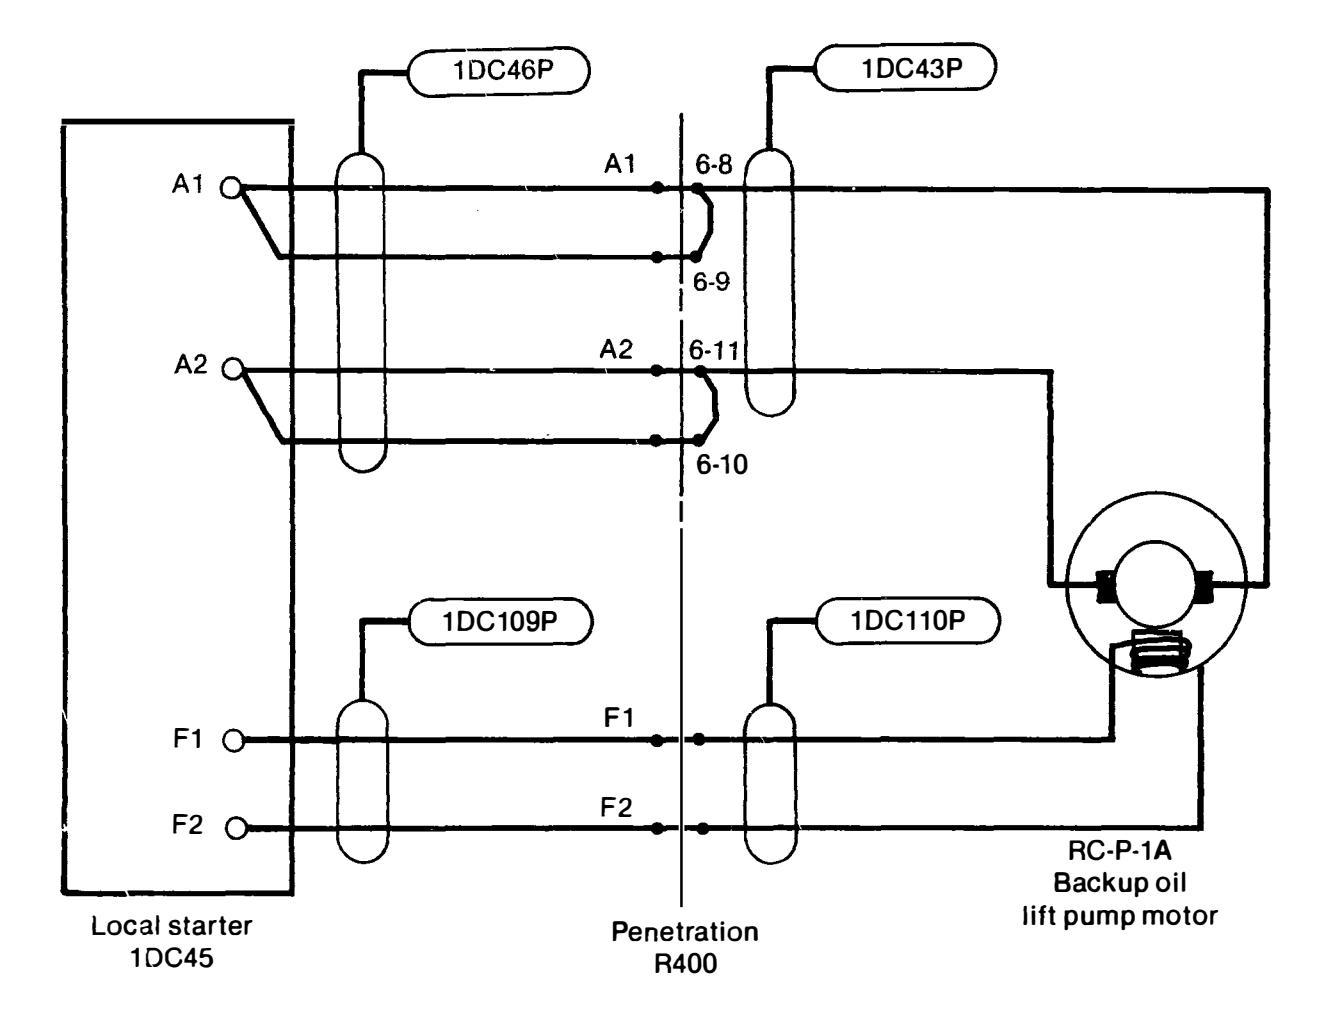
still showed the point of high resistance to be at the equipment. The field circuit also had a high loop resistance, and the location of the fault is seen on the TDR (Figure 23) to be in inner penetration box R400. The test also revealed the absence of the jumper on the Al and A2 circuits (Figure 24) in the inner box of penetration R400.

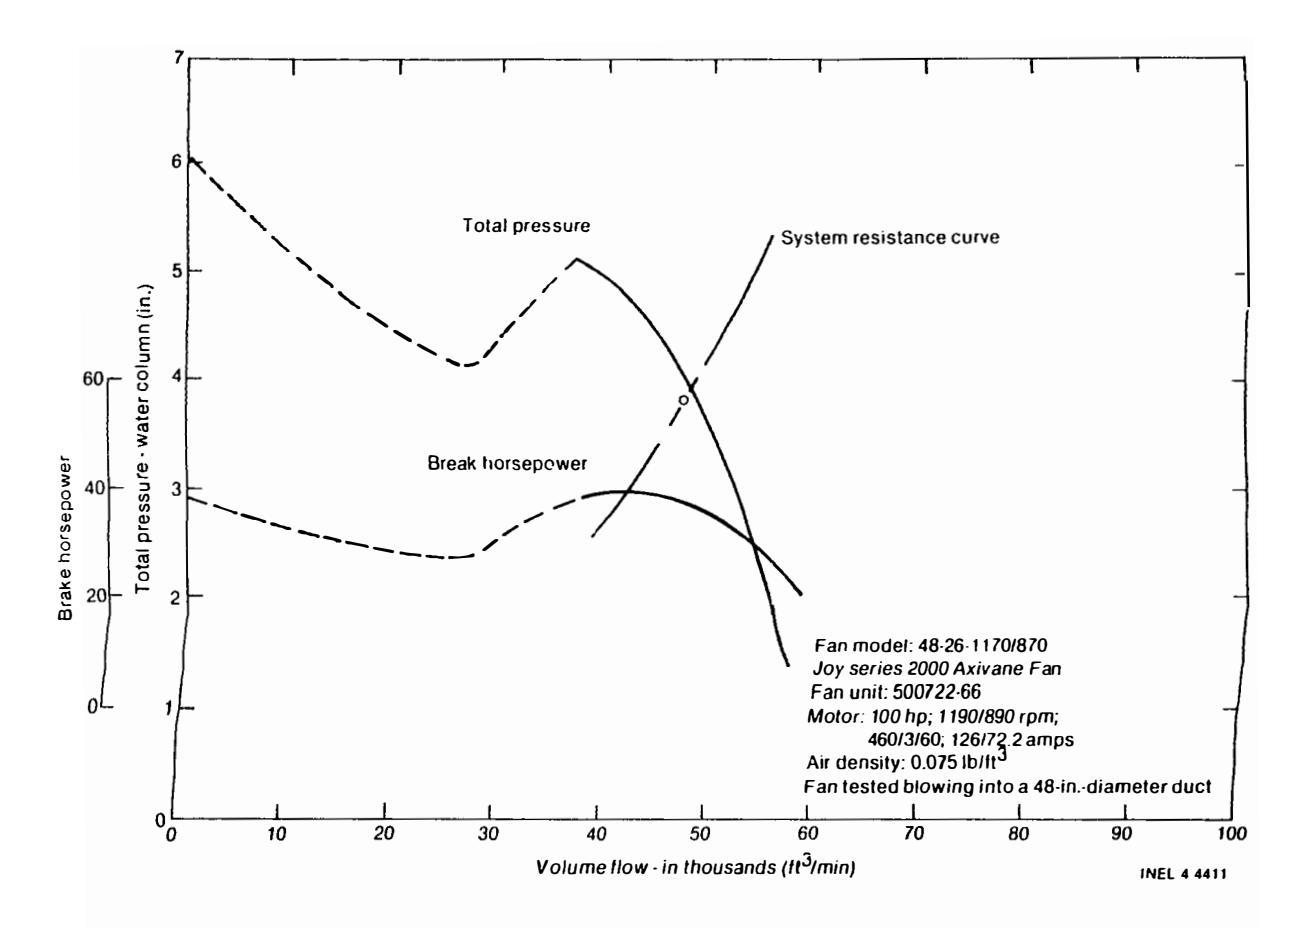
Figure 25. Characteristic curve of a TMI-2 Reactor Building air cooling fan with an air density of 0.075 lb/ft^3 .

- Increased system pressure resulting from higher air density (see Figures 25 and 26)
- Decreased flow resulting from improper operation of the inlet dampers
- Decreased efficiency of the fans and motors resulting from greater friction losses, due to lubrication degradation, and from increased load losses and hydraulic losses.
