TMI-2 PRESSURE TRANSMITTER EXAMINATION PROGRAM  
YEAR-END REPORT: EXAMINATION AND EVALUATION OF PRESSURE  
TRANSMITTERS CF-1-PT3 AND CF-2-LT3

February 1983

Published on Behalf of the GEND Group  
by  
EG&G Idaho, Inc.  
Idaho Falls, Idaho 83415

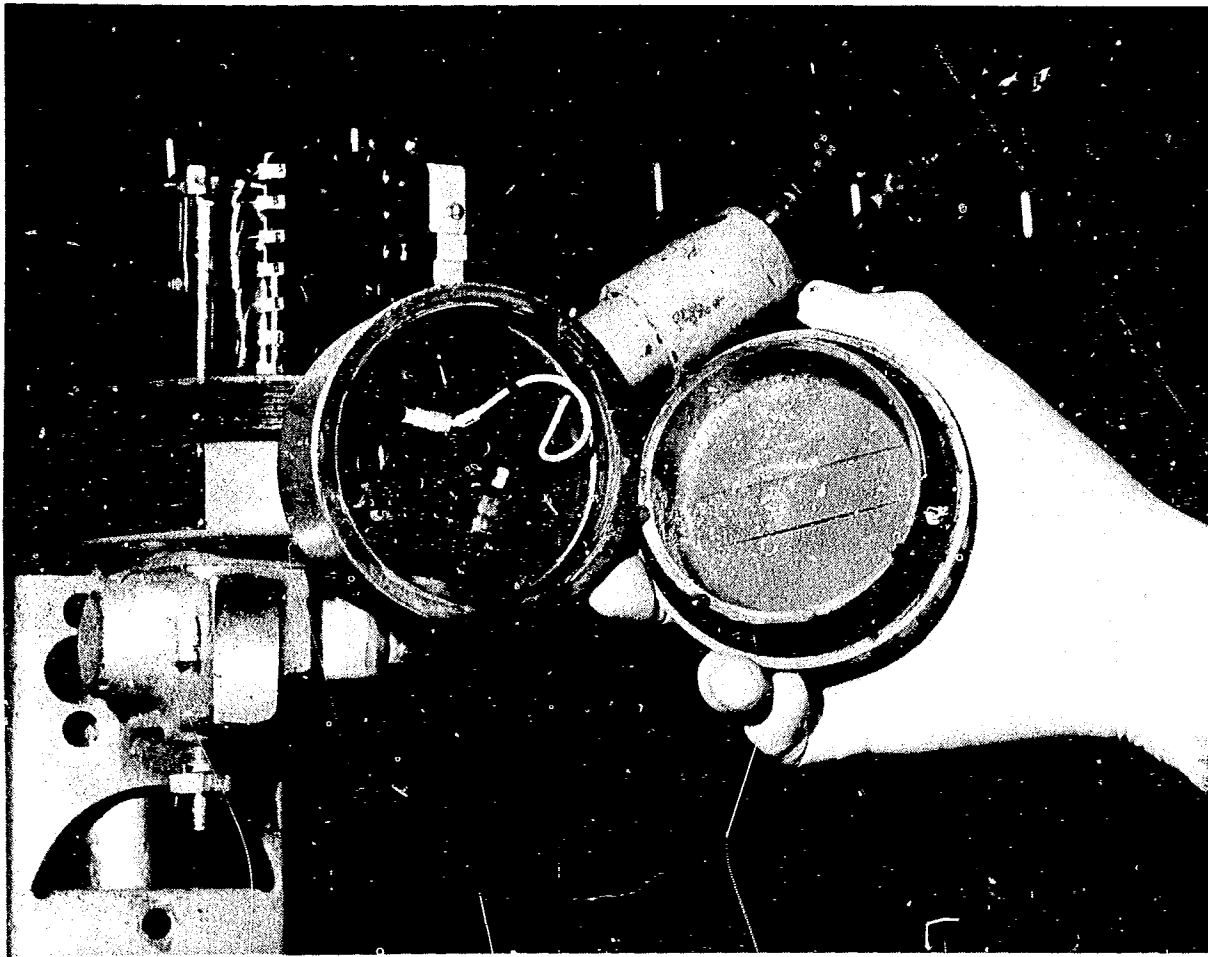
Figure 3. Photograph, Foxboro pressure transmitter.

- o The interior of the sensor/electronic module assembly was clean and free of radioactive and other contaminants.
- o The interior of the circular junction box was radioactively contaminated and appeared to have had water in it, as evidenced by corrosion depositions (see Figure 3). Since the junction box gasket appeared to be in good condition, it is likely that water entered the junction box through the conduit or its associated fittings. A cable seal located between the transmitter and the circular junction box probably prevented moisture from entering the transmitter itself.

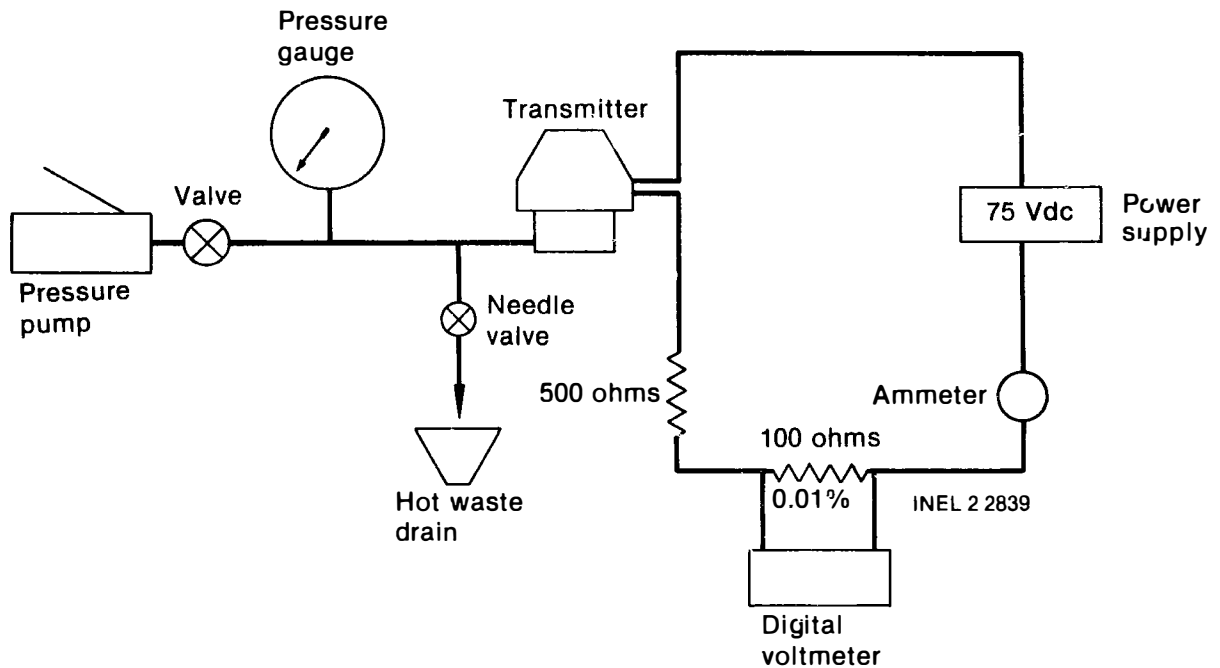
Figure 4. TMI Foxboro pressure transmitter test set up.

The transmitter was then connected to a pressure source, power supply, load, and voltmeter as shown in Figure 4, and without making any adjustments to the transmitter, three calibration cycles of pressure versus output were run. The results of the first pressure cycle and the last known calibration test performed at TMI are given and compared in Appendix A. As can be seen, the results compare favorably, and there appears to be no significant degradation of the instrument.
