EVALUATION OF TMI-2 PRESSURE SWITCHES NM-PS-1454 AND NM-PS-4174

Joseph A. Gannon

Published November 1983

EG&G Idaho, Inc.
Idaho Falls, Idaho 83415

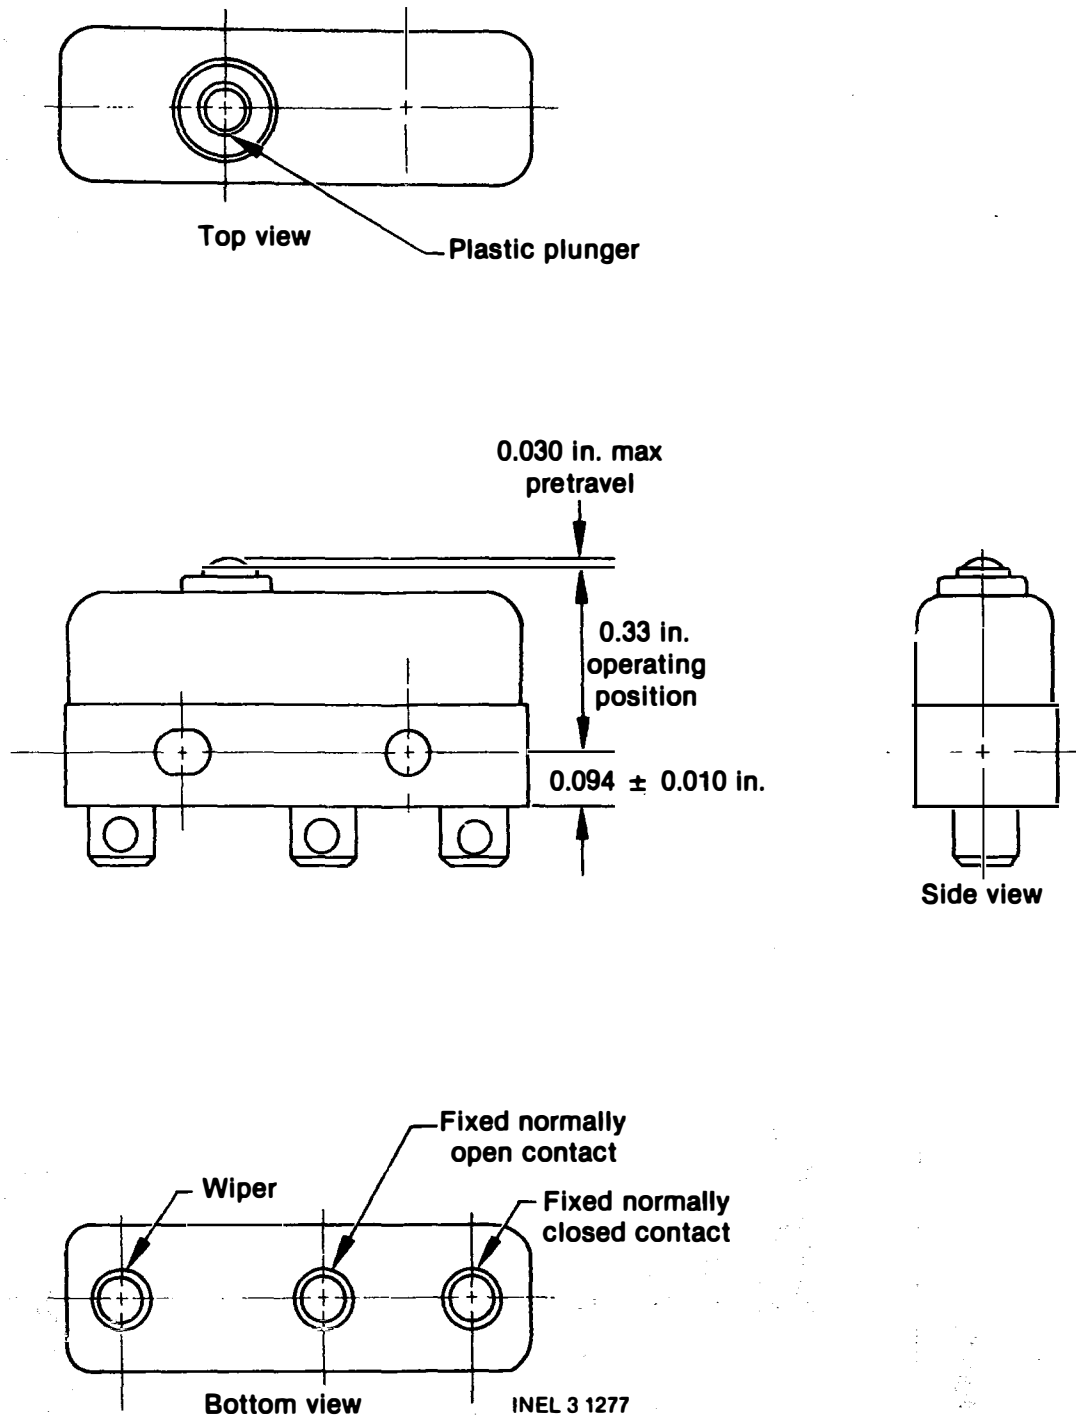
Figure 8. Switch mechanical characteristics showing distance of movement upon activation.

Switch Operating Forces--The switch operating forces were reasonably close to vendor's tolerance. Results are shown in Table 7. (Also see Figure 8 for the mechanical characteristics of the switch.)

Function	Manufacturer's Specification	NM-PS-4174		NM-PS-1454	
		Left Switch	Right Switch	Left Switch	Right Switch
Operate	3 to 5 oz	3.8 oz	2.8 oz	3.8 oz	3.8 oz
Release	1 oz min	2.8 oz	1.95 oz	2.75 oz	2.75 oz
Differential Travel	0.004 in. max	0.003 in.	0.001 in.	0.0015 in.	0.002 in.
Over Travel	0.005 in. min	0.016 in.	0.015 in.	0.0165 in.	0.018 in.

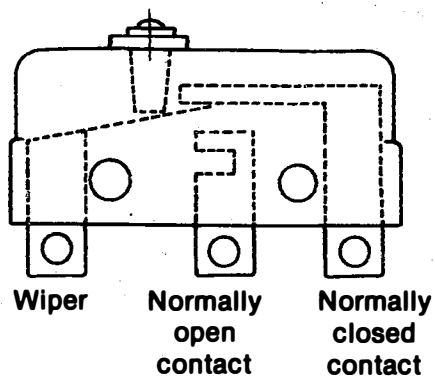
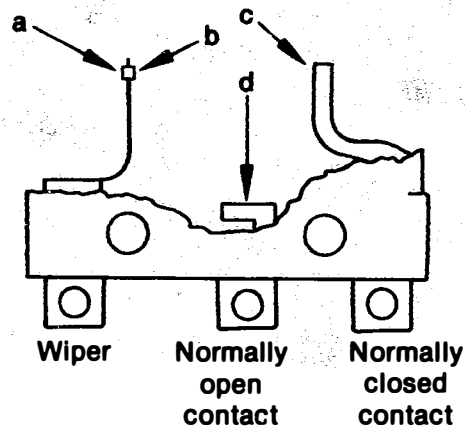
Figure 10. Approximate direction of scanning electron microscope photographs, as indicated by arrows above. (Footnotes correspond with views in Figures 11, 12, and 13.)

AC/DC Overload. Scanning electron microscope photographs of the right switch (ac overload) of NM-PS-4174 showed evidence of marked contact pitting (see Figures 10 and 11). Consequently, this right switch is considered unacceptable for further use. The left switch (dc overload) of both NM-PS-4174 and NM-PS-1454 showed evidence of contact arcing, but pitting appeared to be minimal (see Figures 10, 12, and 13).

"X-ray" view of assembled switch.

Switch contacts bent for scanning electron microscope examination.
