EVALUATION RESULTS OF TMI-2 SOLENOIDS AH-V6 AND AH-V74

Florante T. Soberano

**United Engineers and Constructors
Philadelphia, Pennsylvania**

Published January 1984

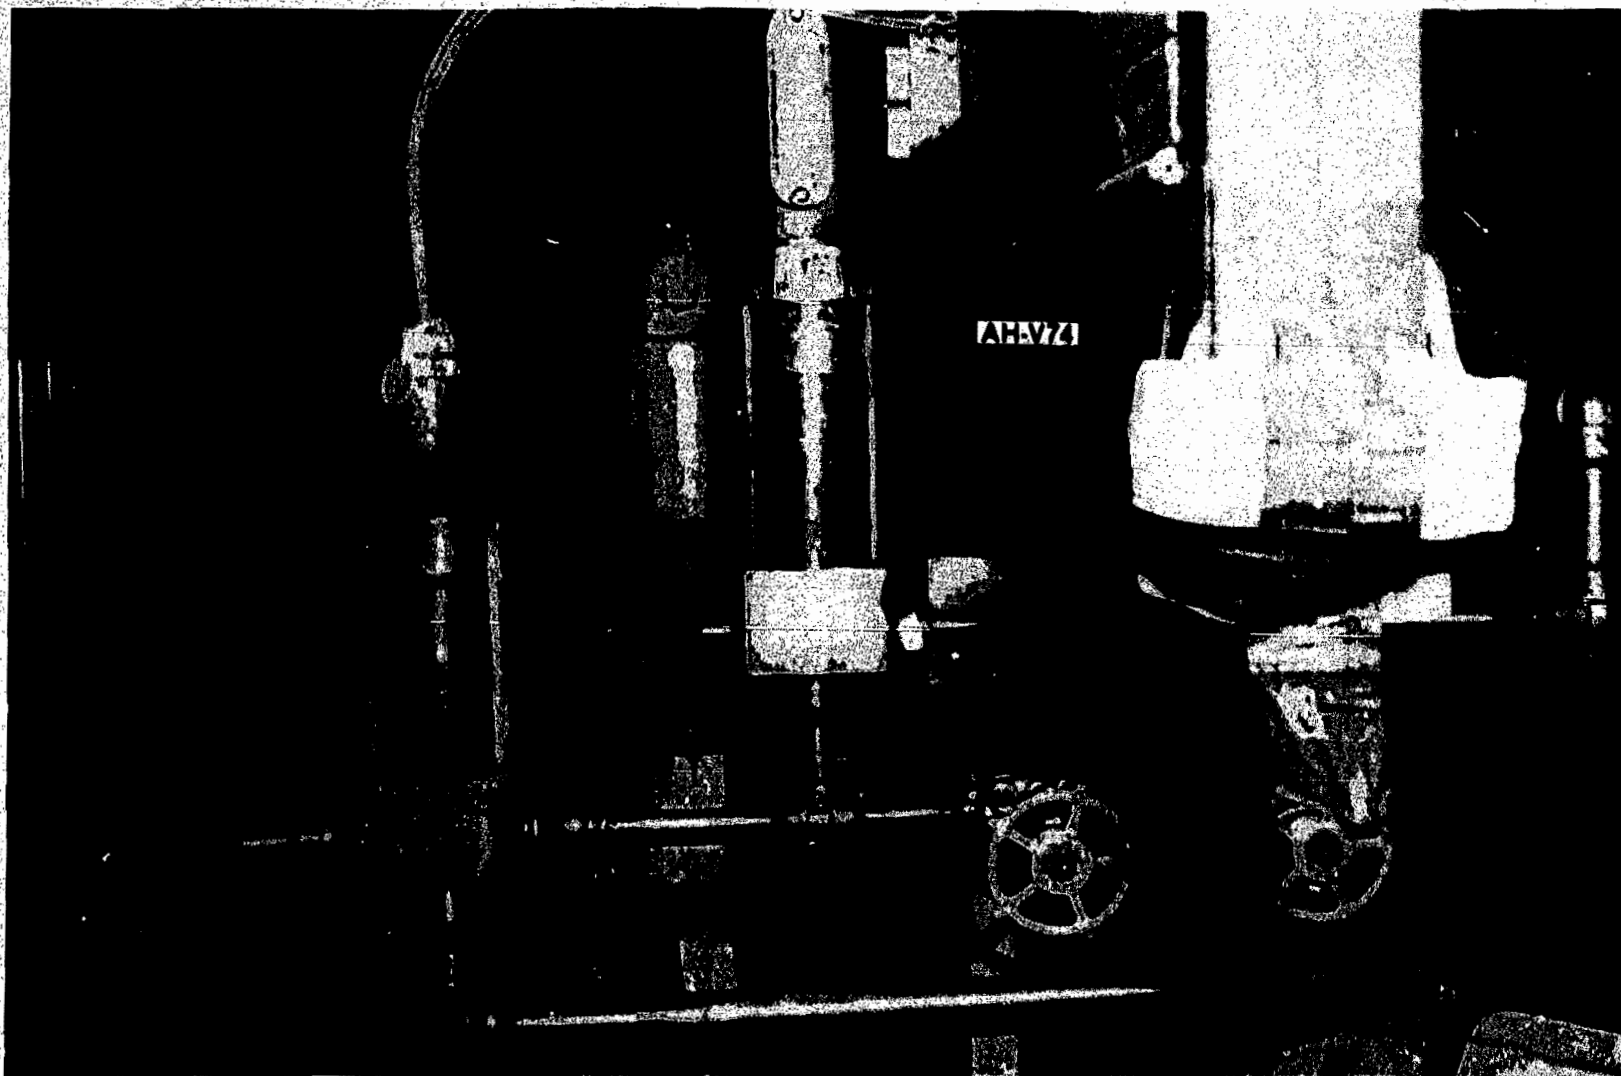
Figure 1. Installation configuration of solenoid valve AH-V6.

Figure 1 is the installation arrangement of AH-V6. The solenoid and limit switch lead wires are brought out of the solenoid housing into the pull box through the flexible conduit. In the pull box, the lead wires and cables M835C and M836C are spliced. As seen in the figure, the pull box sits higher than the solenoid cover. It has a special two-way relief valve that acts as a pressure equalizer and drain. The flexible conduit that connects the solenoid to the pull box is attached on the lower side of the pull box. Analyzing the arrangement, the only possible way a significant amount of water could get into the solenoid is through the flexible conduit. The water may have gotten into the pull box through the two conduits connected on top. Because of the higher-than-atmospheric pressure setting and low drainage capacity of the pressure equalizer, the water level in the pull box may have risen to the level of the side opening and spilled over into the solenoid through the flexible conduit. The water settled on the top and bottom sections of the annulus between the solenoid shell and the enclosure. Due to the O-rings on the bottom of the solenoid, the fluid got trapped in the annulus for an extended period of time.

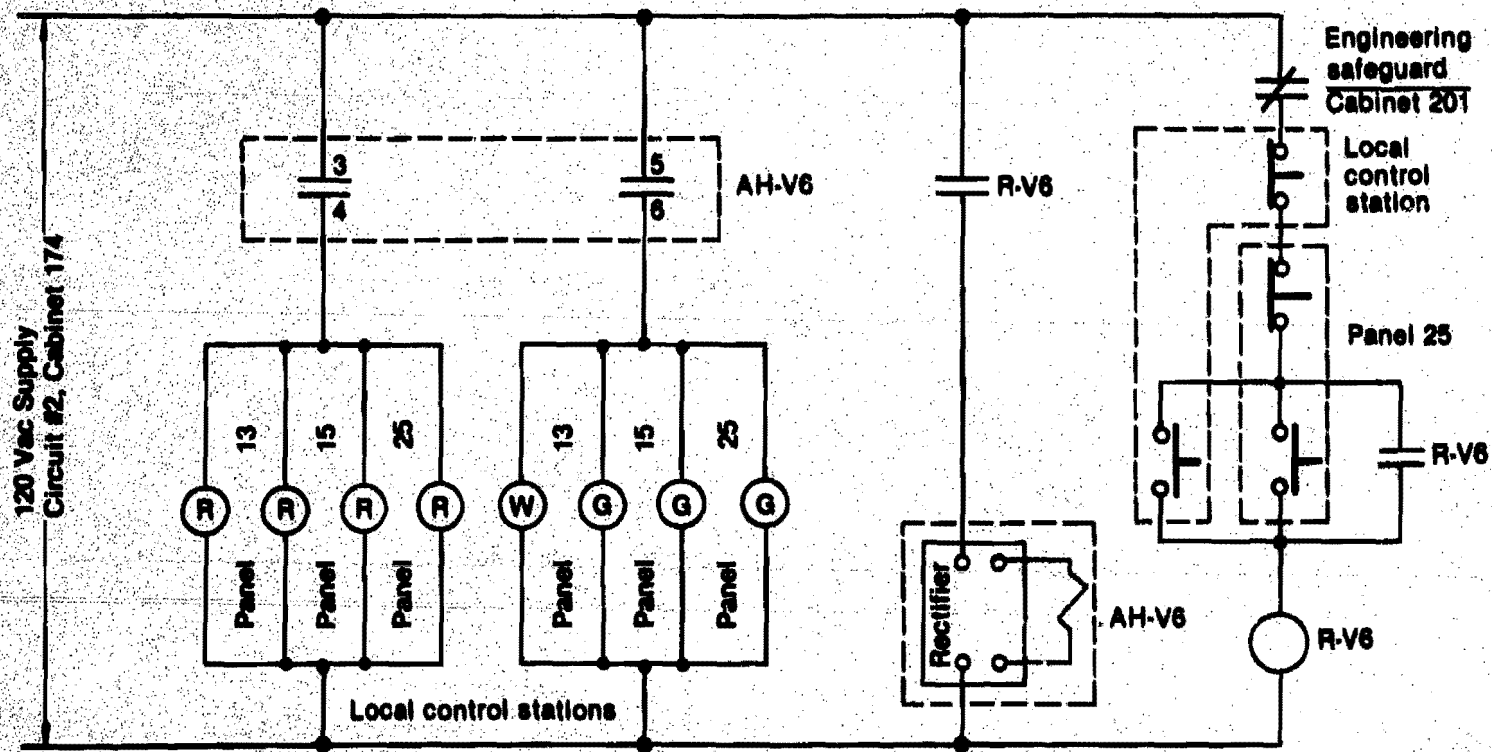
Figure 2. Installation configuration of solenoid valve AH-V74.

Both solenoid assemblies were removed from the Reactor Building without their associated valves. As seen in Figures 1 and 2, the valves are welded in place; consequently, their removal under the existing post-accident conditions was impractical.
