ANALYSIS OF THE POLAR CRANE PENDANT CABLE FROM THREE MILE ISLAND - UNIT 2

R. E. Trujillo
E. H. Richards

Published January 1986

ABSTRACT

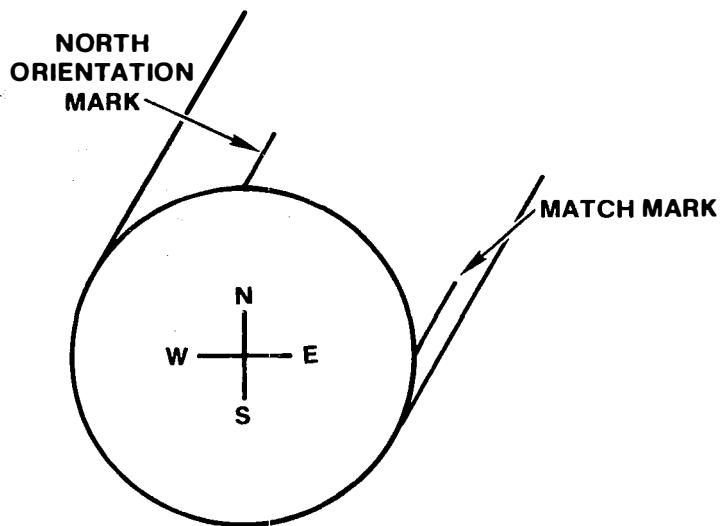
Figure 5. View of PCPC (Section 31) Showing Orientation and Match Marks.

Figure 5 shows the north orientation and match mark for cable section 31. Comparison of the match marks of cable sections 17 through 15 (the transition sections between the upper and lower halves of the cable) shows that these match marks are in approximate alignment and are located on the east side of the cable as it hung in the containment building. Therefore, the approximate alignment of the entire length of cable is known relative to the north orientation of cable section 31.

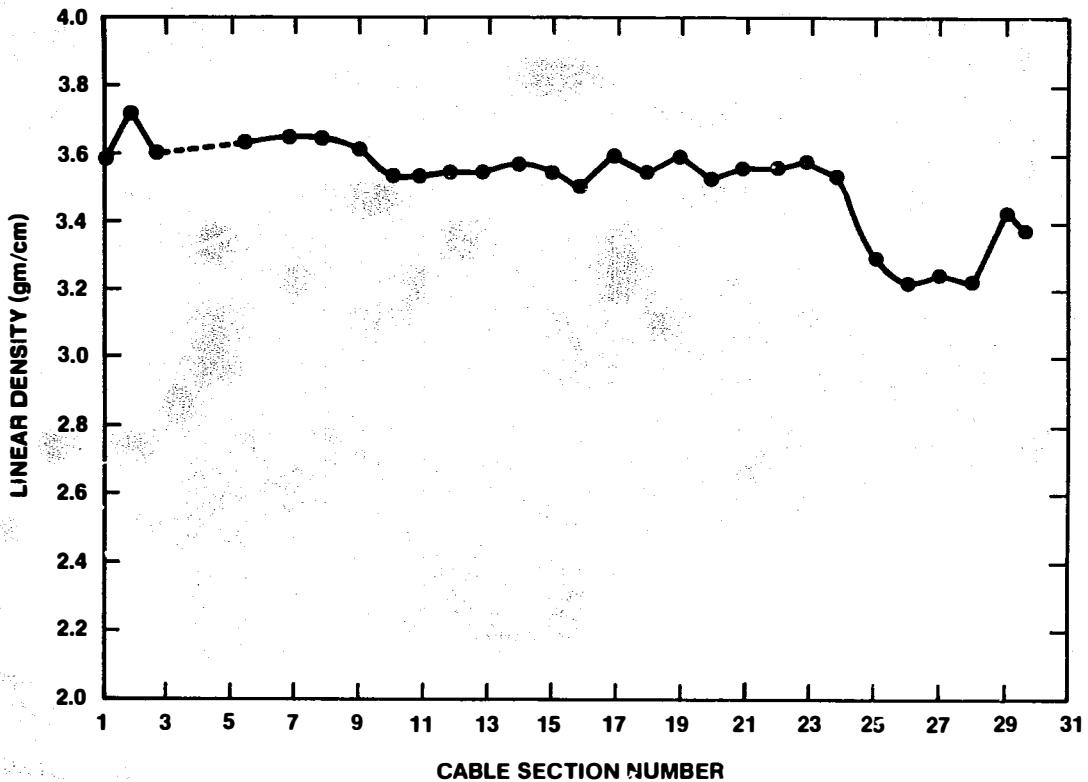
Figure 7. Cable Jacket Linear Density as Function of Cable Section Number.

The transition from the charred to the discolored region of the PCPC, and that from the discolored to the

undamaged region of the cable, were further pinpointed by a visual examination of the cross sections of the test samples. In the charred region, the discoloration beneath the surface charring penetrates into the cable jacket. Figures 8a and 8b show test samples from cable sections 18 and 28, respectively. Test sample 18 shows a partial discoloration at the jacket surface opposite the longitudinal cut. Test sample 28 shows, in addition to surface charring, a circumferential discoloration that penetrates about 40% of the jacket thickness before the normal yellow coloration of the jacket is encountered. Each cable jacket sample was examined to determine the depth of penetration of the discoloration into the cable jacket and the circumferential extent of the discoloration.

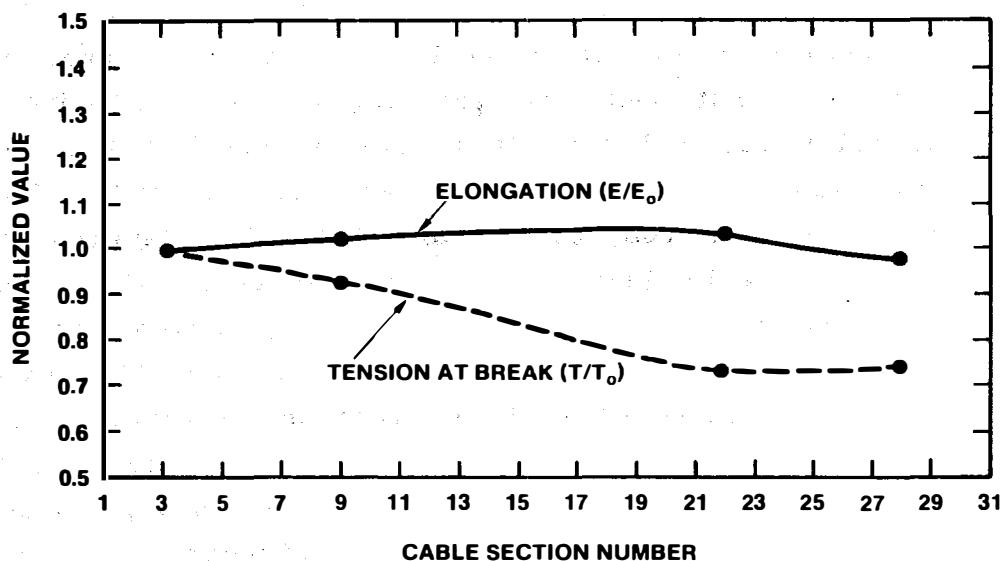
Figure 9. Elongation and Tension of Conductor Insulation as Function of Cable Section Number (Normalized to Value Obtained for Cable Section 3).

The insulation was stripped intact from the copper conductors after first removing the nylon sheath (Figure 4). The elongation (E) and tensile stress at break (T) of each insulation sample was measured by an Instron™ Table Model 1020 at an ambient temperature of $23 \pm 1^\circ\text{C}$. Samples were gripped by pneumatic jaws with an air pressure of approximately 300 kPa (44 psi). Initial jaw separation was 5 cm (2 in) and samples were strained at 13 cm/min (5 in/min); the strain was monitored with an Instron™ Electrical Tape Extensometer clamped to the sample. Figure 9 presents the results of this elongation and tensile stress study. Examination of these results shows little difference among samples in elongation and tensile strength at break even though the samples were obtained from regions of high heat flux (charred), moderate heat flux (discolored), and low heat flux (undamaged). Additionally, samples from the undamaged region (i.e., from cable sections 3 and 9) showed little difference even though they represent low (9) versus high (3) radiation contamination zones.

A visual examination of the PCPC showed that it could be divided into three regions based on the extent of thermal damage. However, both the materials analysis (see Figures 9 and 10) and the electrical examination (see Table 2) revealed no substantial difference in either of these properties among cable sections taken from each of the three regions. Despite the igniting and burning of the jacket surface in the charred regions of the cable, the mechanical and electrical properties did not differ greatly from those of the undamaged regions.

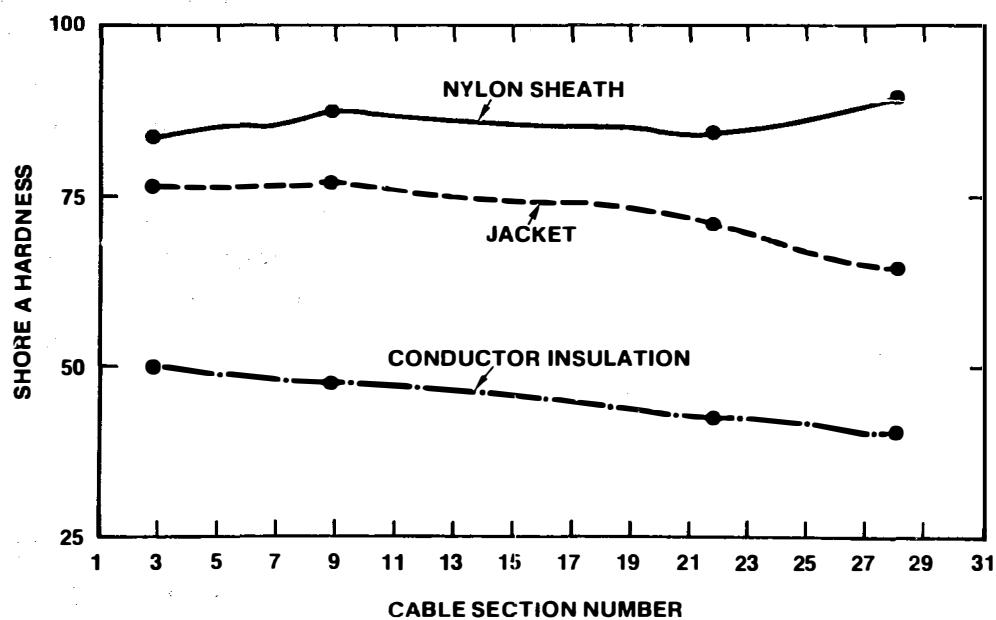
Figure 10. Shore "A" Hardness as Function of Cable Section Number.

A Shore "A" Durometer with a constant load of 820 g (1.8 lb) was used to measure the hardness of the PCPC jacket; the individual conductor samples were taken from cable sections 3, 9, 22, and 28 and their respective nylon sheaths. Each sample was tested at three points and the three values averaged. The data are presented in Figure 10. The data

show no dramatic difference in hardness between the various cable regions for any of the three types of materials tested.

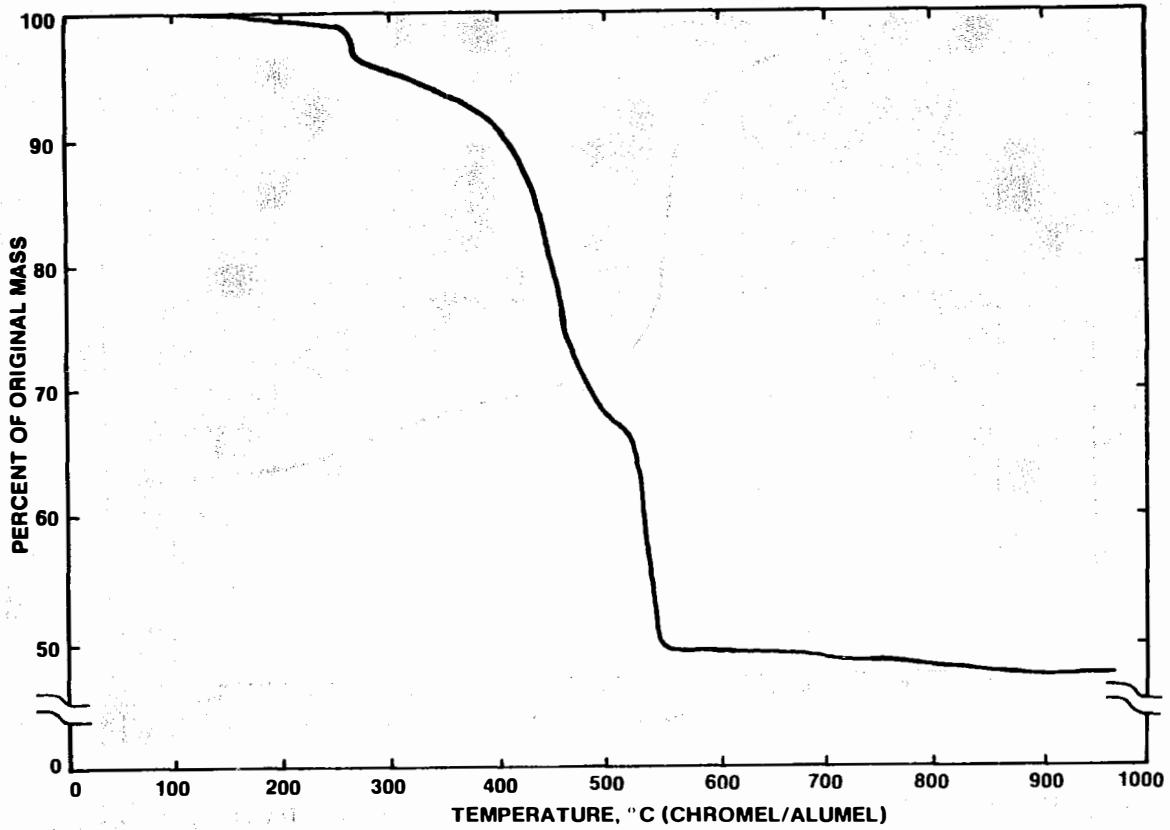
Figure 15. Thermogravimetric Analysis in Air.

A TGA in air was done on a piece of the cable jacket taken from the undamaged region (cable section 9). This sample was neither charred nor discolored. The TGA trace is shown in Figure 15. The sample contained approximately 47% inorganic filler and showed a step-like weight loss at approximately 260°C (500°F). A second trace run on a fresh sample taken from the same piece of cable jacket was removed from the heating cell when the temperature reached 250°C (482°F) and was observed to have turned brown (discolored). These same two TGA experiments were repeated using fresh samples but with an atmosphere of nitrogen instead of air. Figure 16 presents the nitrogen TGA run and shows that the shape of the TGA trace is similar to the trace for the air TGA run. The second sample had turned brown (discolored) when removed from the heating cell in nitrogen at 260°C. This finding establishes that the discoloration is thermally induced and does not require the presence of oxygen.

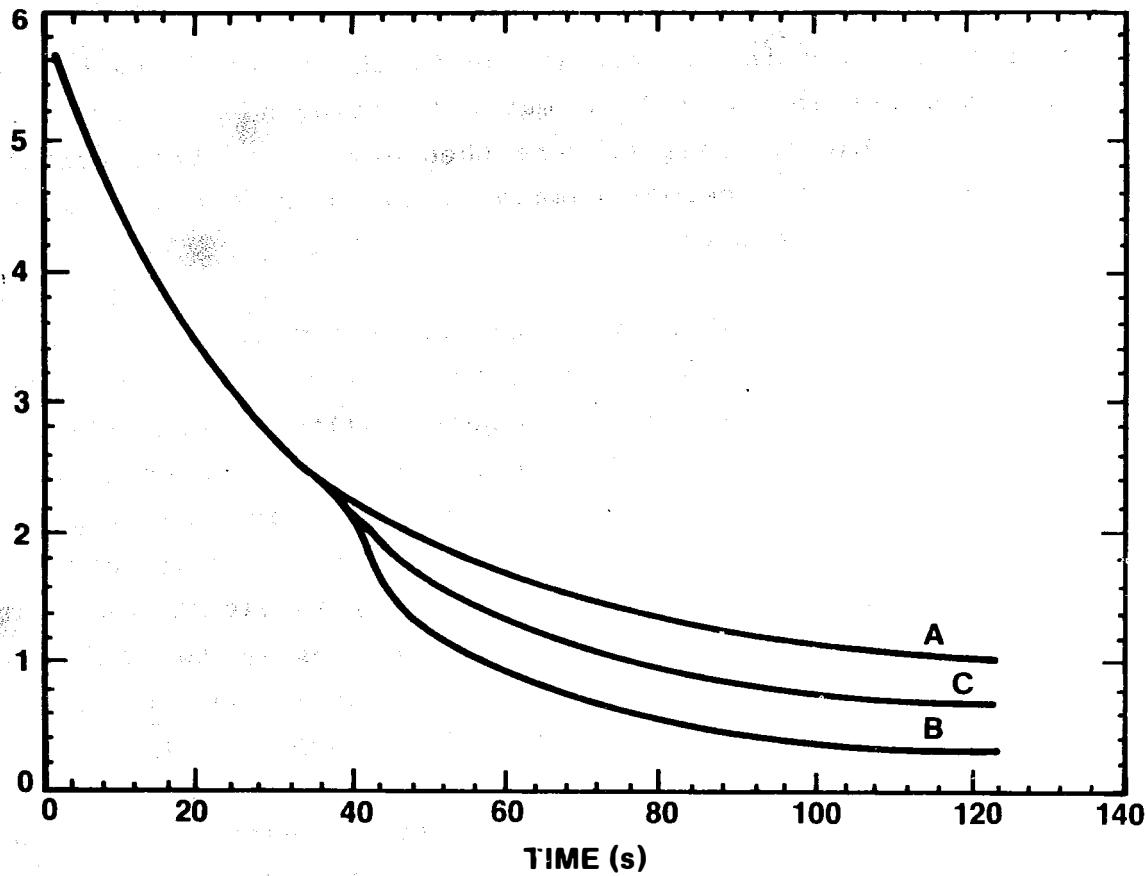
Figure 18. Heat Flux vs. Time Profiles.

Figure 18 shows three heat flux vs. time profiles. One profile is that developed by Art Ratzel's computer code at SNLA. This code had the major limitation of being unable to simulate the effect of containment spray. Since containment spray is expected to have a significant effect on containment cooldown, an effort was made to estimate a containment spray profile and superimpose this estimated profile on the Ratzel profile at 40 s into the hydrogen burn (the approximate time at which the building sprays began wetting the TMI-2 containment). The shape and quantitative aspects of the estimated containment spray profile were obtained from TMI-2 data on containment average temperature and pressure versus time.² This modified heat flux vs. time profile attempts to consider the effect of containment spray and is also shown in Figure 18. All samples were exposed to this modified heat-flux profile after preheating to approximately

Funding for the study of the hydrogen-burn event at TMI-2 should result in the development of a more complete, detailed, and accurate heat flux vs. time profile for TMI-2. Unfortunately, time constraints forced the Cable/Connections Task personnel to use the best profile estimate available (Figure 18) in studying the effect of the hydrogen burn on the PCPC at TMI-2.

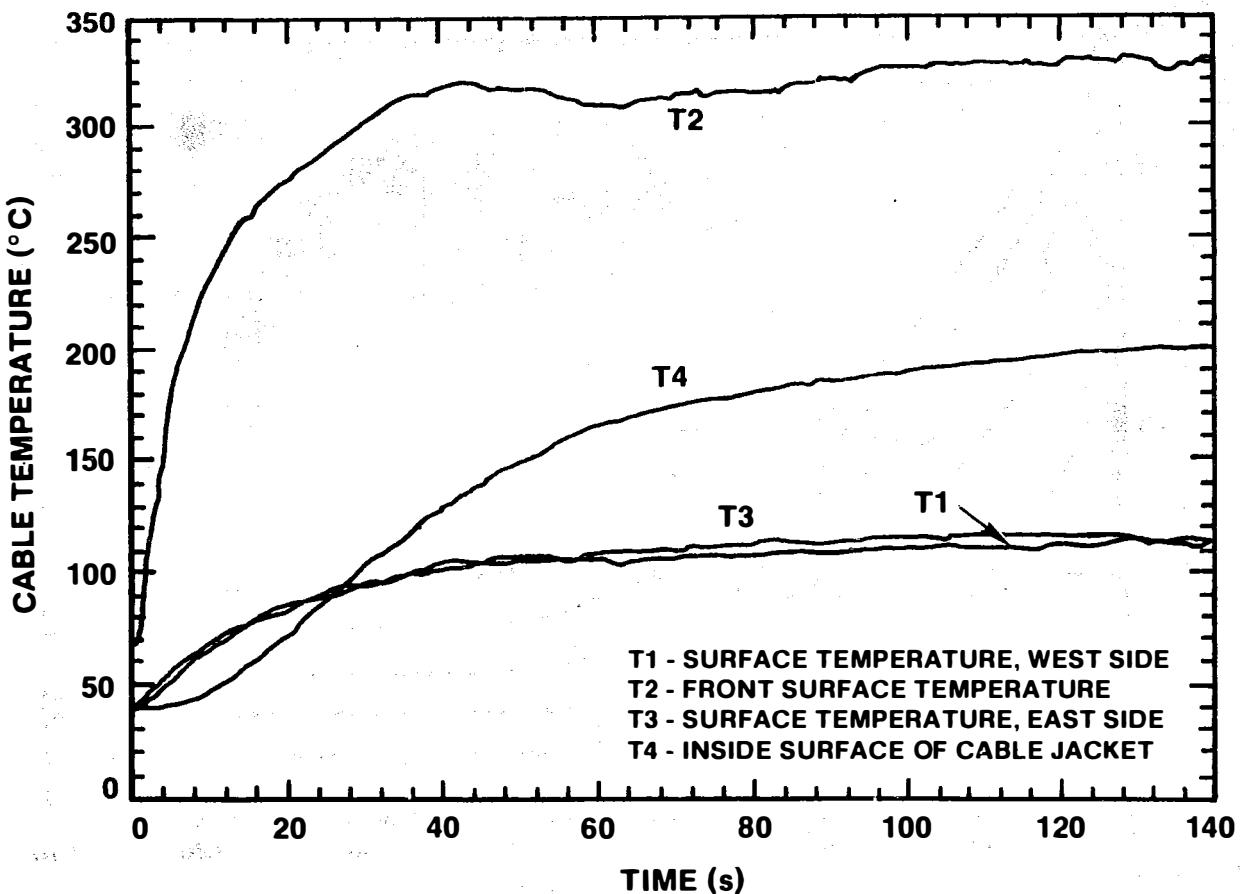
Figure 20. Temperature Response of Cable Jacket Exposed to Heat Flux vs. Time Profile.

The cable samples were mounted vertically between two heat-flux gages at the solar furnace test facility (Figure 19). Figure 20 shows temperature responses recorded for the outer cable-jacket surface thermocouples (1, 2, and 3) and the inner cable-jacket surface thermocouple (4) when the sample was exposed to a heat-flux profile. The outer surface temperature measurements are only approximate, because no special steps were taken to shield the thermocouples from the radiant heat from the the solar furnace. In all studies, the basic profile shape remained the same, varying only the peak heat flux. The solar furnace is not capable of reproducing the calculated profile exactly, but it was adequate for this scoping study. By varying the peak heat flux, it was possible to vary the energy delivered to the sample. The energy delivered equals the product of heat flux and time, or the integrated area under the heat flux vs. time curves of Figure 18.
