**TMI-2 REACTOR VESSEL HEAD REMOVAL**

**Paul R. Bengel**  
**Michael D. Smith**  
**Gail A. Estabrook**

**GPU Nuclear Corporation**  
**Middletown, PA 17057**

This report describes the safe removal and storage of the Three Mile Island Unit 2 (TMI-2) reactor vessel head. The head was removed in July 1984 to permit the removal of the plenum and the reactor core, which were damaged during the 1979 accident. From July 1982, plans and preparations were made using a standard head removal procedure modified by the necessary precautions and changes to account for conditions caused by the accident. After data acquisition, equipment and structure modifications, and training, the head was safely removed and stored; and the internals indexing fixture and a work platform were installed on top of the vessel. Dose rates during and after the operation were lower than expected; lessons were learned from the operation which will be applied to the continuing fuel removal operations activities.

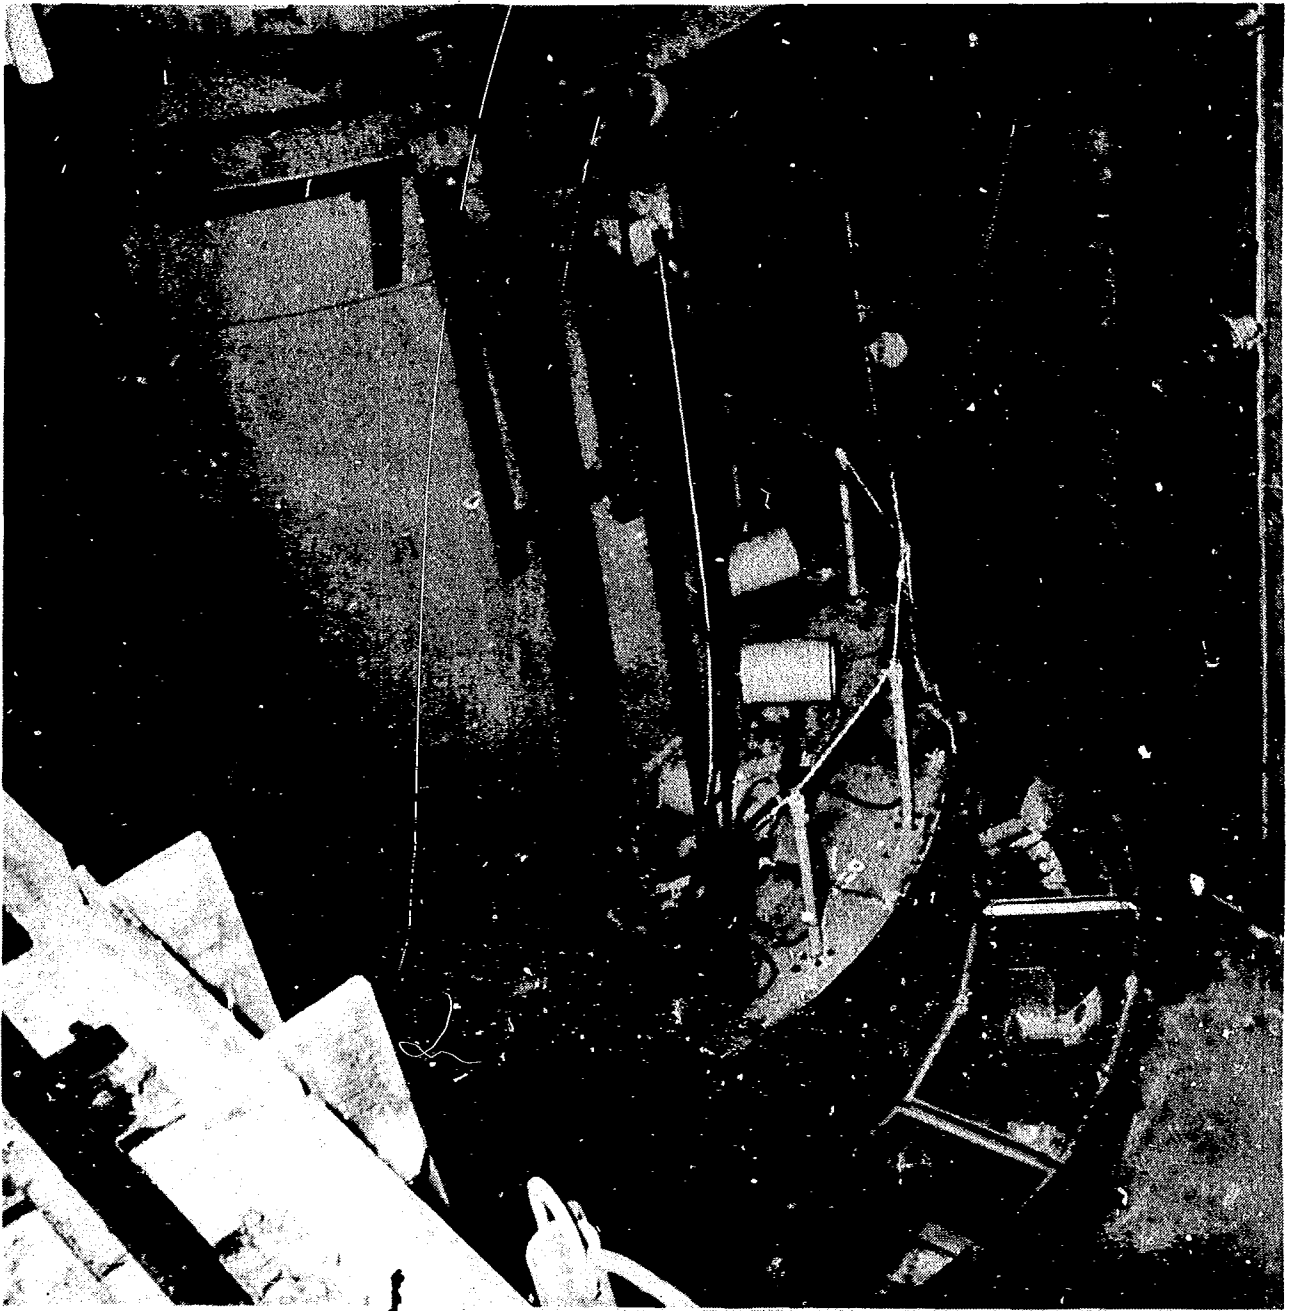
Figure 7. Service structure showing fans and exhaust ports, neutron shield tanks, walkway over reflective insulation, and hoist.

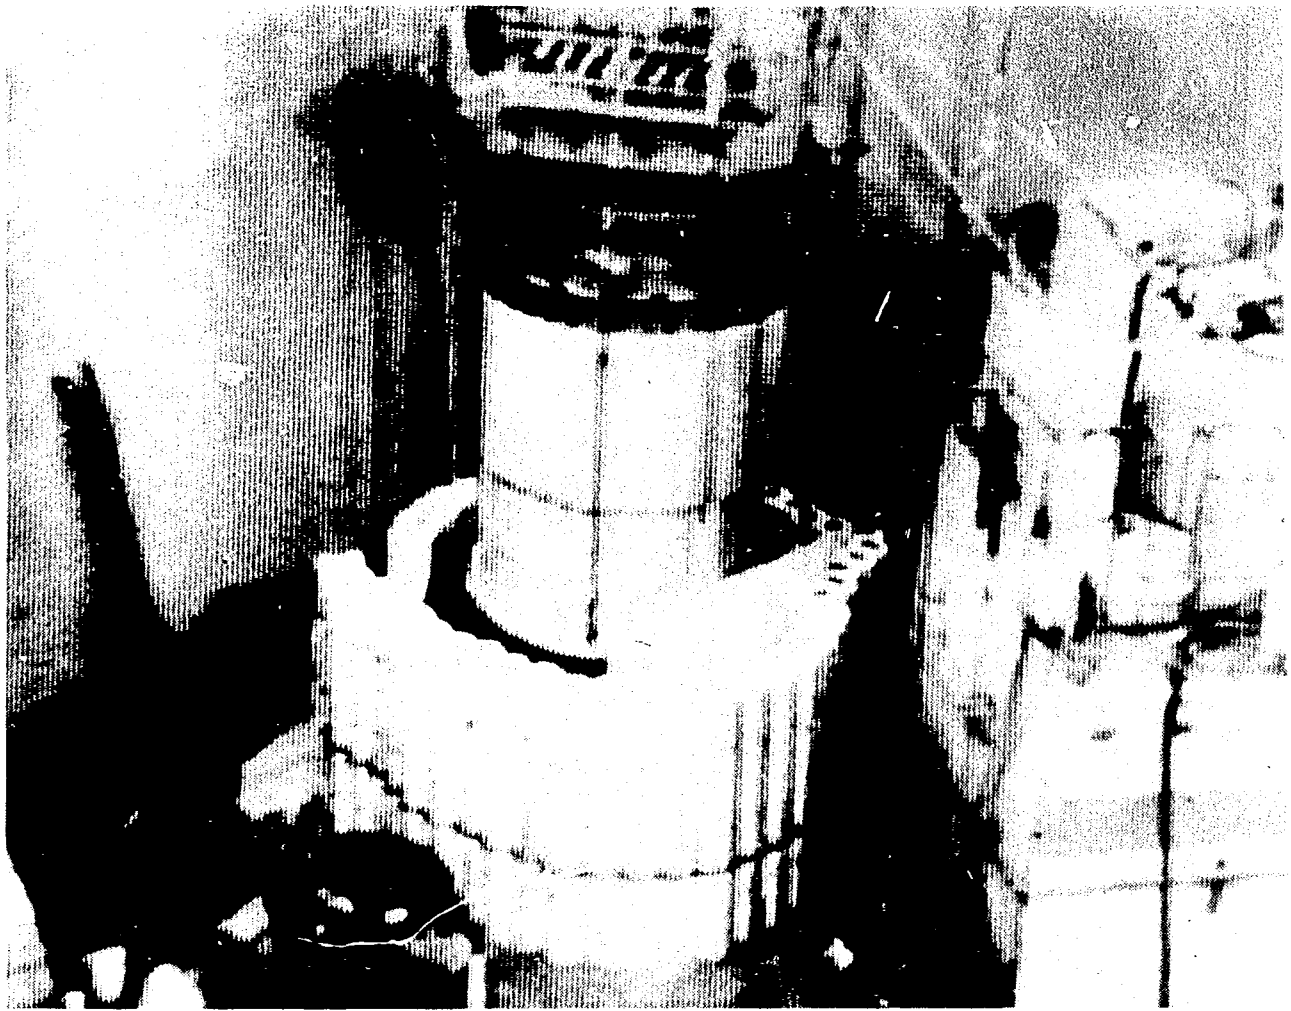
Figure 30. Head lowered onto storage stand.

pre-setting the two centerlines using a plumb bob to set the alignment targets from the main hook. When the head could not be positioned, a scaffold was erected alongside the storage stand shield wall to enable workers to gain access to the head flange. A combination of pry bars and a come-along rotated the head into position. A sleeve was lowered through stud hole 15 to capture a guide stud and provide a pivot point. The nature of the misalignment problem suggests that the center of gravity of the load shifted away from the centerline of the lift. To provide personnel access, a catwalk was installed from the A D-ring near the control station to the service structure. The head was set on the storage stand at noon on July 25 (Figure 30).
