Report of  
Special Review Group,  
Office of Inspection and Enforcement  
on Lessons Learned From  
Three Mile Island

Office of  
Inspection and Enforcement

U.S. Nuclear Regulatory  
Commission

Manuscript Completed: October 1979  
Date Published: December 1979

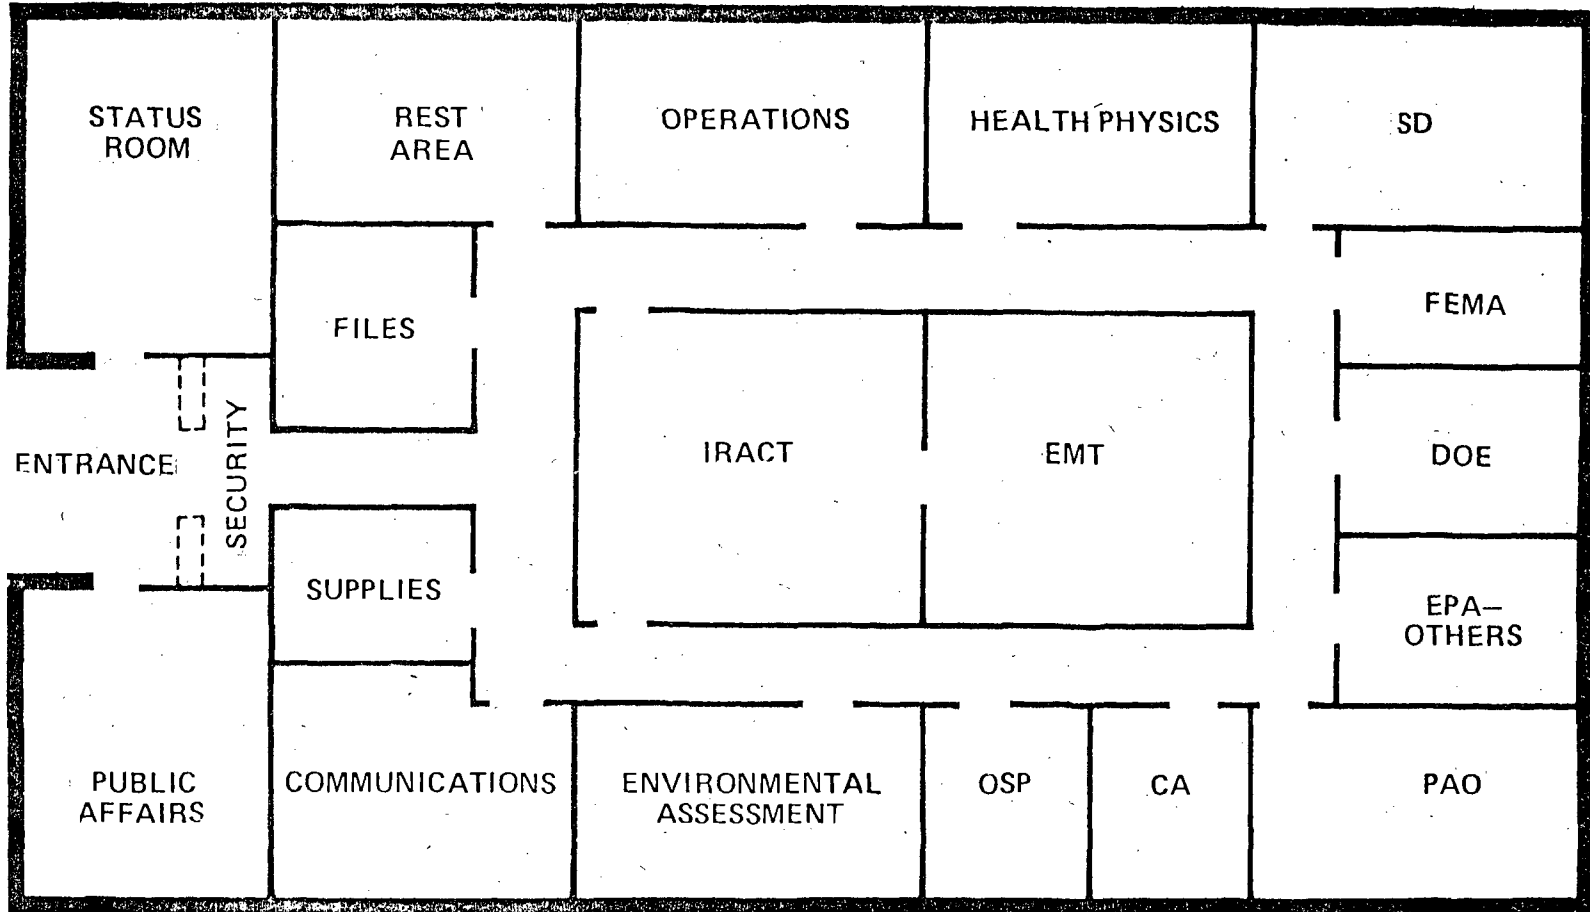
FIGURE 3.9.5.2

1. Redesign and reconstruct the NRC Operations Center to support a major accident (Figure 3.9.5.2). As a minimum, the Operations Center should contain or be designed to the following criteria:

- . Maintain existing size (20' x 25').
- . Place acoustic material on walls to reduce background noise.
- . Locate centrally to surrounding support offices.
- . Restrict access to EMT.
- . Place all telephone extensions in EMT room on each EMT phone.
- . Conference chaining capability on EMT phones.
- . Install a voice recorder system in EMT room to record decision making process.
- . Install a facility data CRT computer terminal in EMT room (See "Equipment," Section 3.11.10).
