Three Mile Island Nuclear Station, Unit 2 (TMI-2) Operating License No. DPR-73 Docket No. 50-320 EPICOR II Liner Evaluation Status

METALLURGICAL EVALUATION REPORT

EVALUATION OF THE LINER INTEGRITY OF THE TMI UNIT 2 EPICOR II RADWASTE SYSTEMS

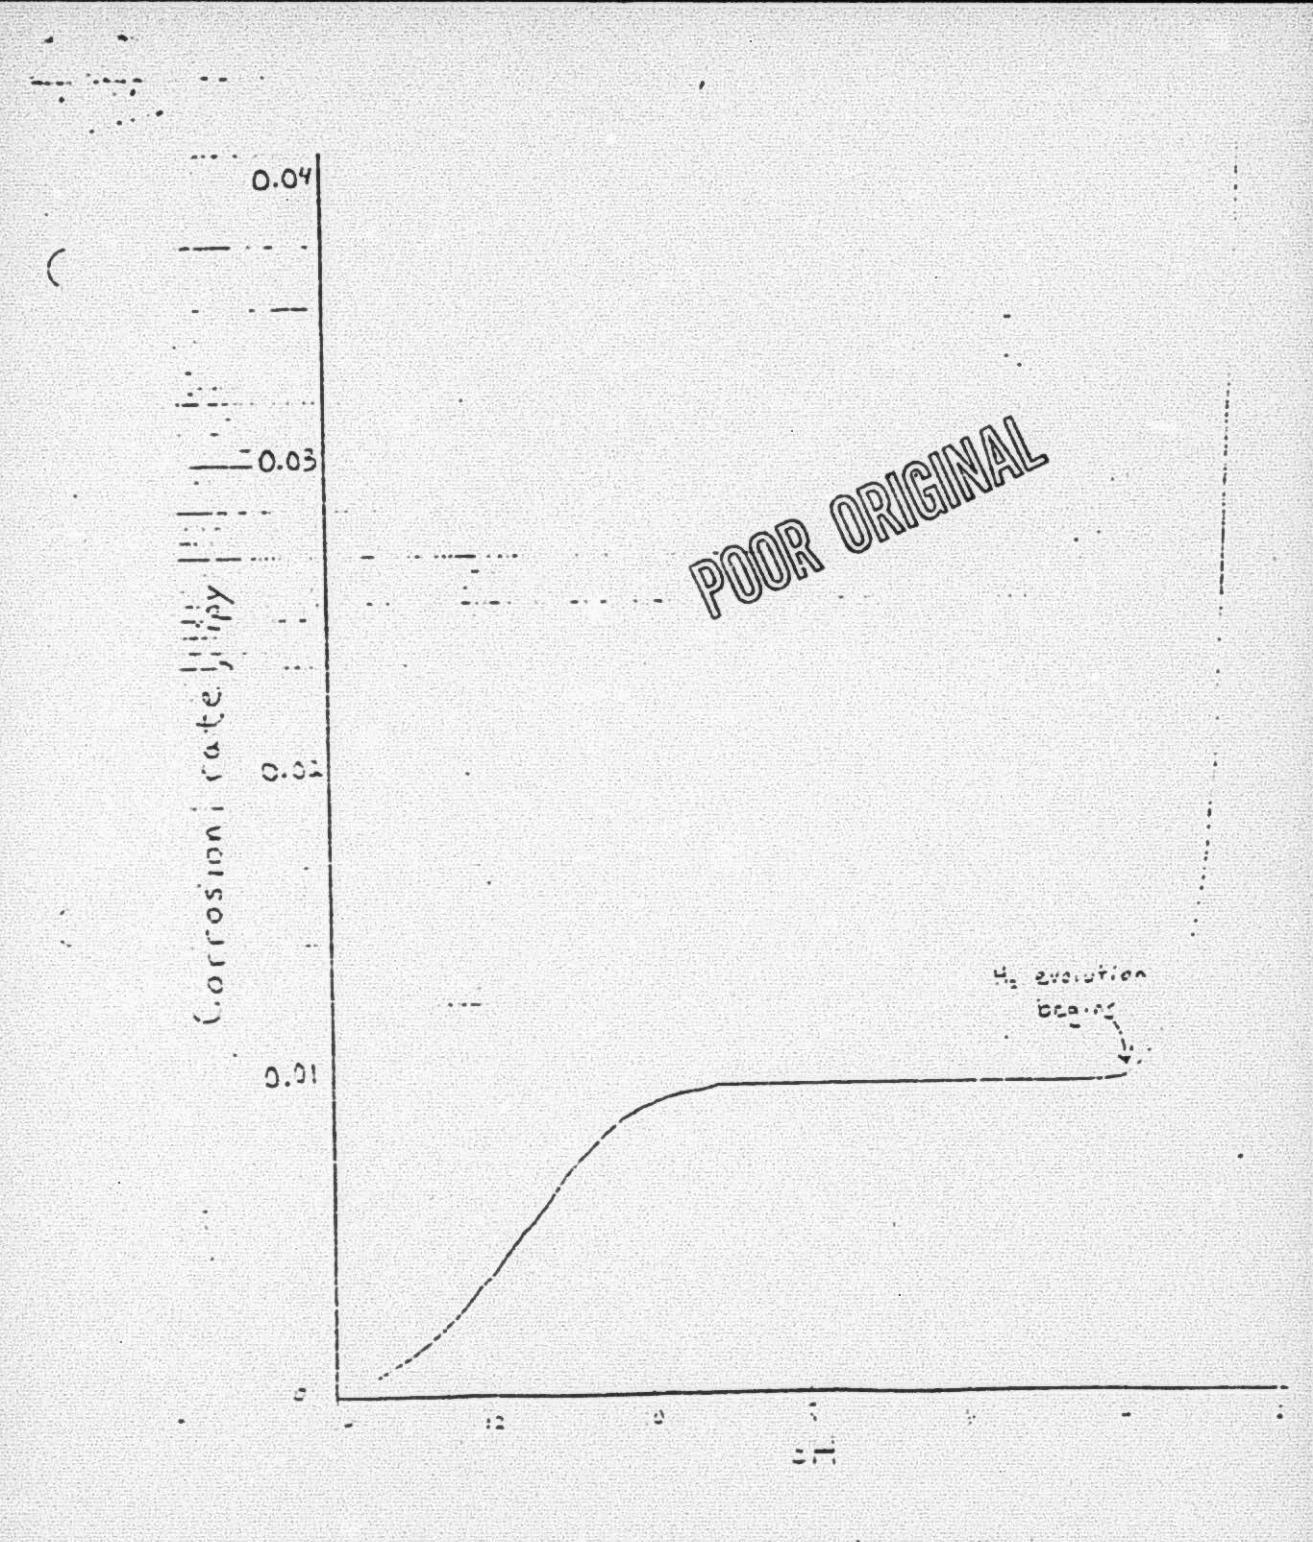
Fig. 1 Effect of pH on corresion of iron in derated soft water, room temperature (Whitman, Russell, and Altieri).

The effect of pH on the corrosion rate of carbon steel in aerated demineralized water is significant, as can be seen in Figure 1. It is readily apparent that between pH 4 to 10 where the pH is normally expected to be inside the liners, that the corrosion rate is relatively uniform and on the order of 10 mils per year.
