CHARACTERIZATION OF EPICOR II PREFILTER LINER '16

J. David Yesso V. Pasupathi Larry Lowry DISCLAIMER -

Battelle Memorial Institute Columbus Laboratories Columbus, Ohio 43201

Published August 1982

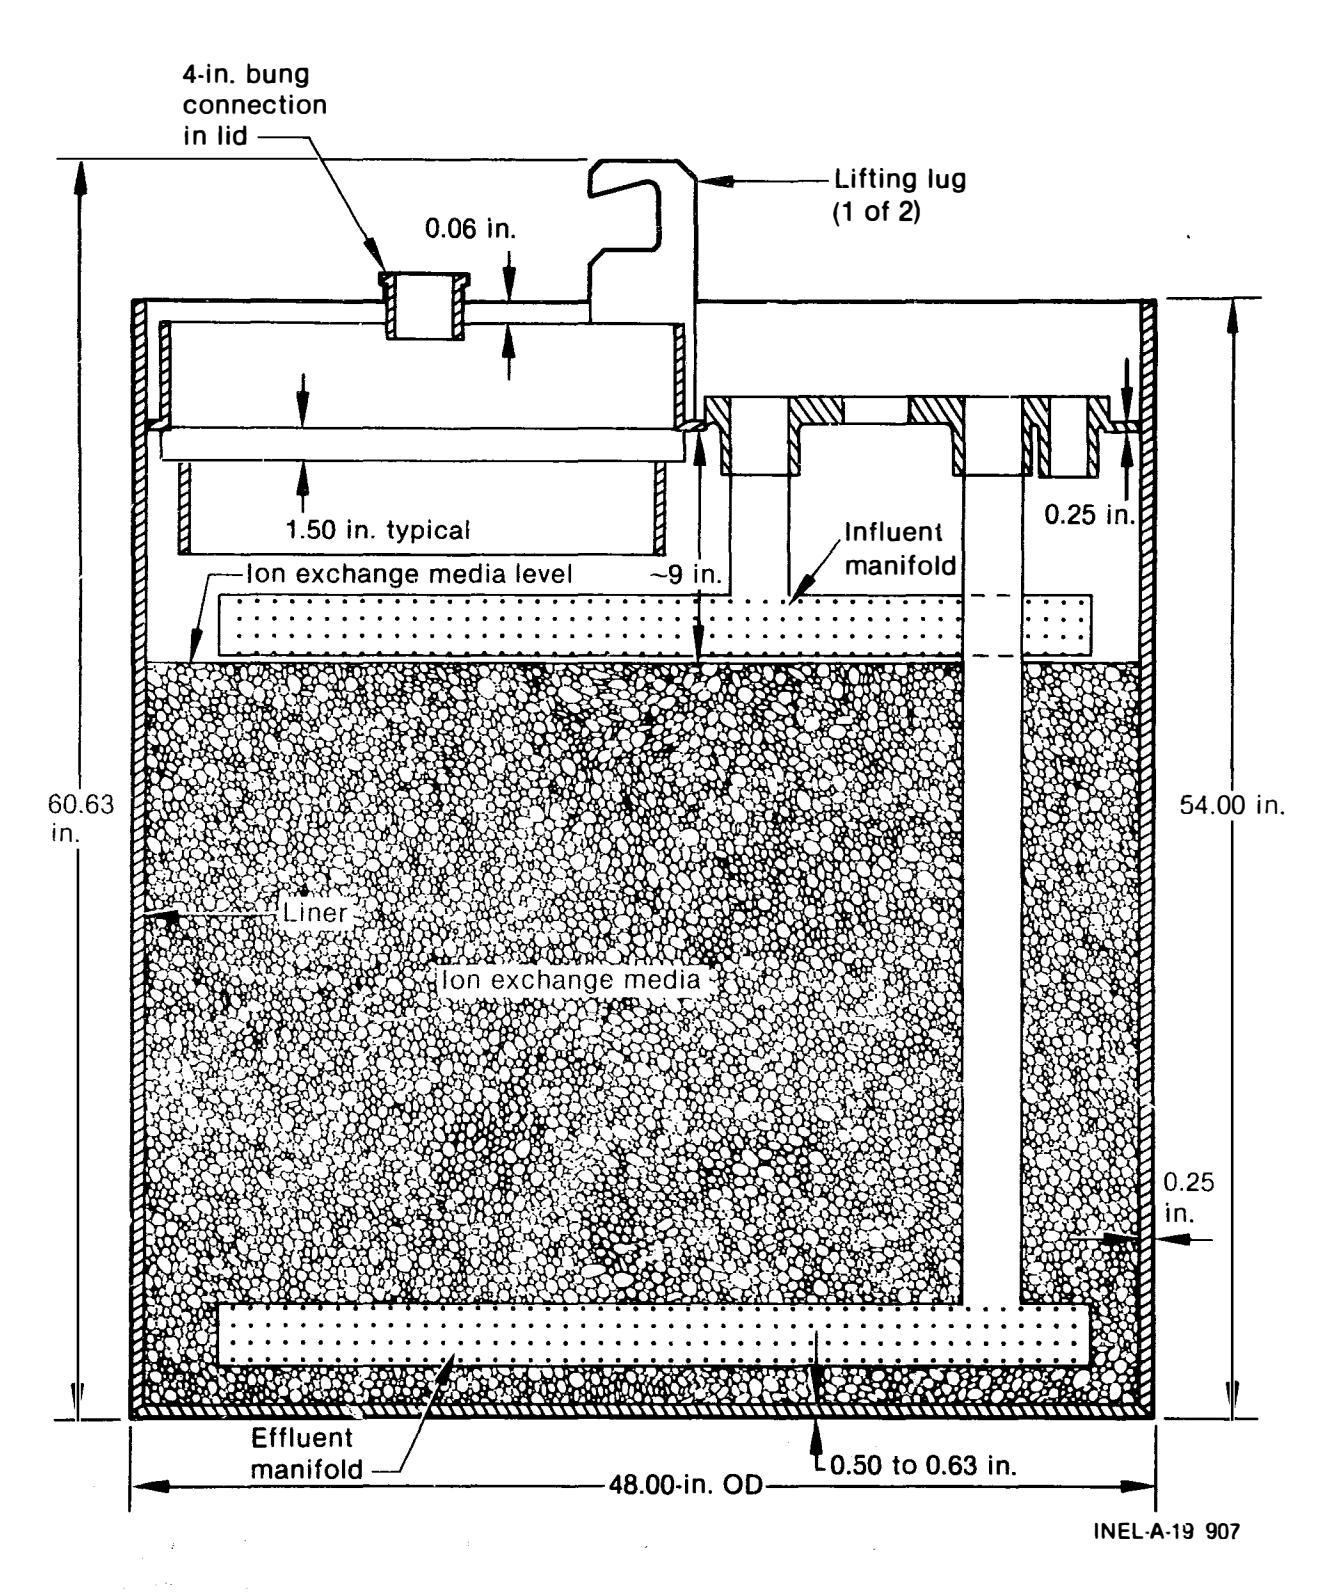
Figure 1. Cross-sectional view of a typical EPICOR II liner.

The EPICOR II prefilter liner is a 5-ft-high right circular cylinder 4 ft in diameter, containing ~ 30 ft³ of ion-exchange media. The walls and top are 1/4 in. thick and the bottom is 1/2 to 5/8 in. thick. The liner is fabricated of A36 carbon steel and is of welded construction. The interior surfaces of the liner are coated with Phenoline 368 to retard corrosion. EPICOR II liners are believed to contain zeolites and three types of organic ion-exchange media--cation, anion, and mixed bed. However, the actual composition of the media as well as additional details concerning the internal structure of the liners is considered proprietary and not available for this document.

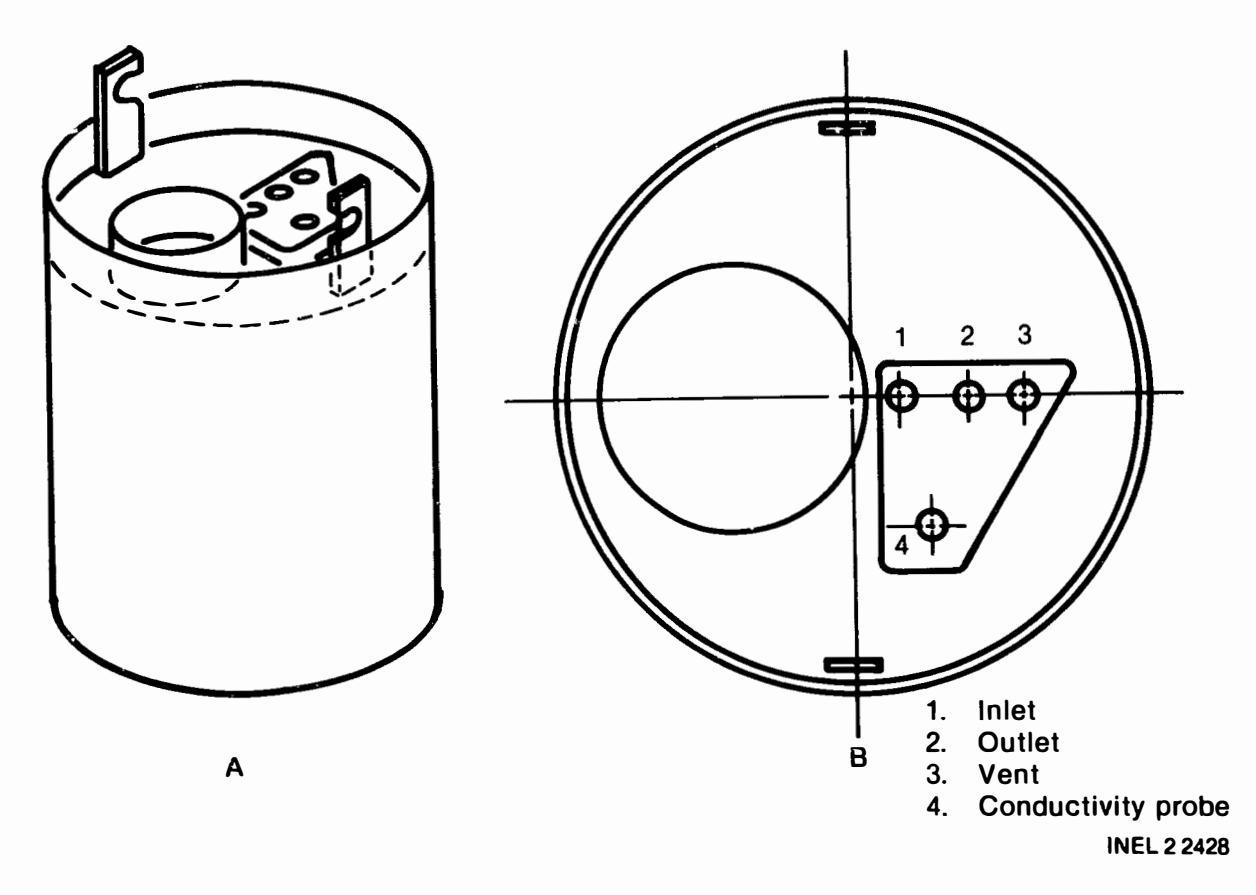
Figure 2. Schematics showing (a) orientation of PF-16 lifting lugs and (b) configuration of PF-16 penetration plugs.

The liner selected for characterization is EPICOR II Prefilter Liner 16 (PF-16). Schematic views showing the configuration of the liner lifting lugs and penetration plugs are presented in Figure 2. This liner was in service during March 3 and 4, 1980, and processed a total of 8,250 gal of water removed from Reactor Coolant Bleed Tank A. On the basis of analyses of the influent water, it was estimated that the curie loading of PF-16 was \sim 1250 Ci of mixeo fission products. A summary of the chemical and radio-chemical analyses of the influent water is presented in Table 1. From an inspection of the radiochemistry data, it is clear that the primary nuclide (\sim 80% of the total activity) was 137 Cs. During final operations by General Public Utility Nuclear Corporation (GPUNC) personnel, an effluent pH of 2.79 was measured.

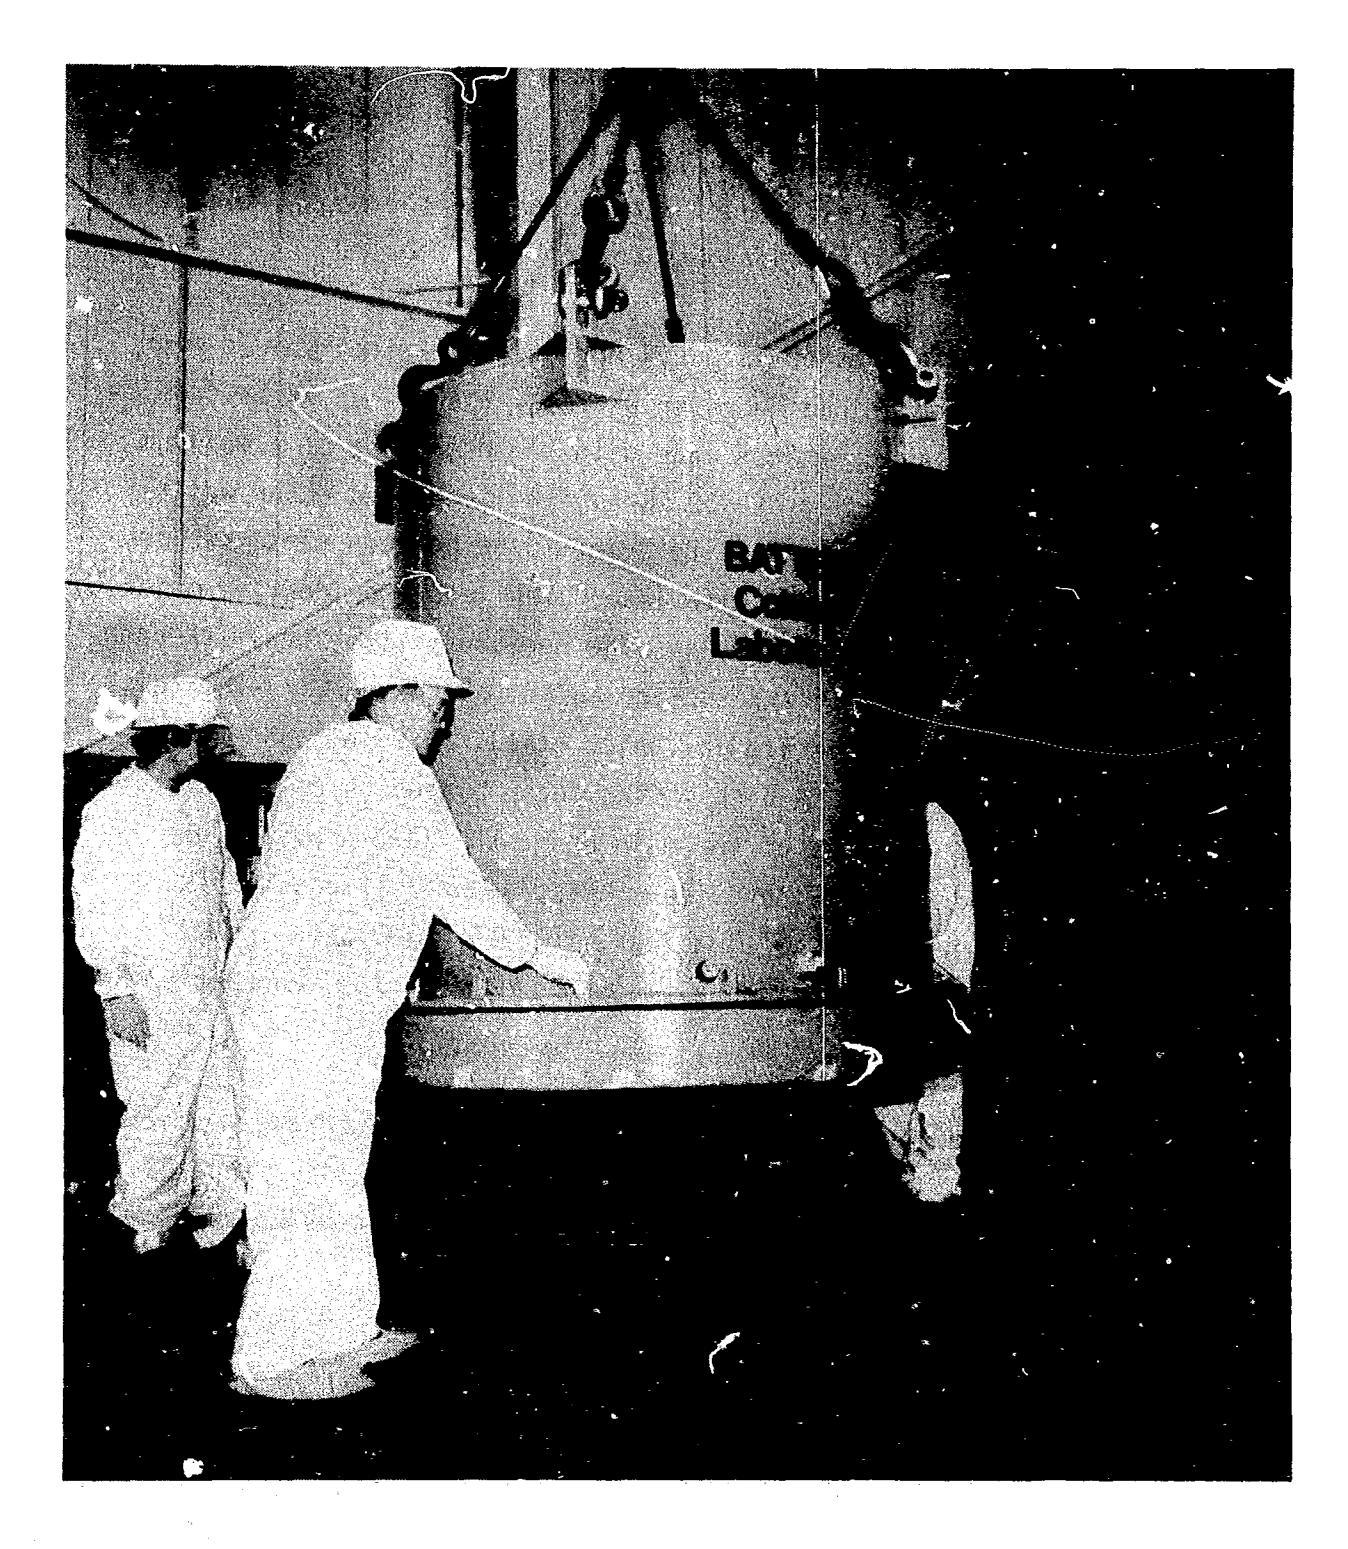
Figure 3. BCL designed liner transfer/storage device.

The transfer/storage device is a cylindrical lead-steel shield with removable top and bottom shielding cover plates. The design of the device was based on shielding calculations made with the objective of a maximum outer surface radiation reading of 0.50 mR/h. The inner and outer walls of the cylindrical body are steel. The 3-in. space between these two concentric steel cylinders is filled with lead. The lead provides the majority of the shielding, and the steel provides the necessary structural strength. The inner and side surfaces of the top and bottom plates are 1/4-in. thick steel and the outer surface is 1/2-in. thick steel. A 2-in. space between the inner and outer surfaces in each of the cover plates is filled with 2 in. of lead. As in the case of the main body, the lead provides the primary shielding and the steel provides the structural strength. The overall height, not including lifting lugs, is 67-1/2 in., the inside diameter is 54 in., and the outside diameter is 62 in. The transfer device is shown in Figure 3.

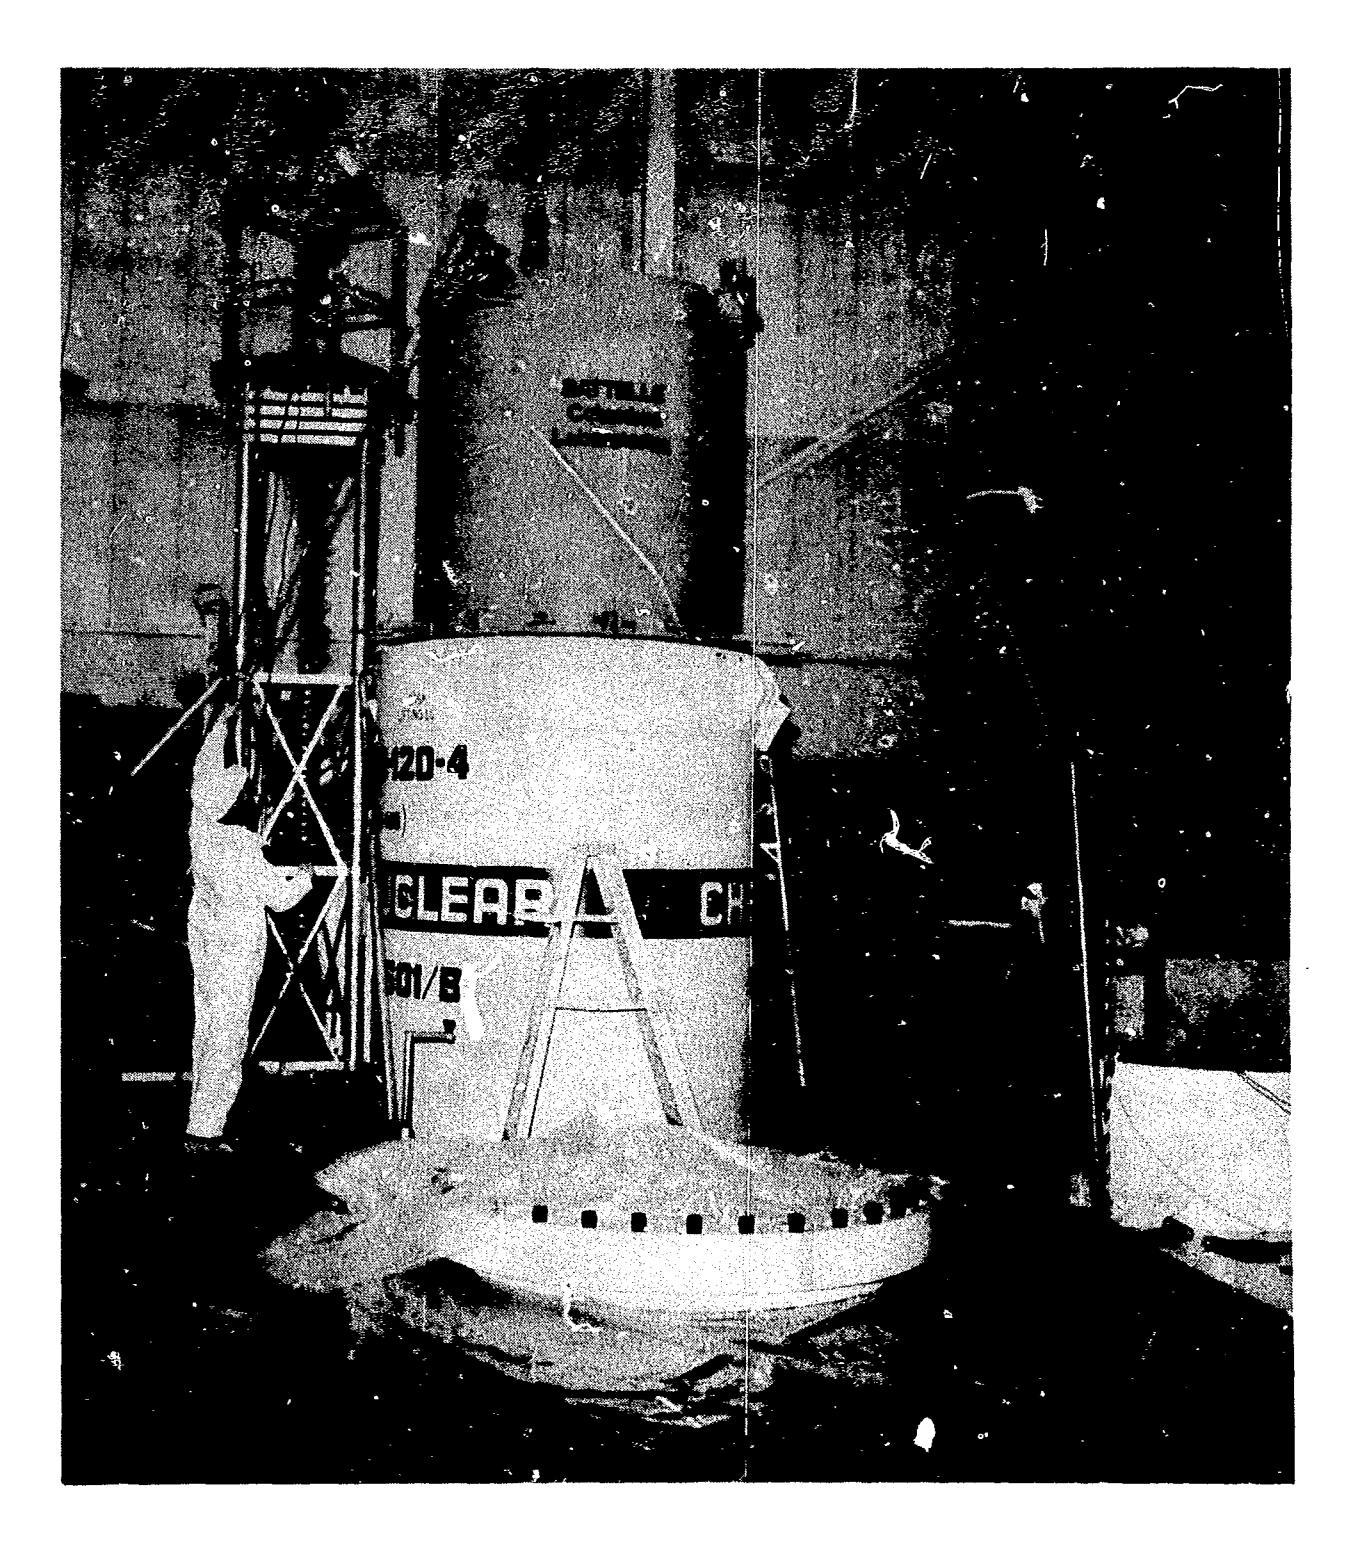
Before the PF-16 liner arrived at BCL, the transfer/storage device was tested using a dummy liner to ensure the device would function properly. Figure 4 shows the device resting on top of the shipping cask containing the liner.

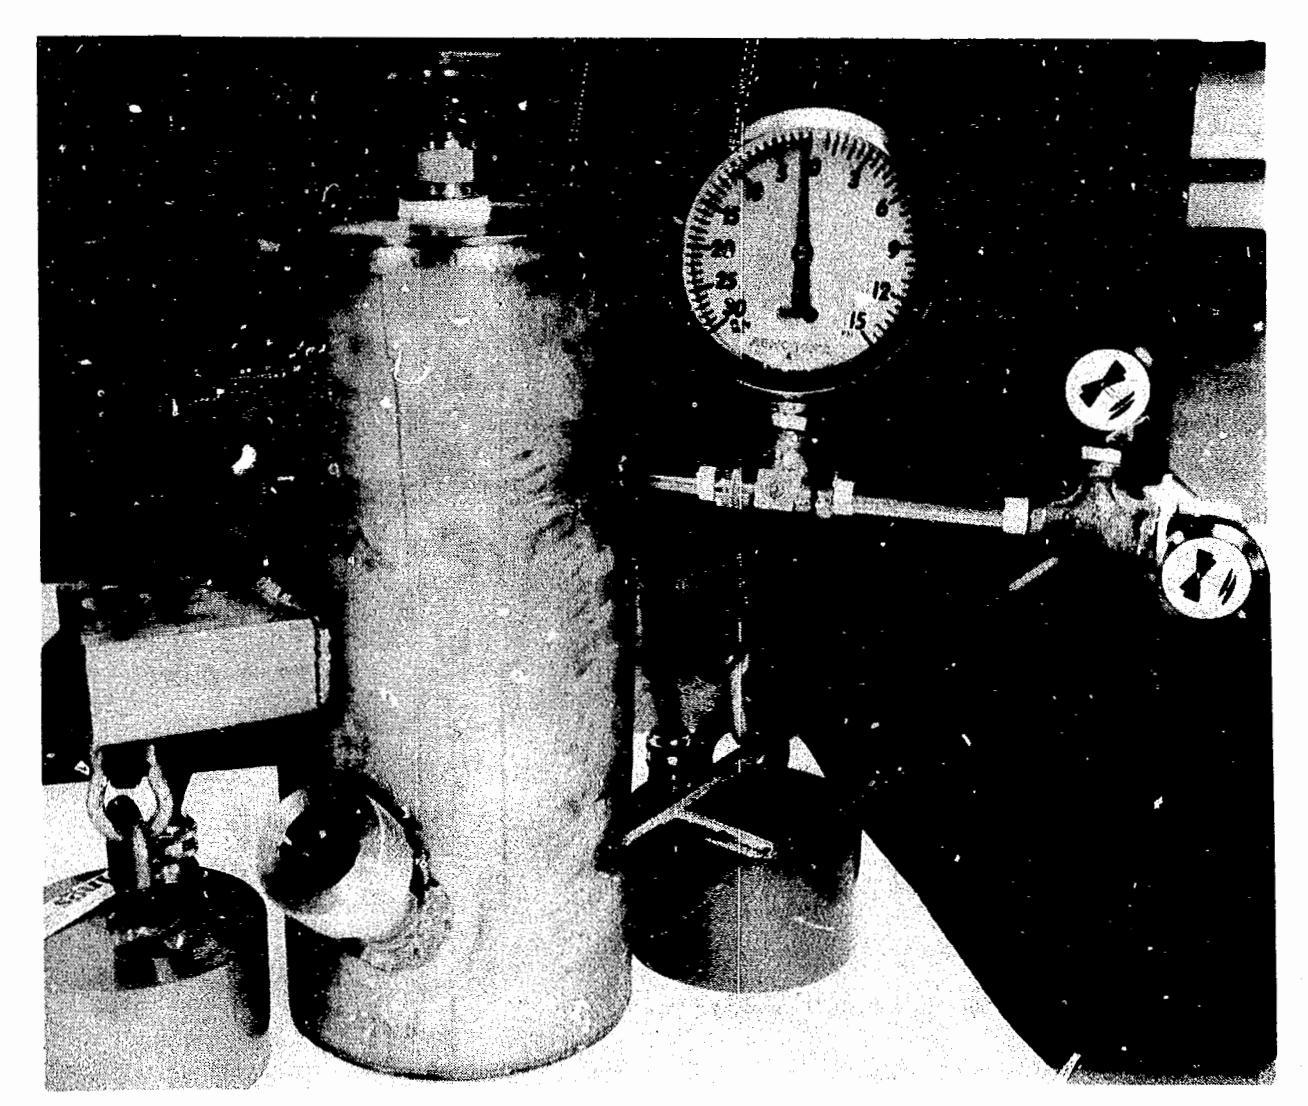
Figure 5. Gas sampling device.

One of the early tasks following the transfer of the liner into the hot cell was to obtain a sample of gas from the free space above the ionexchange media. This was accomplished on May 29, 1981. The general approach was first to affix a sampling chamber (see Figure 5) to the top of the liner using an electromagnetic clamping device. The chamber was then evacuated and the liner plug removed using a T-bar wrench penetrating the sampling chamber through an elastomer seal. The chamber was fitted with a vacuum/pressure gauge calibrated in inches of mercury and readable to within 0.5 in. of mercury. While the vent plug was being removed, the vacuum/pressure gauge was being continuously monitored. As the gas was

released into the evacuated sampling chamber, the gauge indicated that the internal pressure did not exceed atmospheric pressure. After the chamber had filled, an evacuated one-liter gas bottle that was coupled to the system was opened to collect a sample. Following the first sample collection, the vent plug was closed, and the chamber evacuated before another one-half-liter sample was collected.

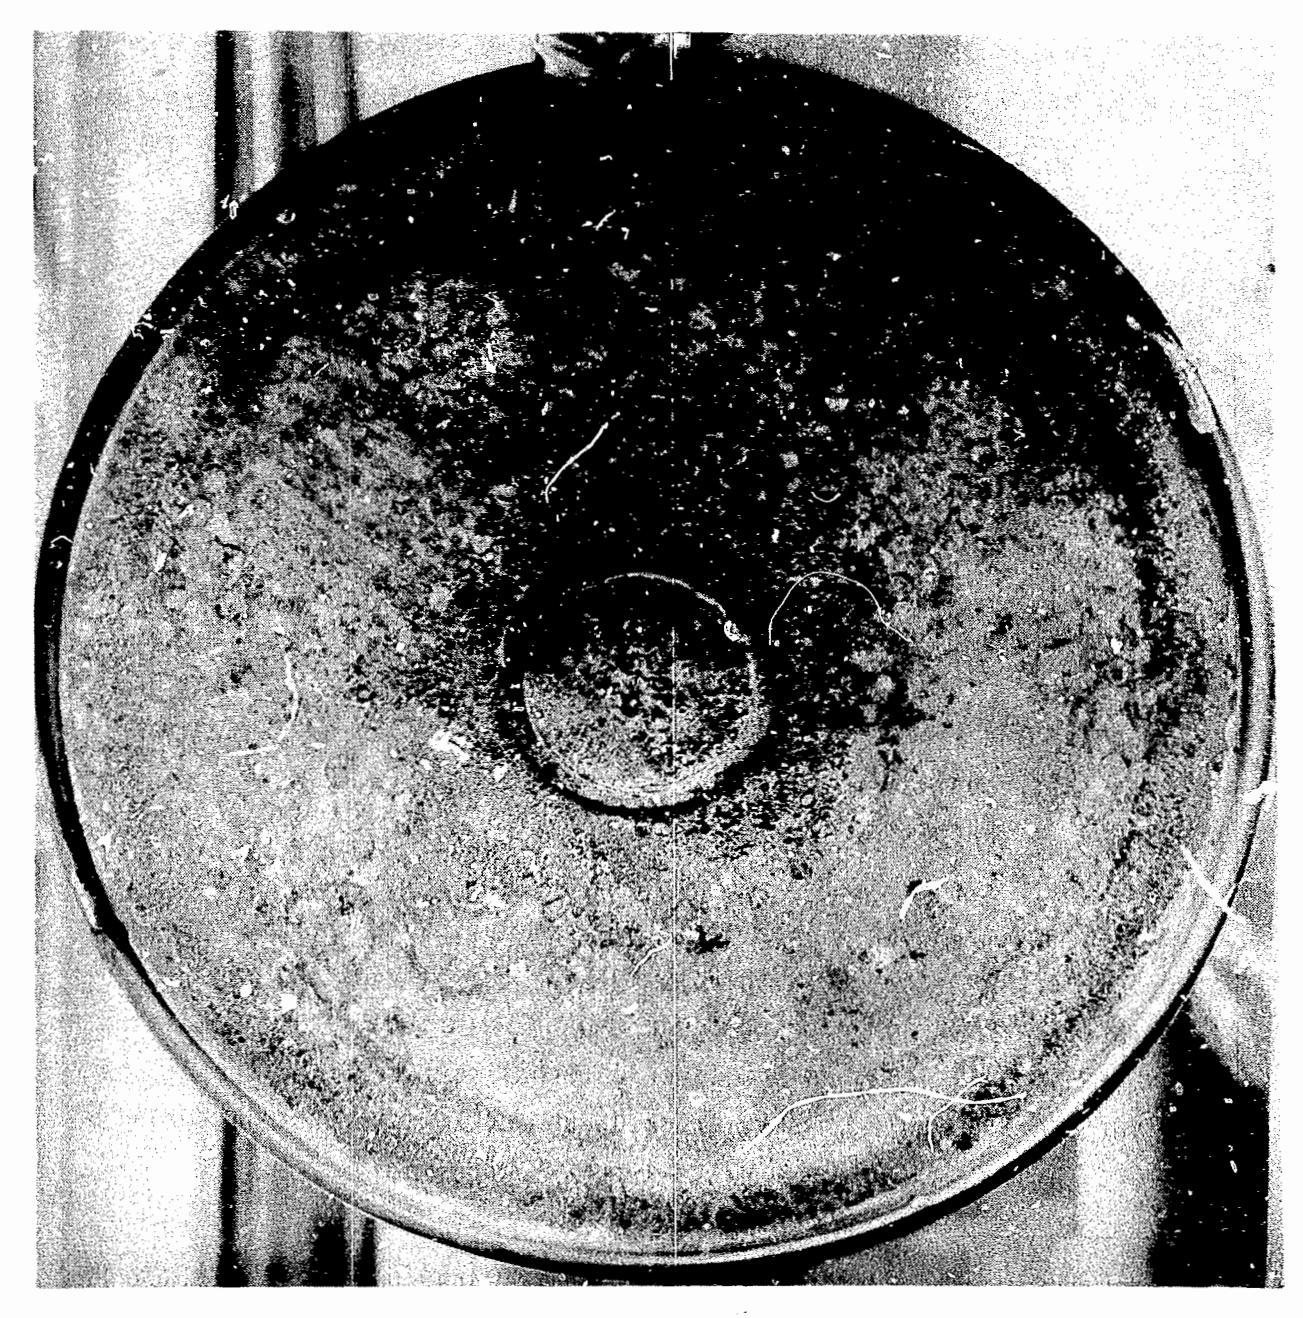
Figure 6. Corroded underside of manway cover.

The underside of the manway cover was heavily rusted, with black deposits on the surface. This surface had not been sealed with a protective coating as had the rest of the liner interior. The under surface of the cover was wet when the liner was first opened, apparently as a result of

condensation of water vapor from within the liner. It would be expected that the condensation from liquid splashing onto the cover during operation of the EPICOR II system would lead to some corrosion of the uncoated surface.

Figure 6 shows the underside of the manway cover. The corrosion of the cover may be clearly seen. Although it is not appropriate to draw any definite conclusions concerning the condition of the cover, several observations were made:

- The corrosion deposits on the cover are reddish-brown, indicating the presence of oxygen, leading to FeO_2
- General corrosion is present
- The pitting does not appear severe, but there is clearly some pitting present
- The amount of pitting cannot be determined without chemical descaling
- Metallographic examination of the pits would be necessary in order to determine the pit depth and, consequently, the likelihood that the cover integrity has been damaged
- Round areas are observed, perhaps indicating that H₂0 had condensed and remained on the cover
- Barnacle-like deposits have built upon the bung closure and surrounding area.

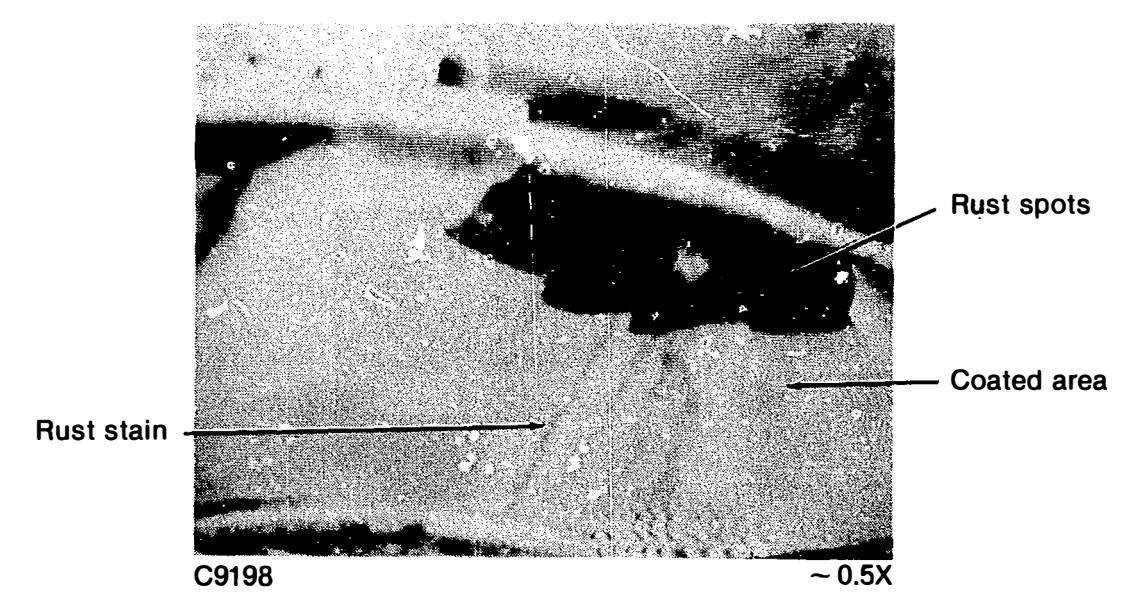
Figure 7. Corroded area on manway cover lip where protective coating was peeled off.

Some of the protective coating on the manway cover lip appeared to have peeled off and rust spots (1/4 to 1/2 in. in diameter) were observed in this area. Figure 7 shows the appearance of the area where the coating had peeled off. The protective coating on the inner surface of the liner appeared to be blistered; however, it seemed intact, with only occasional rust spots ($\sqrt{1/8}$ in. in diameter).

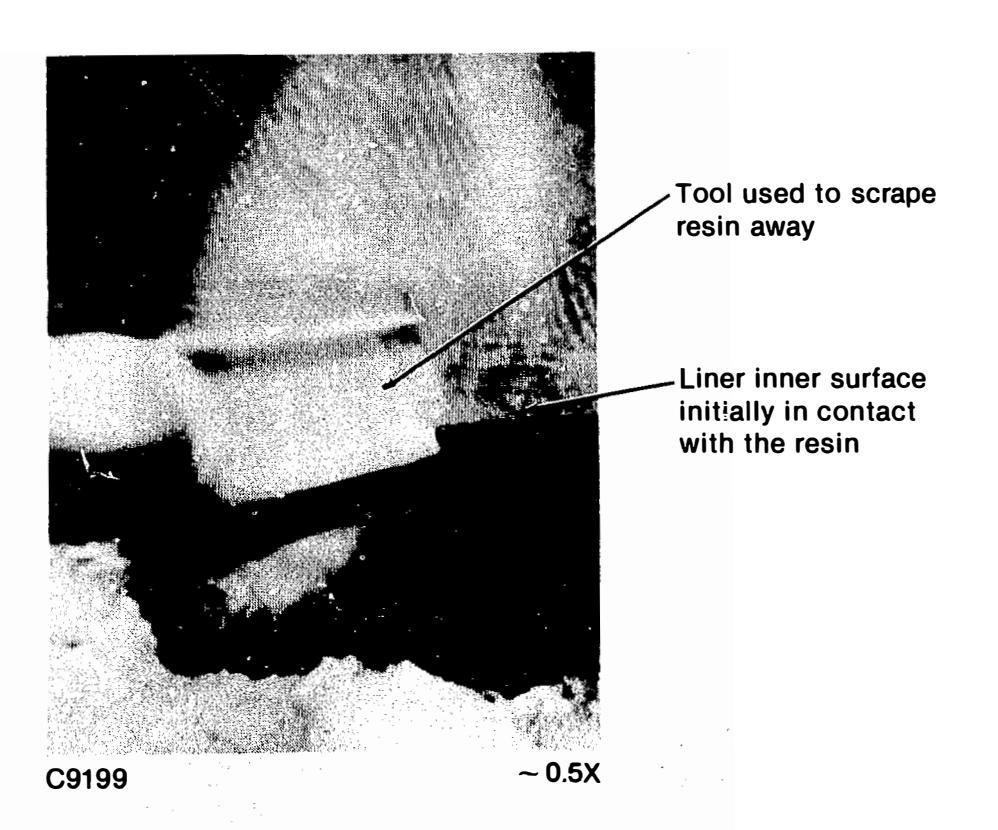
Figure 10. Appearance of the liner interior in contact with the resin.

A small stainless steel spade was used to remove a portion of the ionexchange media in contact with the liner so that the liner ion-exchange media interface area could be examined. No visible corrosion of the liner surface was evident. Figure 10 shows the area of the liner that was in contact with the ion-exchange media.

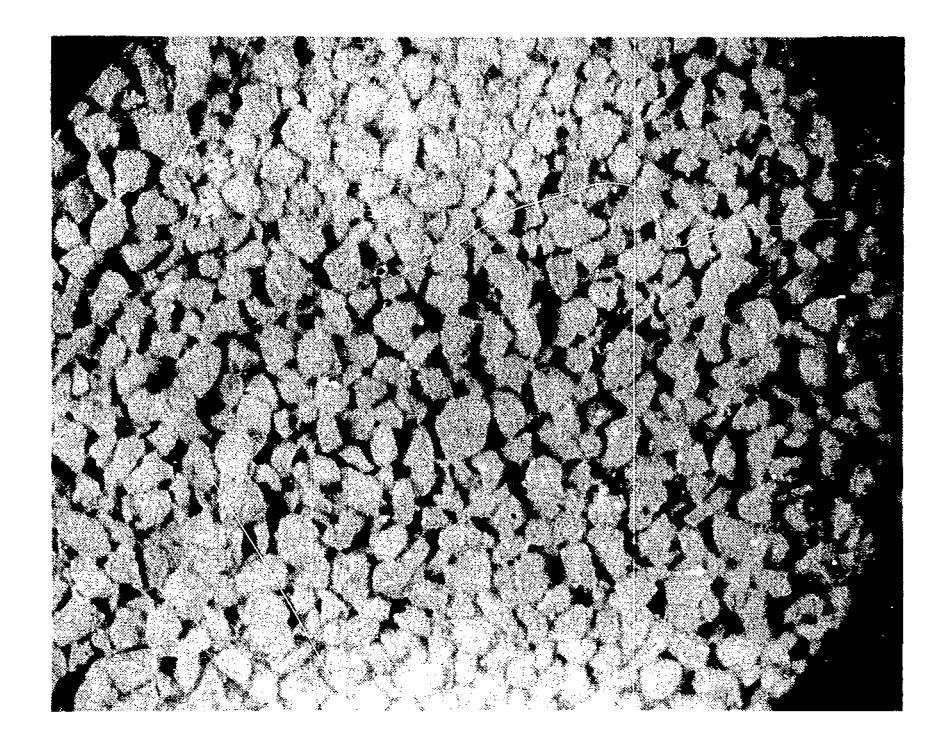
Figure 11. Photomicrograph of core sample, Region I.

Three well defined regions were observed in the core. The top region (Region I) appeared to consist of light-colored, free-flowing, dry, granular, irregular shaped particles. This had a length of $\sqrt{5}$ in. A photo-micrograph of this material is shown in Figure 11.

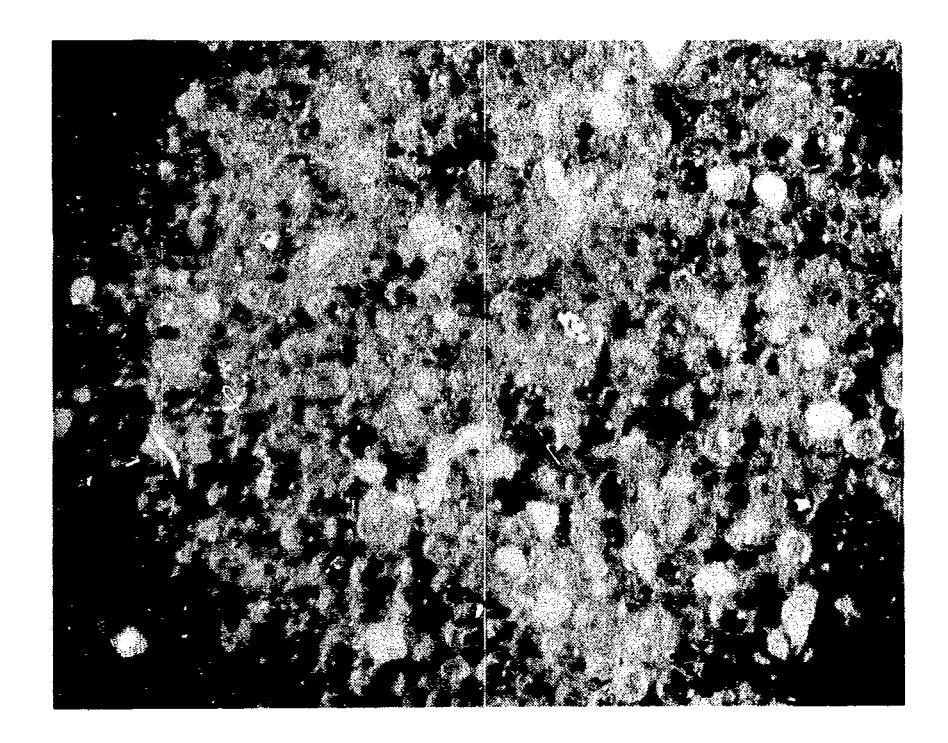
Figure 12. Photomicrograph of core sample, Region II.

Region II was ~ 8 in. long and consisted primarily of regular-shaped, spherical particles that appeared translucent. A few broken particles were observed. There was some observed mixing with the top layer, and the moisture content increased with increasing depth. However, no real difference in color or shade was observed. Near the bottom of this region, there appeared to be some mixing, with occasional opaque, spherical particles. Figure 12 is a photomicrograph of this region.

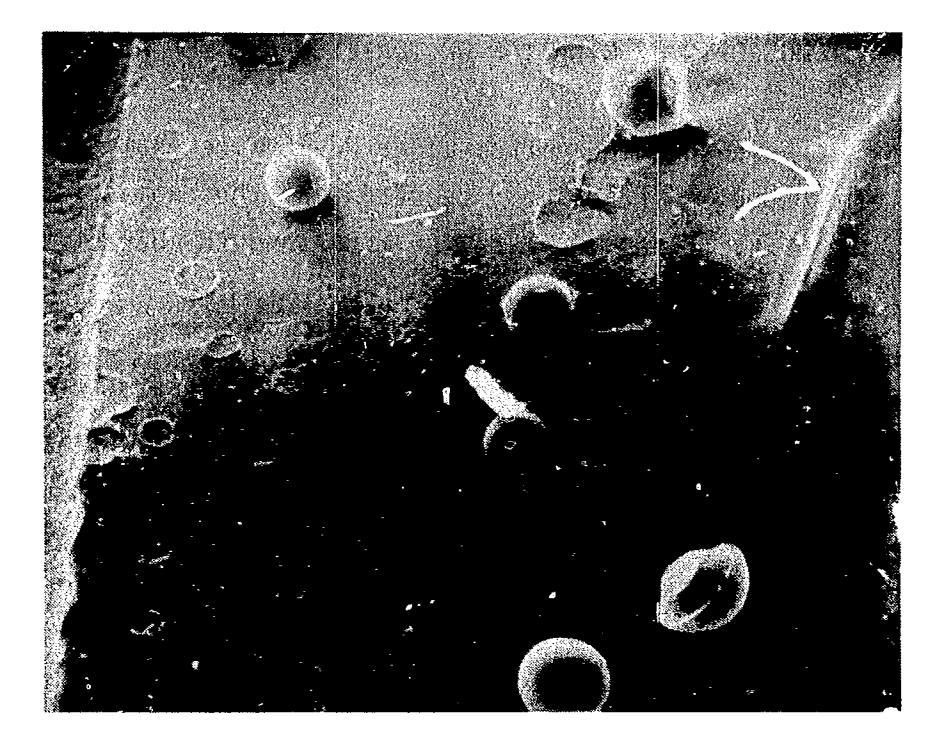
Figure 14. SEM photograph of ion-exchange media, Region III, bottom segment, 20X.

Figure 14 shows the typical appearance of the ion-exchange particles from this segment. Most of the particles appear spherical. Occasionally, cracking and spalling of the surface layer was observed. Figures 15 and 16 show examples of surface defects. EDAX analysis of the particle shown in Figure 16 indicated sulphur as the only detectable element [elements of atomic numbers below sodium (11), including carbon and hydrogen, are not detectable with the EDAX system]. Figure 17 shows the X-ray spectrum obtained on this particle.

In summary, deterioration of the ion-exchange media due to radiation exposure appears to be minimal. Surface cracking and spalling were observed only in one segment, the bottom layer of the core sample. As this is the region the farthest from the highest activity loading, it is likely that the observed degradation is an effect of the high moisture content of the region or chemical attack.

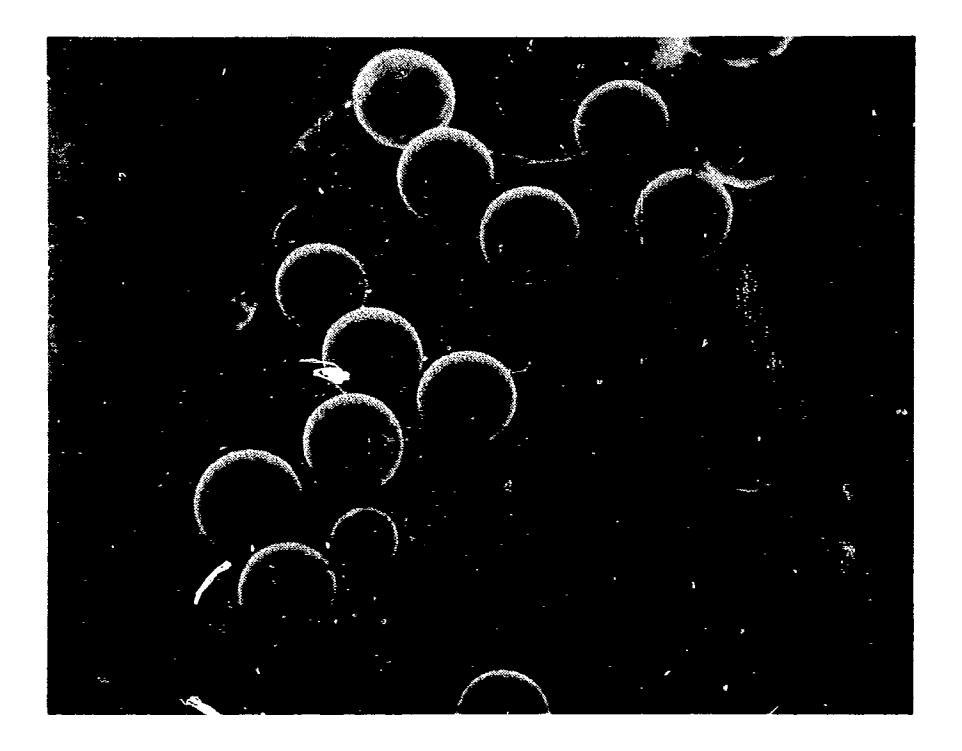
Figure 18. SEM photograph of ion-exchange media particles, Region III, top segment, 20X.

Particles in this segment were all spherical, with little or no evidence of surface defects. Figure 18 shows the appearance of the particle magnified 20%. Figure 19 shows one of the particles at a higher magnification, 130%. EDAX analysis showed predominantly sulphur, with very small amounts of calcium and iron.

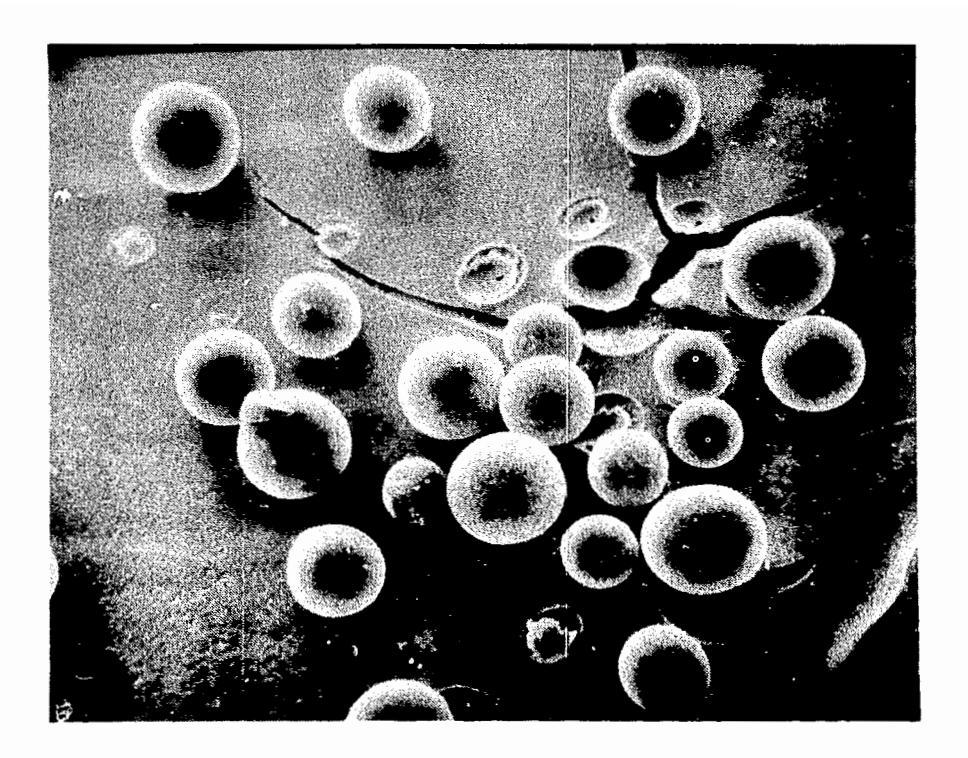
Figure 20. SEM photograph of ion-exchange media, Region II, bottom segment, 20X.

The particles in this segment were also spherical and, again, no surface defects were evident. Figures 20 and 21 show the typical appearance of the particles. X-ray analysis of one of the particles showed a relatively smaller amount of sulphur. A small amount of potassium was observed in addition to calcium and iron. Figure 22 shows the X-ray spectrum obtained on this particle.

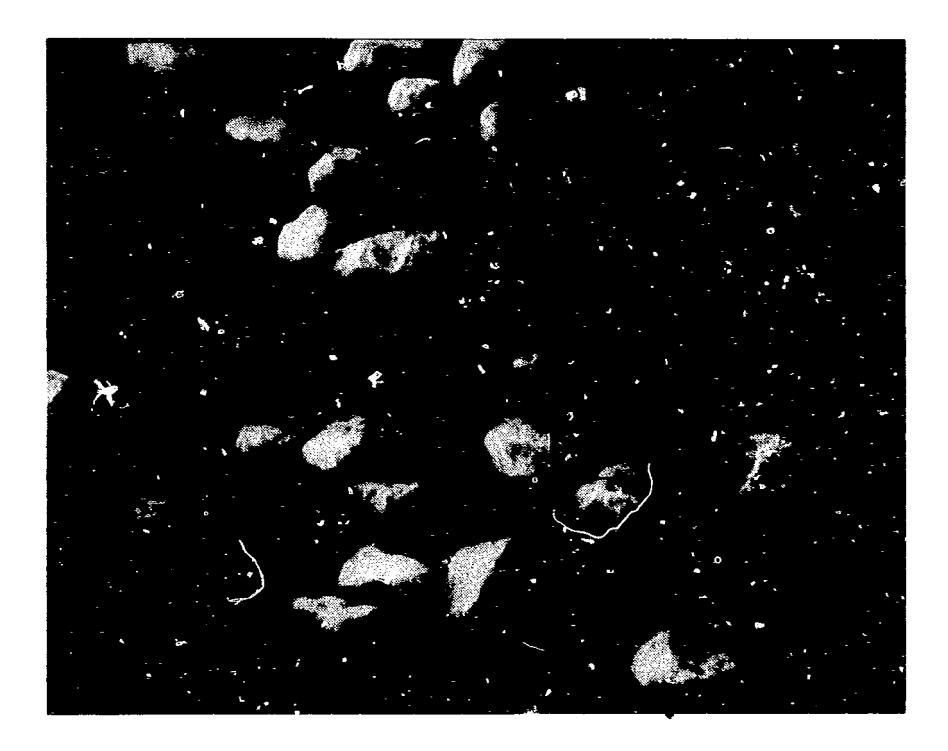
Figure 23. SEM photograph of media particles, Region II, top segment 20X.

The particles in this segment were acicular with rough "rocklike" surfaces. Figure 23 shows the appearance of the particle at 20X. A higher magnification view (130X) is shown in Figure 24. The surfaces, when examined at higher magnification, showed the presence of crusty deposits. Analysis of the deposits showed high concentrations of calcium and iron. Figure 25 shows the X-ray spectrum obtained. Elements of mass numbers below potassium could not be detected because of the radiation level of the particles.

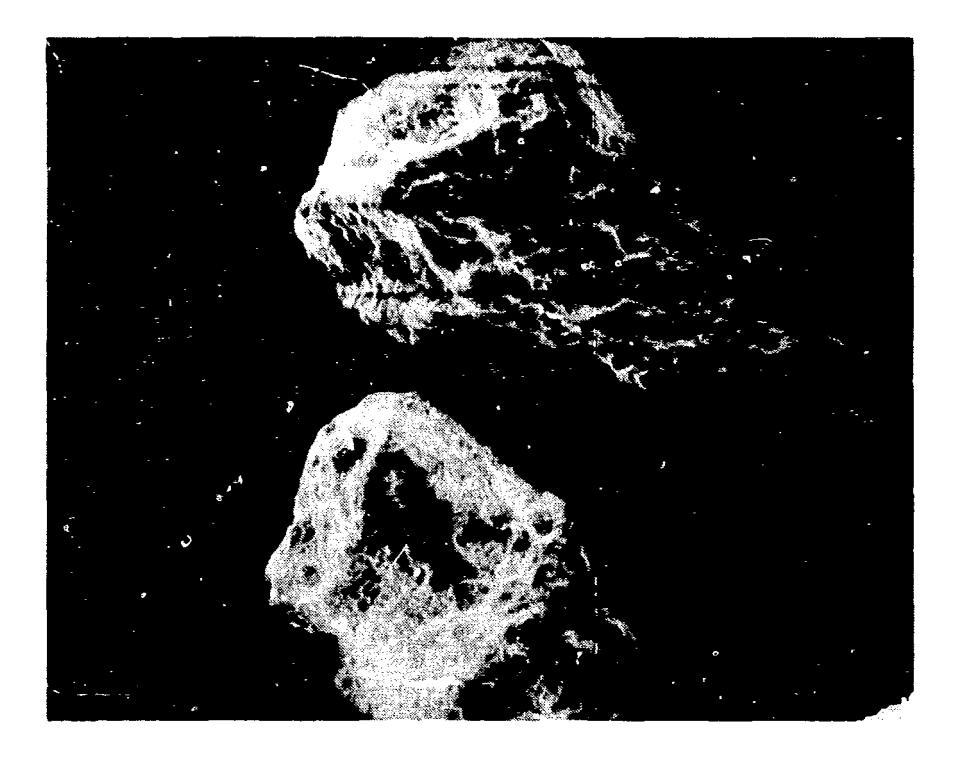
Figure 26. SEM photograph of media, Region I, 65X.

The particles in this segment were very similar to those in the previous segment. Figure 26 shows the appearance of the particle. Figure 27 shows the presence of deposits on the surface of the particle. X-ray analysis of the surface showed relatively less calcium and more iron. Small amounts of titanium were observed, as well as potassium as seen in the particles from Region II, bottom segment. None of the particles appeared to have been affected significantly by radiation.

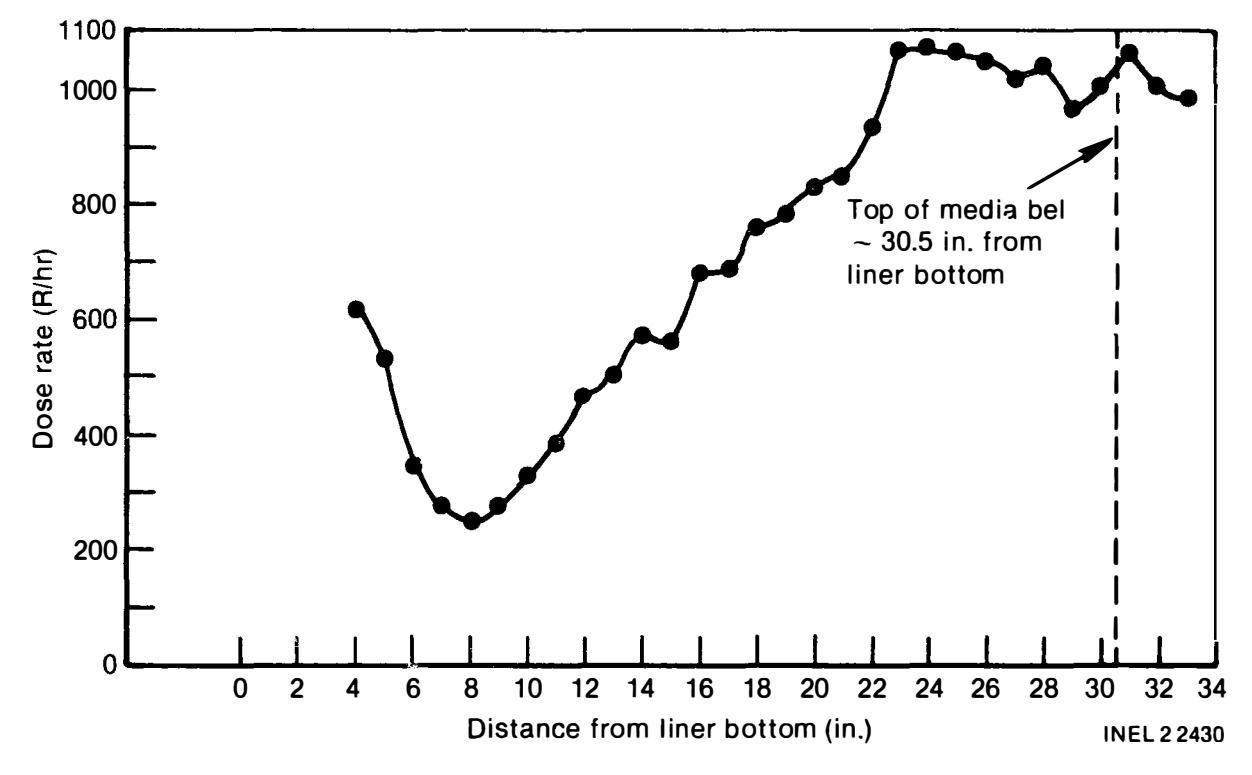
It was noted that the gamma dose decreased rather smoothly from a relatively level plateau between 33 and 23 in. to a minimum at 8 in. from the liner bottom. The dose rises again to the last reading taken at the 4 in. level. The smooth change is expected since each TLD is bombarded by radiation from all directions and the radiation field is a smooth gradient from the high levels at the top of the liner to lower levels at the bottom of the liner. The rise seen at the bottom of the liner was not expected since

neither the direct probe axial profile nor the axial gamma scan taken outside the liner showed a higher activity at the bottom of the liner.

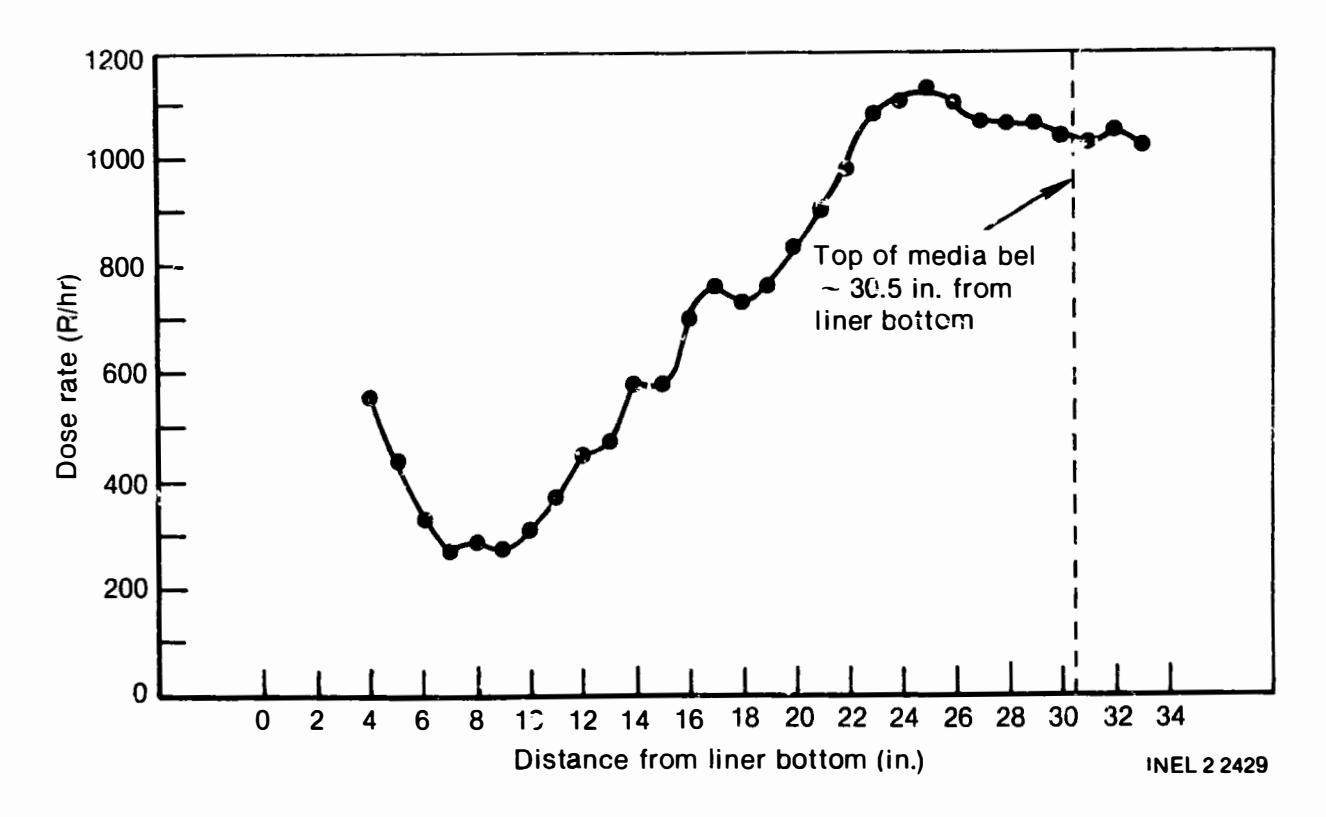
To verify the first profile, a second set of 15 TLDs were inserted into the liner caisson for 1 h. The results of this second test are given in Table 9 and plotted in Figure 29. As can be seen, both plots (see Figures 28 and 29) show a rise at the lower end of the liner. It is felt that the bottom TLD is partially imbedded in the resin at the open end of the caisson and the close proximity of the lower two TLDs (bottom 4 in.) caused these to receive a higher dose. Once the distance from the exposed resins reached about 4 in., the radiation contribution was primarily from the resins surrounding the caisson. Therefore, it is felt that the increased dose observed from the TLDs is geometric or related to the distance from the resins, and in reality the dose rate at the lower end of the resin liner is relatively constant at about 300 rem/h.
