CHARACTERIZATION OF EPICOR II PREFILTER LINER '16

J. David Yesso V. Pasupathi Larry Lowry DISCLAIMER -

Battelle Memorial Institute Columbus Laboratories Columbus, Ohio 43201

Published August 1982

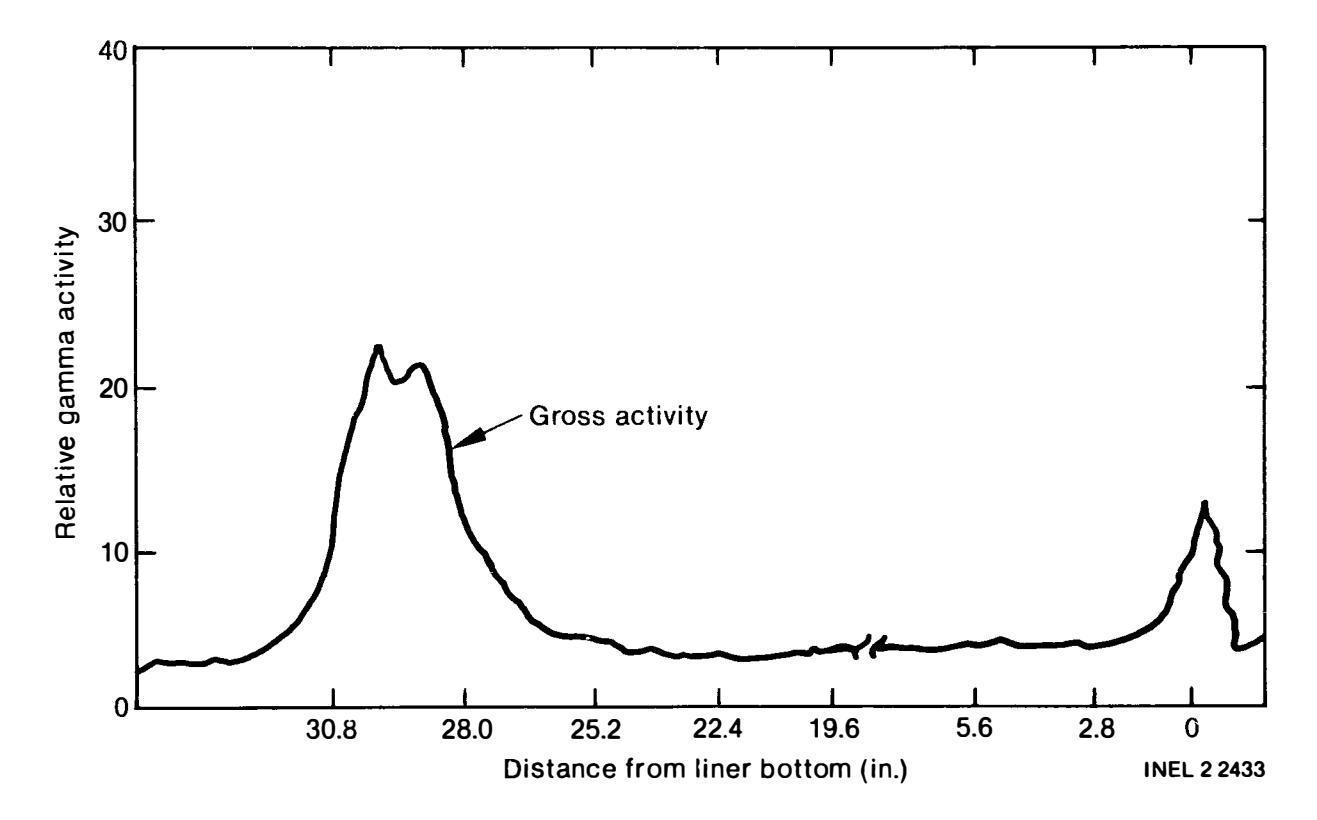
Figure 30. Gamma activity profile along outside of liner.

Figure 30 shows a typical gamma activity profile along the length of the liner. Gamma spectroscopy performed at the location of the peak activity showed that >90% of the gamma activity is 137 Cs and 134 Cs. The gamma scans also showed that most of the activity is concentrated in the top 3 to 6 in. of the ion-exchange media bed. The peak at the bottom of the liner was caused by a gamma source attached to the outside of the liner for axial liner position reference, and is not indicative of any activity in the media bed.
