Three Mile Island Nuclear Station, Unit 2 (TMI-2) Operating License No. DPR-73 Docket No. 50-320 Polar Crane Auxiliary Hoist Inspection and Refurbishment Plan

POLAR CRANE AUXILIARY HOIST REFURBISHMENT PLAN

- 1.0 PURPOSE
 - 1.1 The purpose of the refurbishment plan is intended to provide a comprehensive and logistical outline to renovate and restore the auxiliary hoist feature of the TMI-2 refurbished polar crane to its original rated capacity of 25 tons.
 - 1.2 This plan is only intended for use as a guide and is subject to change based on actual events.

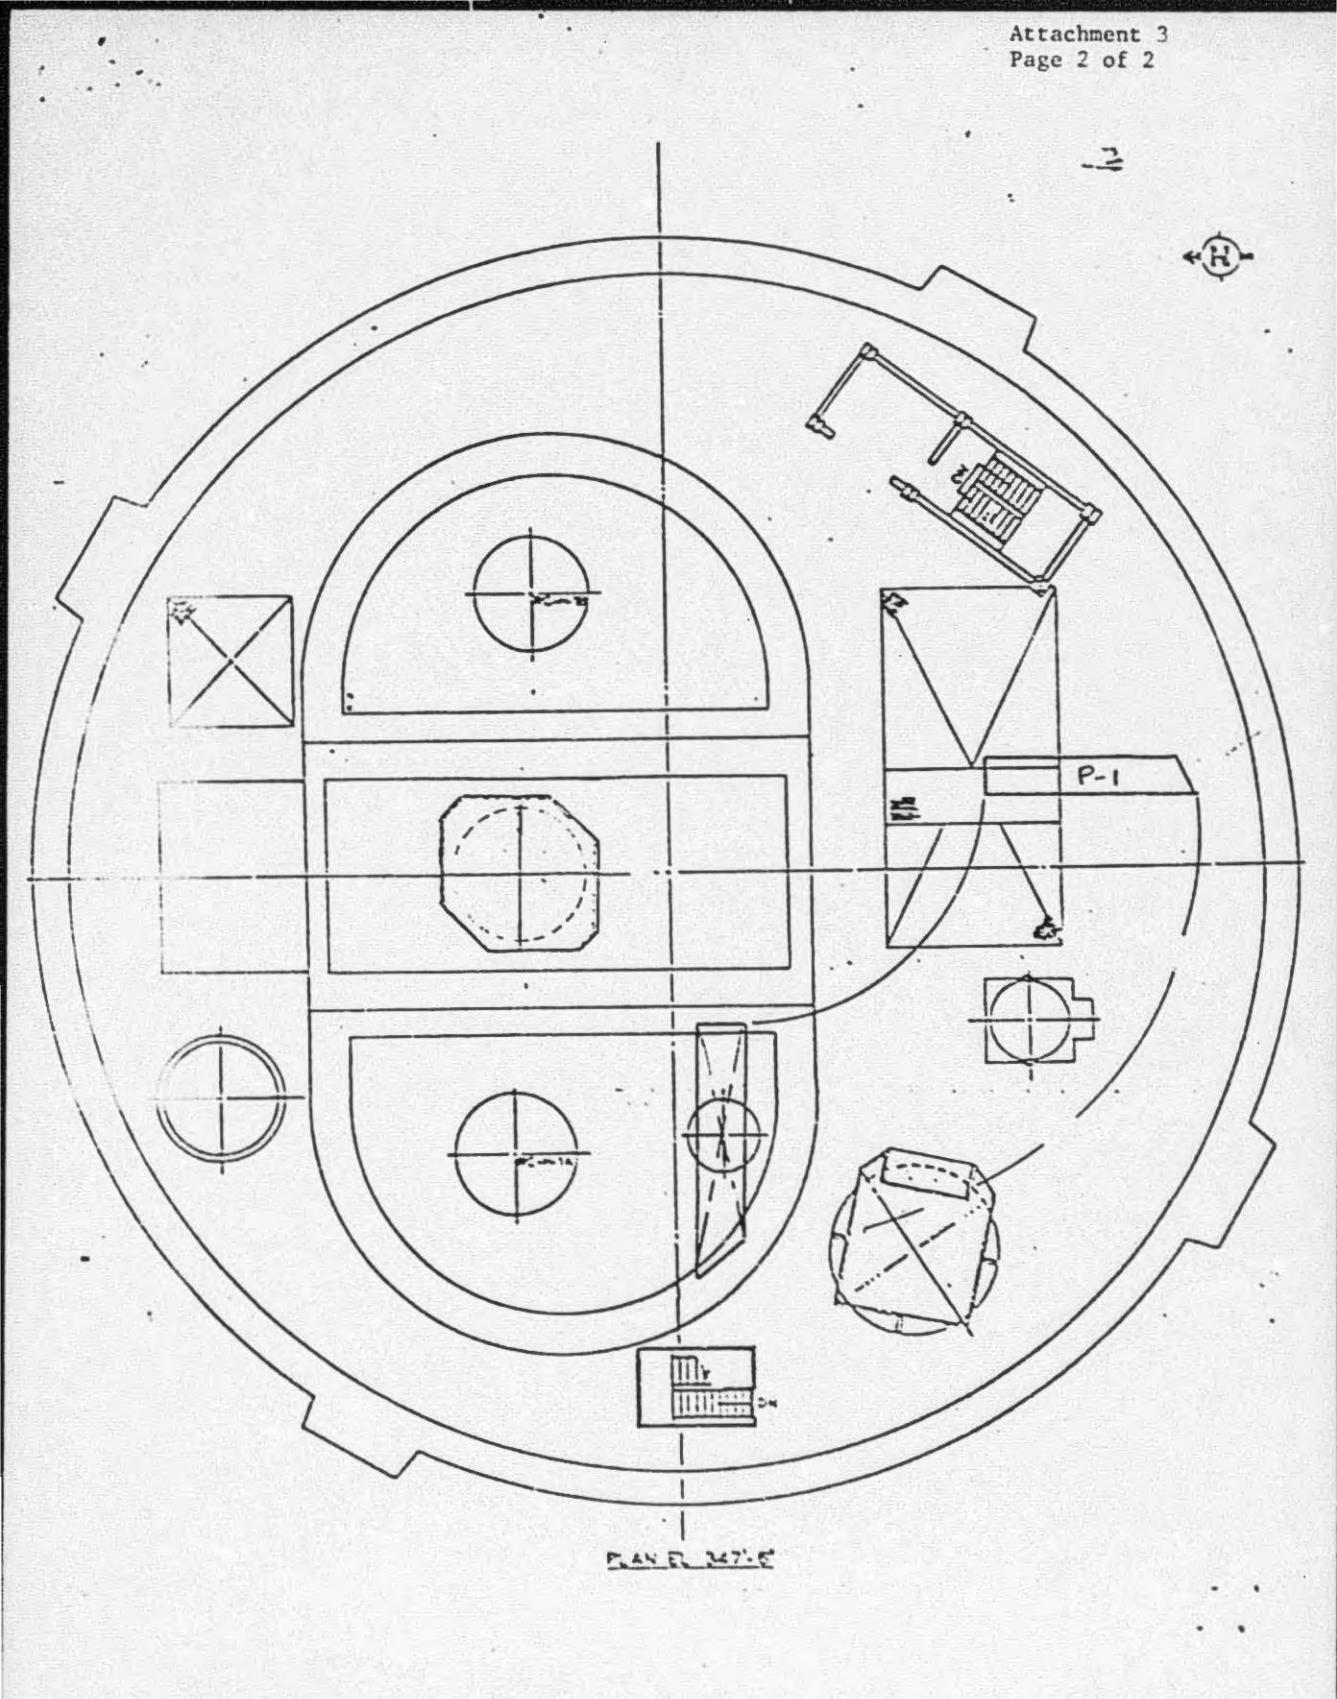
The pressurizer missile shield shall be lifted and relocated with the main hoist along the load path as shown on the attached sketch.

The test load will consist of the lift rigging a load indicating device, and the pressurizer missile shield. Because the pressurize missle shield exceeds the maximum 31.25 tons required for performing a load test at the recommended 125 percent of the 25 ton rated load, it shall be necessary to obtain approval from the crane manufacturer for the excessive load as permitted by ANSI B30.2-1976, Paragraph 2-2.2.2.
