THI-2 LEADSCREW DEBRIS PYROPHORICITY STUDY

R. L. Clark R. P. Allen M. W. McCoy

Pacific Northwest Laboratory Richland, Washington 39352

# Prepared for the U.S. Department of Energy Three Mile Island Operations Office Under DOE Contract No. DE-AC07-761D01570

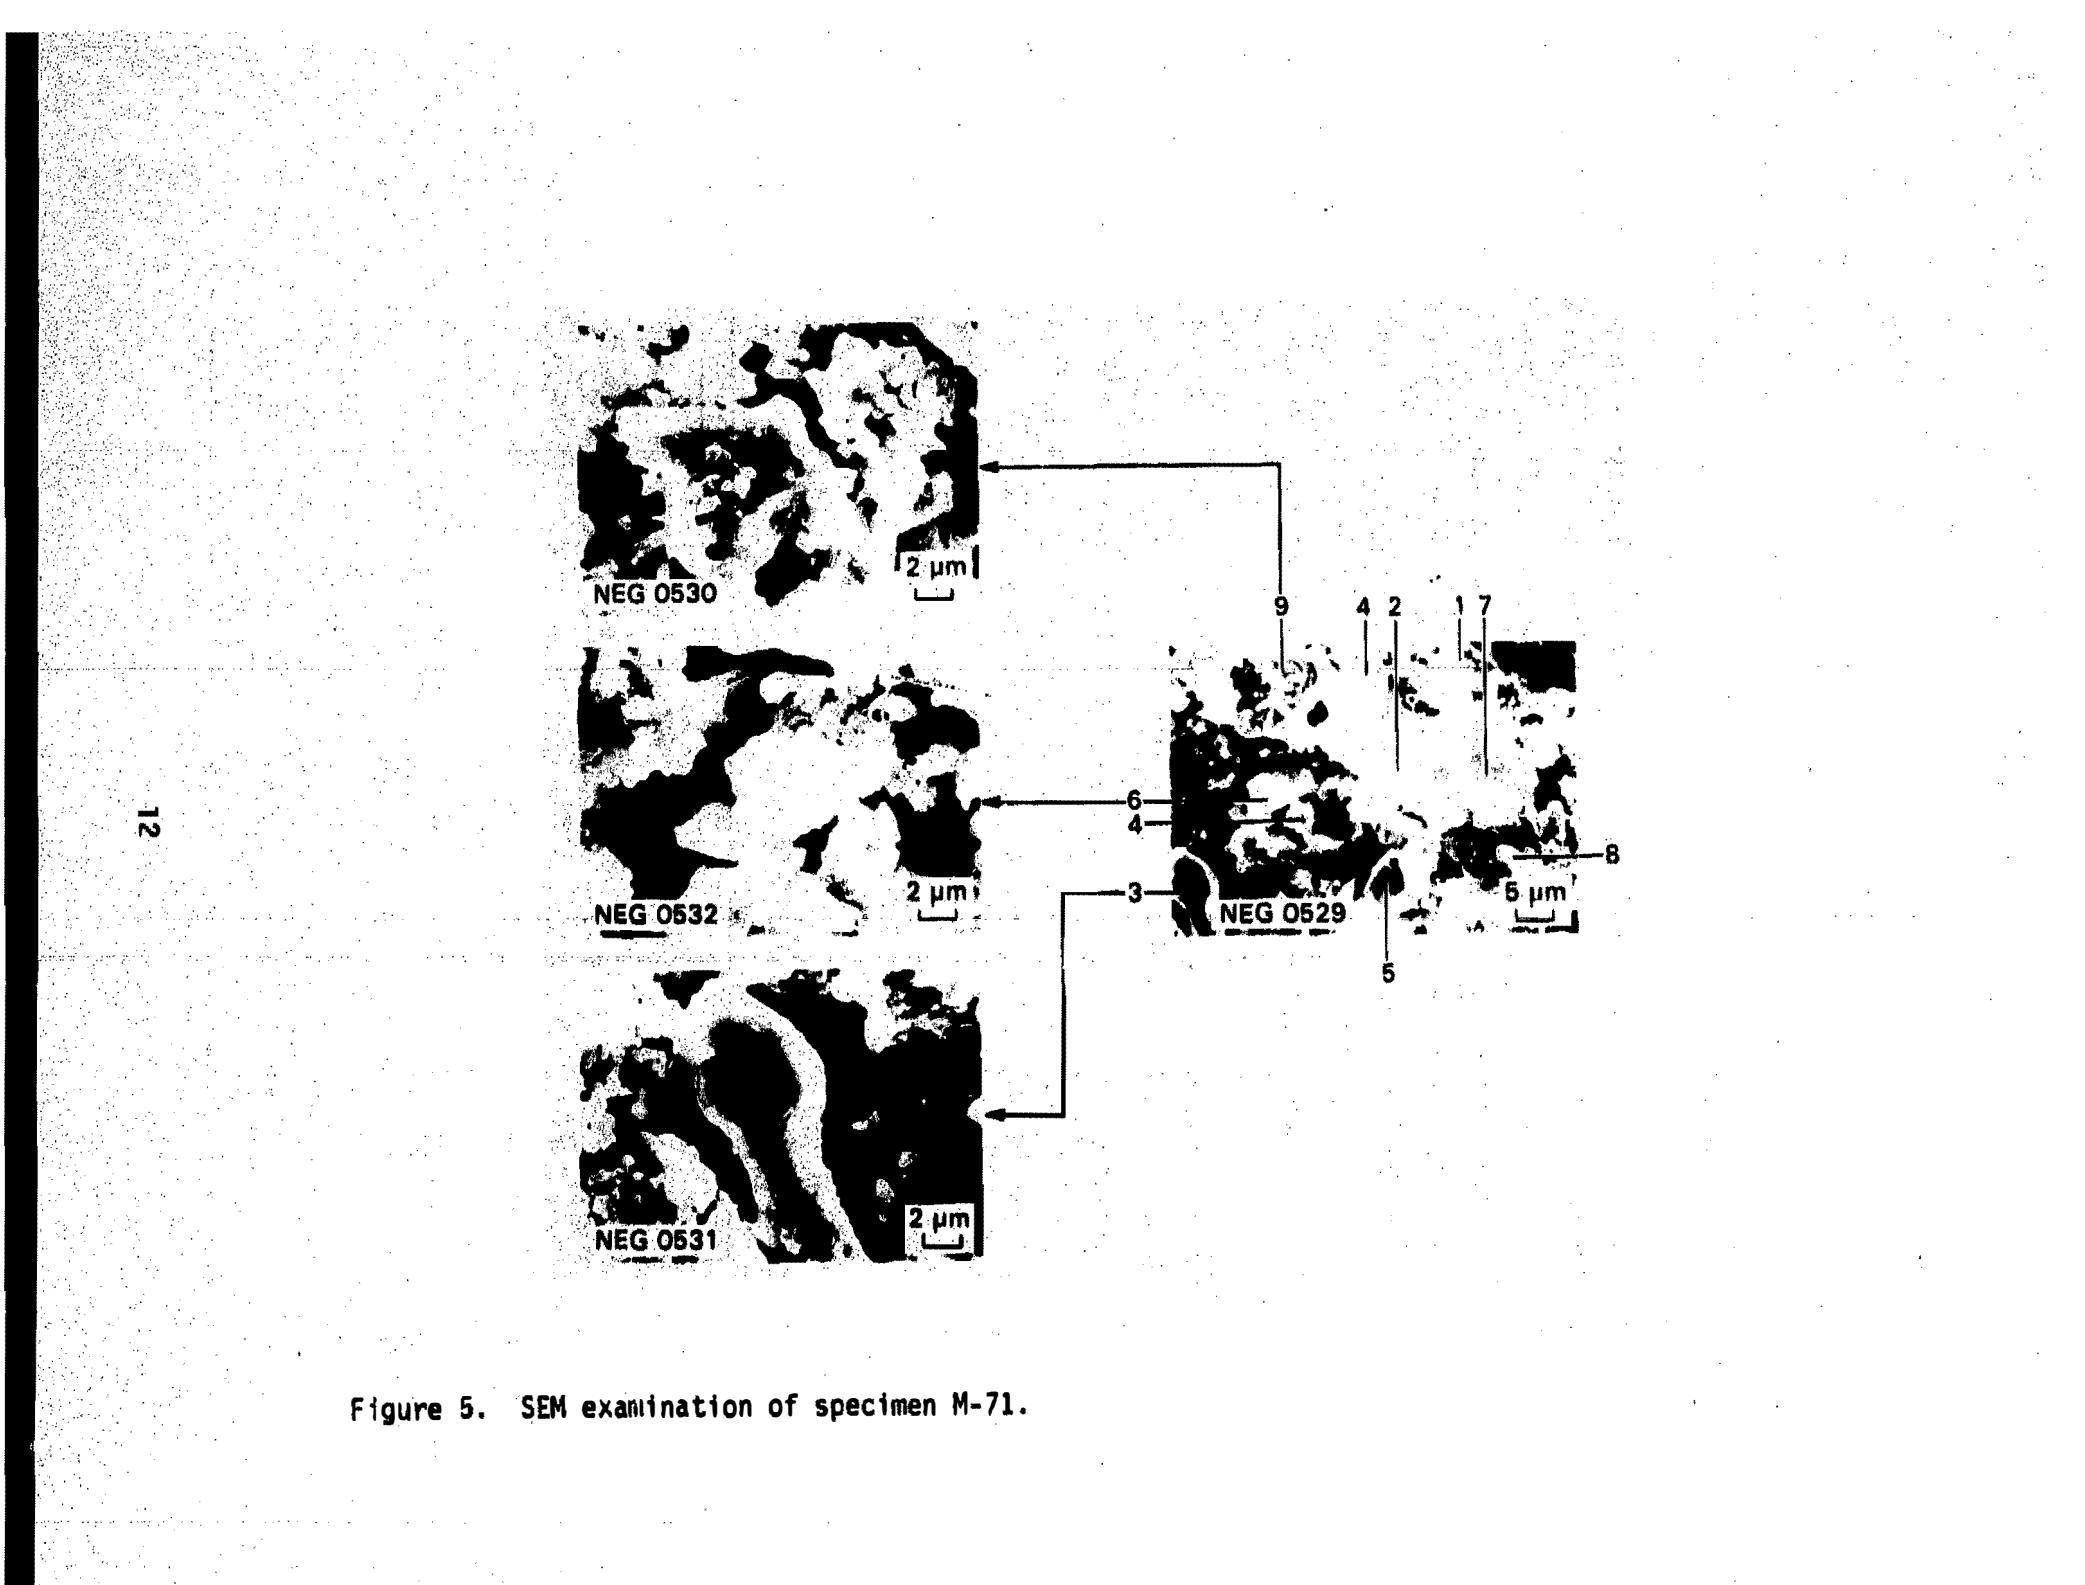
SEM micrographs of a typical area on specimen M-71 are shown in Figure 5. The debris consists of two types of particles: large solid particles measuring 5 to 25  $\mu$ m in diameter and agglomerates, made of 1  $\mu$ m particulates. Table 3 tabulates the major elements, based on EDX analyses for particles shown in Micrograph No. 0529 (Figure 5). The major particle compositions exclusive of elements with atomic numbers below aluminum were uranium, aluminum/silicon, zirconium/silver, and iron.

Micrographs in Figures 5 and 6 are based on secondary electrons emitted from the specimen surface due to the electron beam excitation. Images that are based on backscattered electrons from the beam cause particles composed of high atomic number elements, uranium, for example, to appear brighter than particles composed of lower atomic number elements, such as iron, chromium, and aluminum. Comparison of backscattered and secondary electron images of the same area on M-72 (Figure 7) suggests that the higher atomic number particles, probably e.g. uranium, are larger than 5  $\mu$ m.

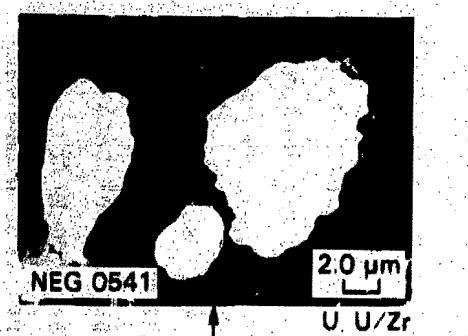
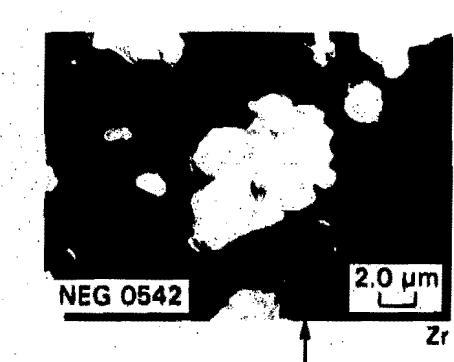
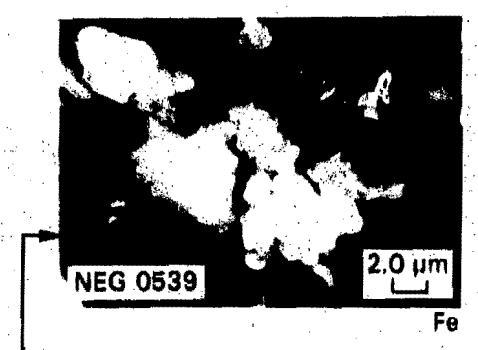
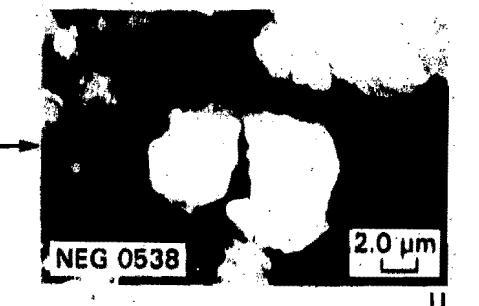
Figure 6. SEM examination of specimen M-72.

The particle density was lower for specimen M-72 than for specimen M-71. SEM micrographs of typical areas on specimen M-72 are shown in Figures 6 and 7, and the corresponding major elements for selected particles in these regions are provided in Table 4. Figure 6 suggests that the aluminum/silicon, iron, zirconium, and zirconium/silver particles were all agglomerates of smaller particulate. The uranium particles appeared to be faceted crystals (see Micrograph No. 0541 in Figure 6). The uranium/zirconium particles may be uranium particles coated with zirconium agglomerate (see Micrograph No. 0540 in Figure 6).

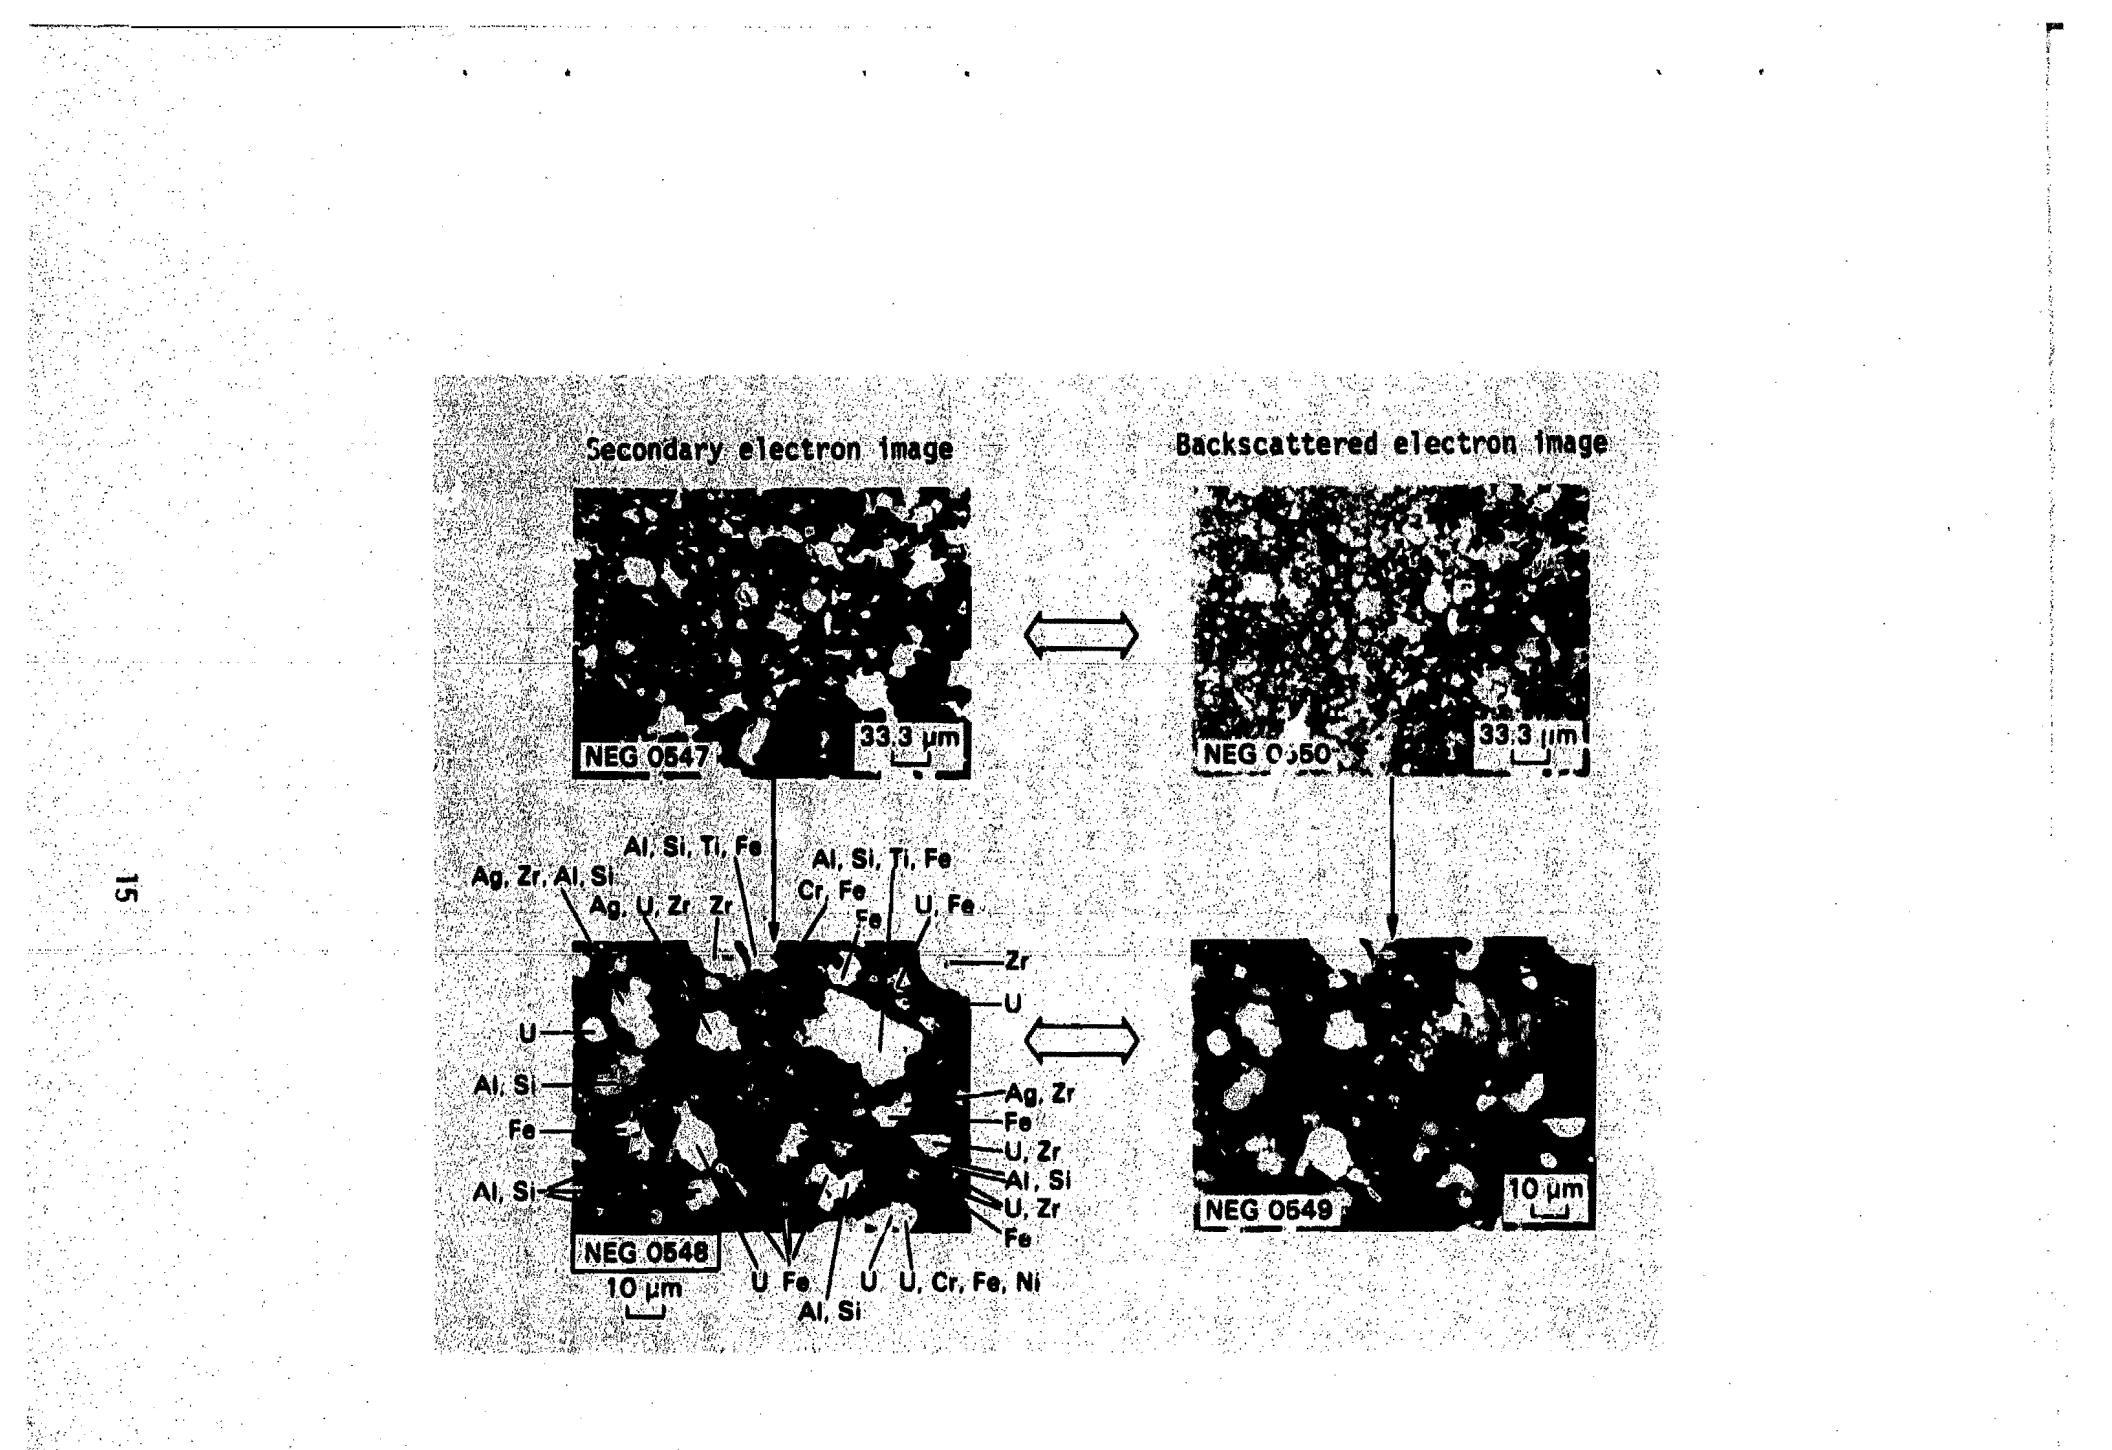
Figure 7. Backscattered and secondary electron SEM examination of specimen M-72.

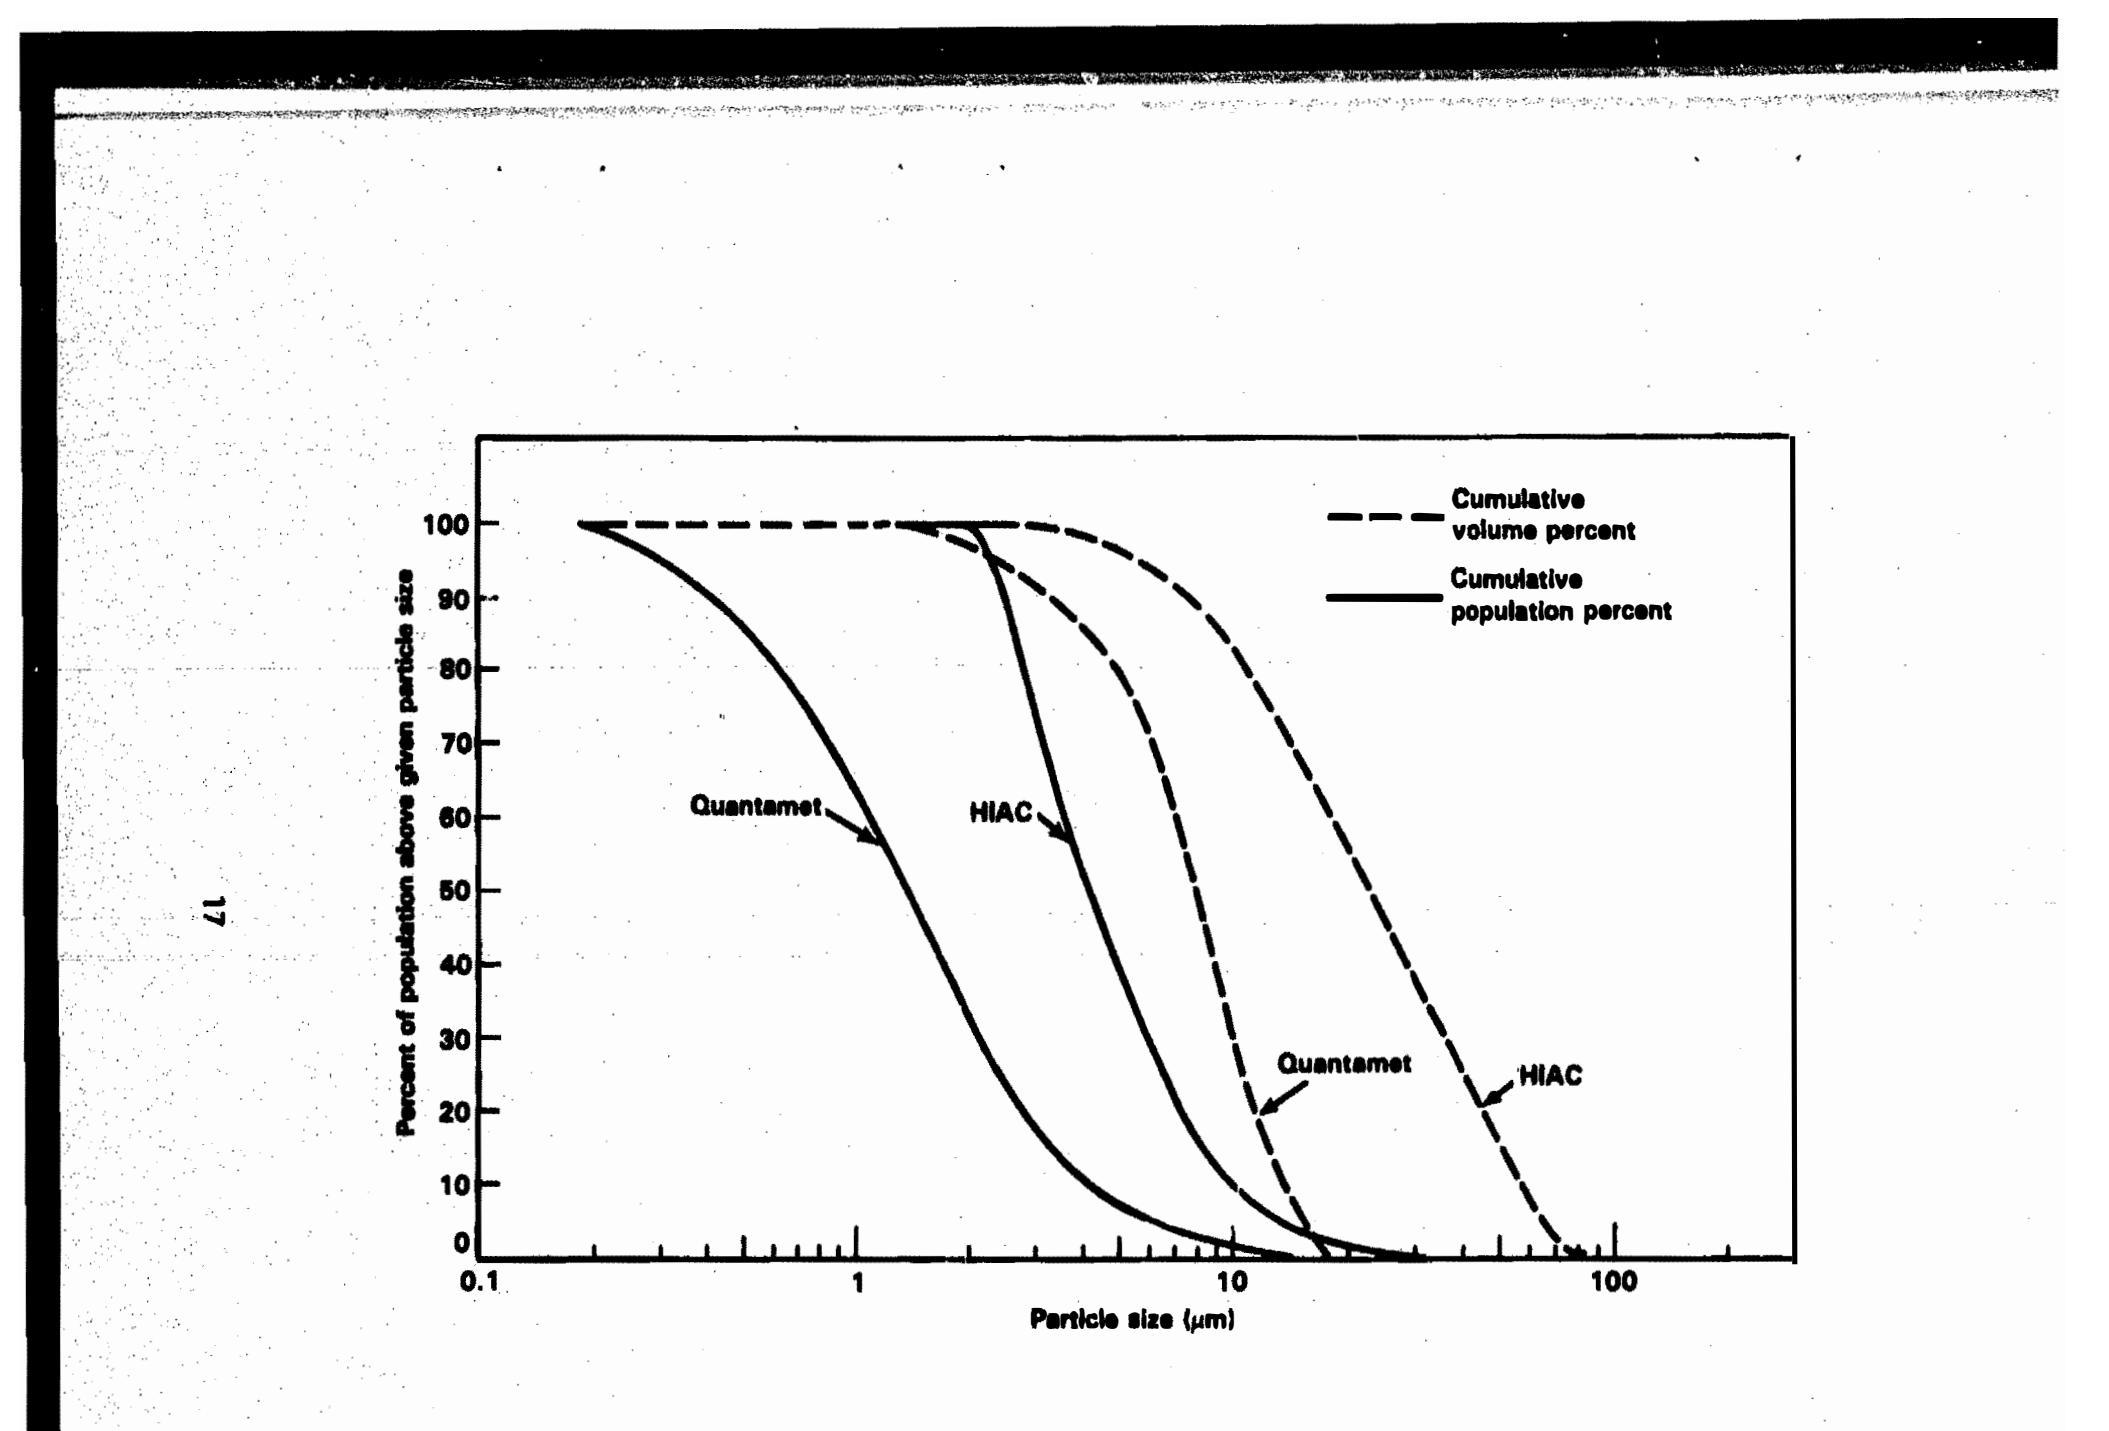
Figure 8 shows the cumulative population distributions based on particle size and equivalent spherical volume for both the HIAC and the Quantamet analyses. Based on particle diameters, 50% of the population is between 0.7 and 2.5  $\mu$ m for the Quantamet analysis and between 3 and 6.8  $\mu$ m for the HIAC analysis. However, the population distribution curve based on volume percent for the Quantamet analysis does not have a tail at the upper end. This suggests that the SEM examination missed most of the very large particles in the debris. The population distribution curves based on volume fraction indicate that 50% of the volume is made up of particles between 5.5 and 10  $\mu$ m according to the Quantamet analysis and between 8 and 25  $\mu$ m according to the HIAC analysis.

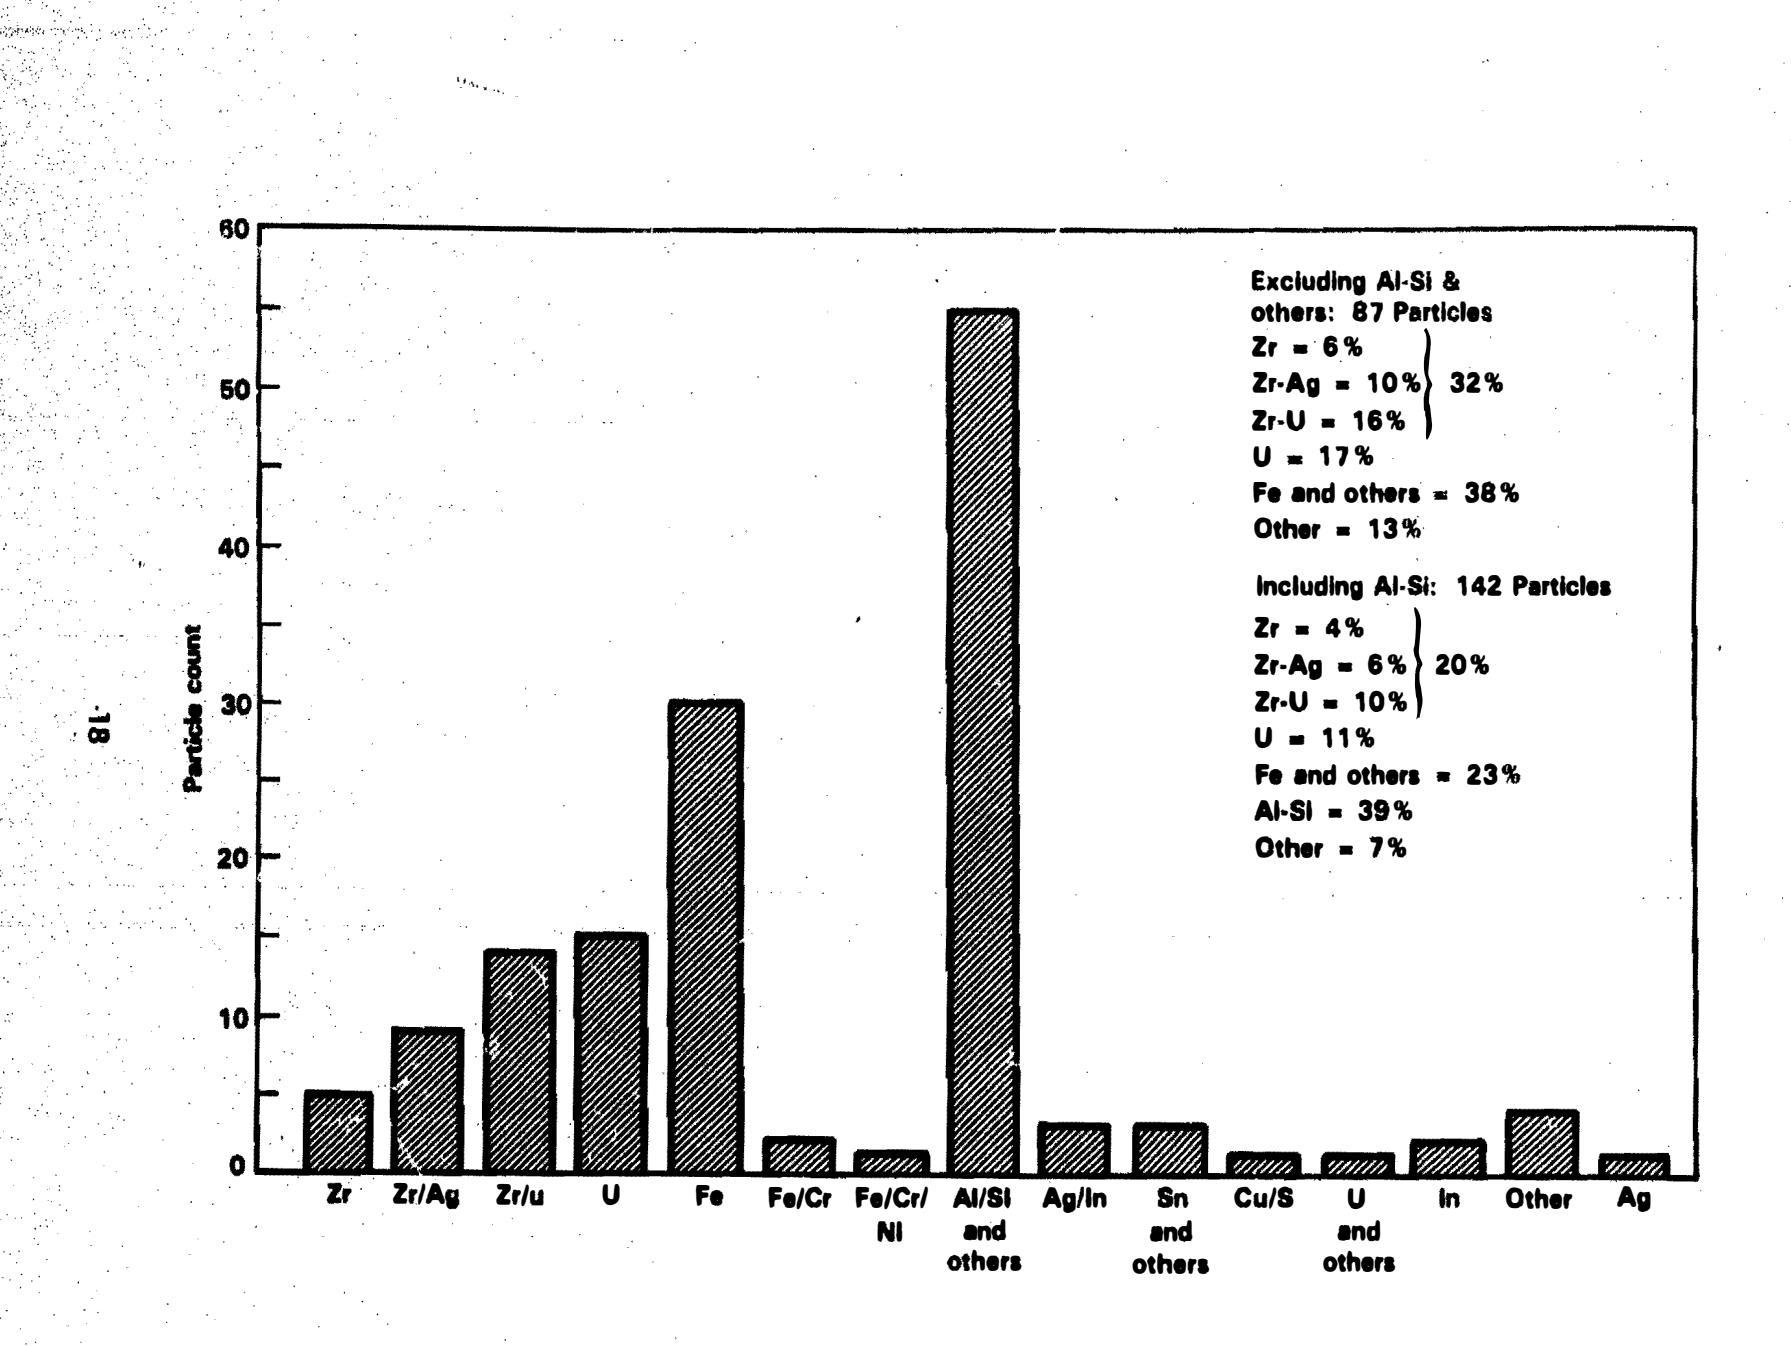
Figure 9. Particle counts by composition.

Figure 9 shows a histogram that summarizes the size distribution of 142 particles of different compositions. Particles centaining zircenium including zirconium/silver and zirconium/uranium, accounted for 20% of the total number. If aluminum/silicon particles are excluded (see Discussions and Conclusions), then the zirconium-containing particles represent 32% of the total number. Table 5 summarizes the mean diameter and volume fractions of the particles tabulated for the histogram (Figure 9).

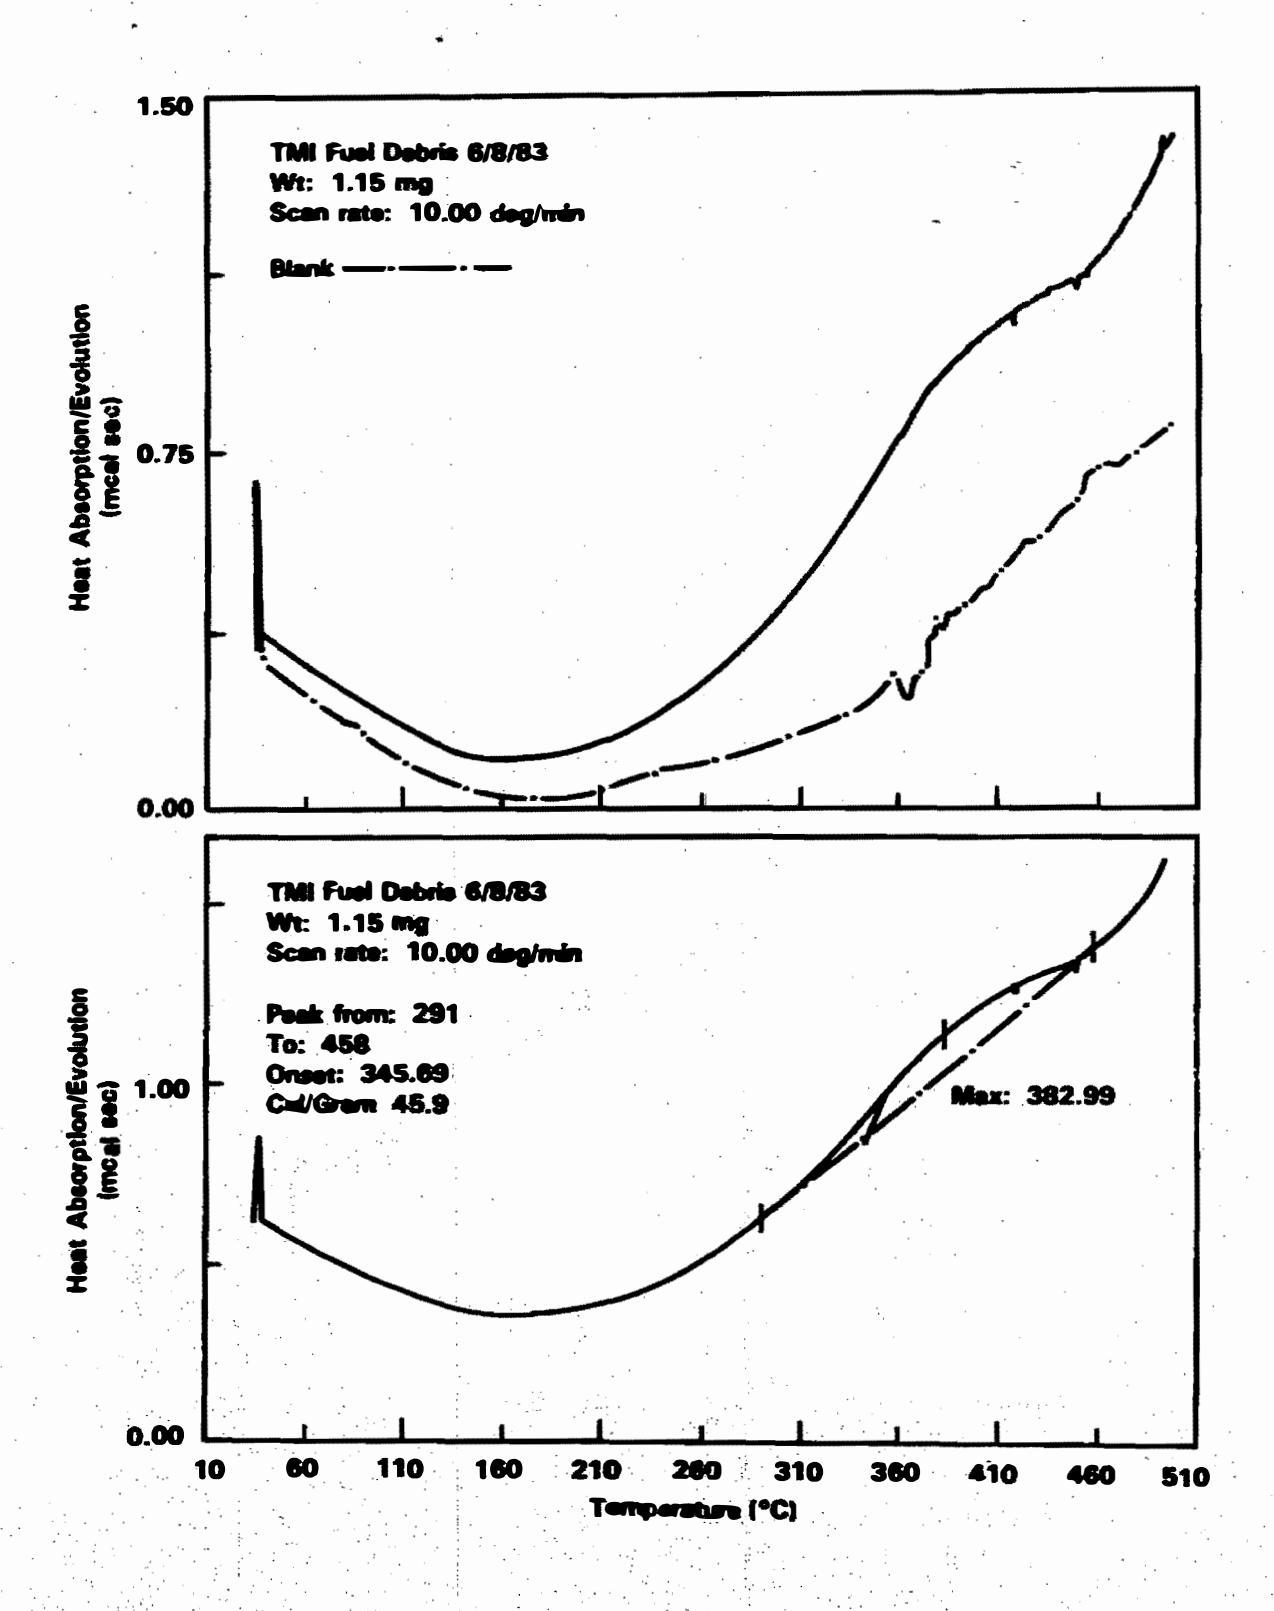
Figure 10. DSC analysis of leadscrew debris.

DSC was used to determine if the debris removed from the leadscrew would undergo an exothermic reaction upon heating in air. The measurements were made using a Perkin Elmer DSC. A 1.15 mg sample of the debris in an aluminum pan covered with a crimped aluminum lid was analyzed. Heating the specimen from room temperature to 500°C produced only a small, spread out, endothermic peak in the region from 310°C to 450°C (see Figure 10). This peak was probably due to a slight phase change rather than a chemical reaction, since the specimen only absorbed 46 cal/g over the 140°C interval. The absence of any detectable exotherm strongly suggests that a pyrophoric reaction due to exposure of the debris to air is unlikely.

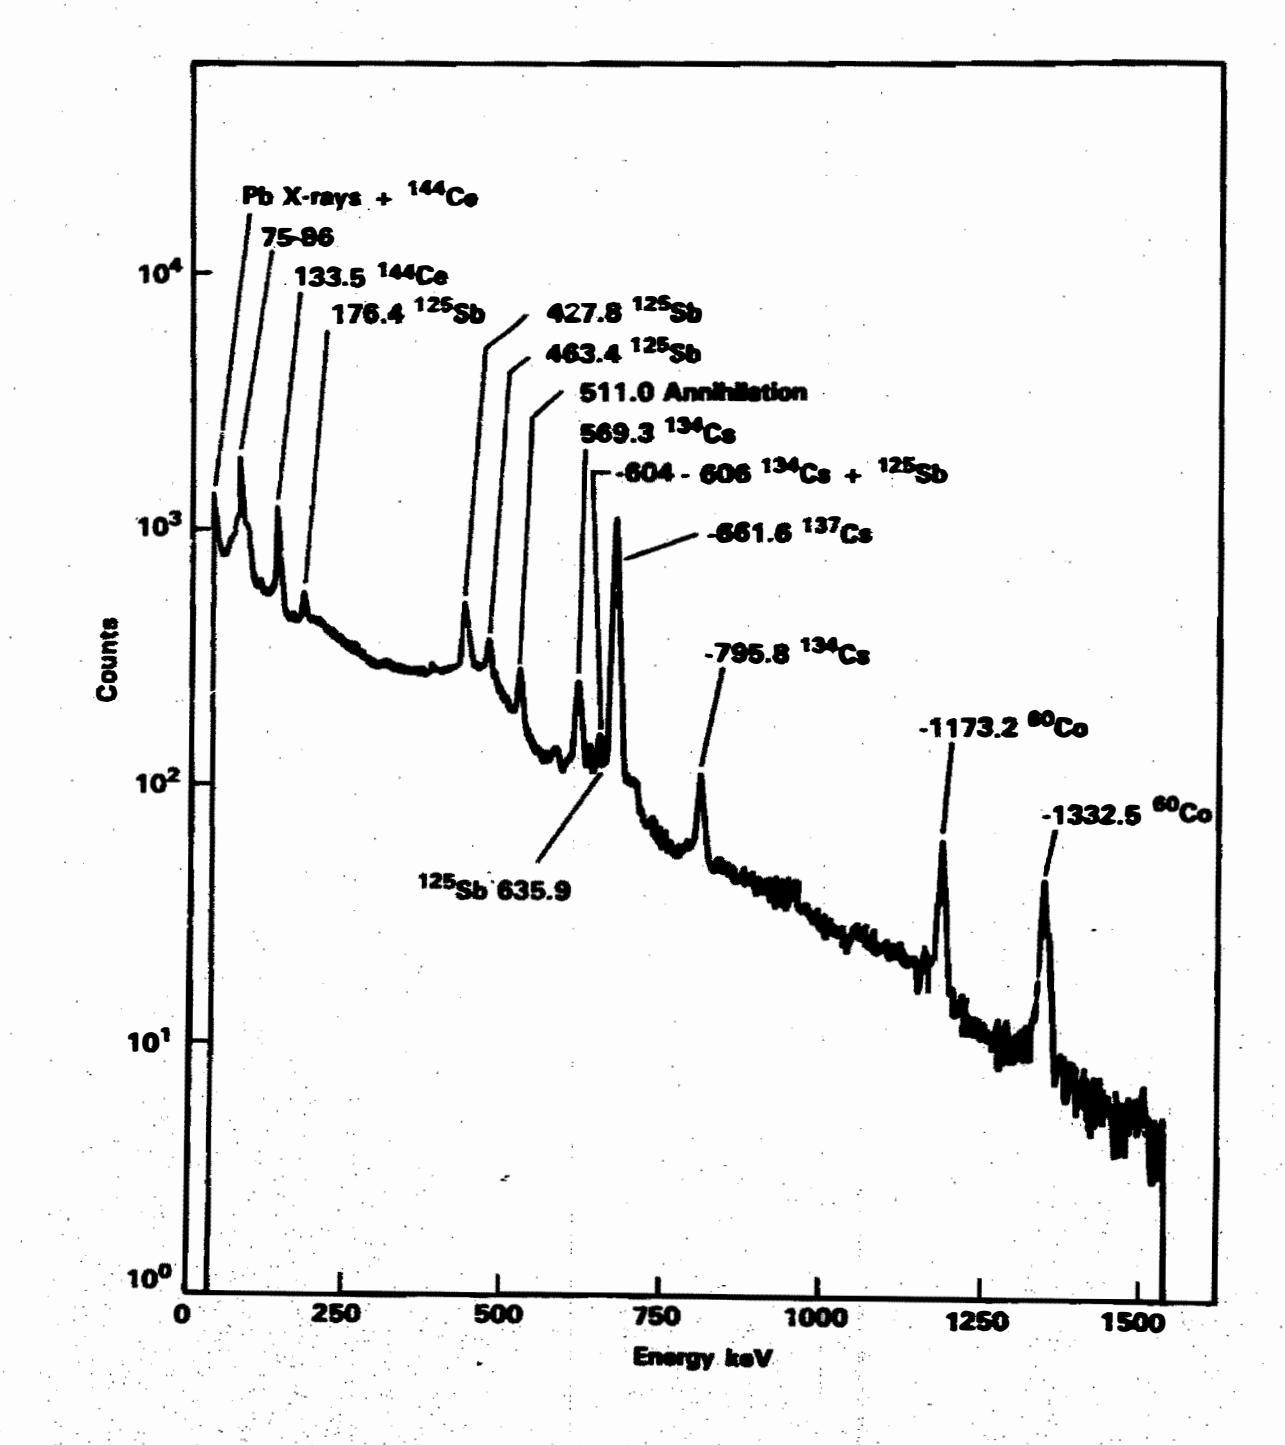
Gamma spectral data for a 0.235 g debris sample on filter caper contained inside two plastic vials was obtained using a germaniumlithium drifted coaxial detector. The <sup>22</sup>Na and <sup>60</sup>Co standards were measured in the same counting geometry as the debris sample. The results are summarized in Figure 11 and Table 7. Most of the gamma activity was due to  $13^7$ Cs,  $13^4$ Cs, 125Sb, 144Ce, and 60Co. The 137Cs

contributed 58%, <sup>134</sup>Cs contributed 13%, <sup>60</sup>Co contributed 12%, and <sup>125</sup>Sb and <sup>144</sup>Ce each contributed approximately 8% of the total gamma activity. The specific activity of the debris for <sup>137</sup>Cs was calculated to be approximately 1275  $\mu$ Ci/g. The specific activity for <sup>134</sup>Cs was 165  $\mu$ Ci/g, and for <sup>60</sup>Co was 75  $\mu$ Ci/g. TLD measurements of the 0.235 g debris sample gave a dose rate of 4 mr/hr through 125 mils of aluminum at 8 in.

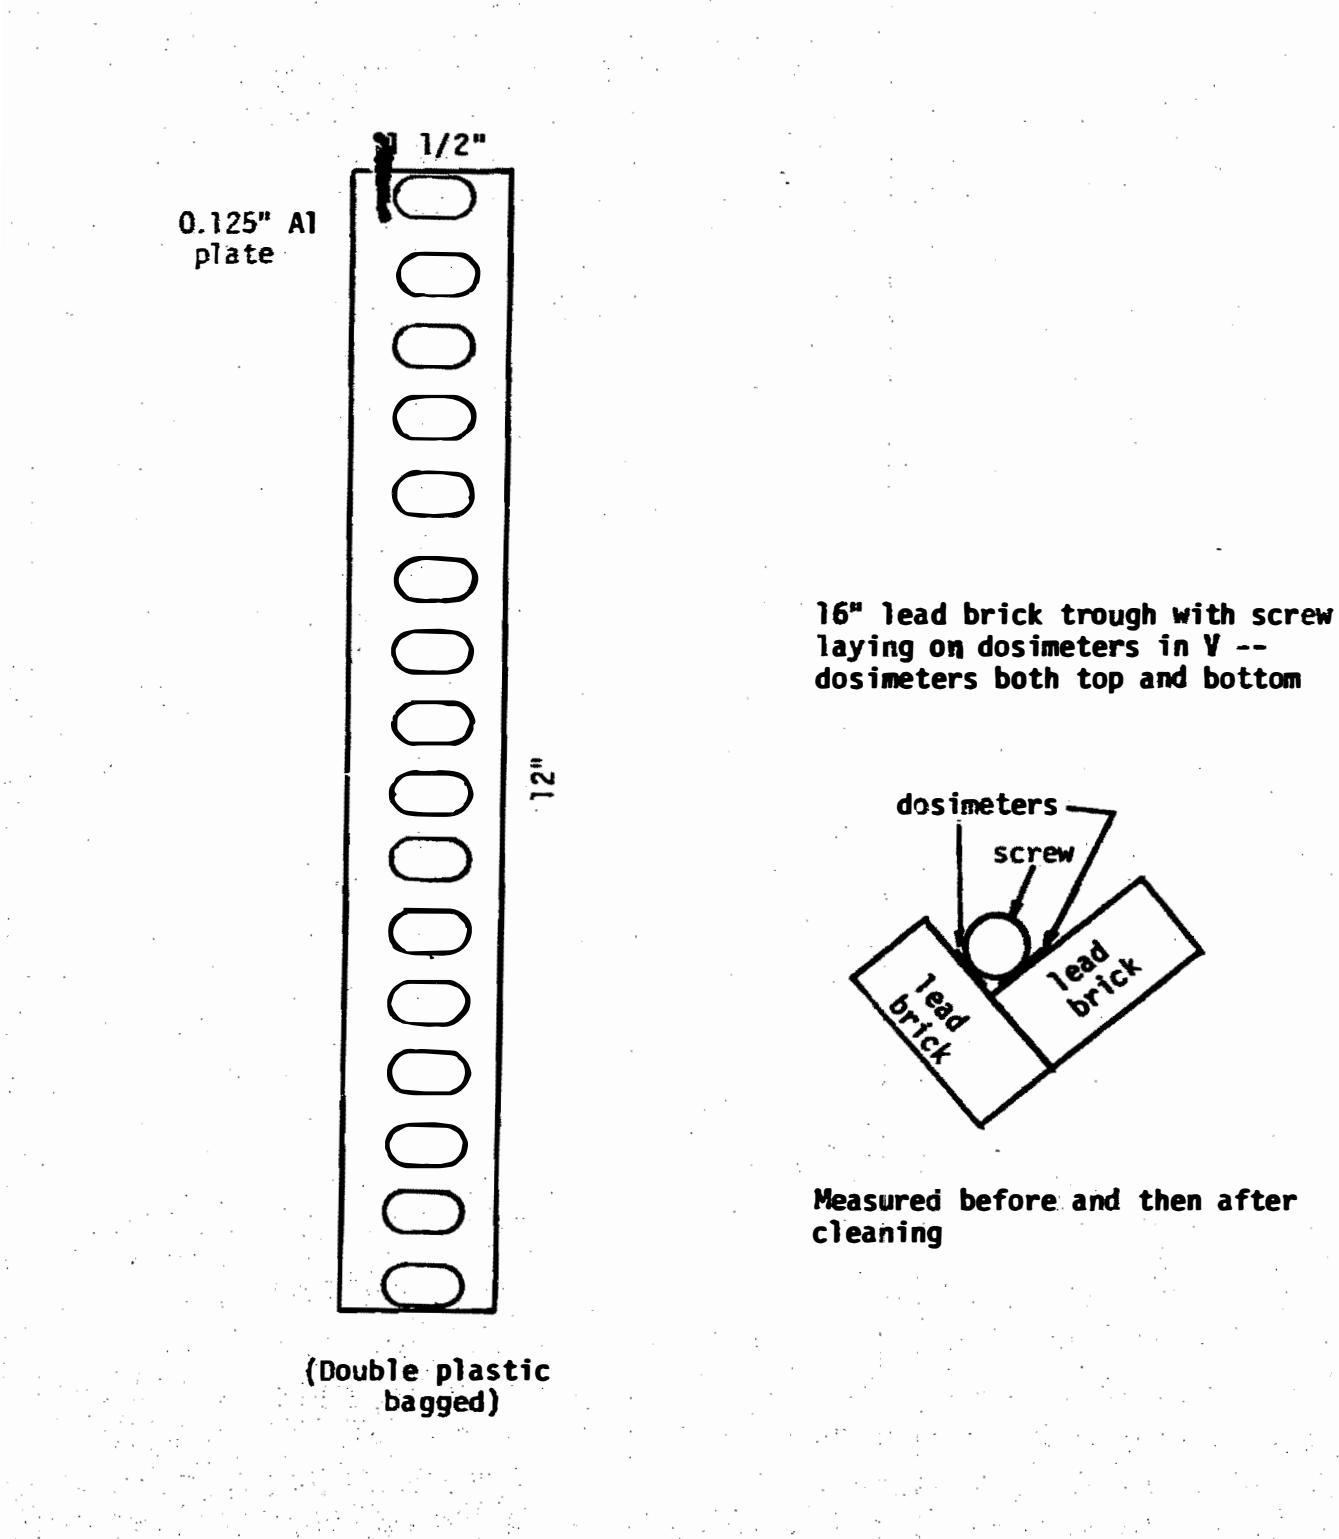
Figure 12. Position of TLDs on leadscrew before and after cleaning.

Using TLDs, gamma and beta dose rate measurements at the leadscrew surface were obtained before and after cleaning. Figure 12 shows the TLD configurations that were used, with the results tabulated in Table 8. Various filters were used for the TLDs, ranging from thin Mylar to 125-mil aluminum, to allow separation of beta and gamma radiation. The Mylar is transparent to most of the beta energies, while the 125-mil aluminum foil absorbs all of the beta radiation and photons with energies of up to 50 keV. Table 8 shows that the radioactivity was nonuniformly distributed on the leadscrew both before and after cleaning. While the apparent decontamination factor due to cleaning was 40 for beta radiation

and 3 for gamma radiation, the relative spatial distribution of radioactivity on the leadscrew was unchanged. Gamma spectra of the leadscrew suggested that most of the radioactivity was due to 137Cs followed by 134Cs, and that the 60Co intensity was small.
