GEND-INF-023 Volume II

ESTIMATED TEMPERATURES OF ORGANIC MATURIALS IN THE THI-2 REACTOR BUILDING DURING HYDROGEN BURN

H. W. Schutz P. K. Nagata

December 1982

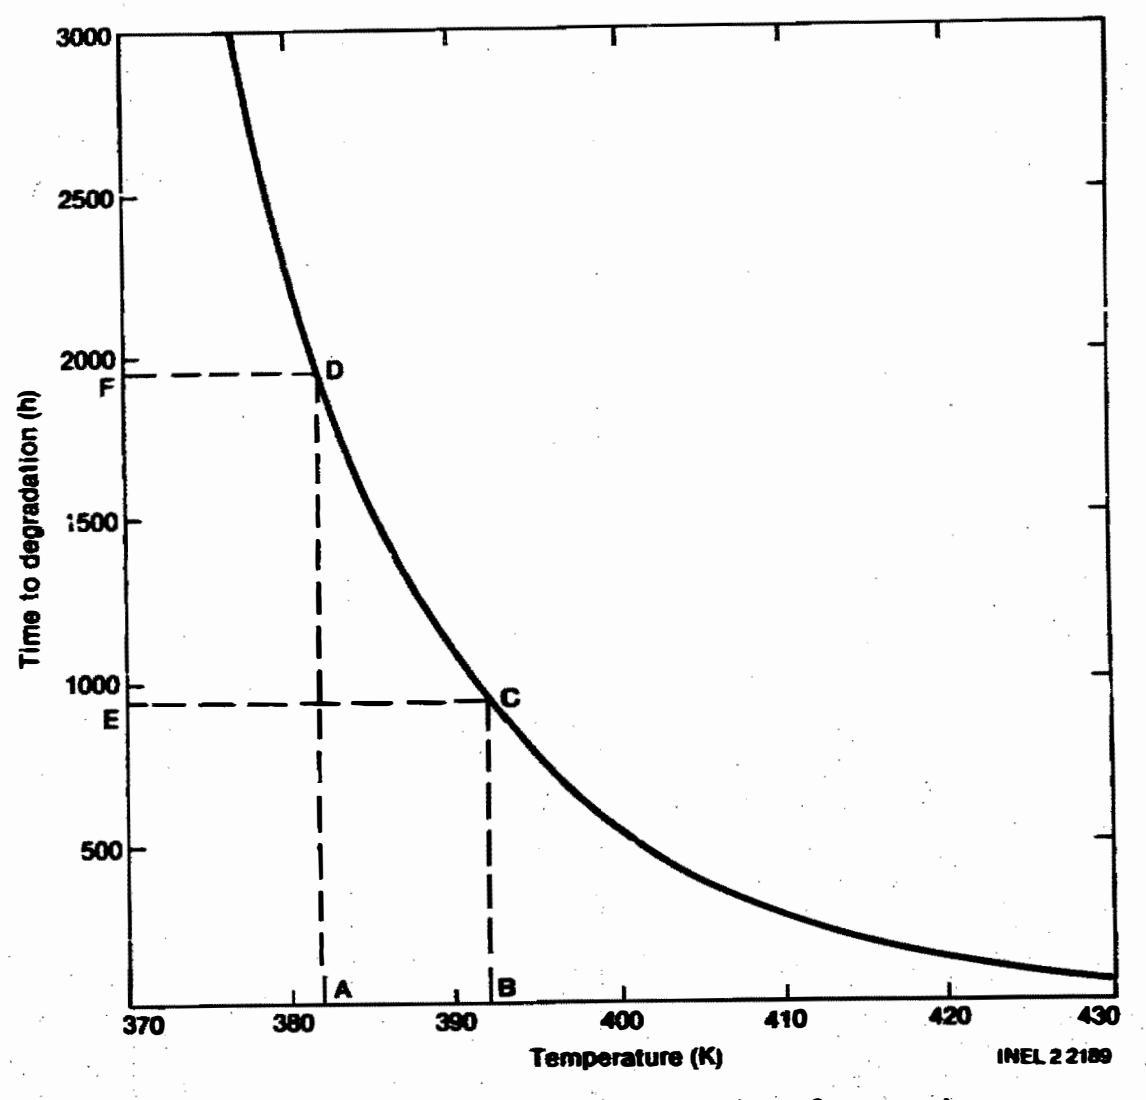
The equation is plotted in Figure 4 for temperatures between 380 and 430 K (224 and $314^{\circ}F$).^a

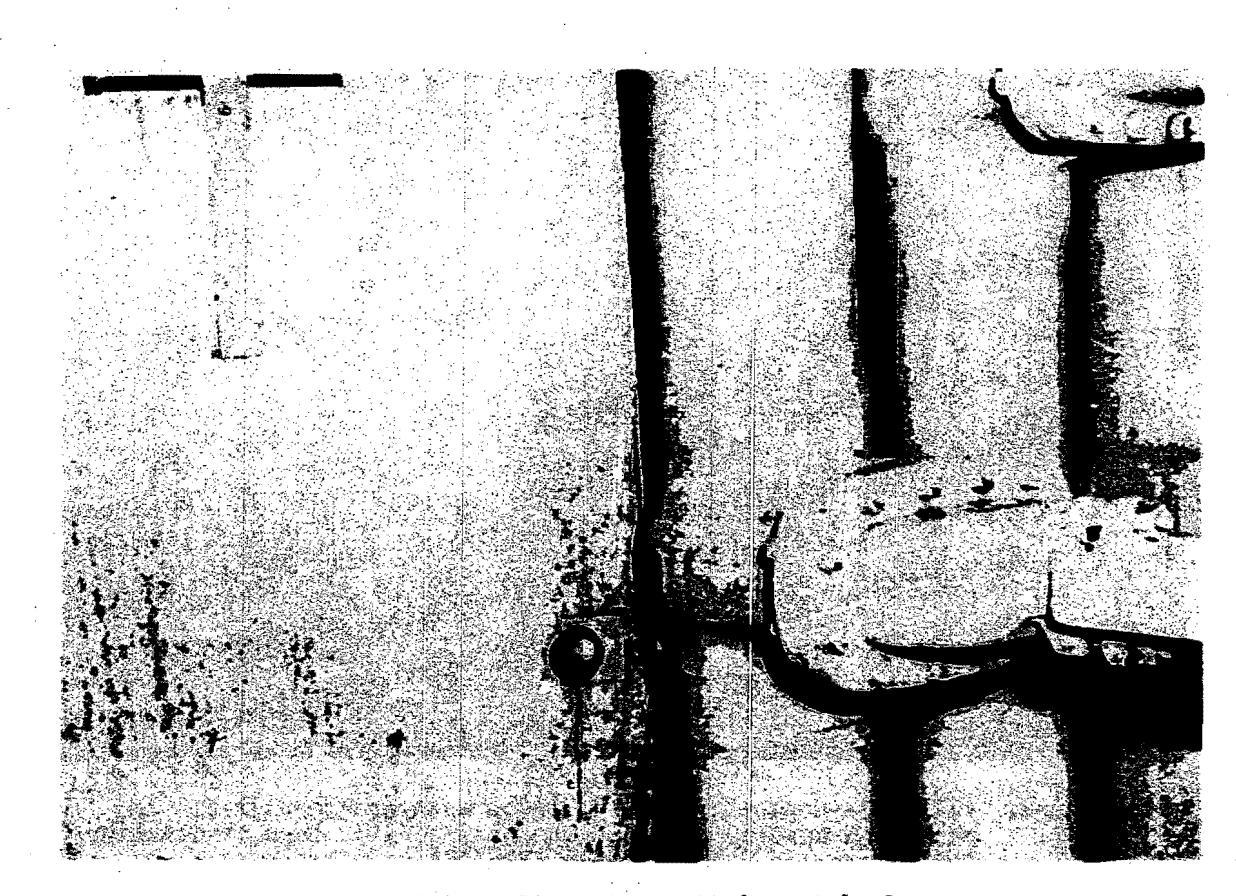
Figure A-1. Entry I, film roll 1, frame 23 (I-1-23)--Door was blown open, but material believed to be styrofoam was not singed or burned. Estimated temperature 200°F (366 K).

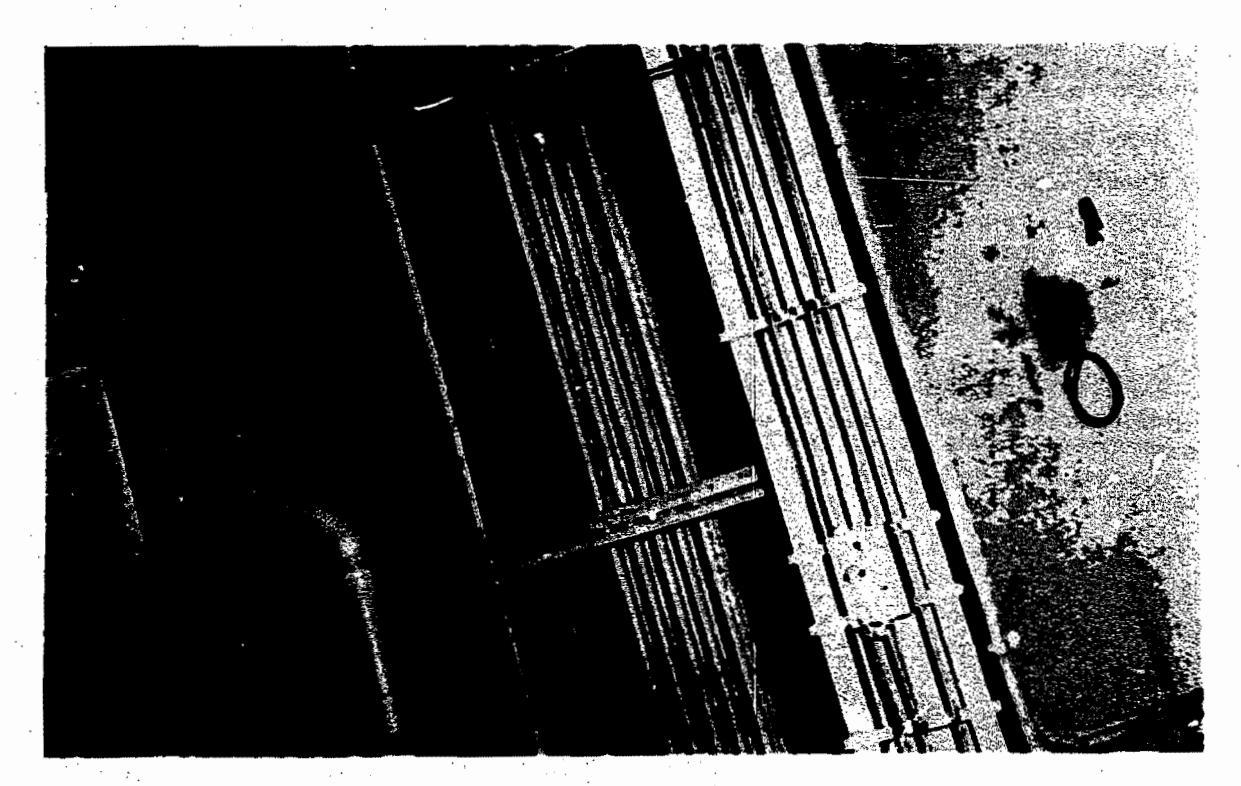
Figure A-3. (1-2-20)--Conduit; red wall phone with coils relaxed. The phone and headset are ABS, the dial acrylic cord, insulation PVC. Temperature would have been 165 to 200°F (347 to 366 K).

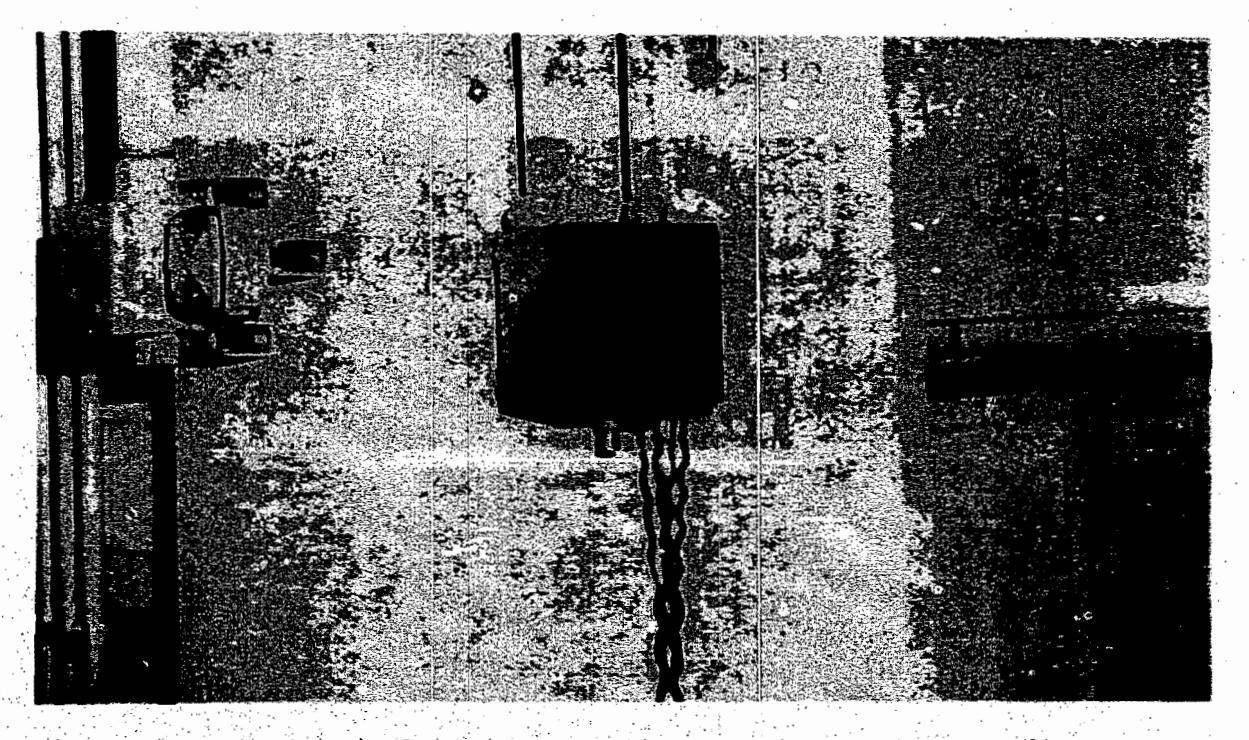
Figure A-4. (I-2-36)--The red phone, whose base and headset are ABS with an acrylic dial, is in good condition. The PVC cord coils are relaxed, indicating a temperature from 165 to 200°F (347 to 366 K).

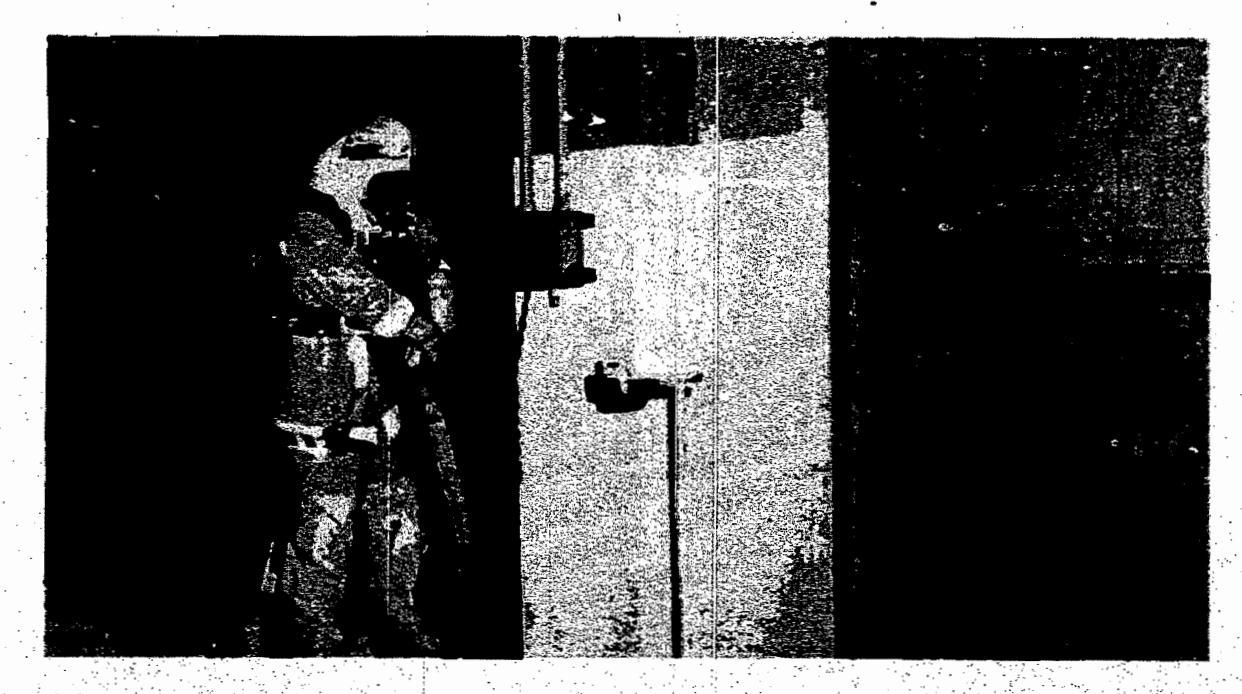
Figure A-6. (II-1-0)--A better view of the red telephone with relaxed cord noted in Figure A-4. Temperature was between 165 and 200°F (347 to 366 K).

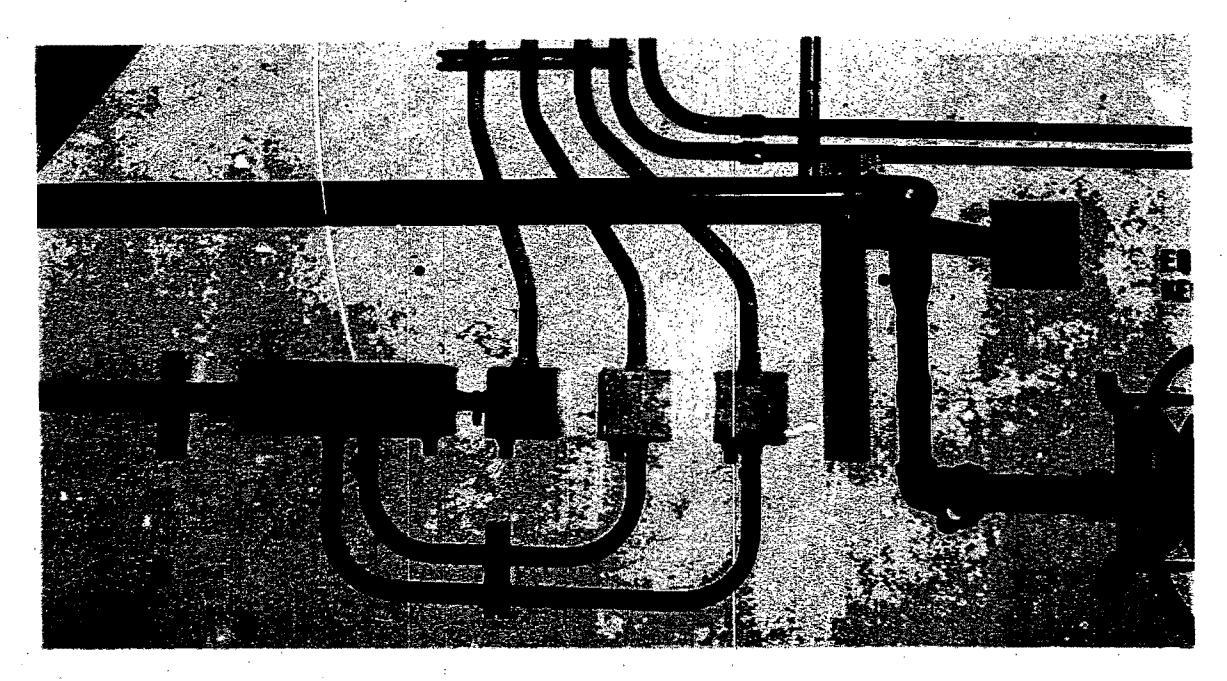
Figure A-9. (II-1-6)--Although the red paint on the fire water pipe conduit is in good condition as is the gray paint on the other pipes in the background, the paper tags are browned. The temperature here would be from 360 to 400°F (455 to 478 K).

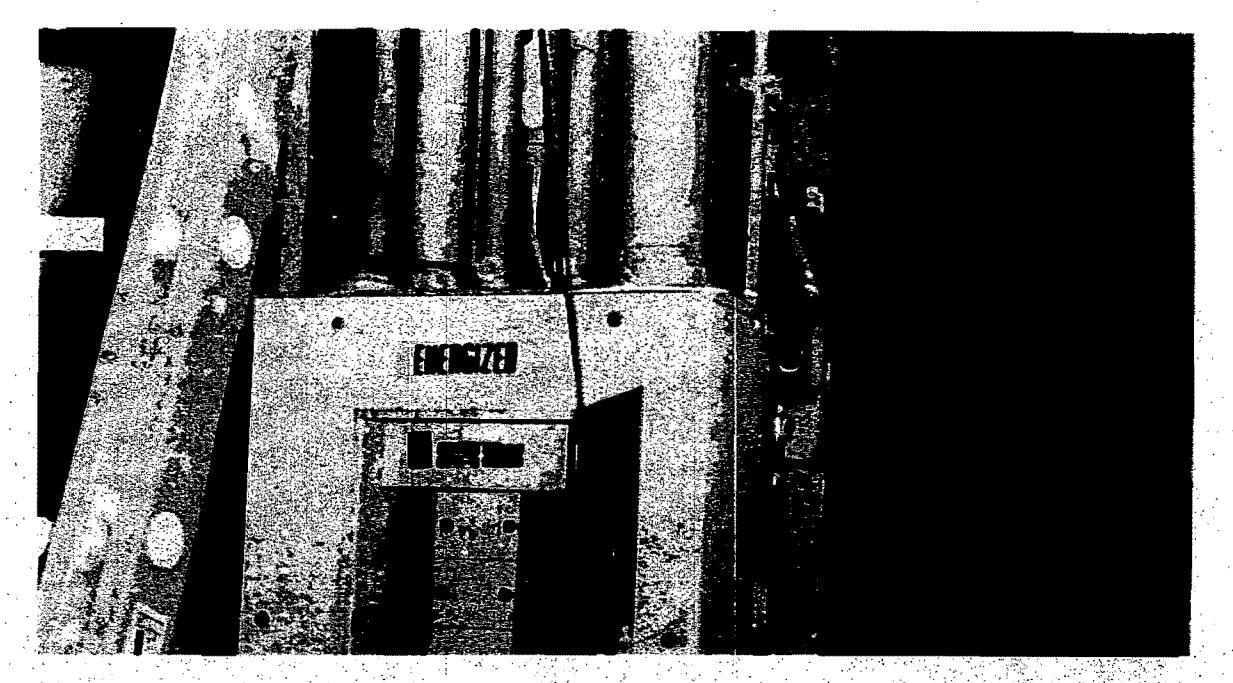
Figure A-10. (II-1-7)--The temperature in this area was <260°F (400 K). The red paint on the aluminum ladder, the polypropylene rope, and the red reset button eight feet off the floor show no ill effects from the heat.

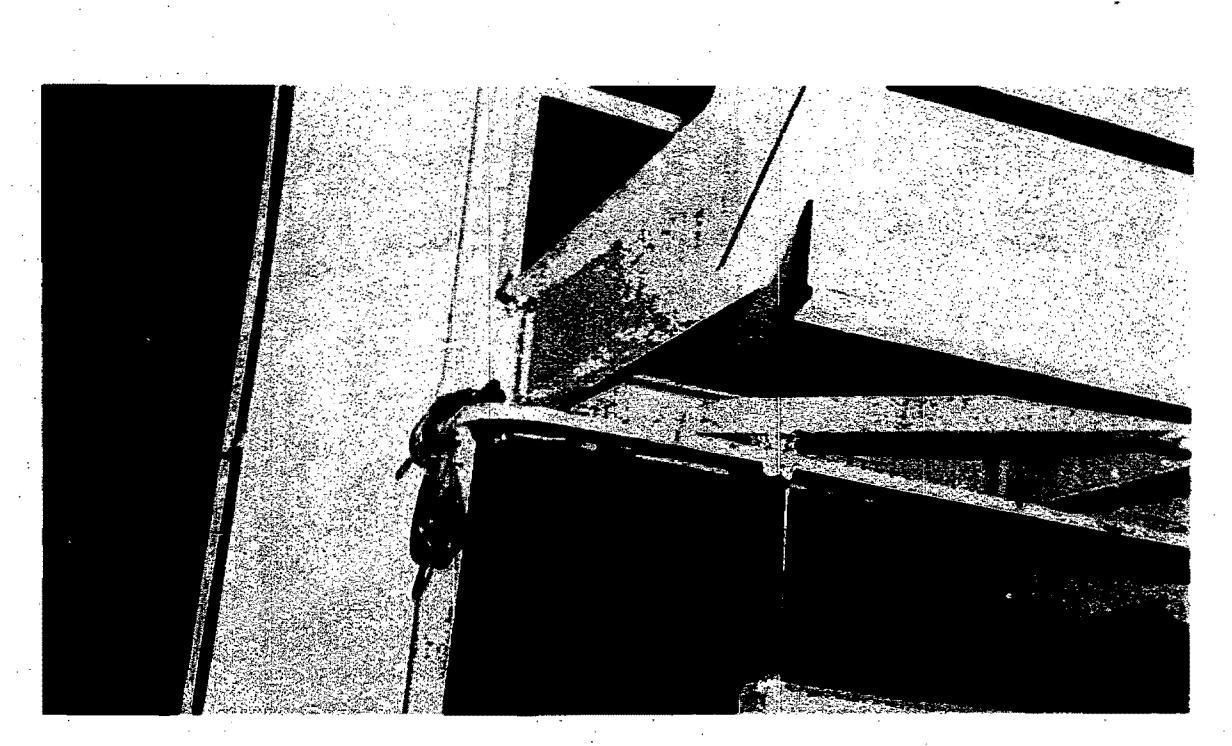
Figure A-11. (II-1-9)--The clear polymer tubing (thought to be Tygon R-3603) is unsoftened or only barely softened. This would mean the temperature was 200°F (366 K).

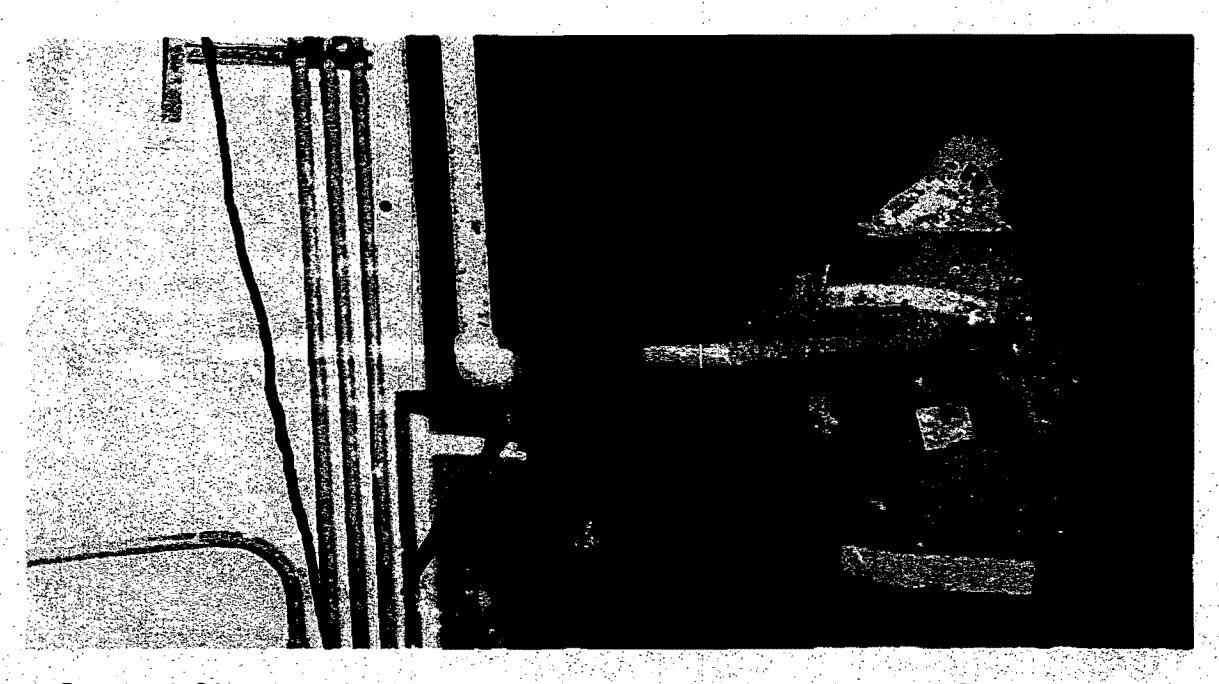
A wiping rag left on a nitrogen line became scorched (Figure A-14, Appendix A). The following conclusions were reached from discussions with experts at Cotton, Inc., New York, NY, and Raleigh, NC, and at the Textile Research Institute, Princeton, NJ. If the rag was cotton, the temperature

was 482 to 572°F (523 to 573 K); if rayon, 410 to 554°F (483 to 563 K). See Reference 17. If flame retardants were incorporated into the rag, a higher scorching temperature would be indicated.¹⁸ However, no evidence exists to suggest retardants were incorporated into the rag.

Figure A-14. (II-1-27)--Although the paint on the steel surfaces remains undamaged, proof of temperatures from 375 to 500°F (464 to 533 K) exists. There are rough edges on the electrical cord in the foreground. The rag (probably cotton) wrapped around the pipe ignited.

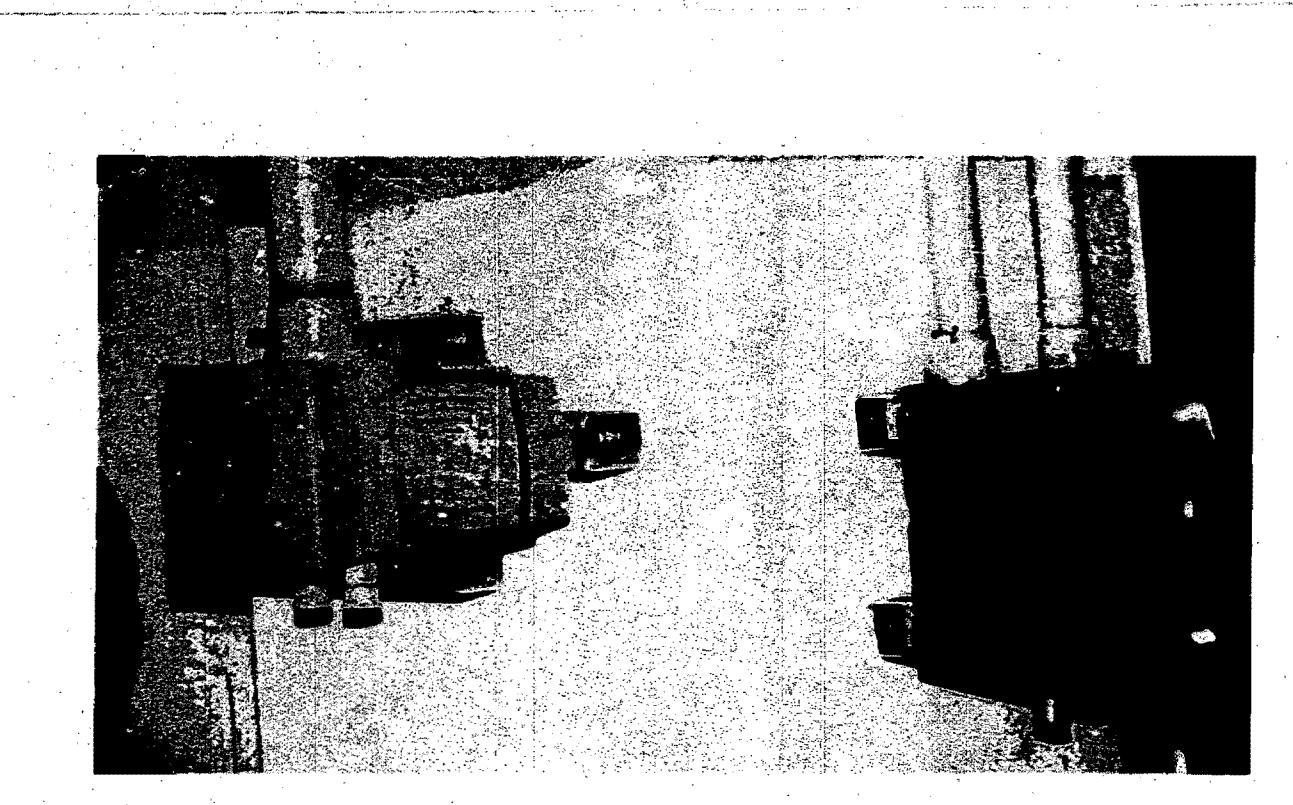
Figure A-15. (II-2-1)--The condition of the telephone forms the basis for estimating the temperature from 165 to 200°F (347 to 366 K). Again, the (ABS) telephone and surrounding paint are in good condition, while the PVC cord is relaxed.

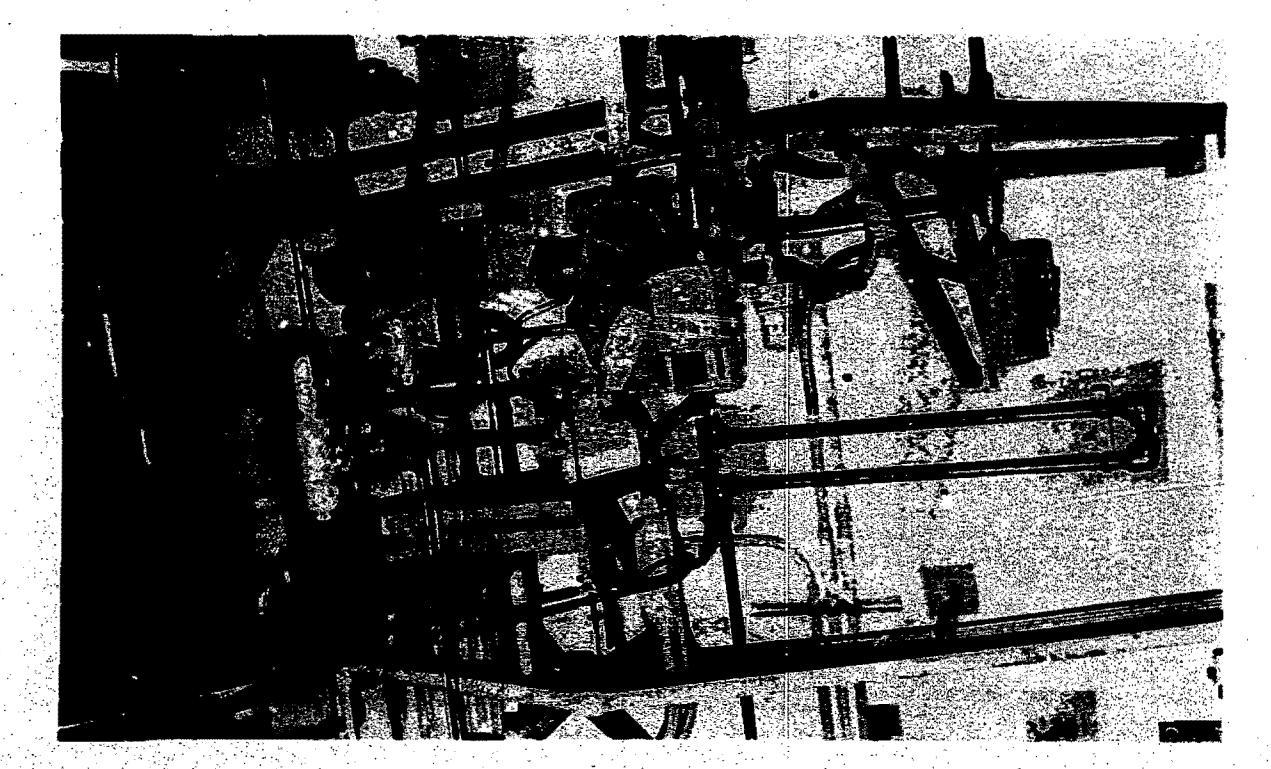
Figure A-16. (II-2-4)--This picture of some motorized valves shows damage from rust rather than heat. Even the paper tags were unbrowned. The temperature, then, was <360°F (455 K).

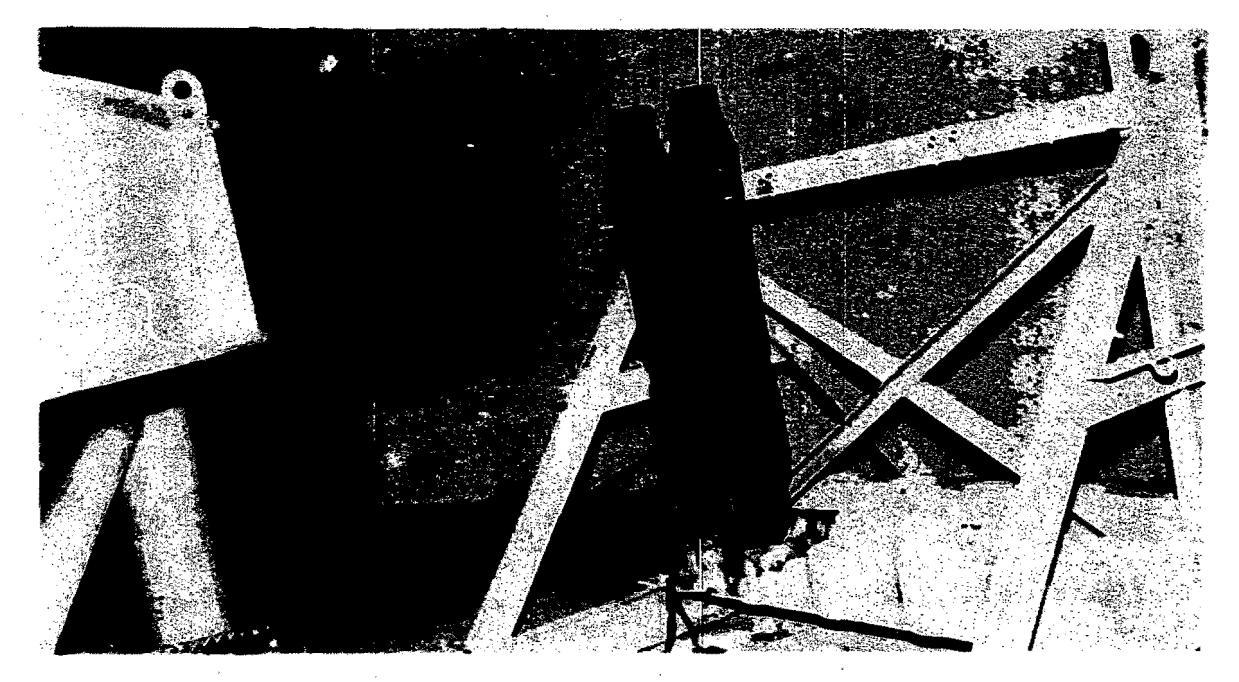
Figure A-19. (II-2-32)--Inspection of the polypropylene rope at INEL, as well as the 36-in. high rust damage throughout the area, indicates a temperature from 260 to 320°F (400 to 433 K).

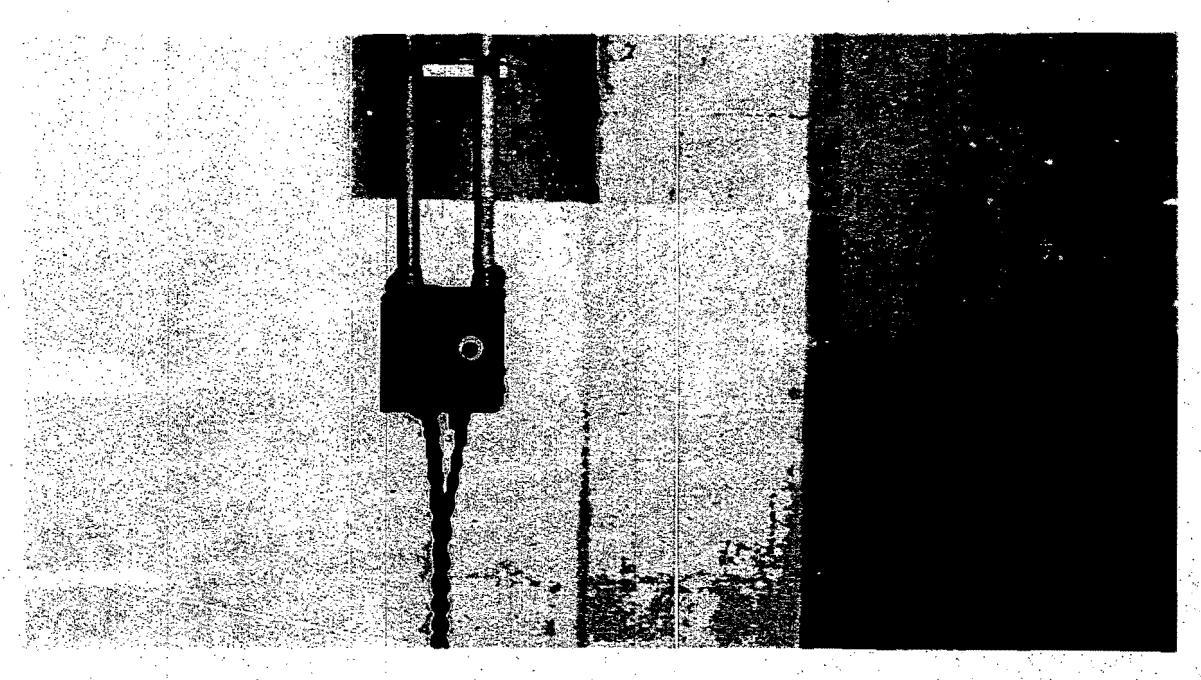
Figure A-20. (IV-1-1)--A telephone, this one next to the elevator, shows the temperature to have been 165 to 200°F (347 to 366 K). The headset is fine, the PVC cord relaxed and somewhat cracked.

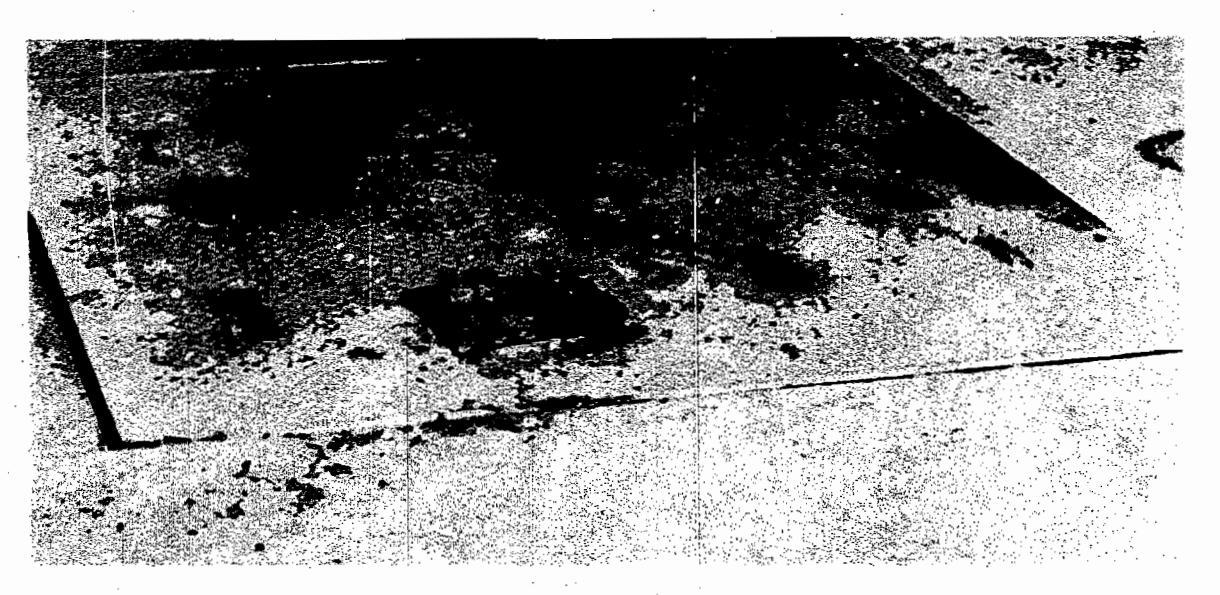
Figure A-21. (IV-1-12)--A yellow HRA notice, "RWP required for entry," is shown. The paper or clear plastic protector on this sign was singed in the upper left hand corner. The sign, one of the items taken to the INEL for inspection, must have fallen from somewhere above. Furnace tests proved the singeing occurred at 360°F (455 K).

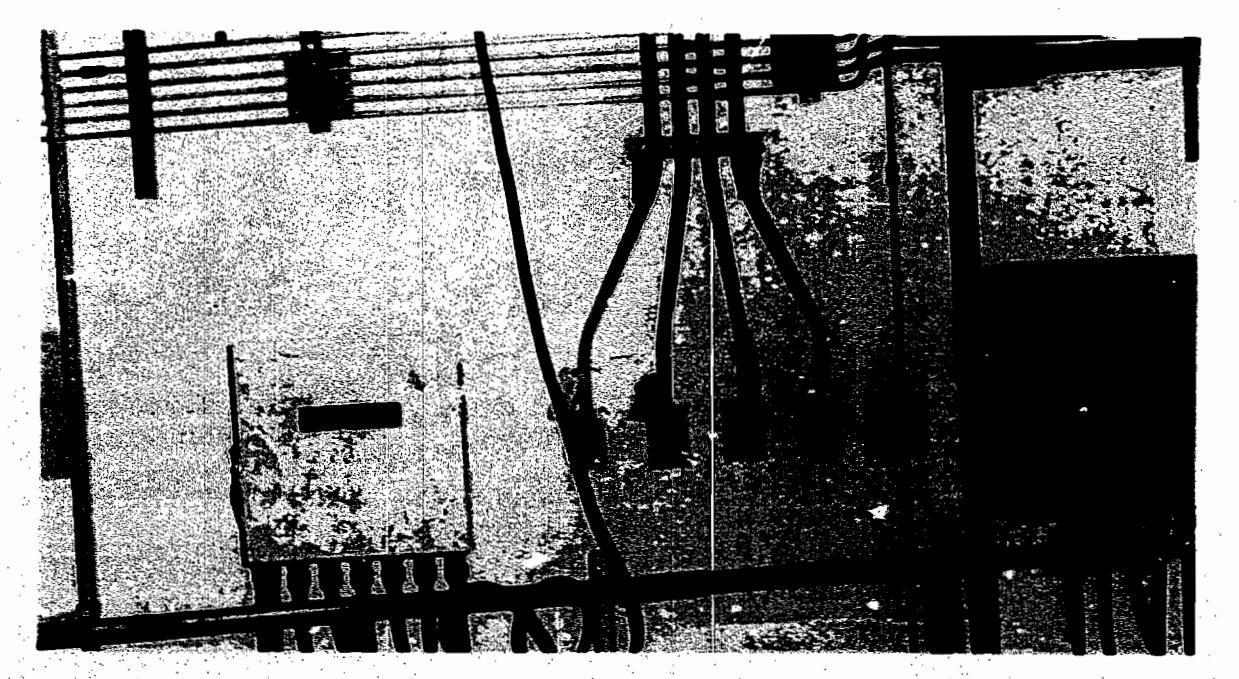
Figure A-22. (IV-1-13)--Evidence in this photograph of the 480 V junction box places the temperature from 250 to 356°F (394 to 453 K). The paper tags on the 120 V outlets were not brown, while the "480 V" tape tags were slightly browned.

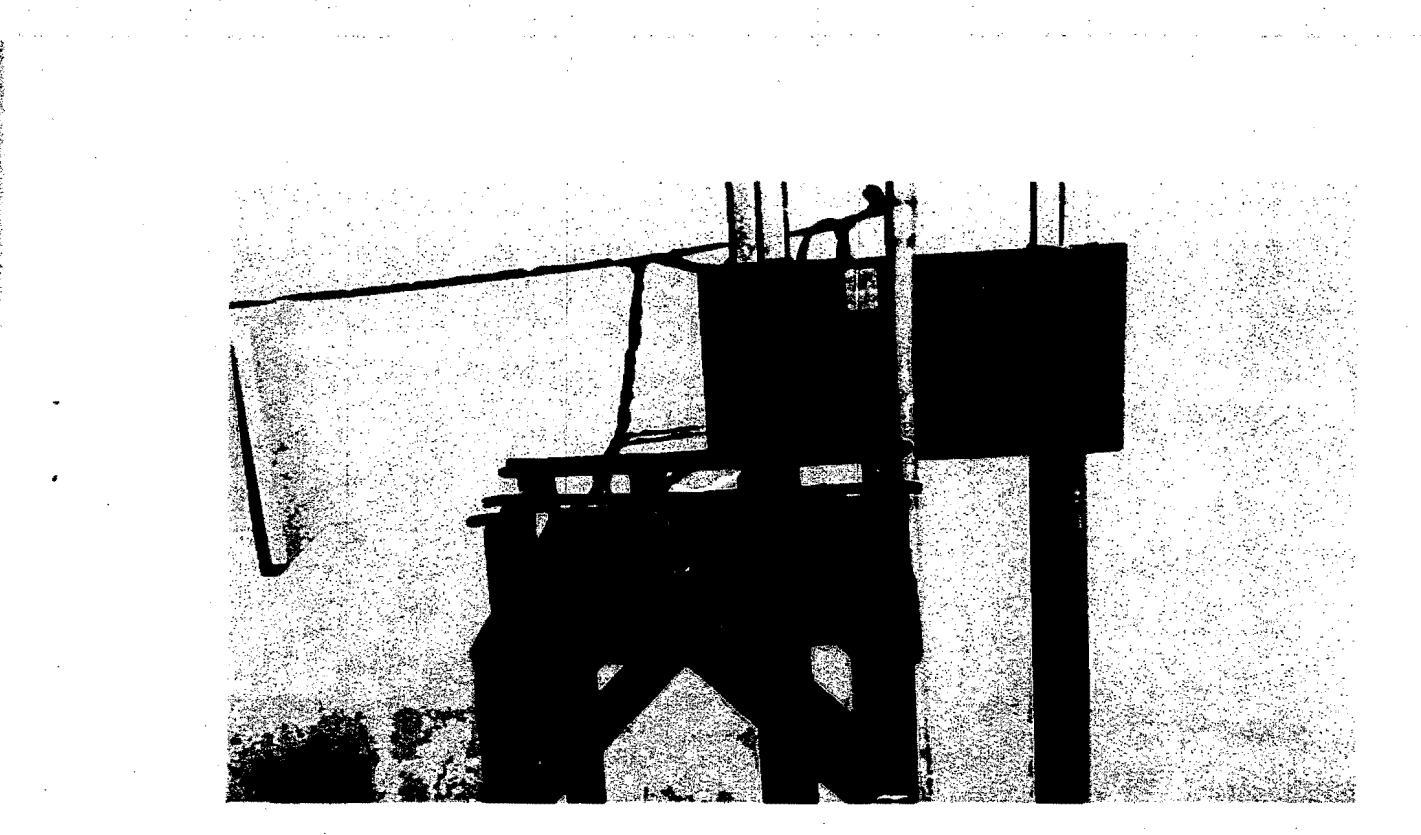
Figure A-23. (IV-1-18)--This A8S phone and headset were sent to the INEL for inspection. The black phone on the bench sustained enough damage to estimate the temperature from 200 to 220°F (366 to 378 K). The case, numeral ring, and dial were distorted, the cord coils relaxed.
