QUICK LOOK REPORT  
ENTRY 2  
THREE MILE ISLAND UNIT 2  
AUGUST 15, 1980

Bechtel Northern Corporation/  
General Public Utilities Nuclear Corporation

## ABSTRACT

This report summarizes tasks performed during Entry 2 at Three Mile Island Unit 2. During the entry into containment, which was made on August 15, 1980, the lights on Elevations 305 and 347 were turned on, general area surveys were obtained, 67 pictures were taken, 12 swipe samples and 2 scrape samples were obtained, several items were removed from containment, a protective covering experiment and a directional dose experiment was accomplished, and a decon test using smear and masslinn swipes was performed.

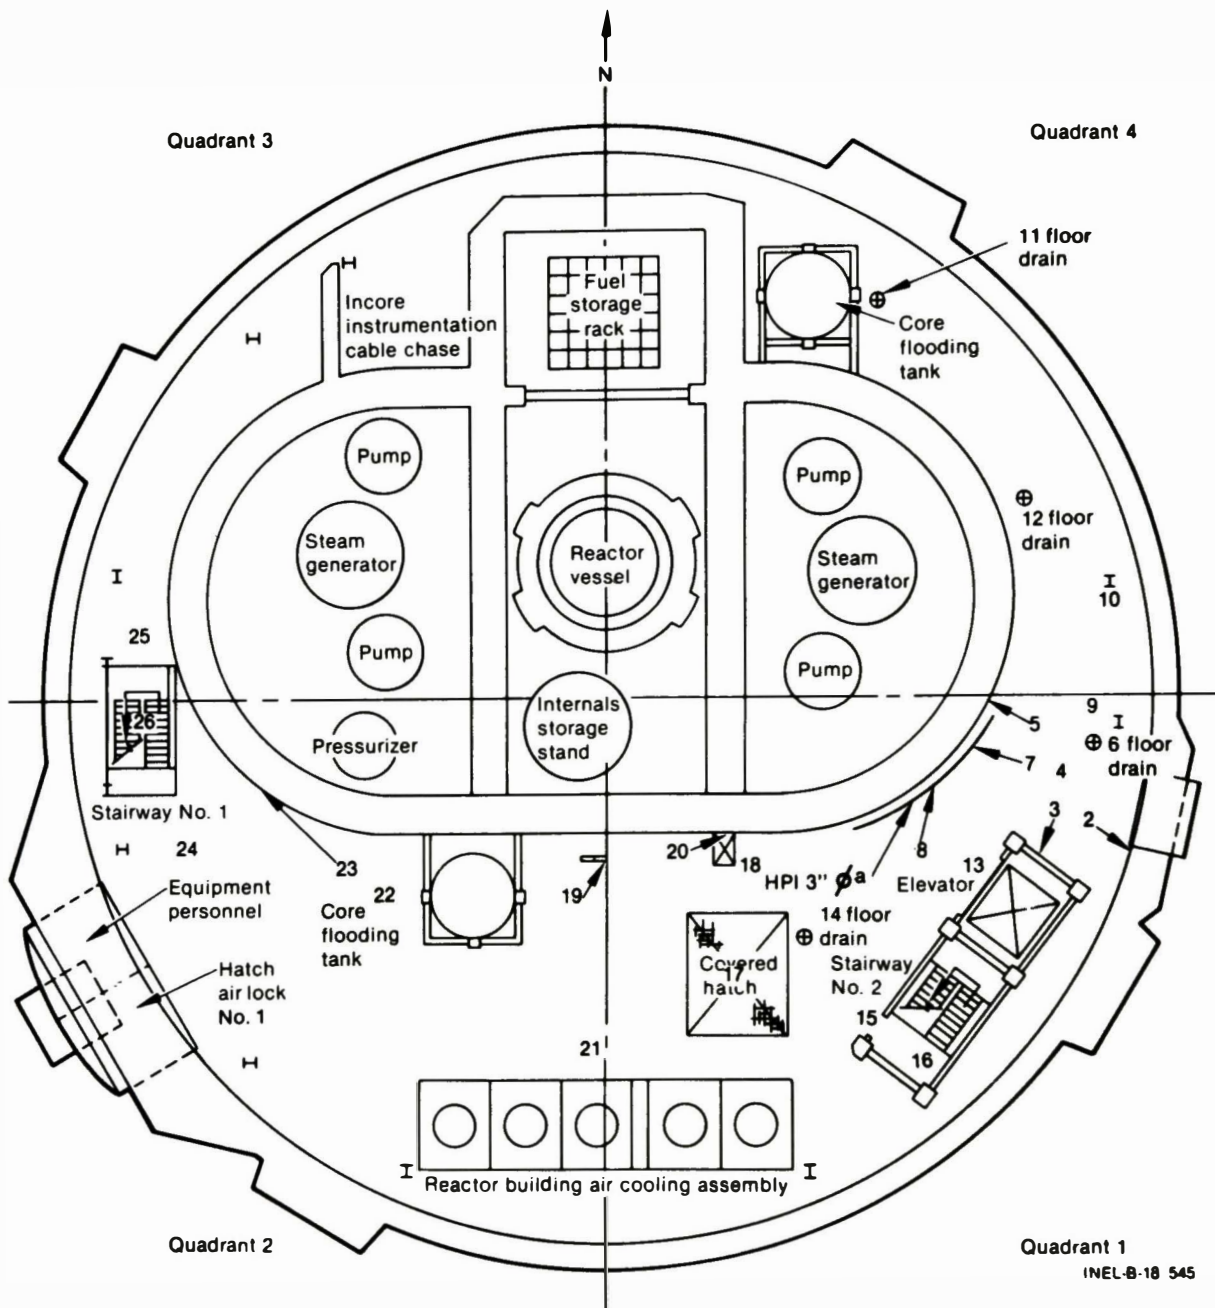
Figure 1. Elevation 350 reactor building radiation survey summary July 23, and August 15, 1980.

a. Location numbers correspond to numbers on Figures 1 and 2.

a. HPI 3"  $\odot$  indicates 3-inch diameter high-pressure Injection line.

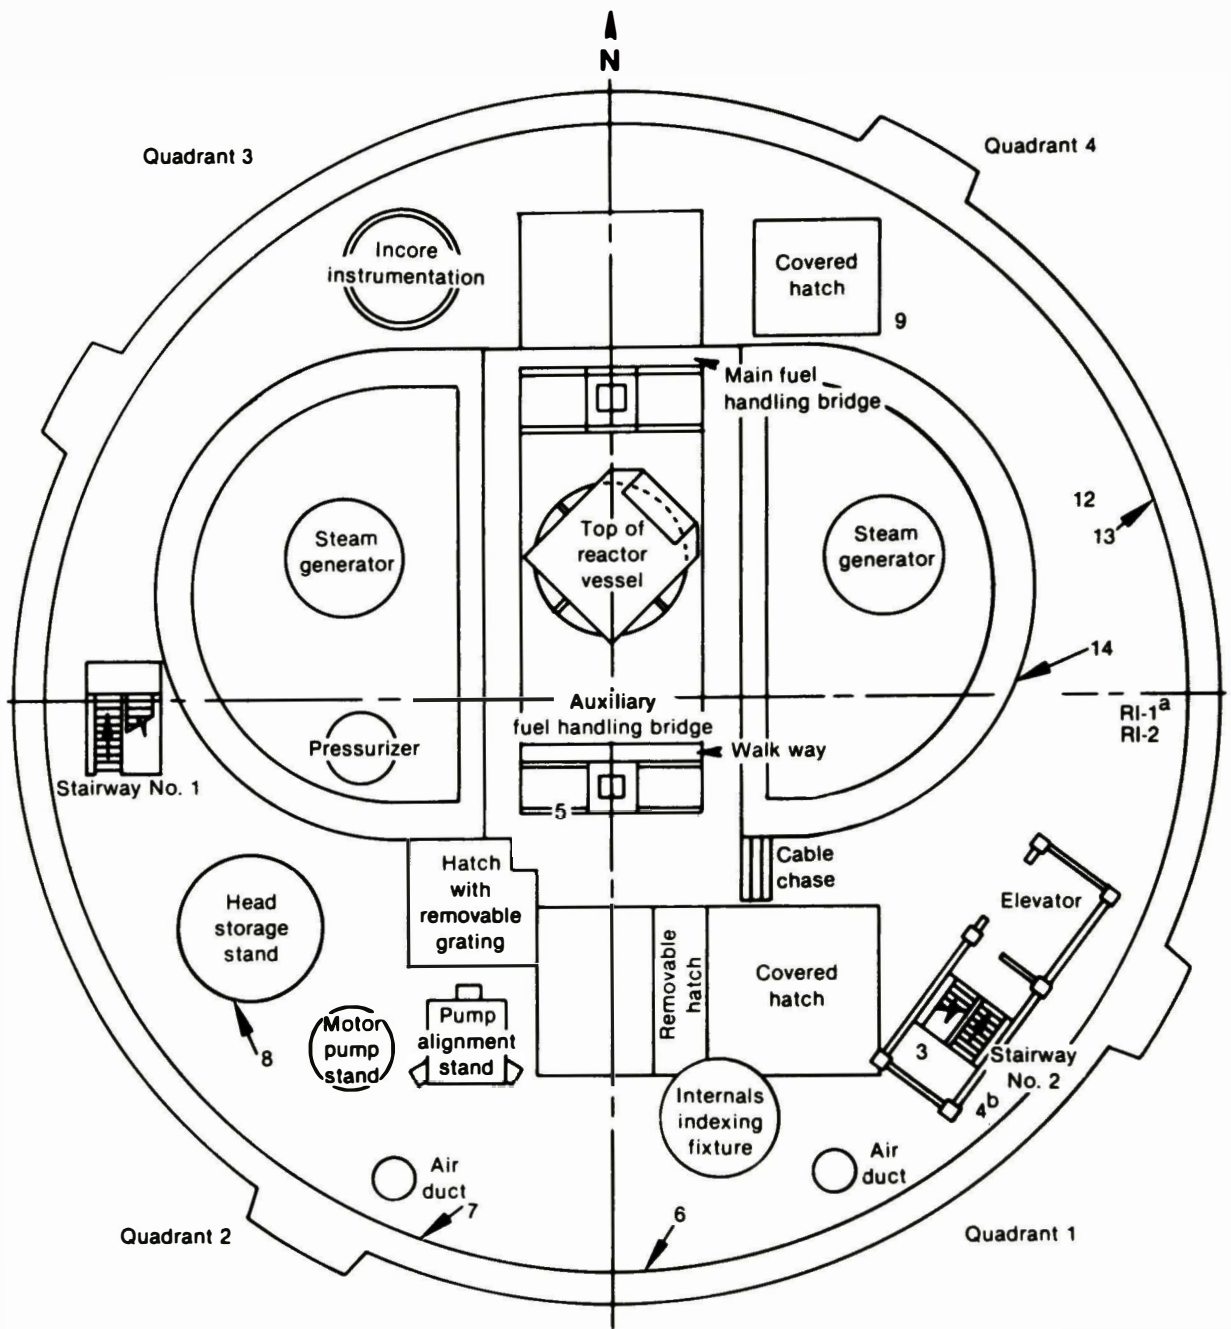
Figure 3. Elevation 347 swipe specimen locations.

a. Swipe/specimen numbers correspond to those shown in Figures 3 and 4.

- a. Number 4 is 14 wipes
  - b. RI-1 is reflective insulation 1C-1B05,  
RI-2 is reflective insulation 1C-2B02
- Note: S wipes 10 and 11 were not used

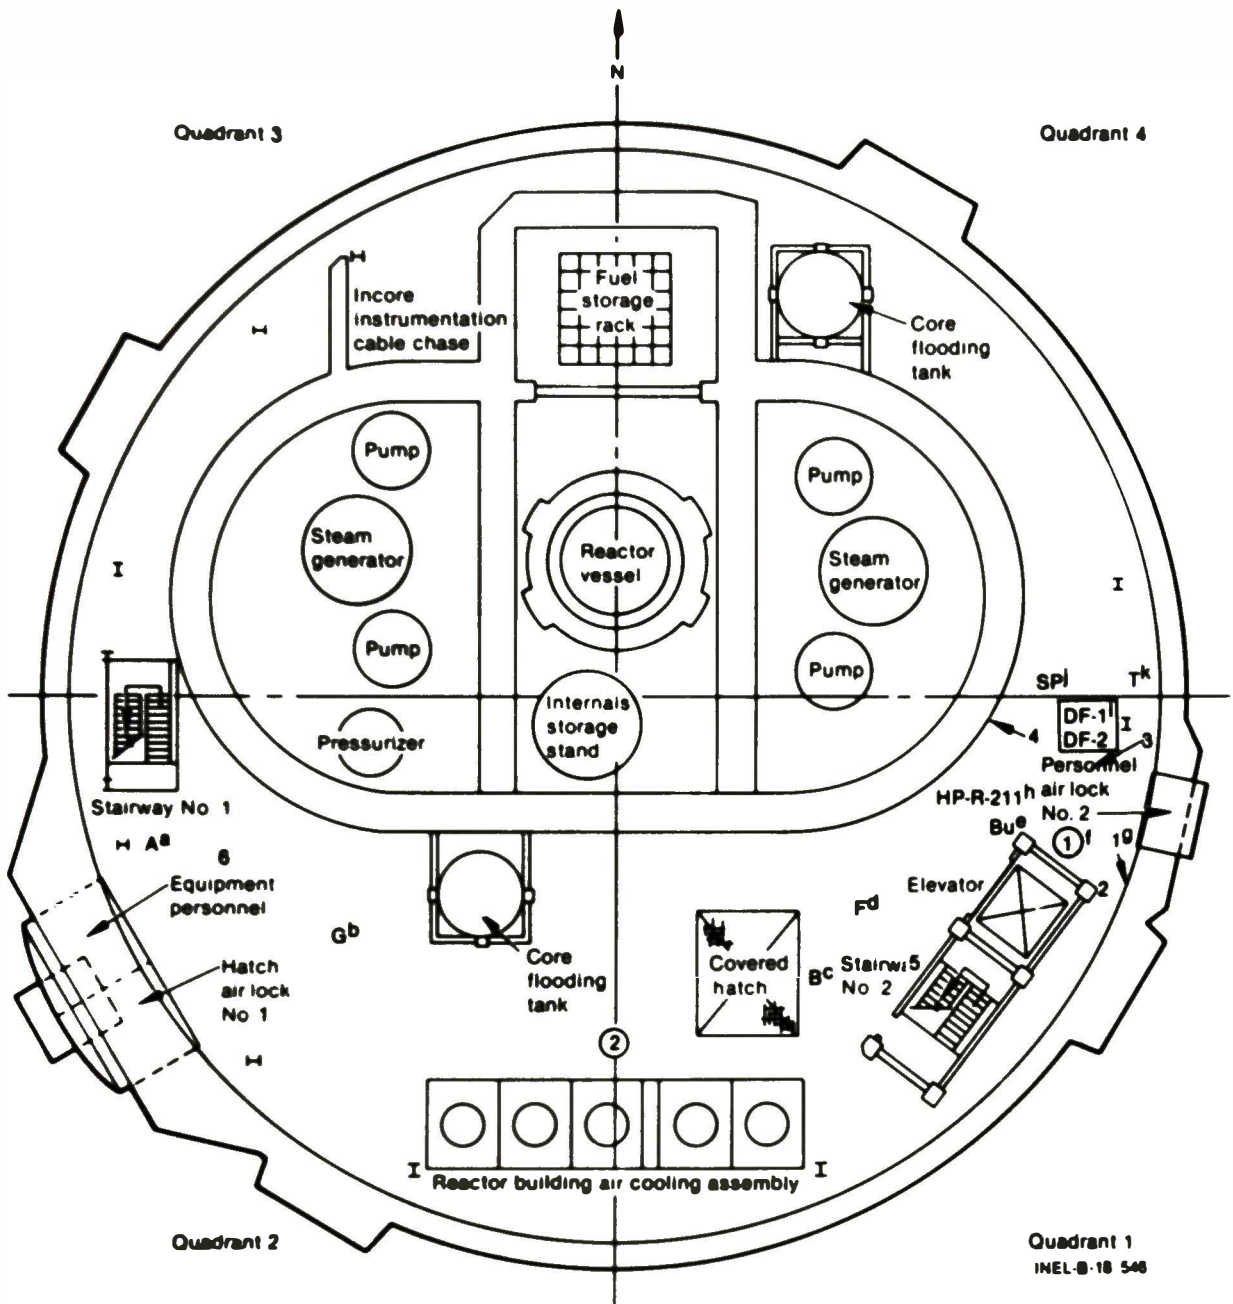
Figure 4. Elevation 305 swipe specimen locations.

- a. A is floor specimen.
- b. G is glass.
- c. B is floor specimen.
- d. F is funnel.
- e. Bu is bucket.
- f. Wipes ① and ② were taken 8/15.
- g. Wipes 1 thru 6 were taken 7/23.
- h. HP-R-211 is a radiation monitor.
- i. DF-1 and DF-2 are wipes after area maitlin.
- j. SP is steel plate.
- k. T is telelector.
