EGG-TMI-7489  
December 1986

TMI-2 ACCIDENT SCENARIO UPDATE

Published December 1986

This report summarizes the current best-estimate TMI-2 accident scenario describing the initial core heatup and degradation, continued degraded core heatup, and eventual core failure and migration of molten core materials into the reactor vessel lower plenum. Also included are discussions of fission product release, chemistry, and final postaccident distribution and inventory. The evidence indicates that the core damage and relocation occurred within 4 h of the accident initiation, after which the degraded reactor core was stable.

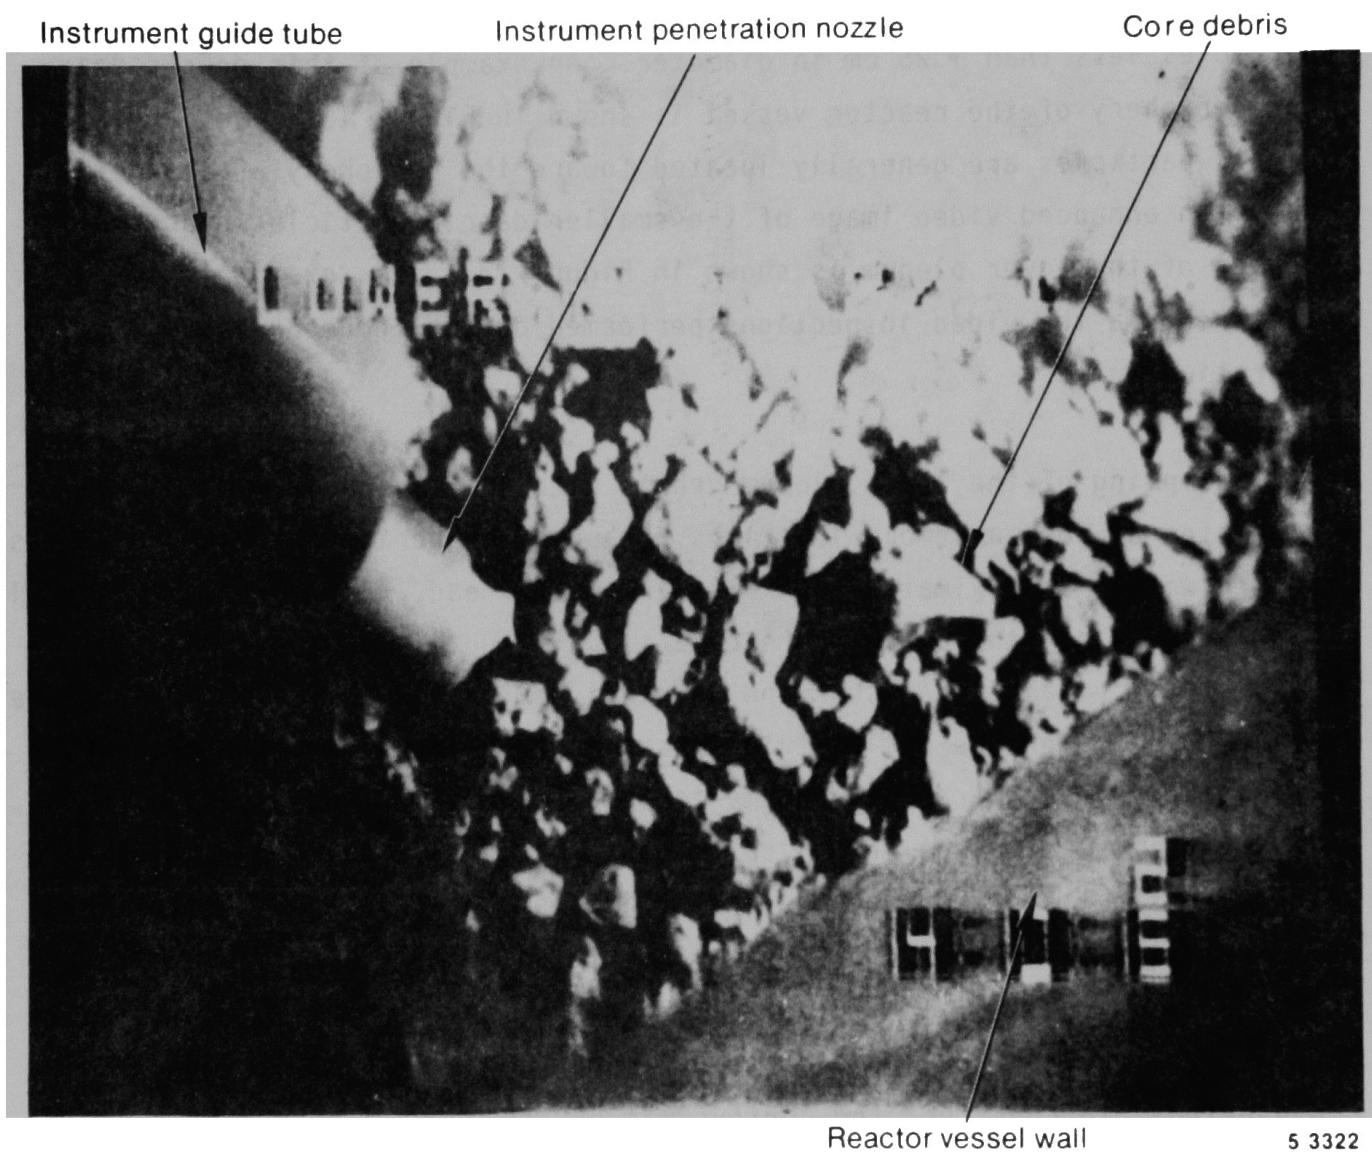
5 3322

Figure 12. Debris particles in the TMI-2 lower plenum resting on the surface of the lower head.

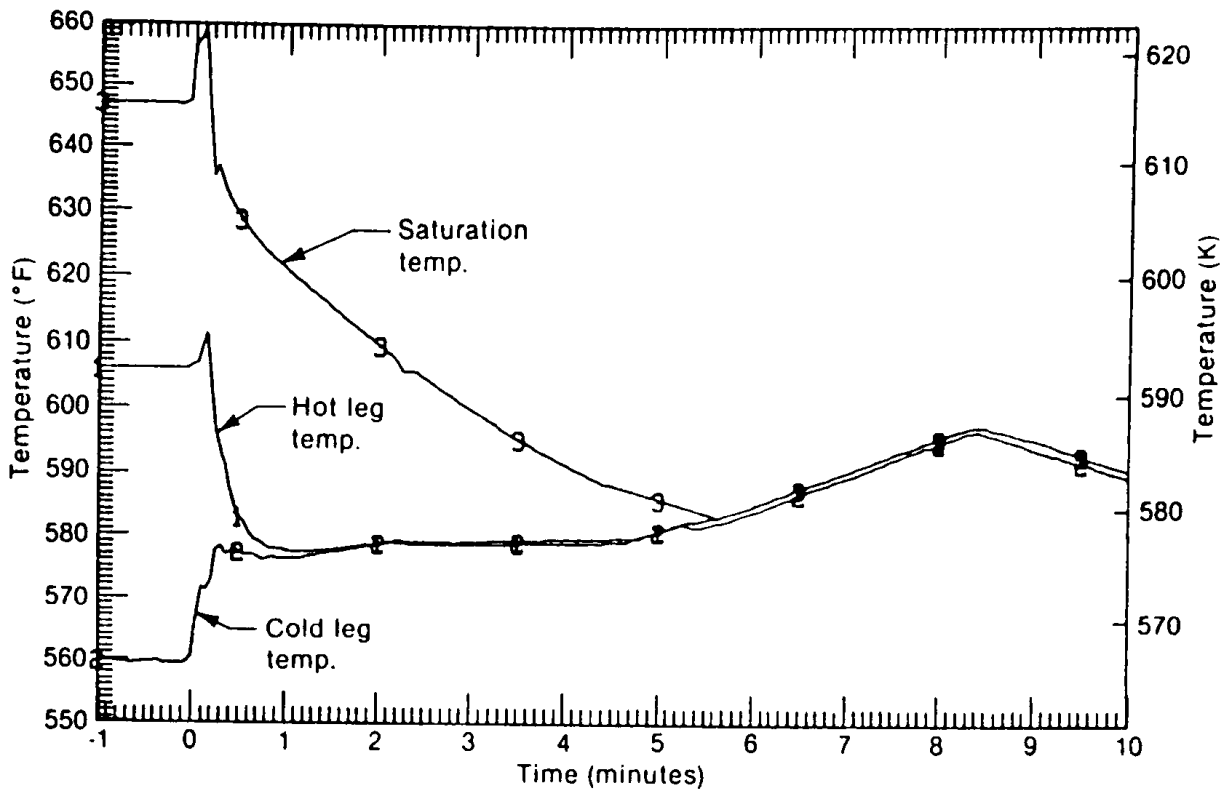
6 0641

Figure 17. TMI-2 A-loop hot leg, cold leg, and saturation temperatures (0 to 10 min).

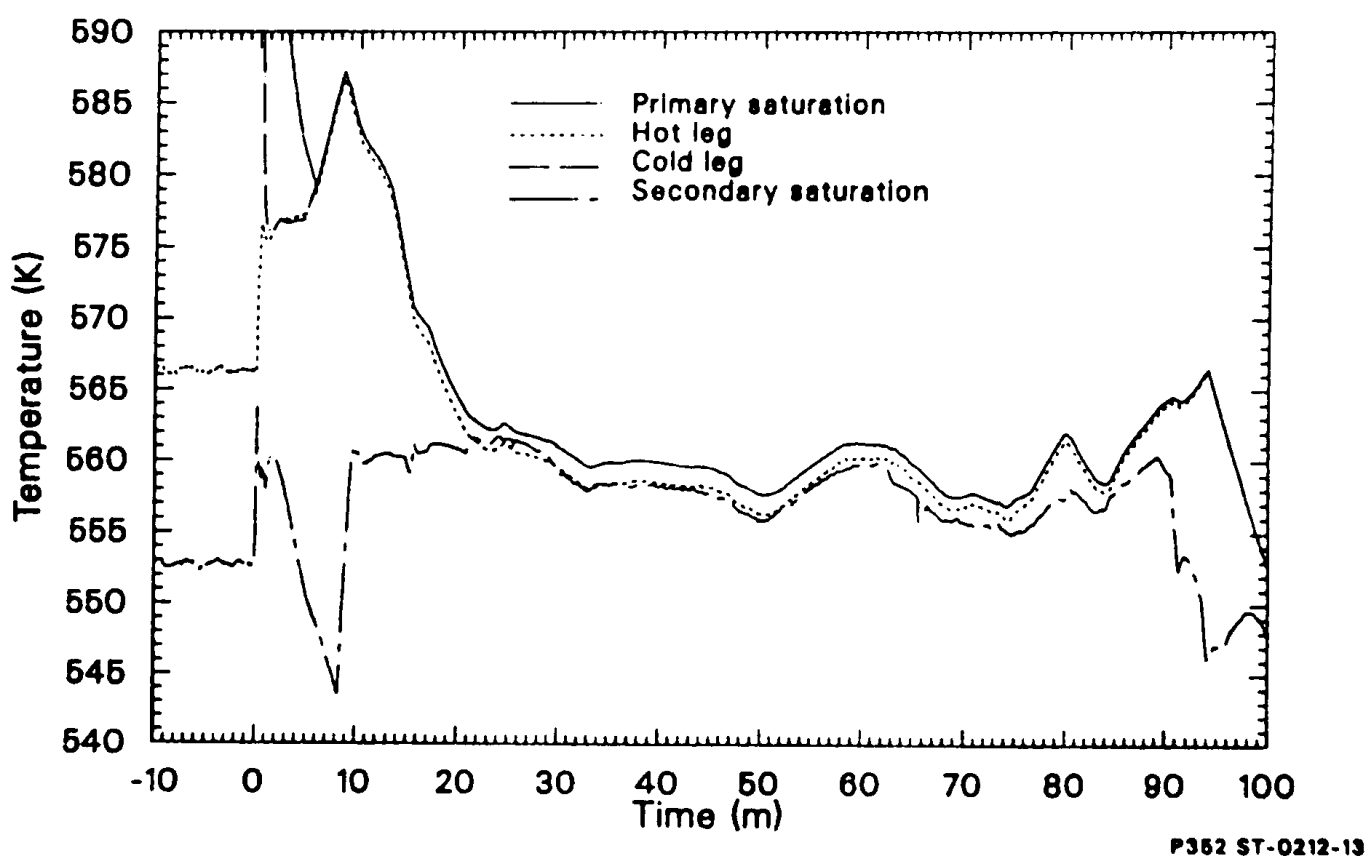
Figure 19. TMI-2 A-loop hot leg, cold leg, primary saturation, and secondary saturation temperatures (-10 to 100 min).

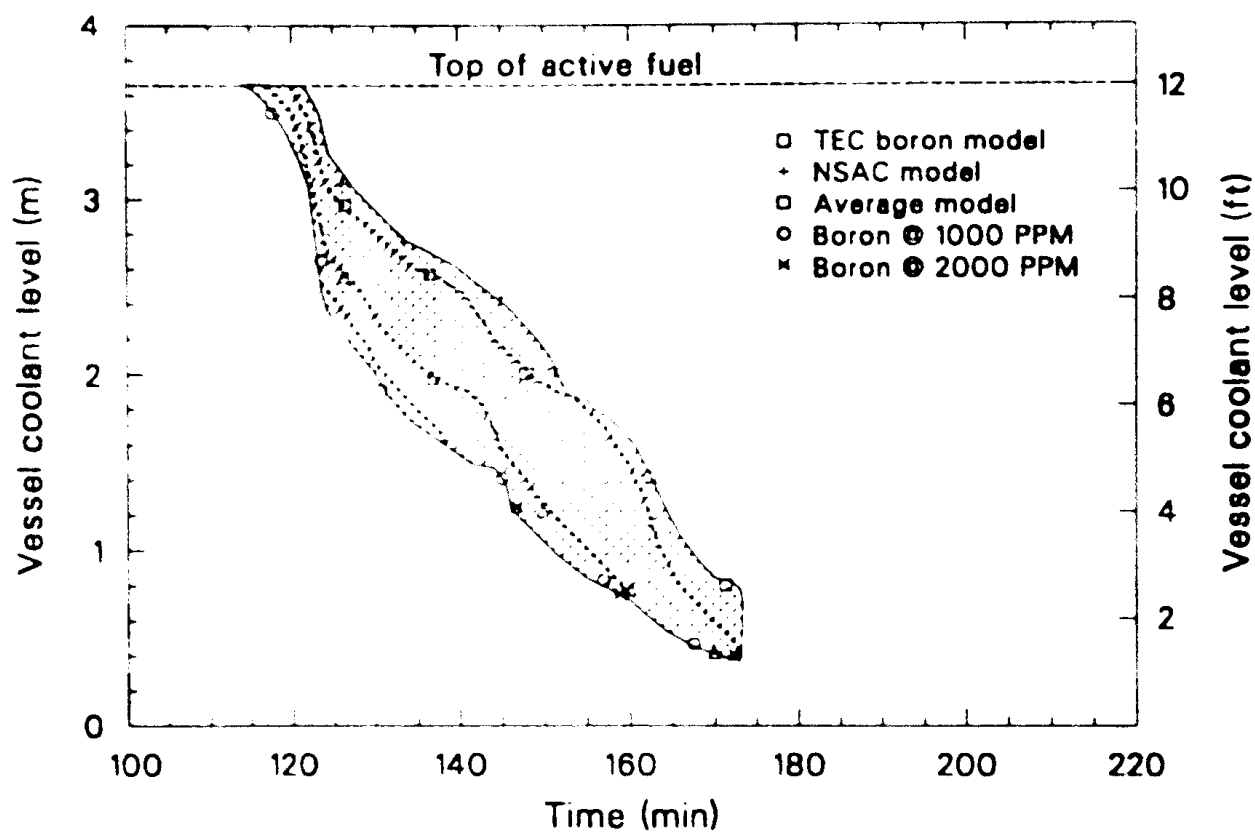
Figure 20. Bounding estimates of IMI-2 core liquid level versus time based on SRM data evaluation.

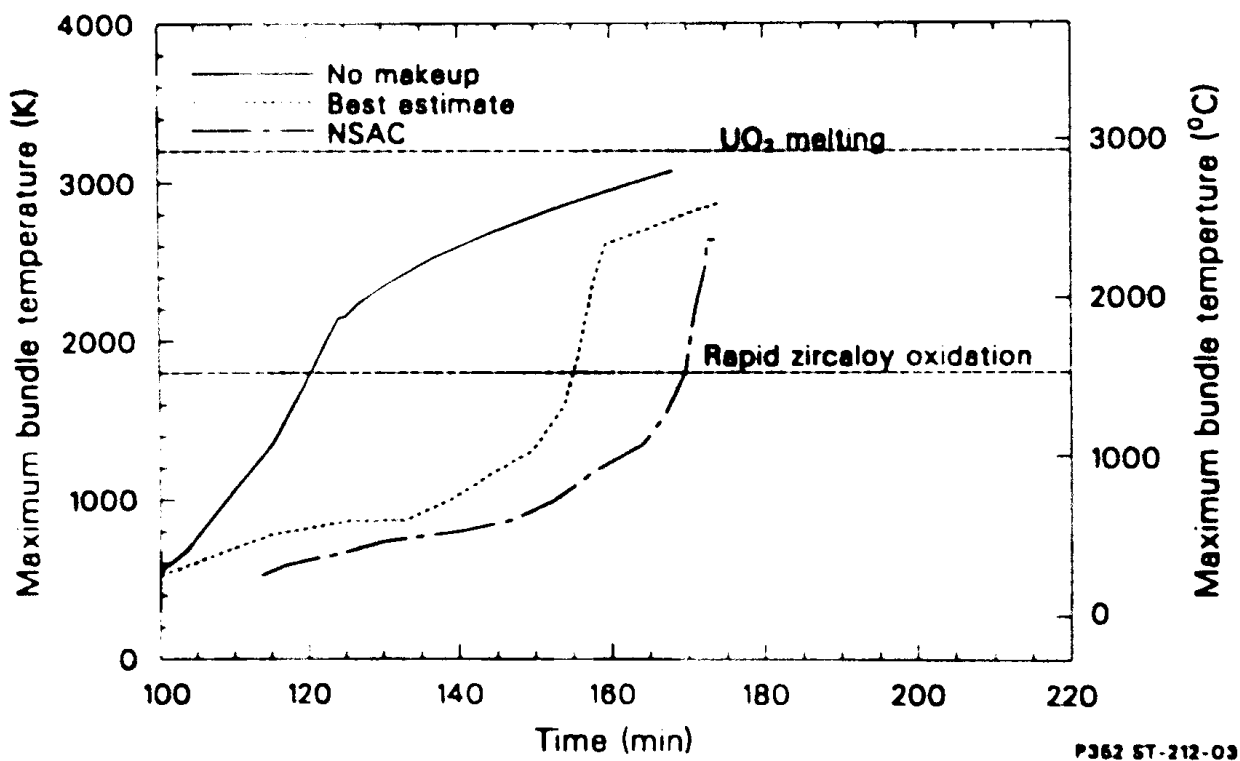
Figure 24. Summary of SCDAP calculations (assumed bounding cases for core liquid level and peak core temperatures).

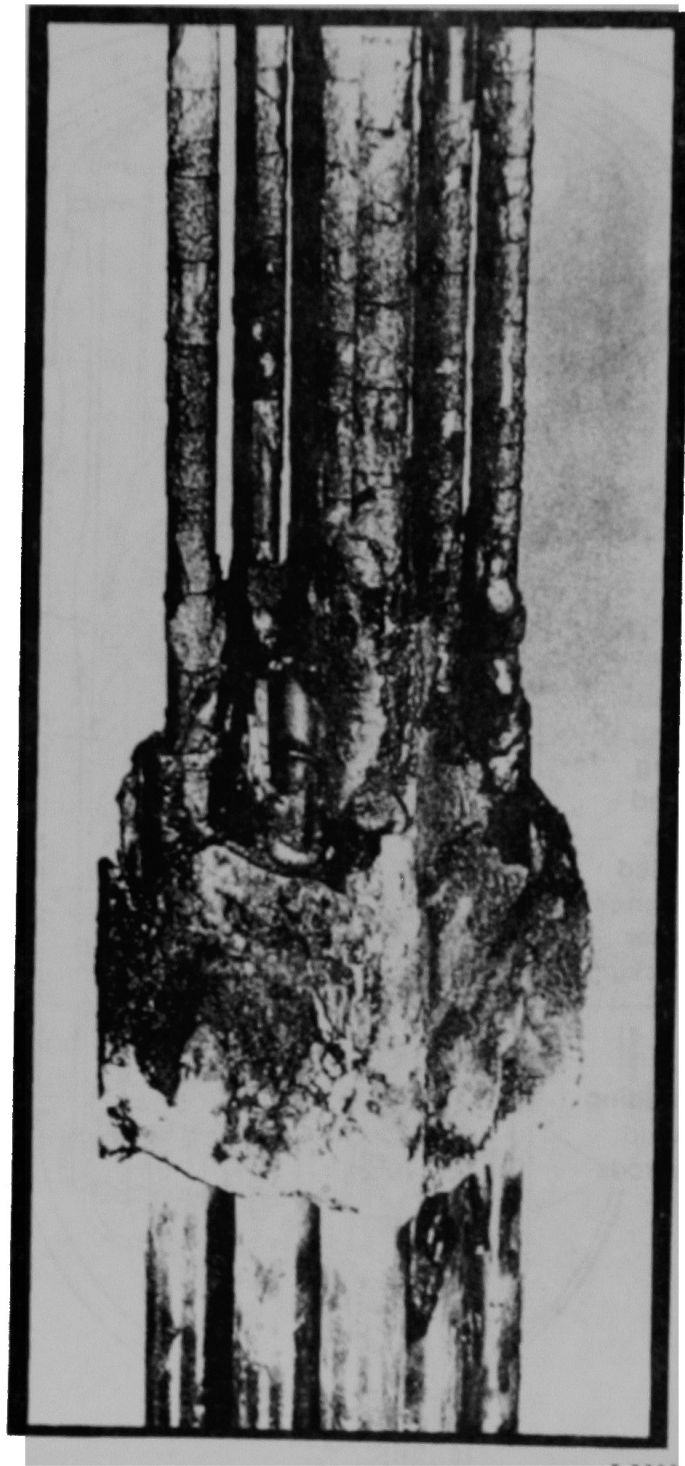
5 8608

Figure 25. End-state condition of fuel rods from ESBU-1 experiment (reproduced from Reference 24).
