**Color Photographs
Of The Three Mile Island Unit 2
Reactor Containment Building:
Volume 1—Entries 1, 2, 4, 5, 6**

October 1981

**EG&G Idaho, Inc.
Idaho Falls, Idaho 83415**

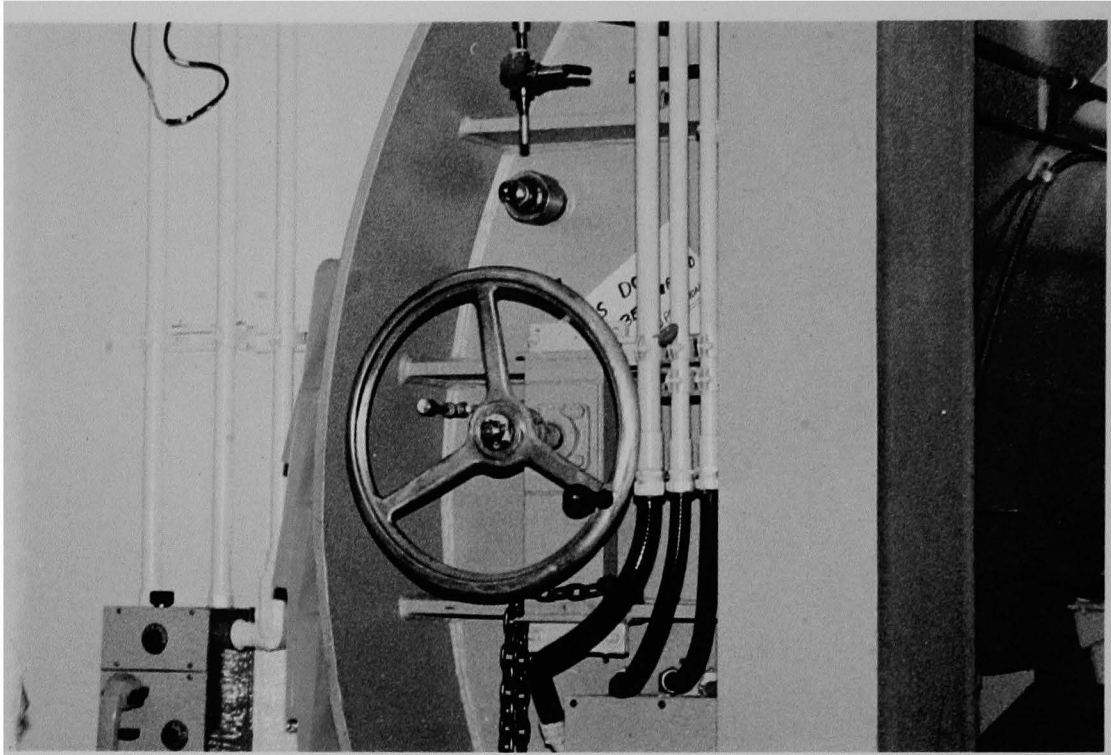
Figure 3 (5B). Handwheel on anteroom side of air lock 2.

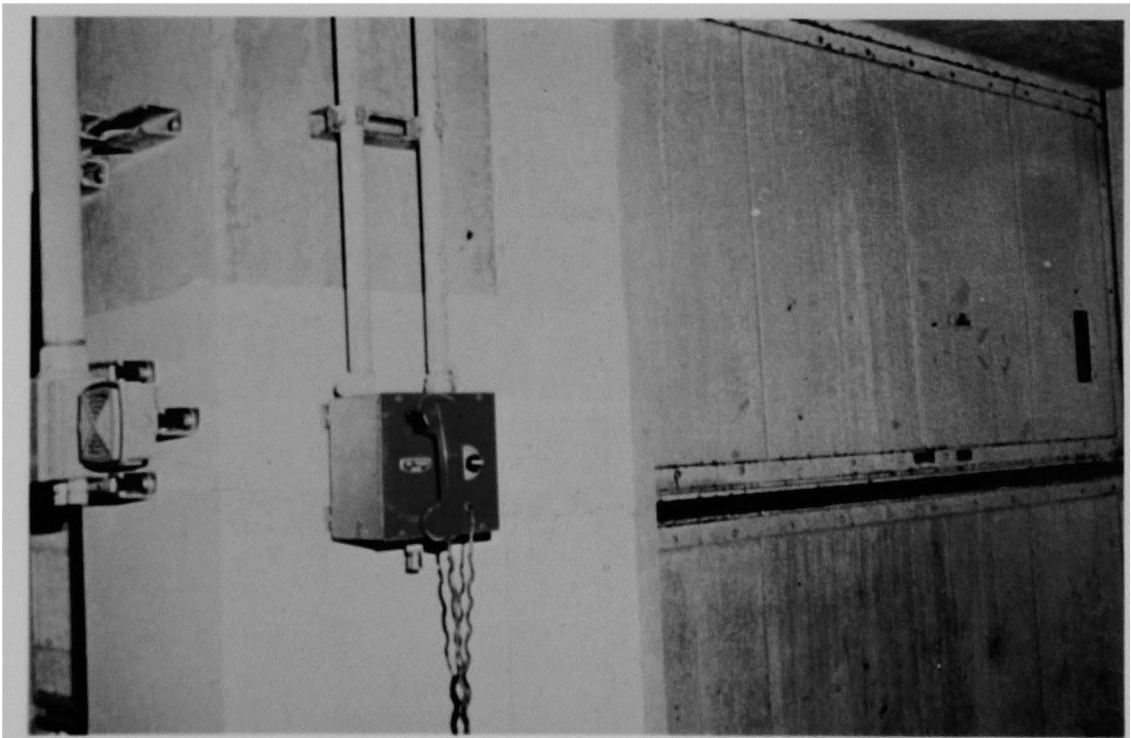
Figure 10 (1A). Gai-tronic telephone and elevator door.

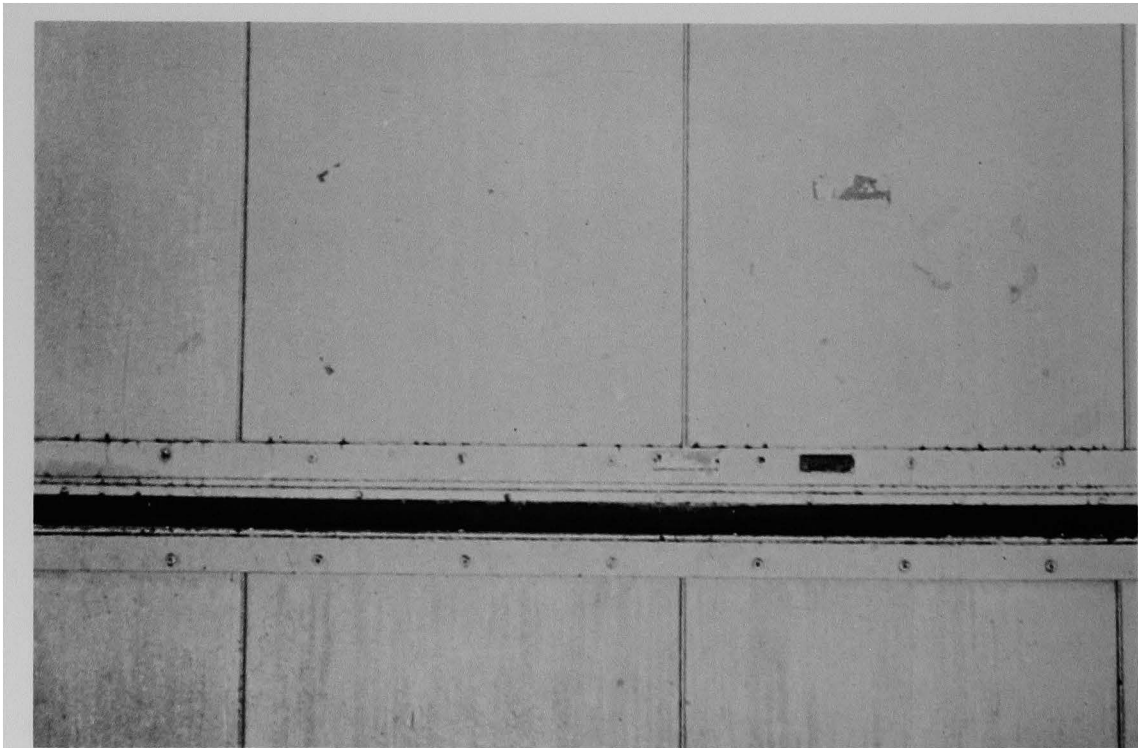
Figure 12 (1A). Close-up of elevator door at elevation 305.

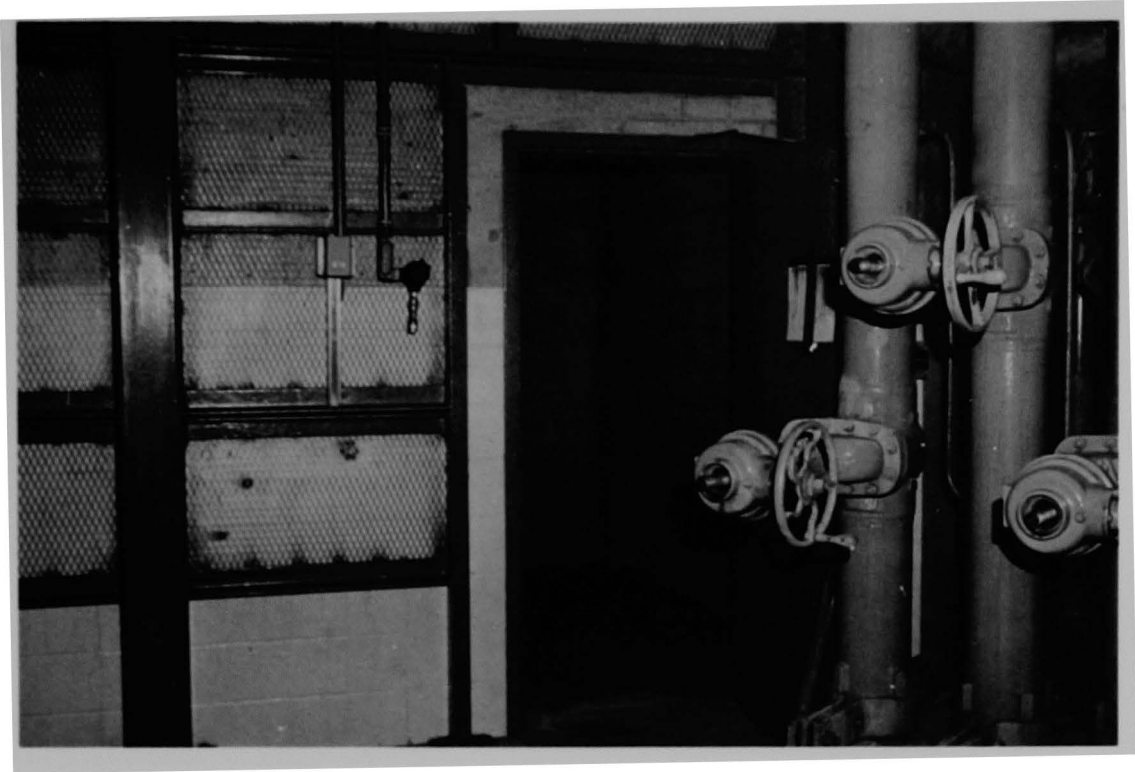
Figure 21 (4A). Door to enclosed stairway and river water piping to air coolers.

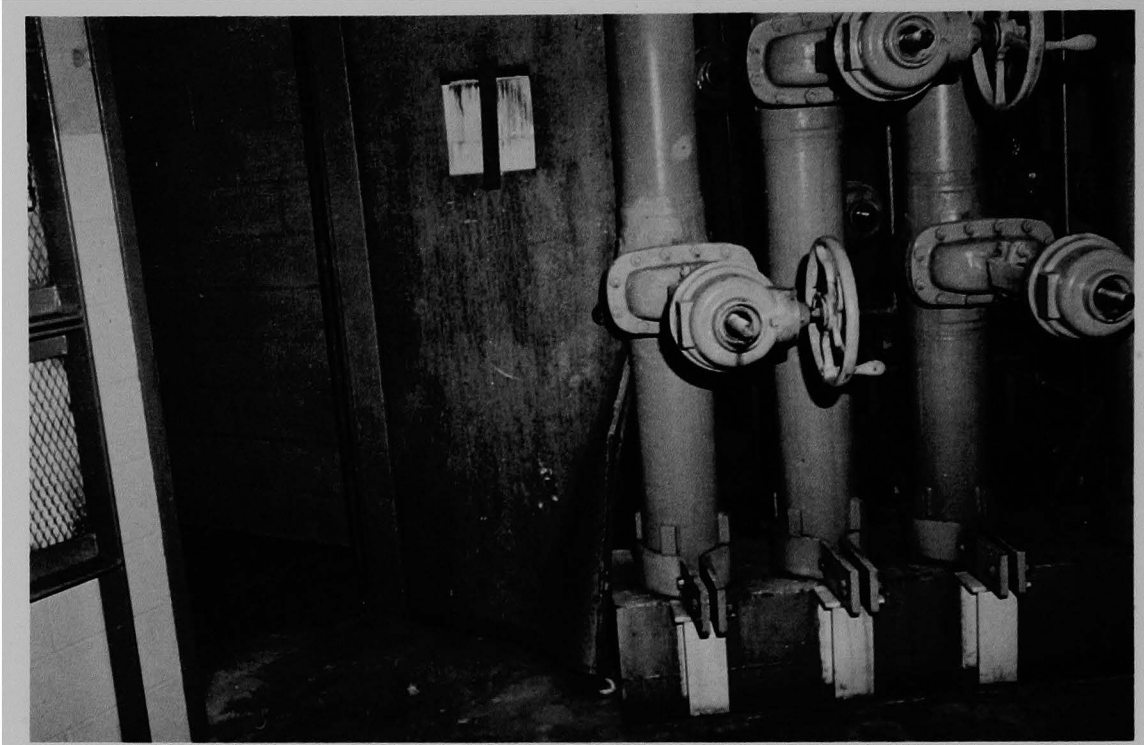
Figure 23 (4A). Lower portion of door to enclosed stairway.

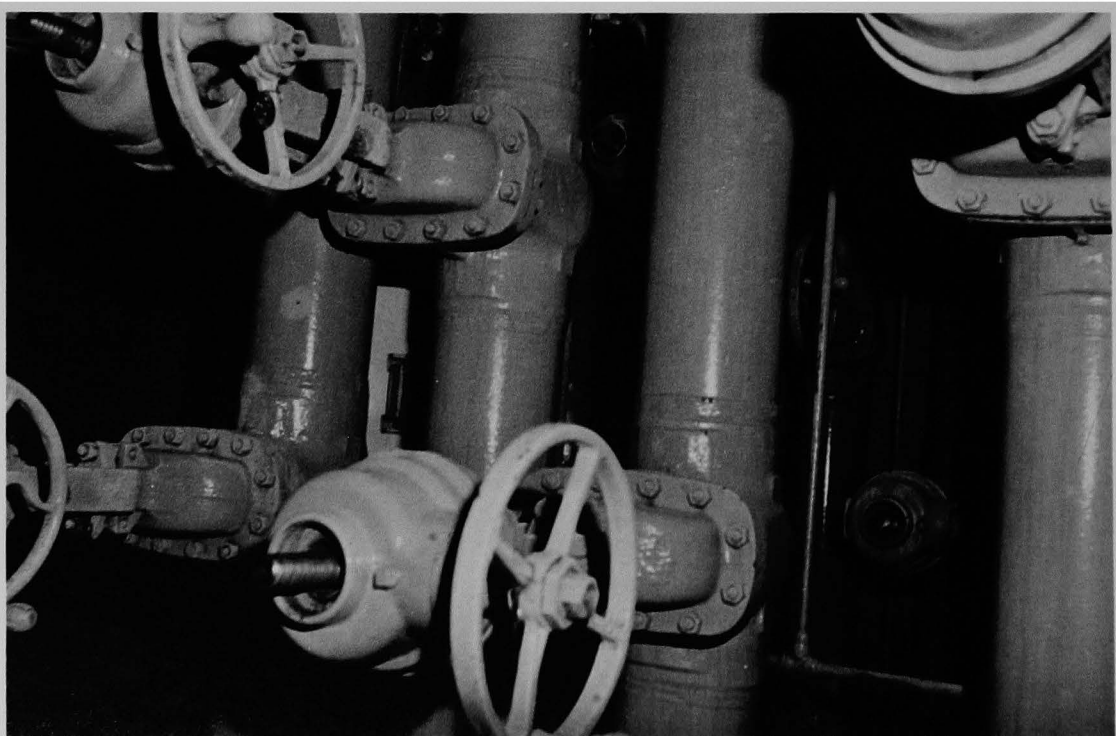
Figure 24 (2A). River water piping associated with air coolers; stairwell in background left.

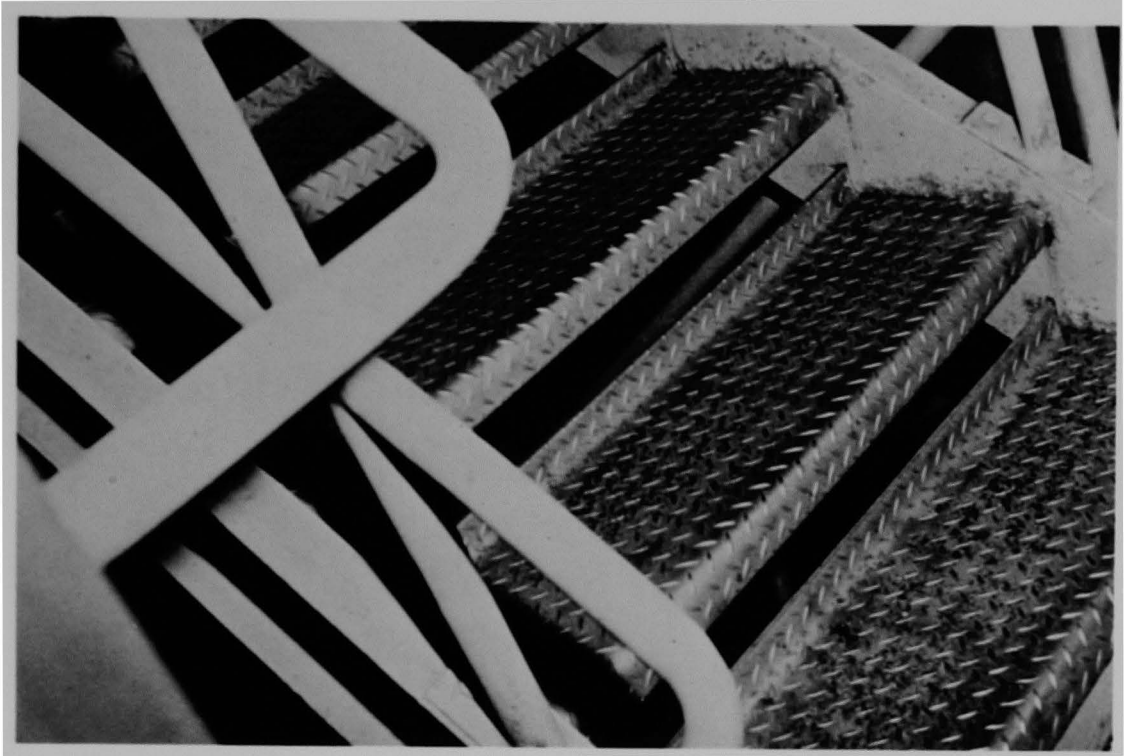
Figure 29 (1A). Enclosed stairs, beginning ascent from elevation 305.

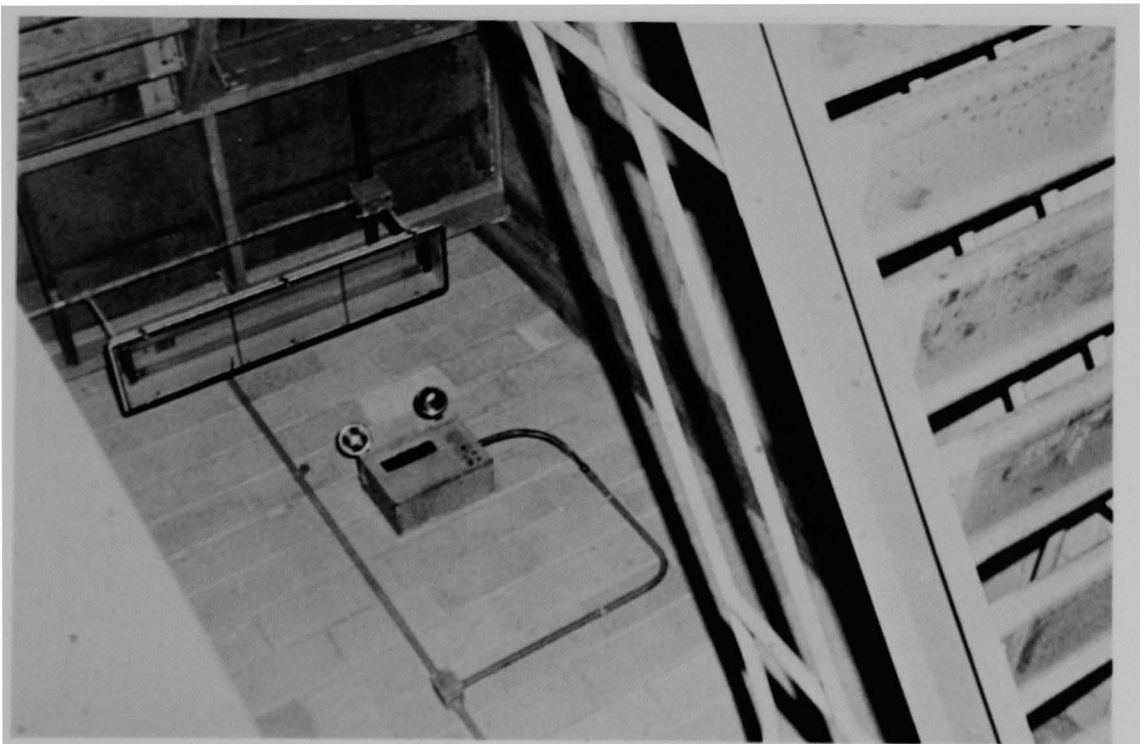
Figure 30 (1A). Emergency lights in enclosed stairwell, view up from elevation 305.

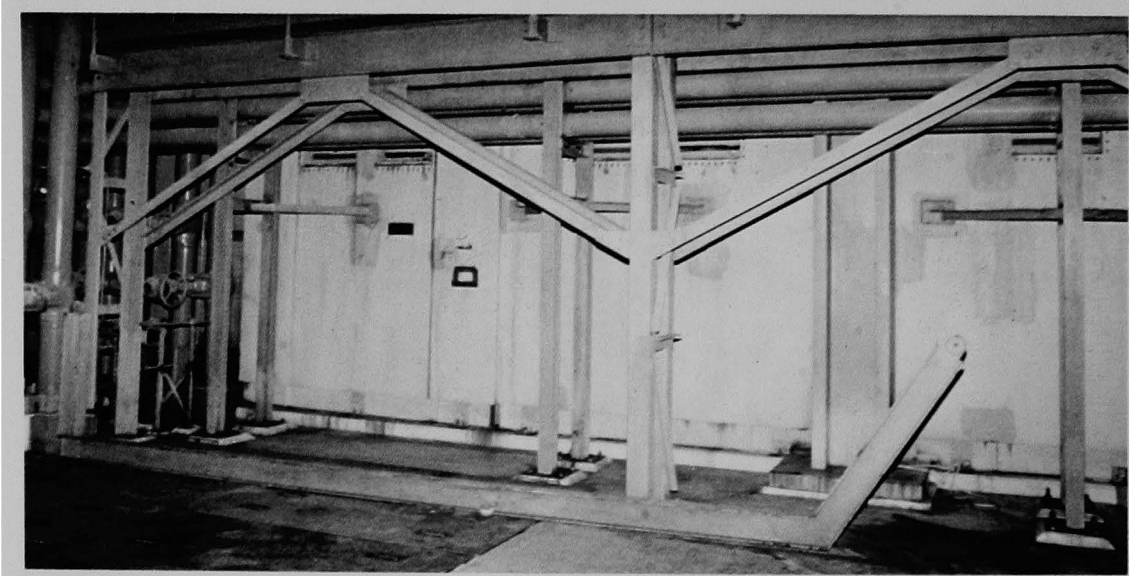
Figure 31 (5C). East units of air cooling assembly.

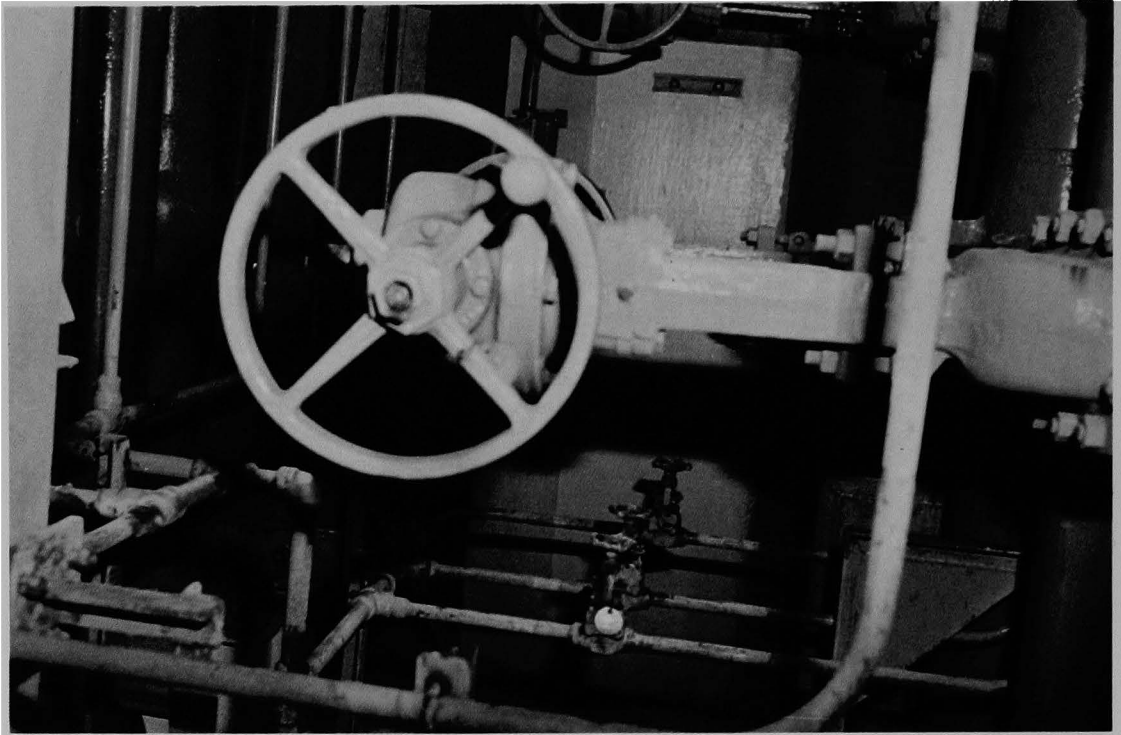
Figure 35 (2A). River water cooling pipes and valves, east end of air cooling assembly.

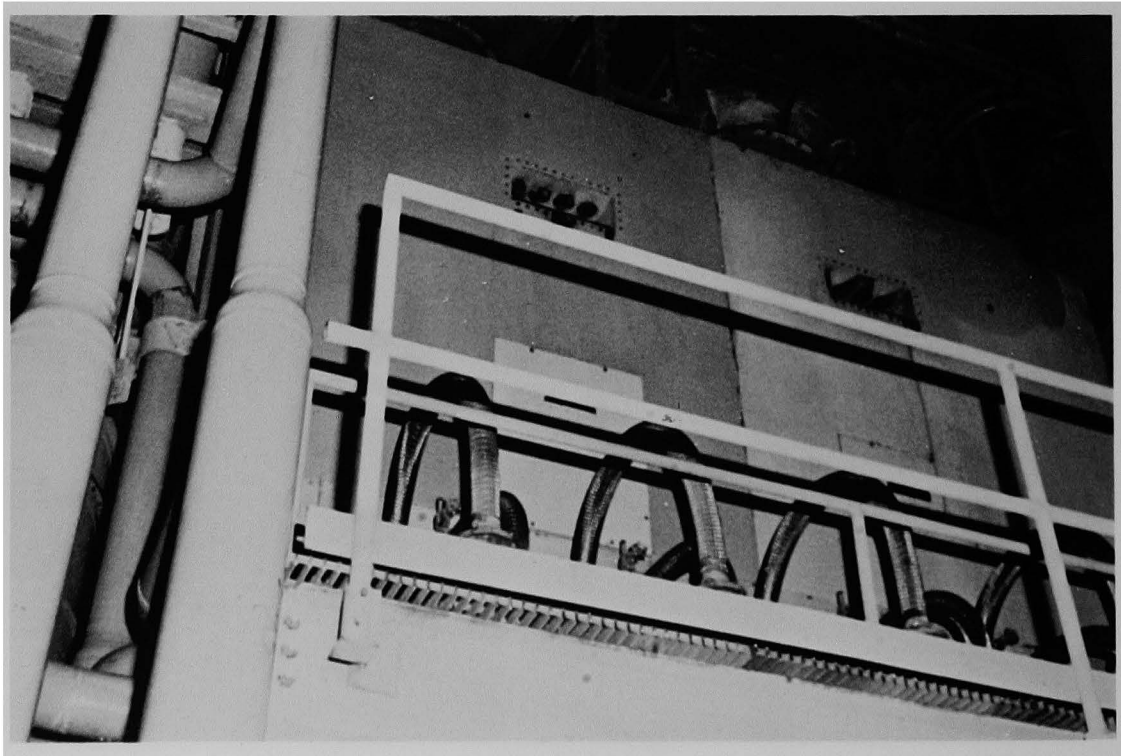
Figure 36 (1A). Upper east end of air cooling assembly.

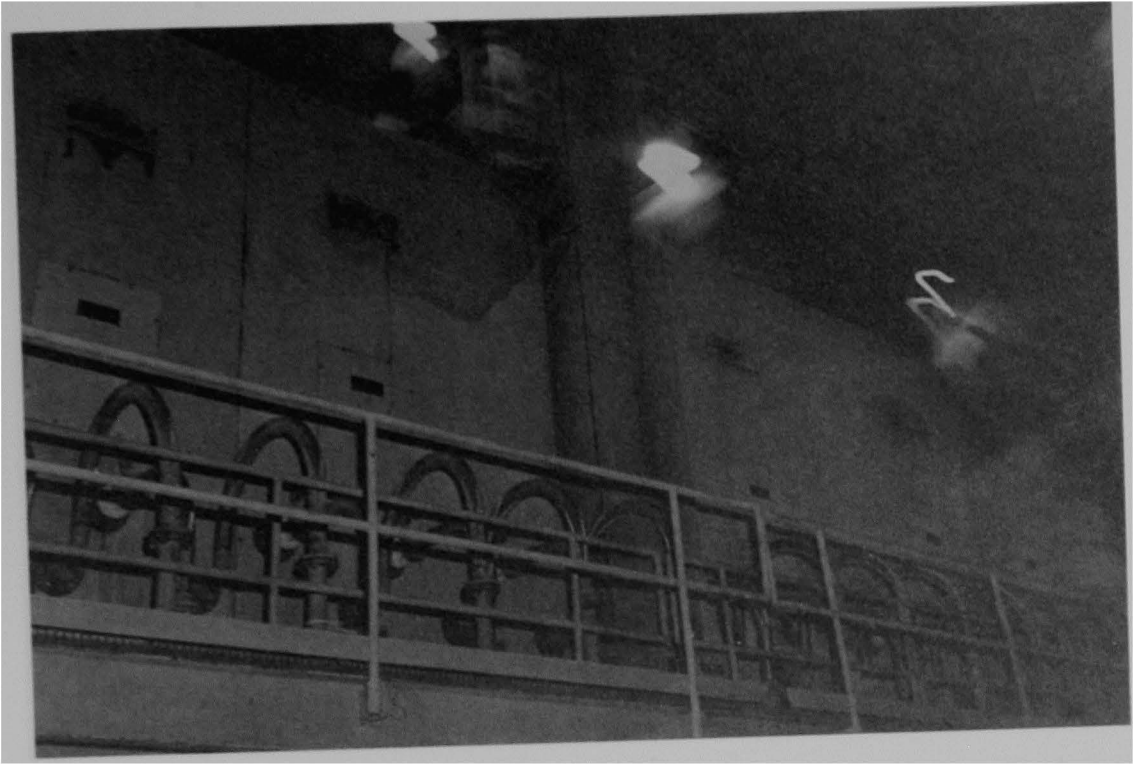
Figure 37 (6A). Upper center portion of air cooling assembly.

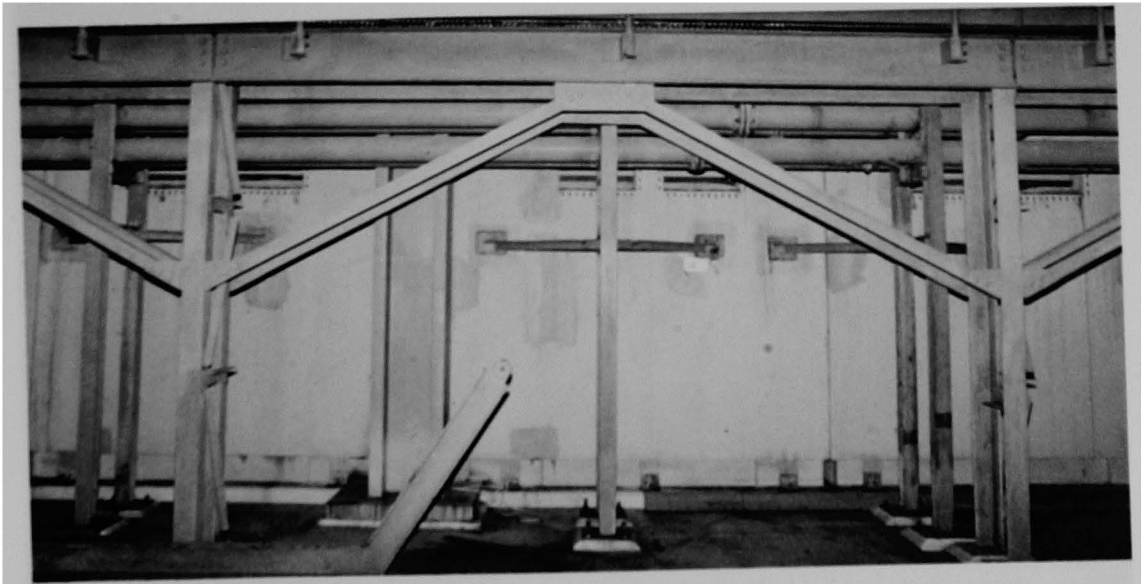
Figure 38 (5C). Center units of air cooling assembly.

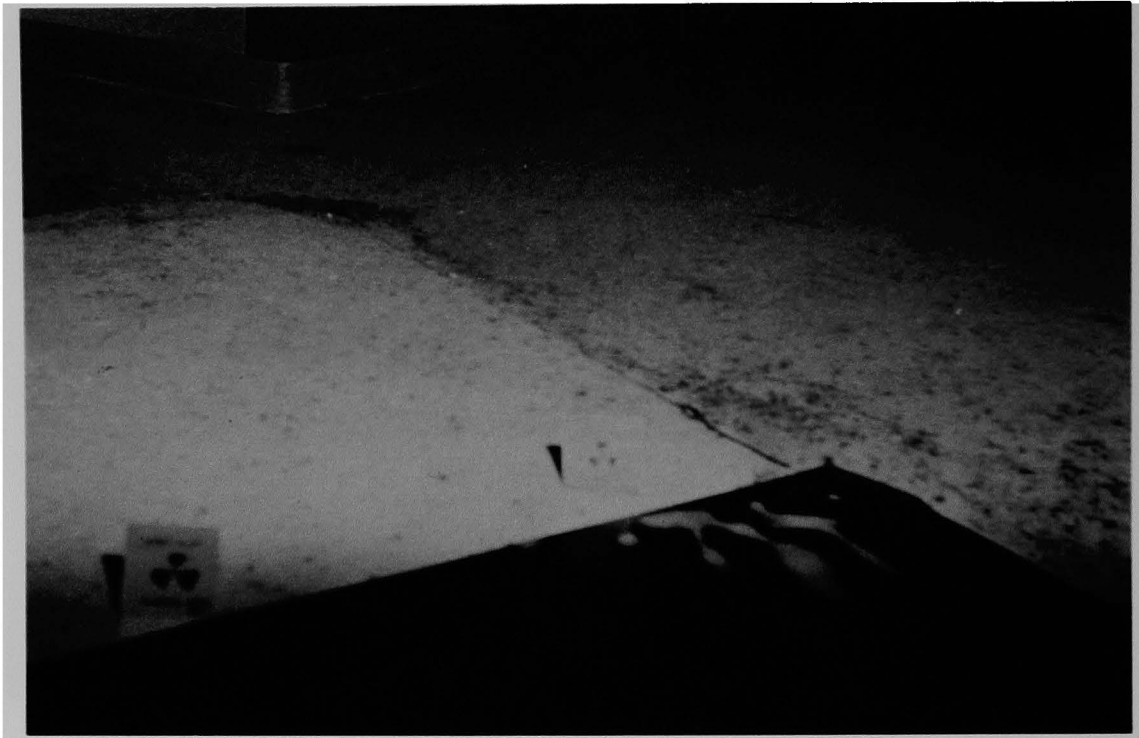
Figure 39 (4A). Floor area for decontamination test (black matting in foreground used for beta shielding).

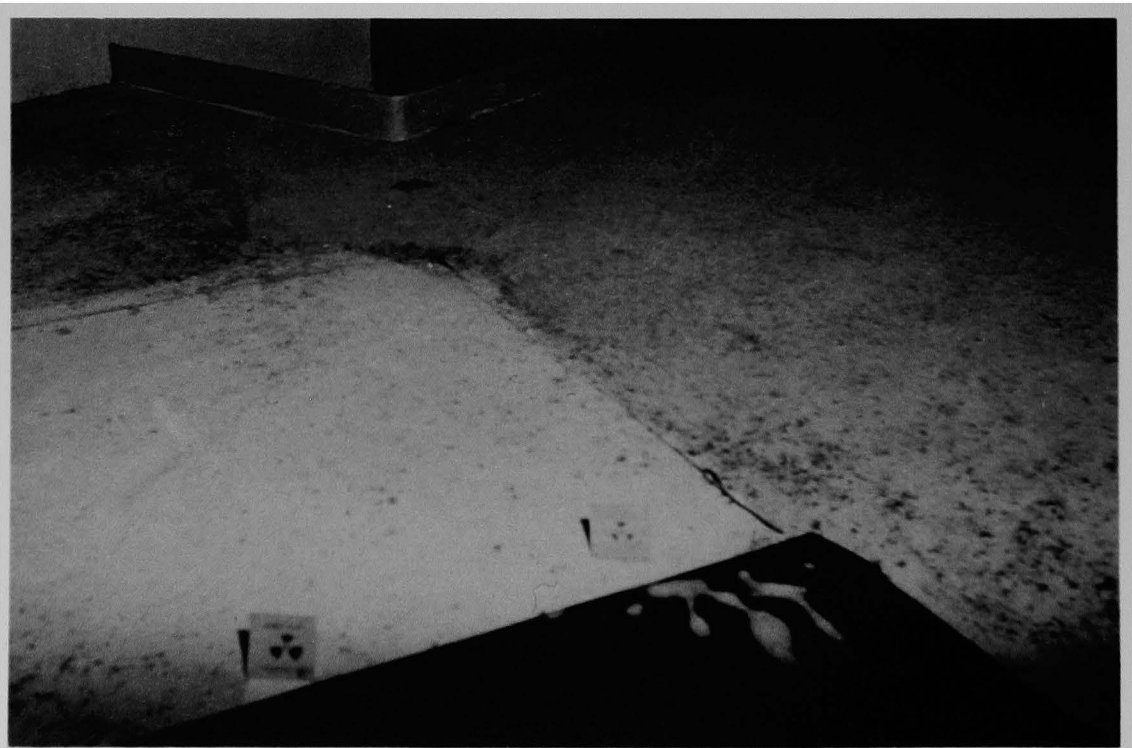
Figure 40 (4A). Floor area for decontamination test, second view.

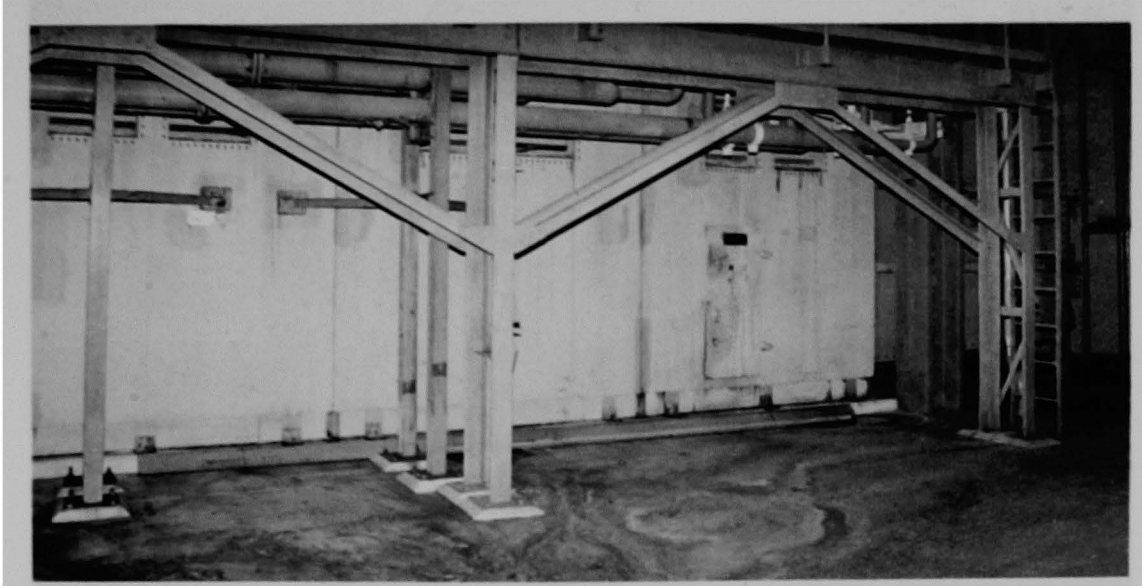
Figure 44 (5C). West units of air cooling assembly.

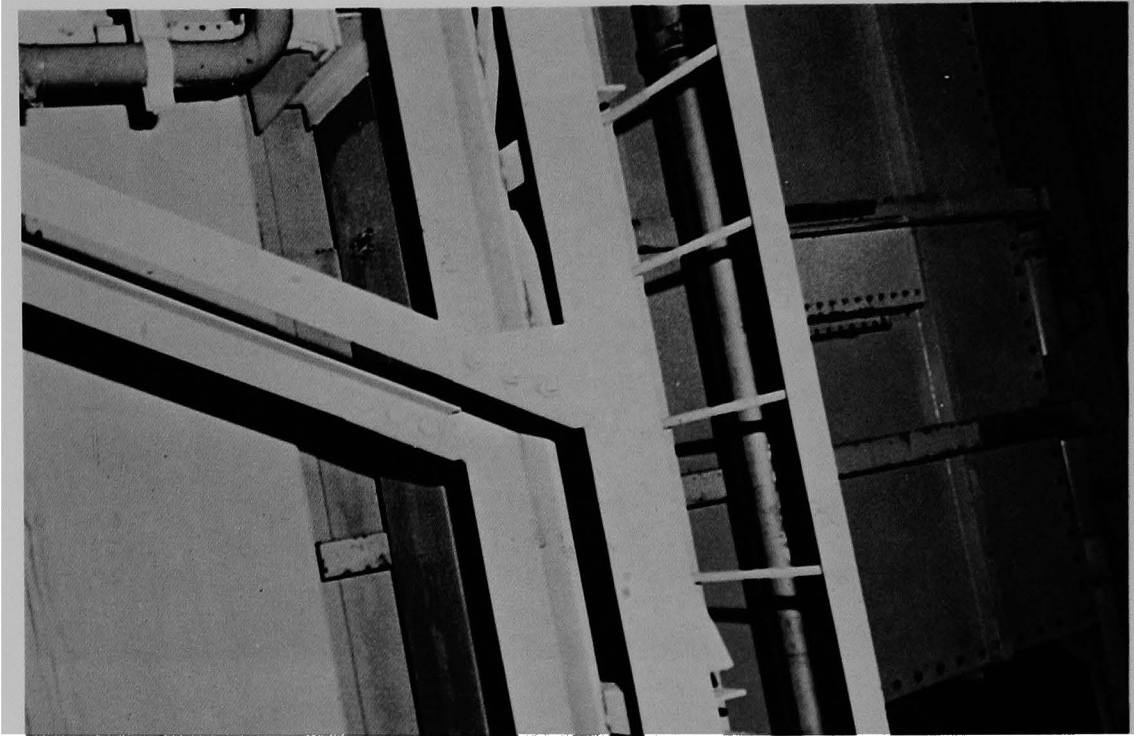
Figure 46 (1A). Brace and ladder at west end of air cooling assembly.

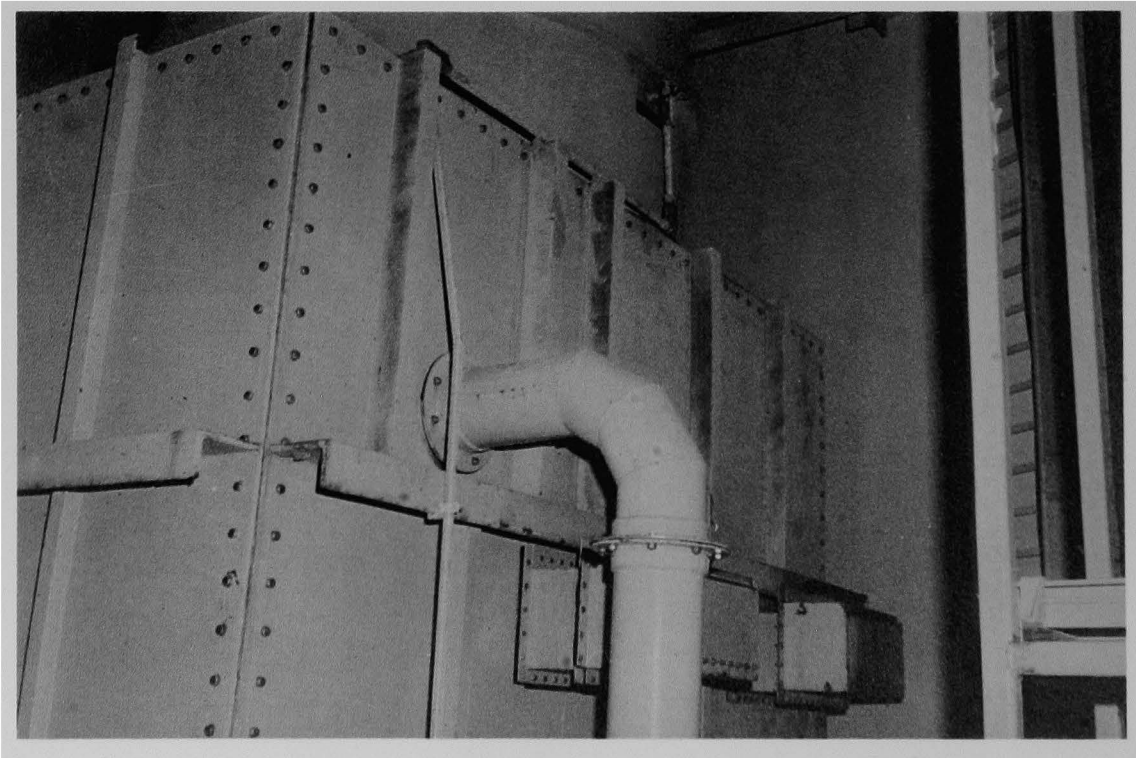
Figure 47 (6A). Plenum at upper west end of air cooling assembly.

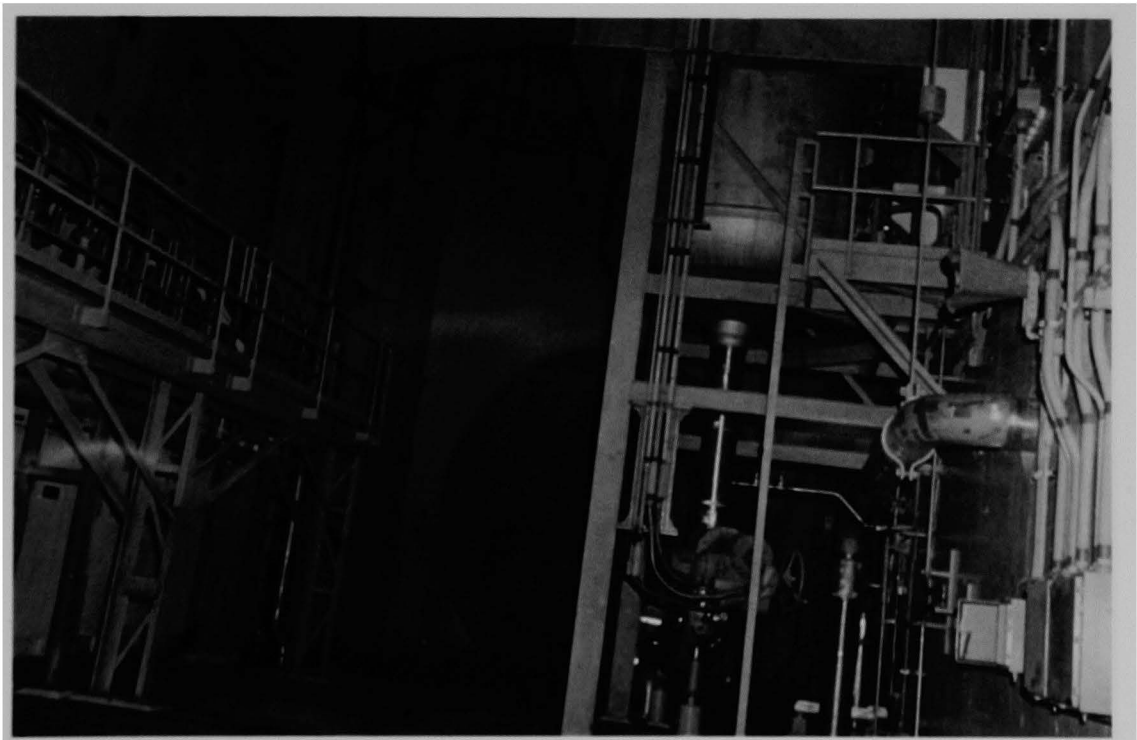
Figure 49 (2A). From left: air coolers, personnel air lock 1 within equipment hatch, core flood tank B, D-ring wall.

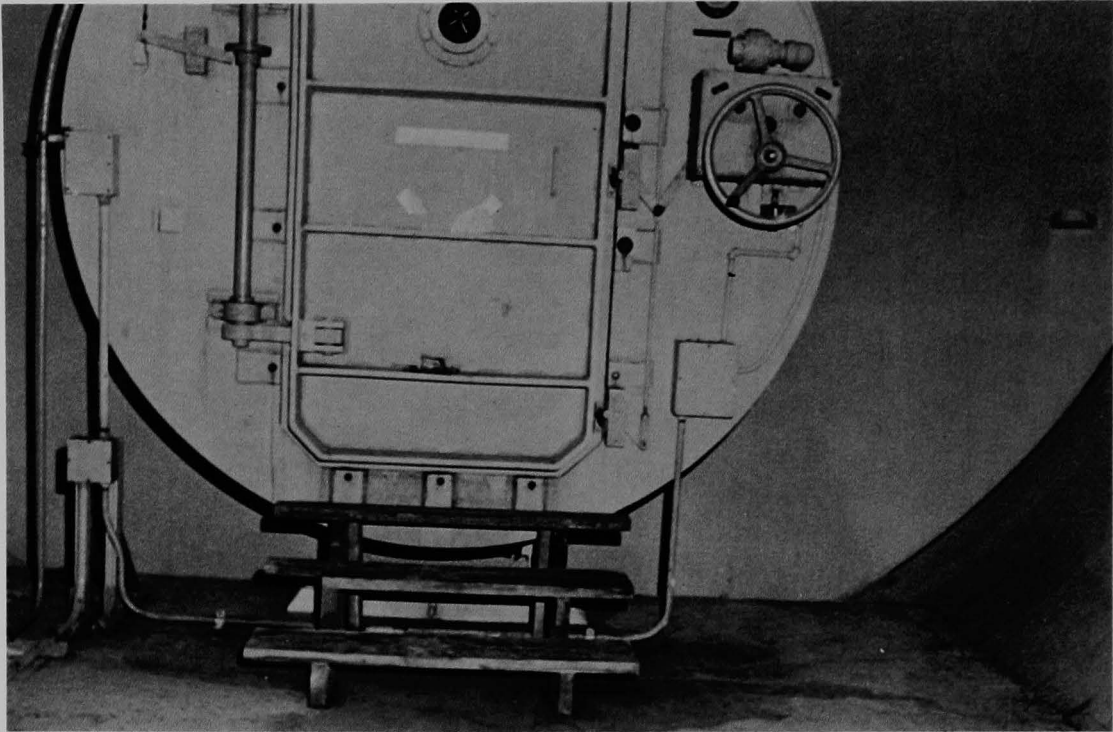
Figure 50 (1A). Personnel air lock 1, within equipment hatch.

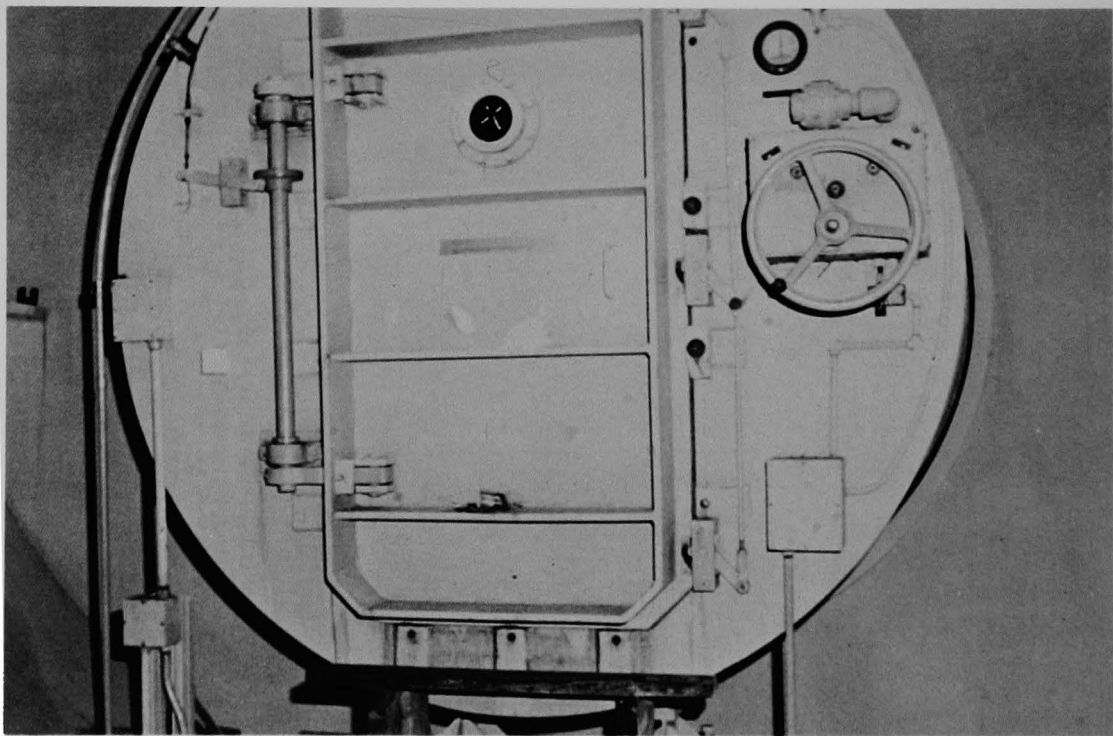
Figure 51 (1A). Door assembly of personnel air lock 1.

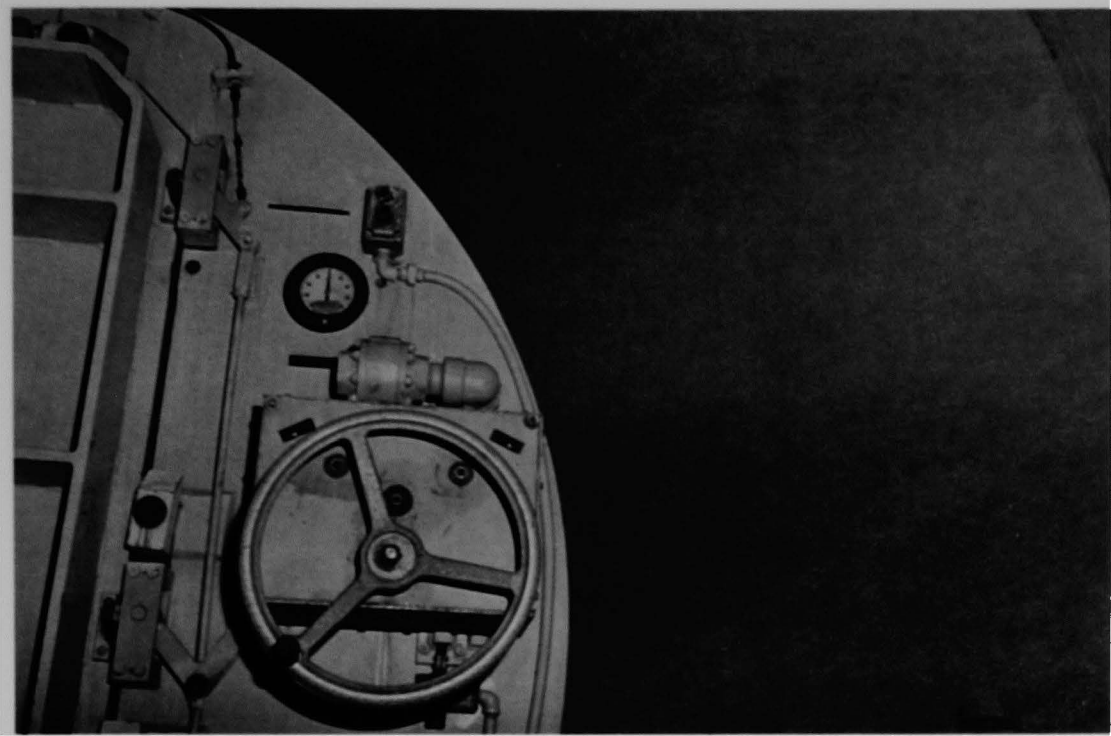
Figure 52 (2A). Handwheel on personnel air lock 1.

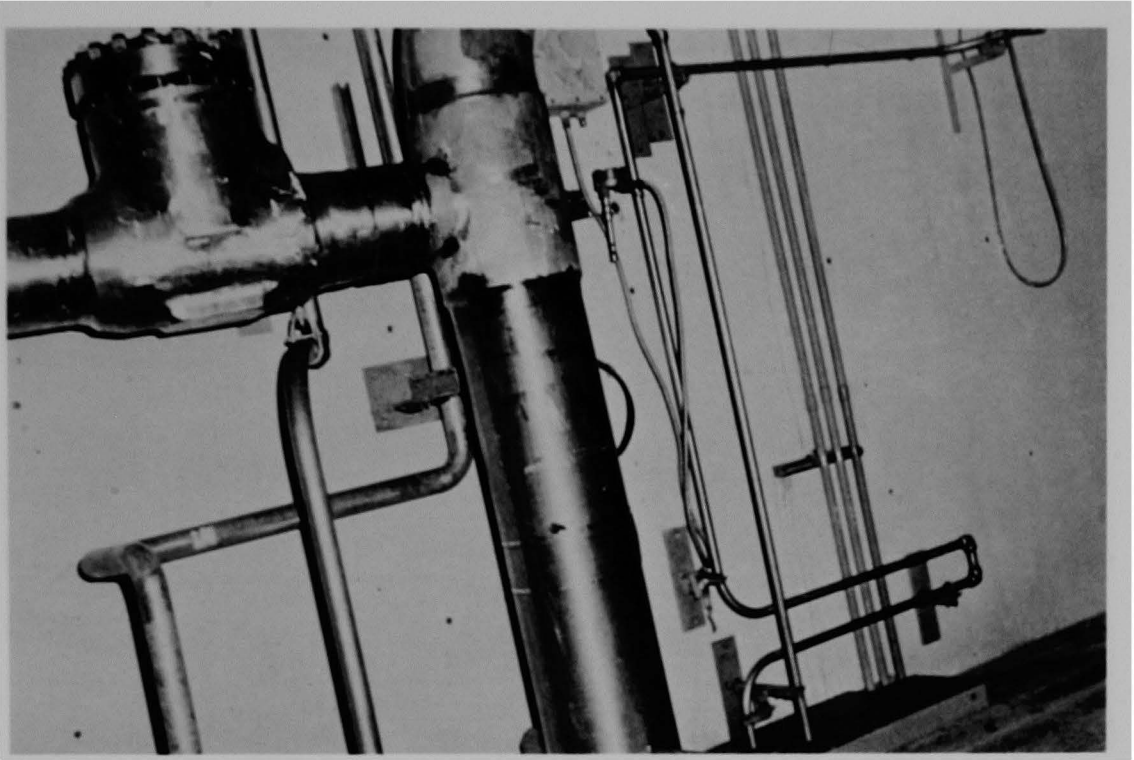
Figure 60 (1A). Core flood tank B piping on seismic support.

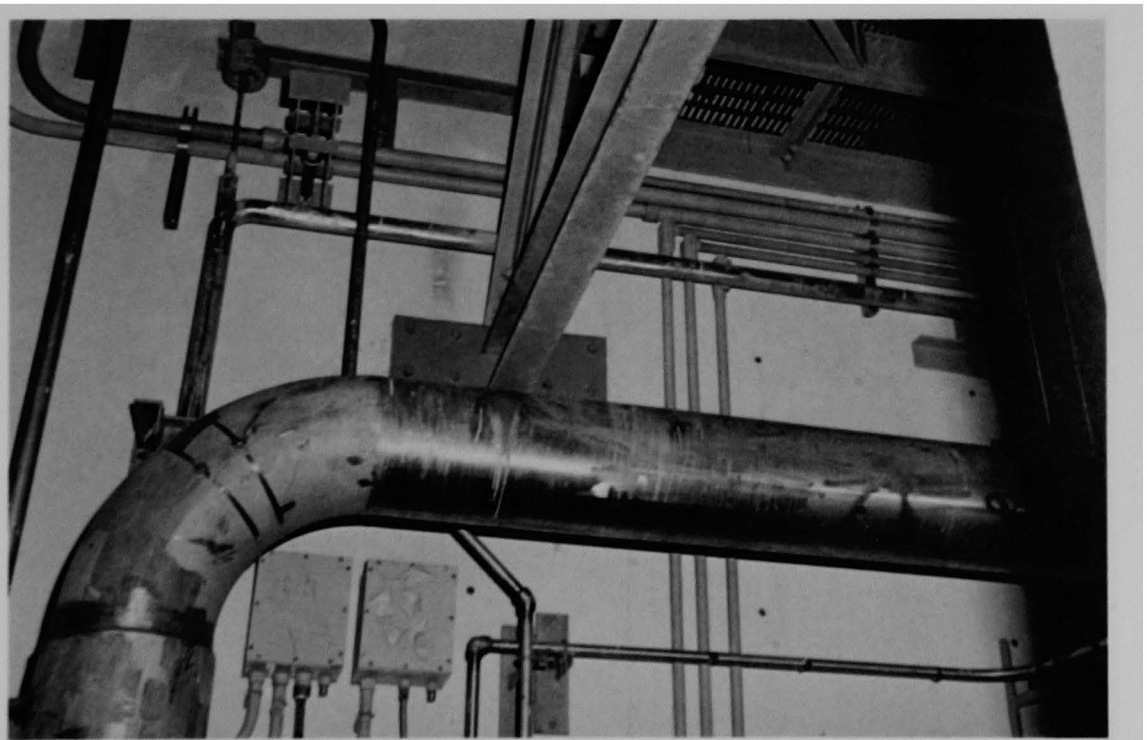
Figure 61 (2A). Core flood tank B piping running under access platform to core flood tank valves.

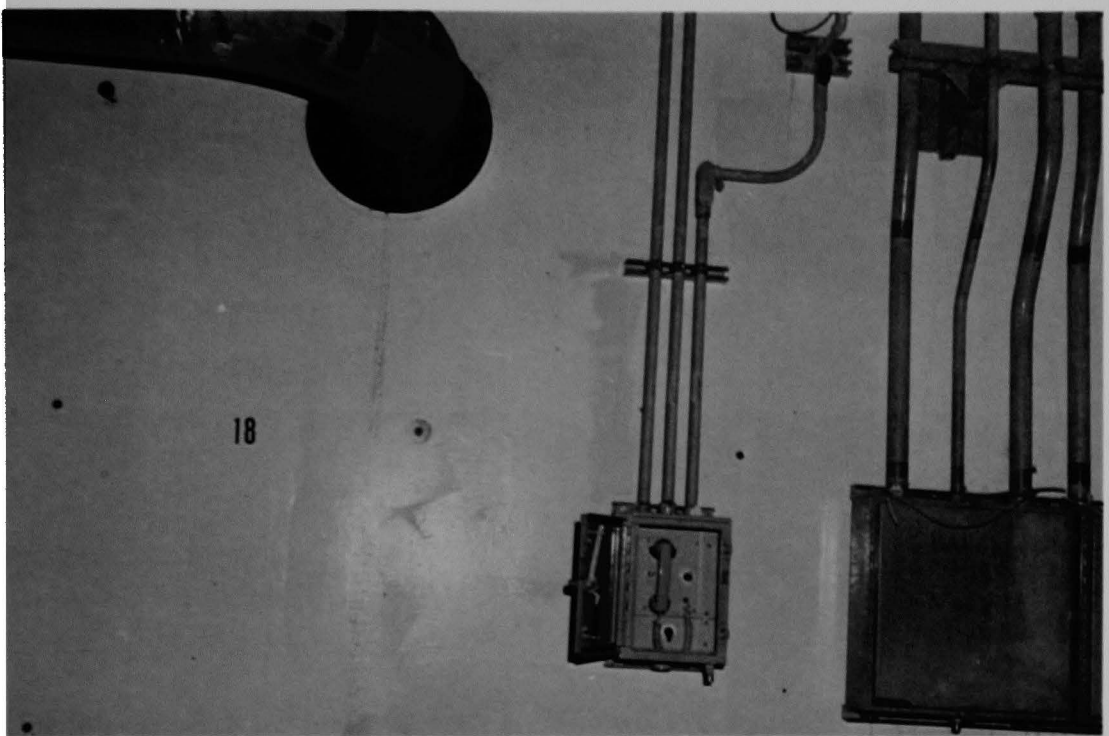
Figure 64 (2A). Core flood tank inlet piping, Gai-tronic telephone, and source range instrumentation panel.

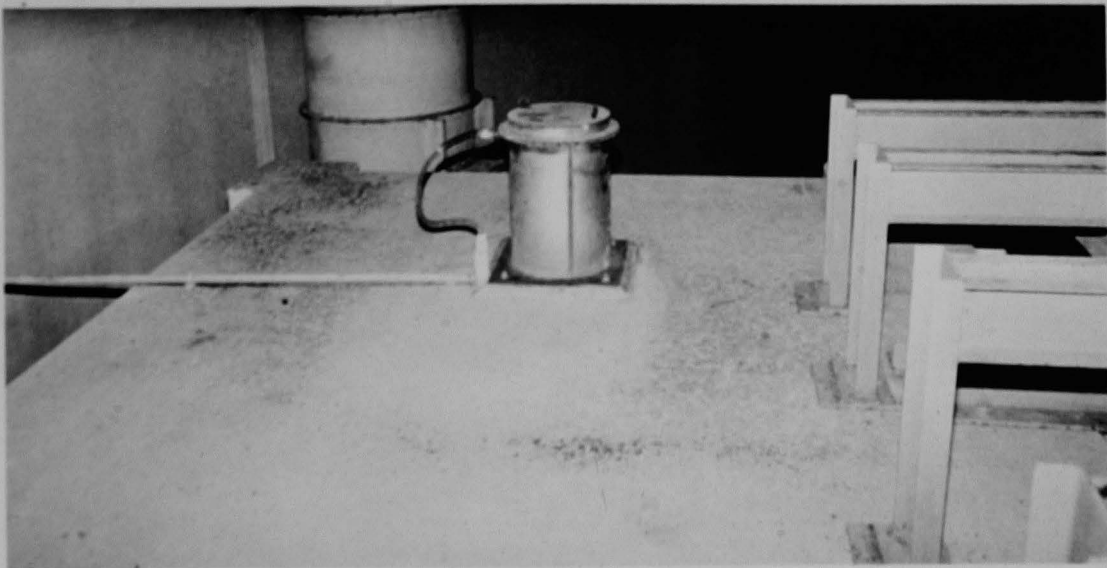
Figure 106 (5C). South end of elevator roof, HP R-211 dome monitor center; brackets for head lifting slings right.

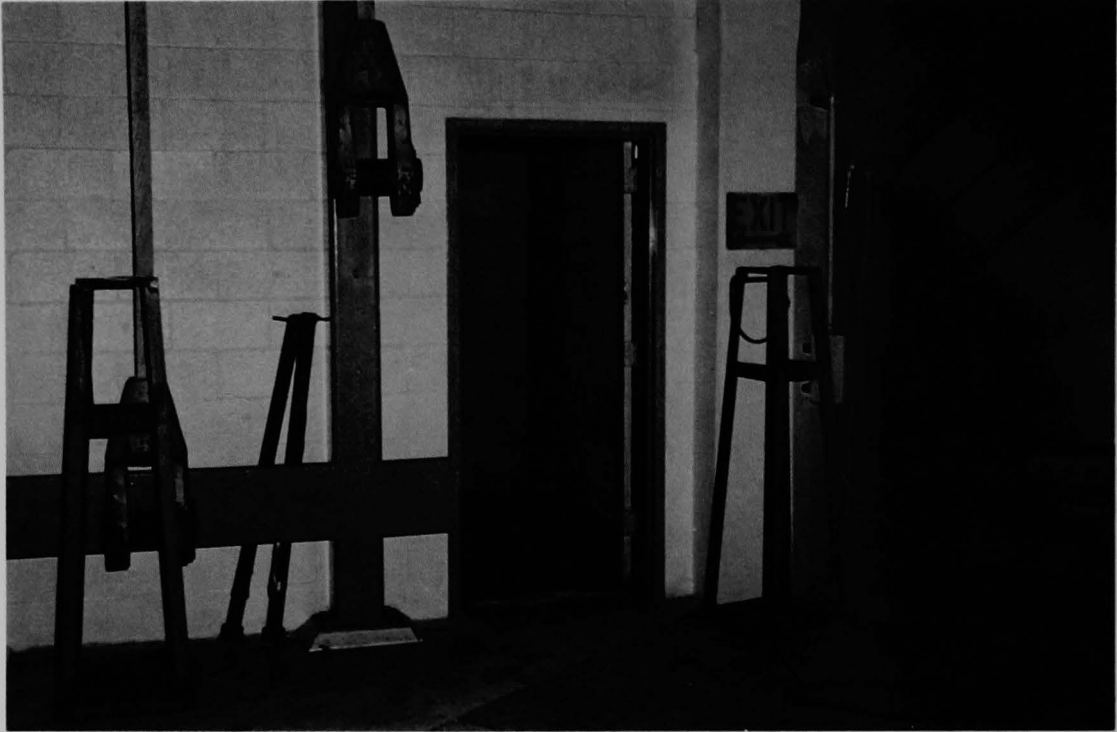
Figure 107 (4A). Enclosed stairway; head lifting slings left, air duct right.

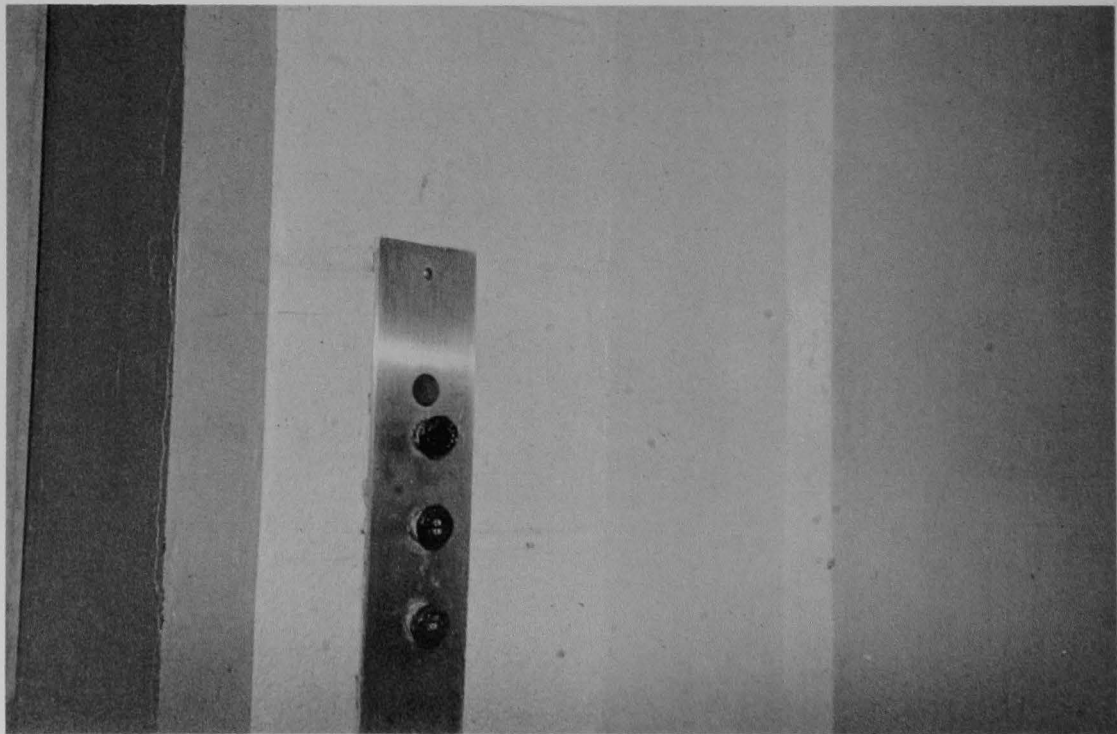
Figure 108 (6A). Close-up of elevator control buttons next elevator door (elevation 347).
