**Color Photographs
Of The Three Mile Island Unit 2
Reactor Containment Building:
Volume 1—Entries 1, 2, 4, 5, 6**

October 1981

**EG&G Idaho, Inc.
Idaho Falls, Idaho 83415**

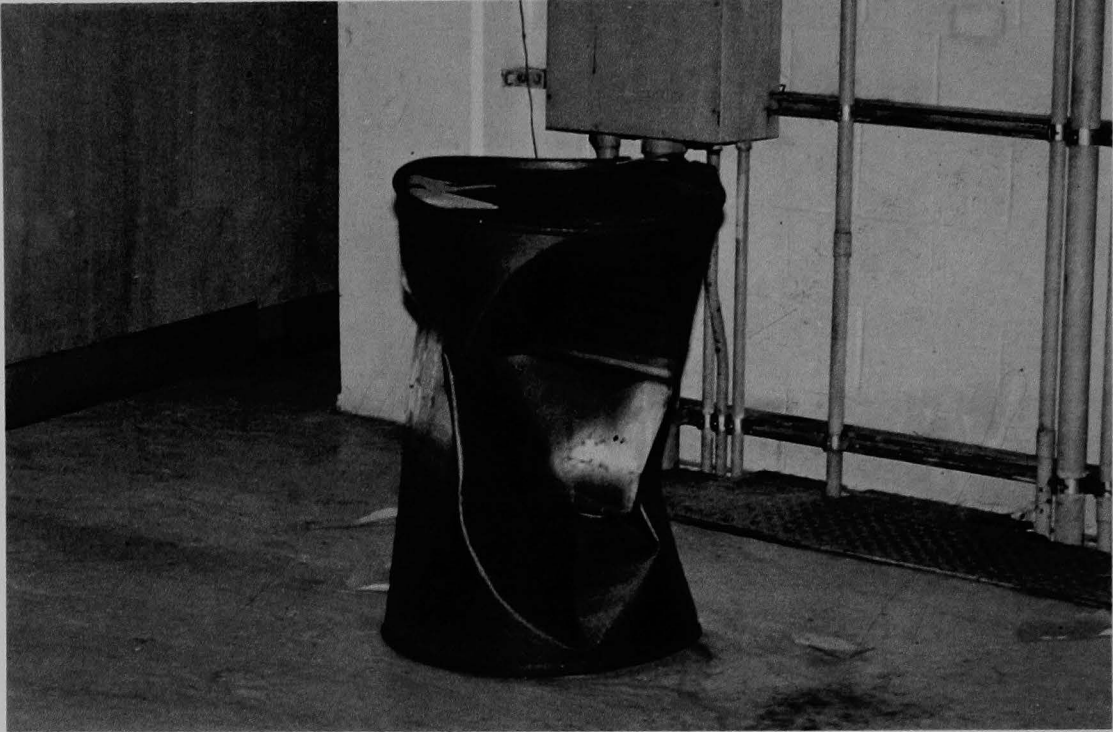
Figure 111 (4B). Fifty-five gallon drum, closer view of Figure 110.

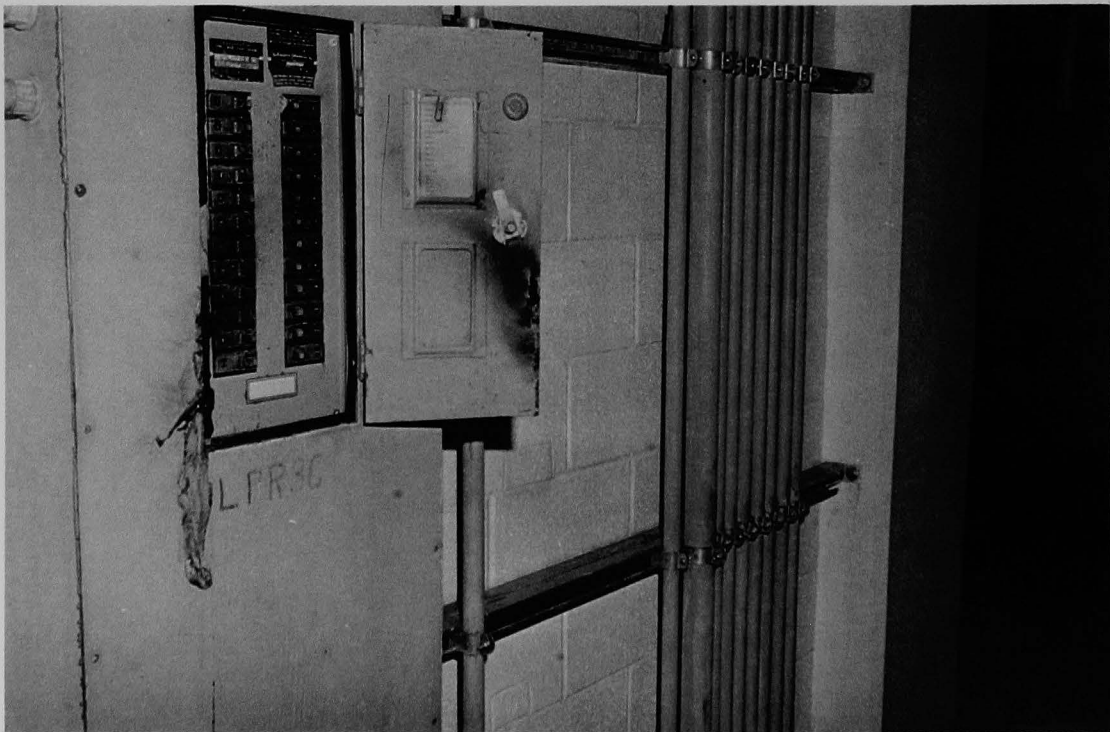
Figure 112 (6A). Northeast end of enclosed stairwell, electrical breaker box mounted on elevator wall.

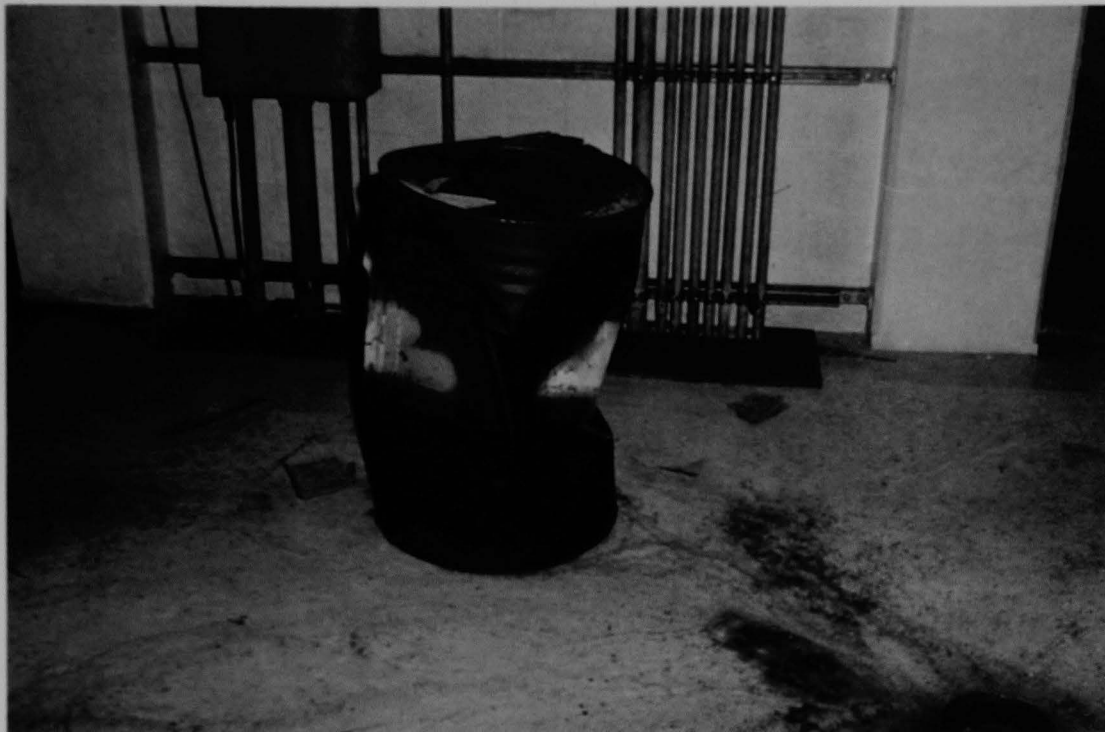
Figure 113 (4A). Fifty-five gallon drum; northeast elevator wall in background.

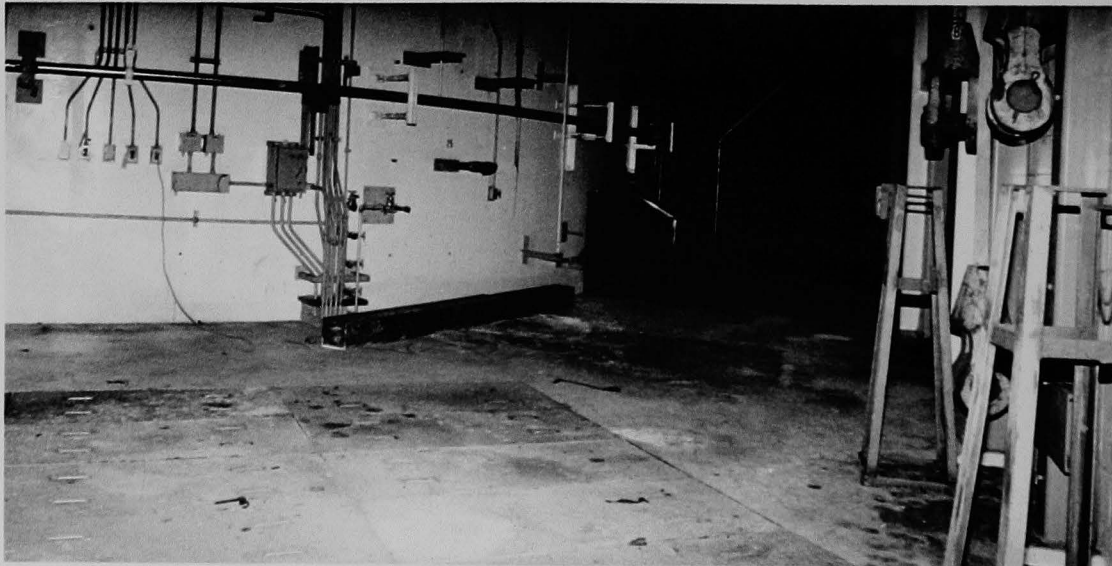
Figure 116 (5C). South end of D-ring; head lifting pendants right.

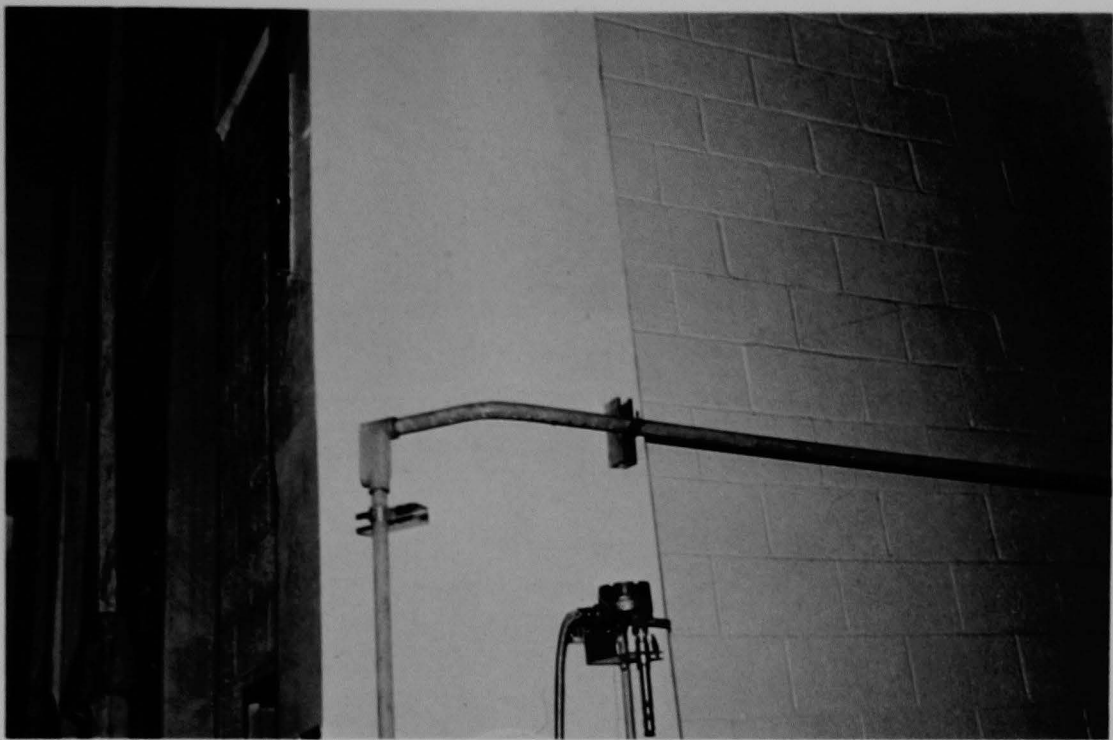
Figure 117 (2B). West corner of enclosed stairway; head lifting pendants left, temperature instrument center.

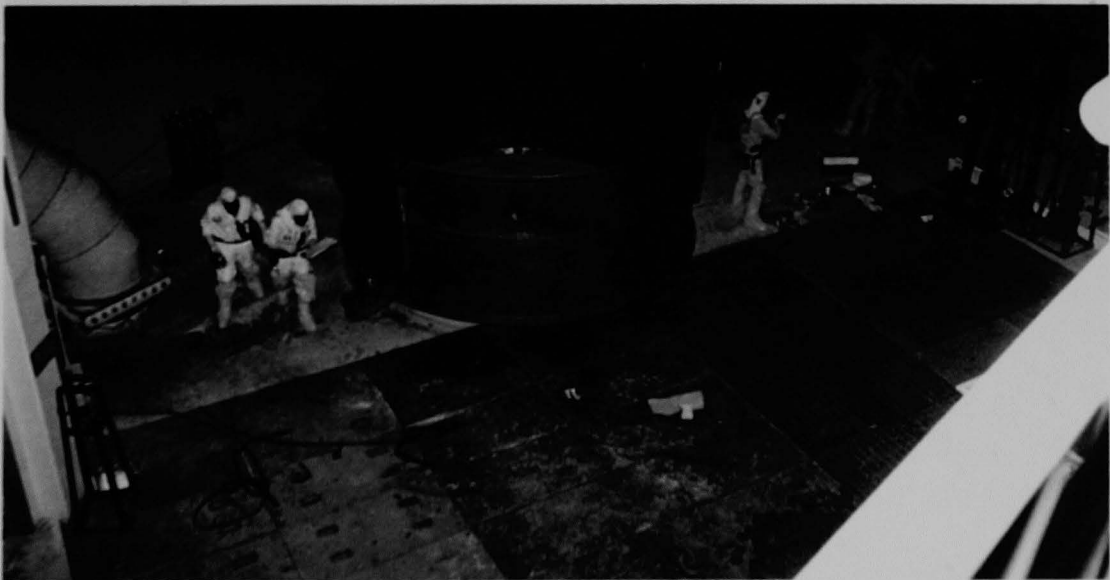
Figure 118 (5C). Operating deck from atop D-ring A, technicians performing decontamination tests.

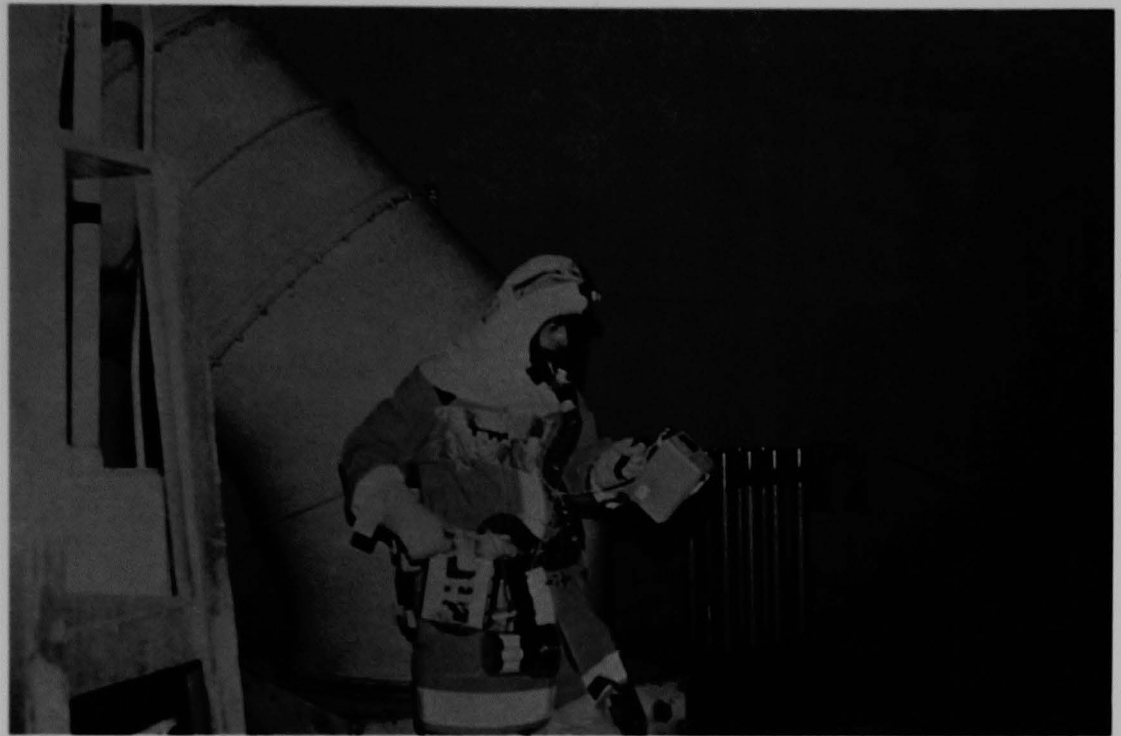
Figure 125 (2B). Radiation surveying southwest of enclosed stairway (cf. Figure 118 background left).

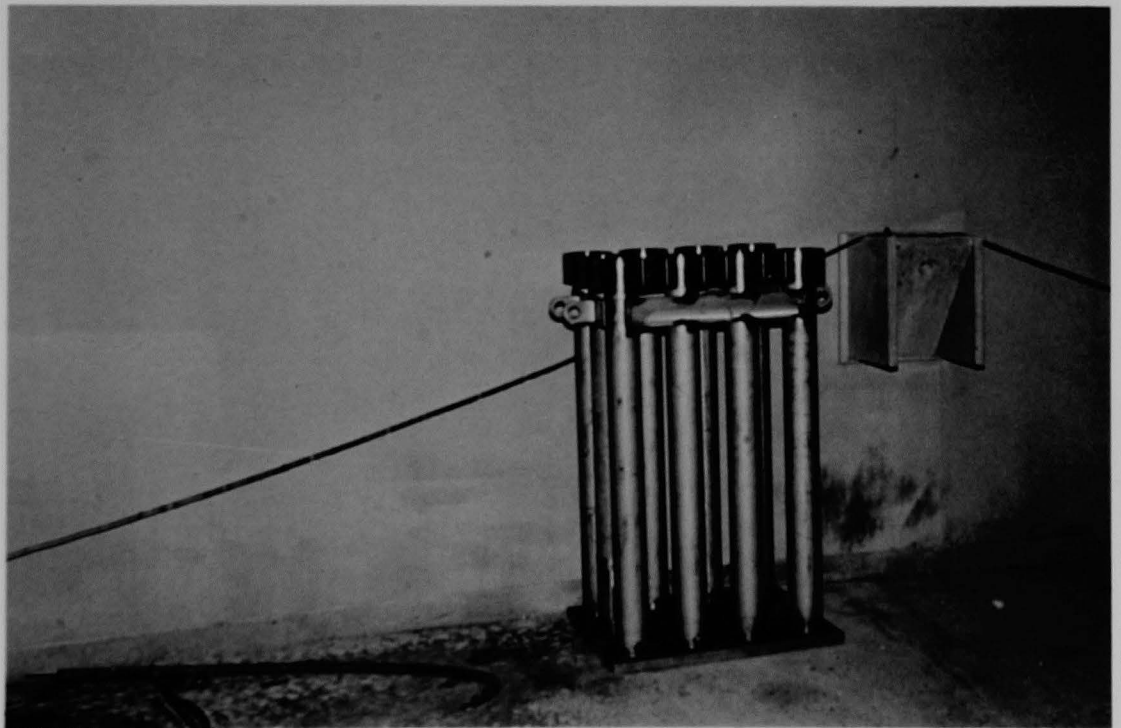
Figure 126 (2B). Stainless steel specimen capsule storage stand.

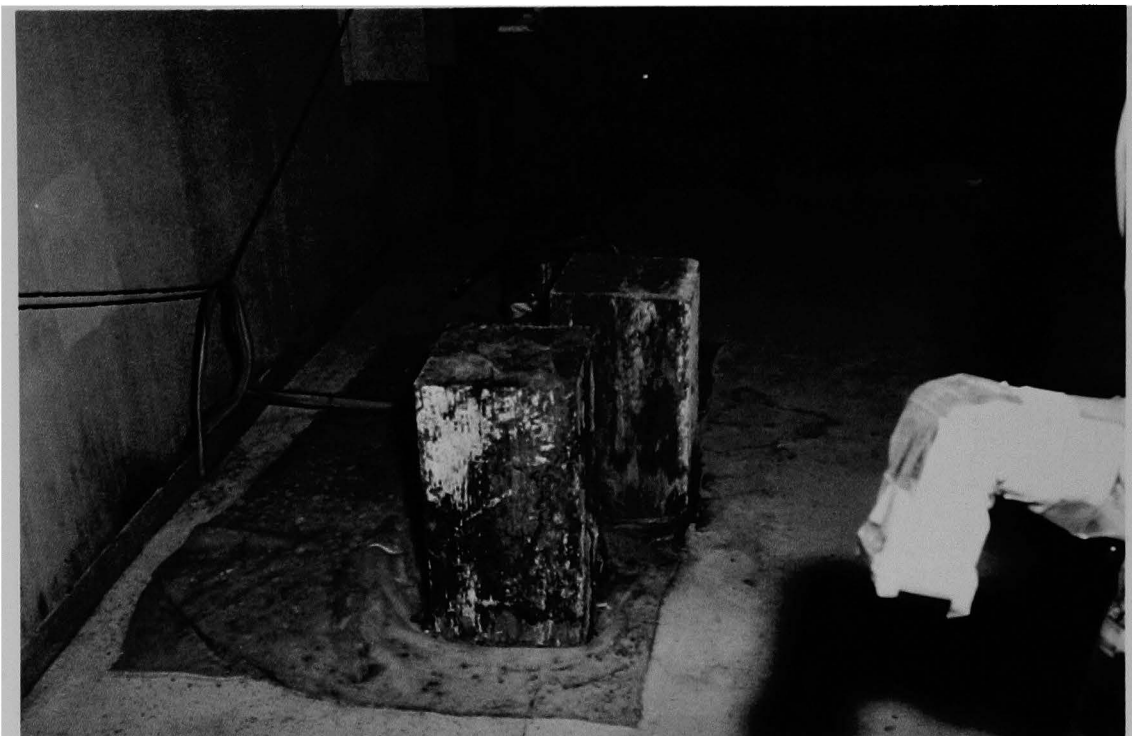
Figure 127 (4A). Wood blocks; liner left, technician right (cf. Figure 125, right).

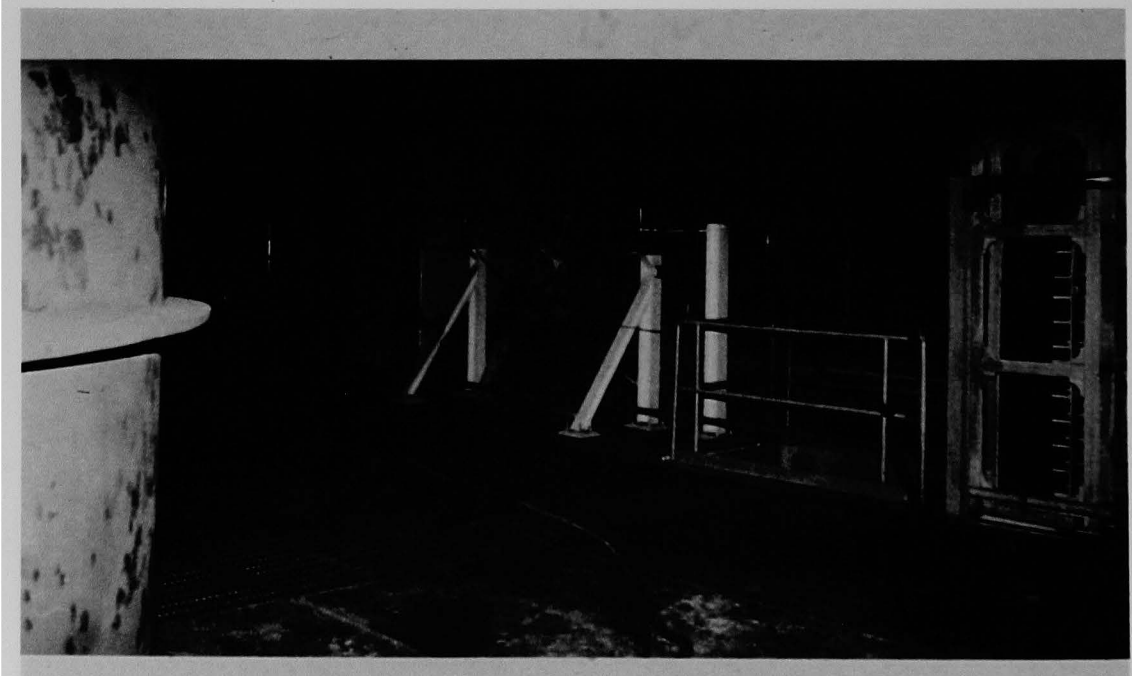
Figure 128 (5C). Auxiliary fuel handling bridge area.

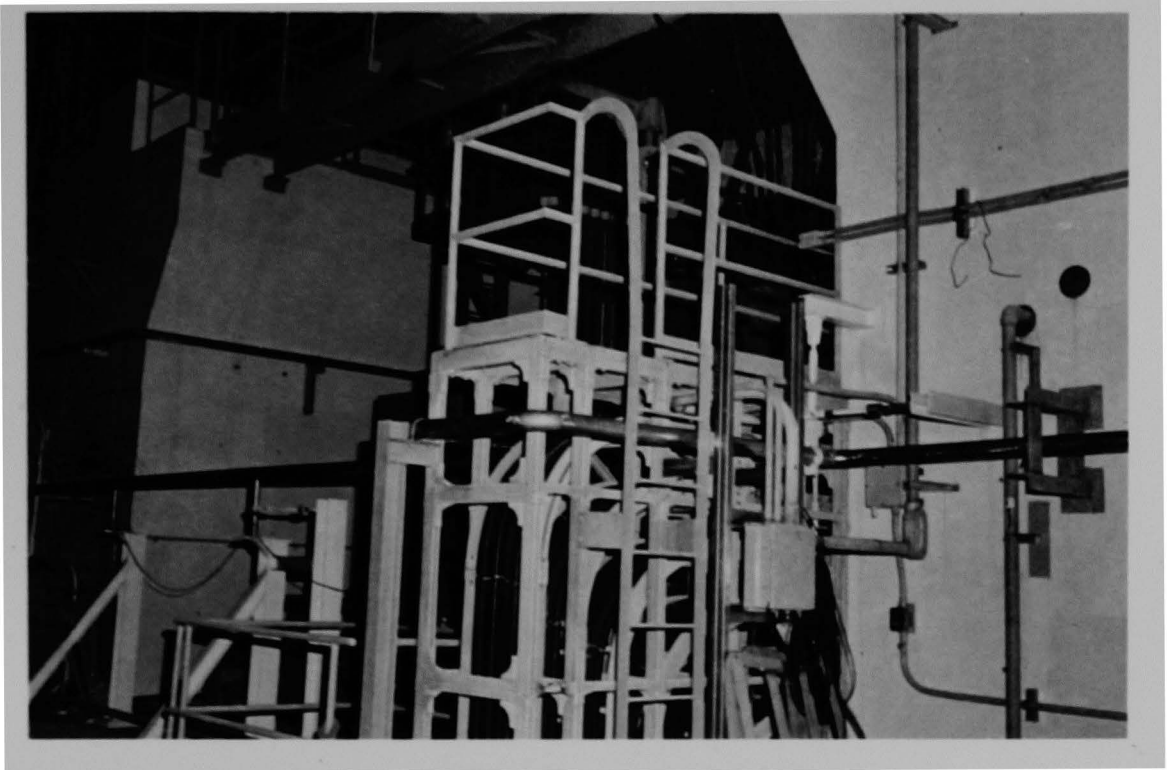
Figure 129 (2A). Control rod drive mechanism cable trays (see Figure 97, left).

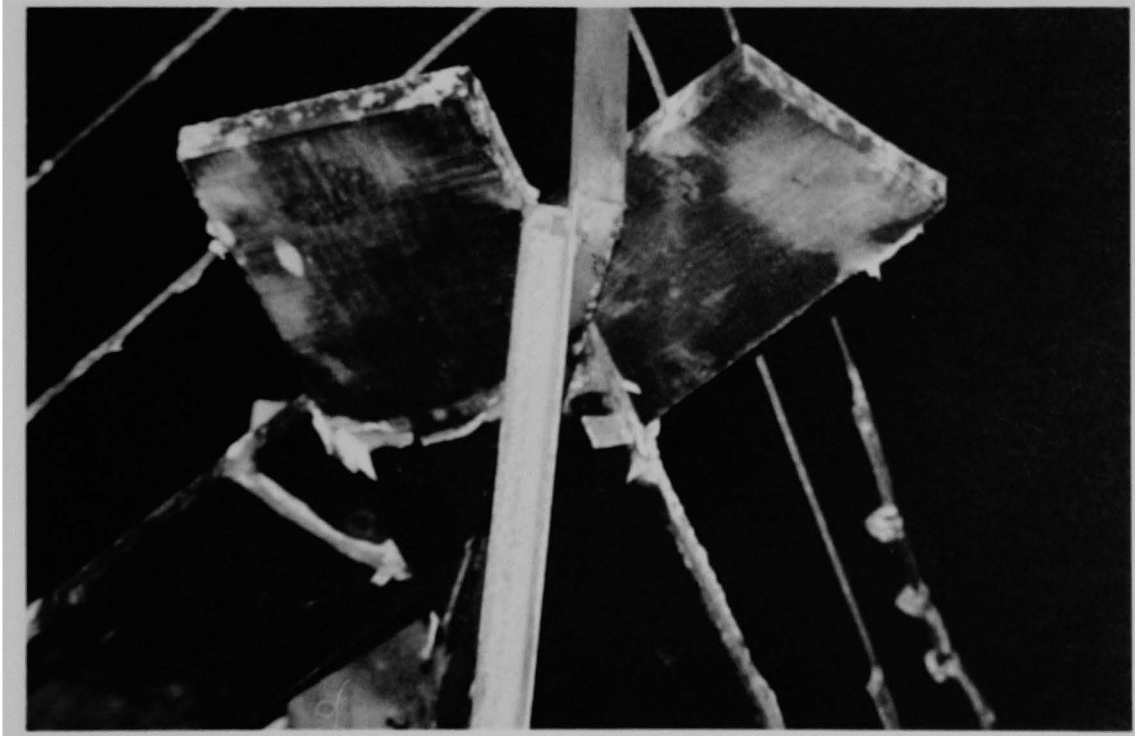
Figure 131 (4B). Scaffolding (see Figure 130).

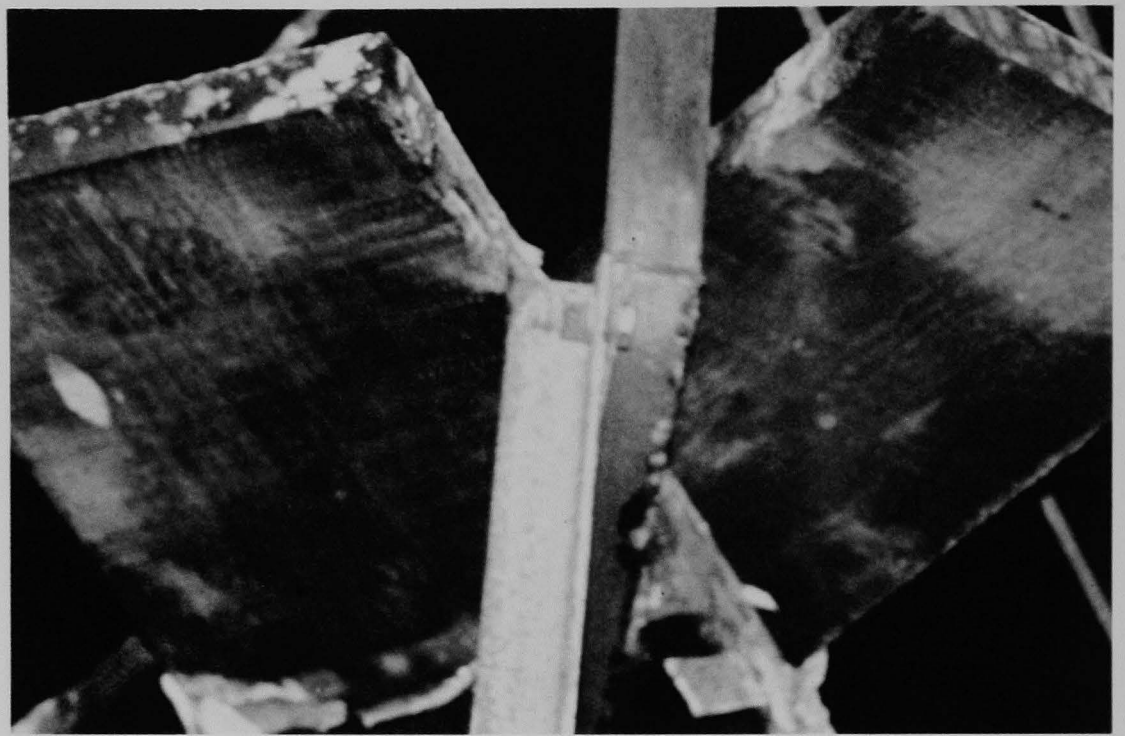
Figure 132 (4B). Close-ups of boards on scaffolding (see Figure 130).

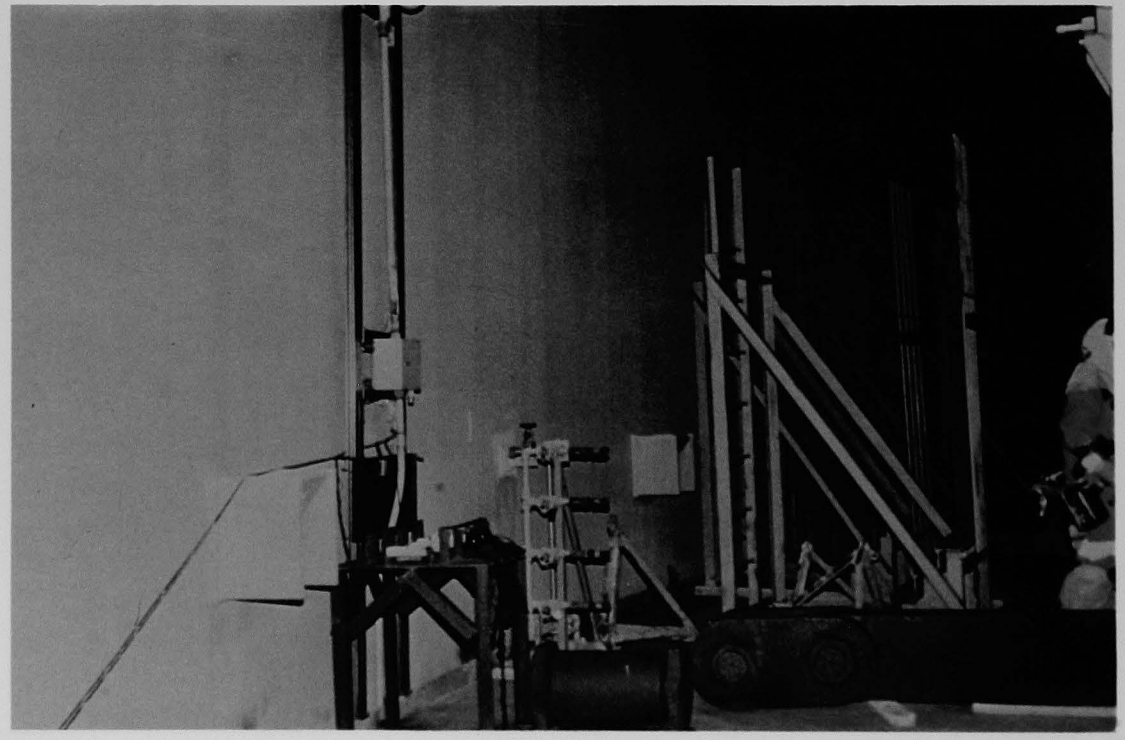
Figure 133 (2B). South liner wall: telephone bench, internals handling extension on floor, storage stand behind, internals indexing fixture right.

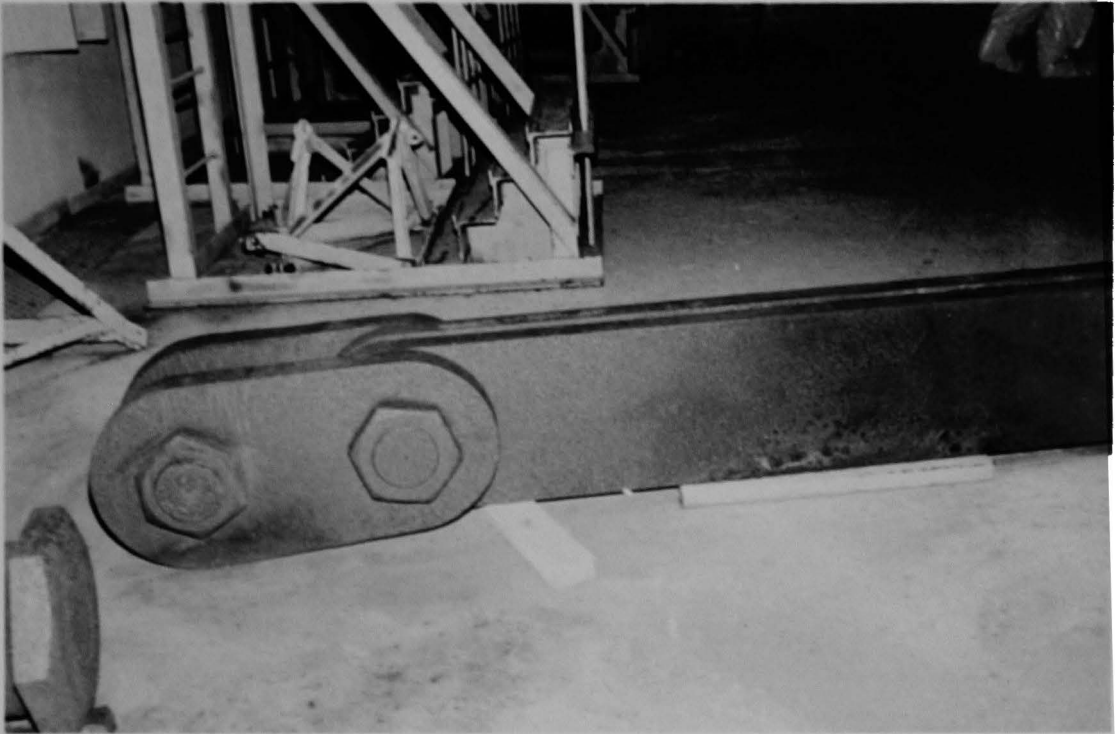
Figure 134 (2B). Close-up of internals handling extension.

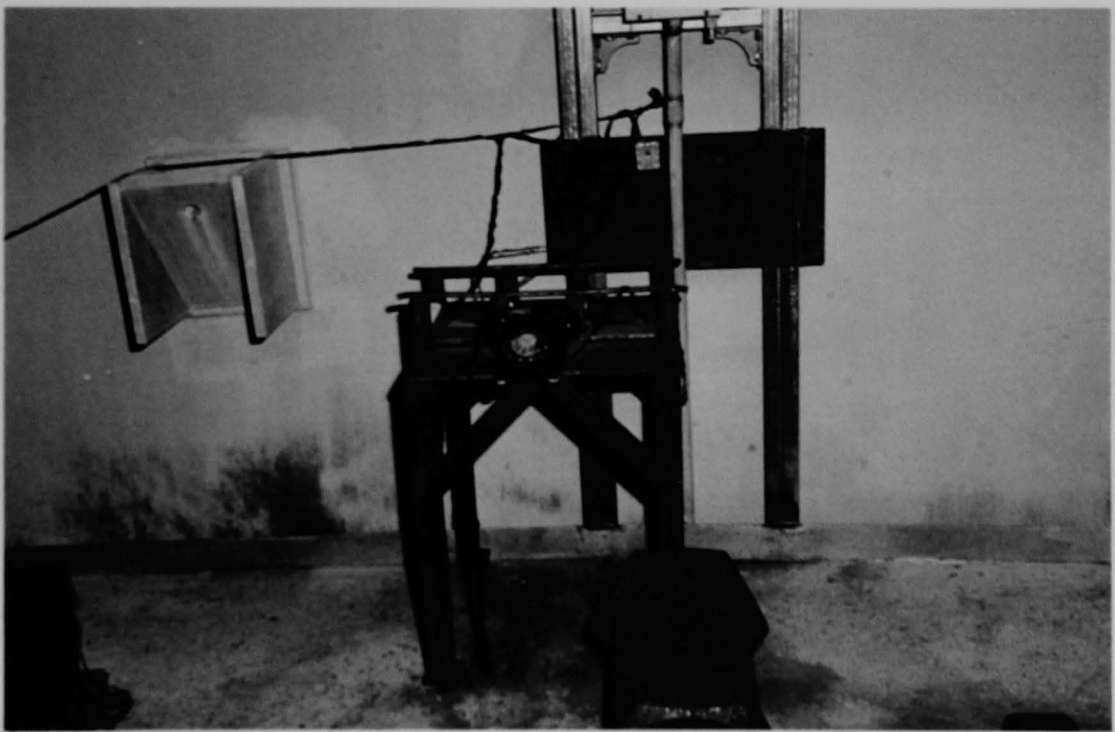
Figure 135 (4A). Telephone bench, due south against liner.

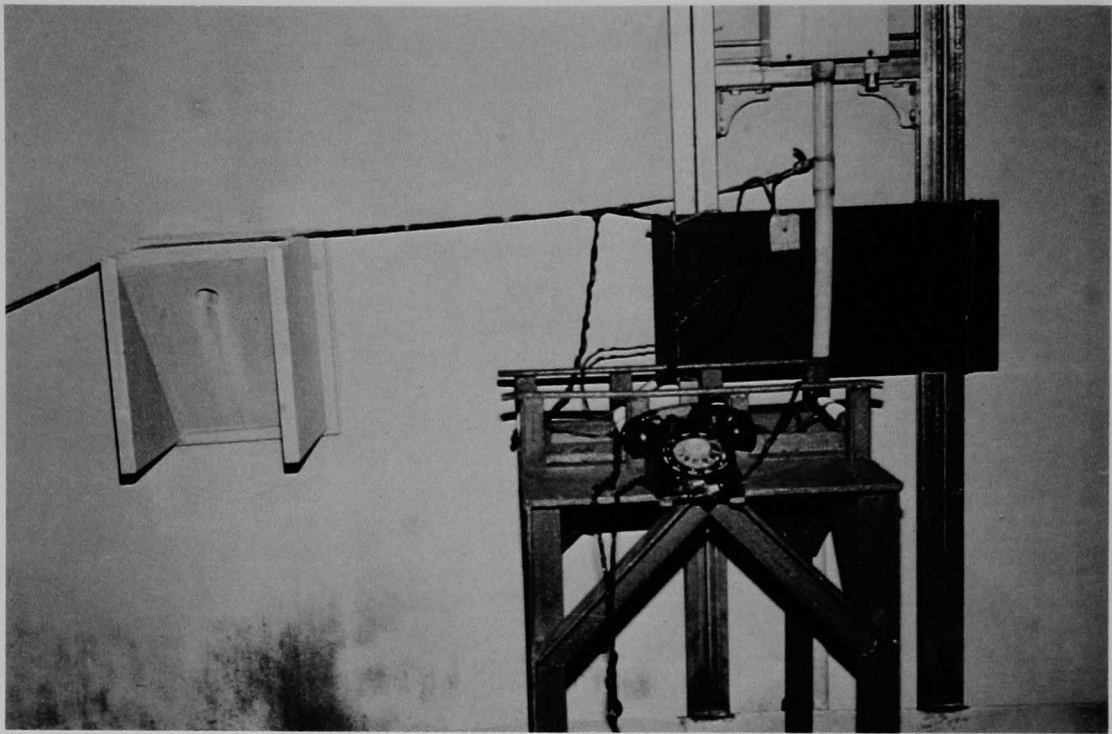
Figure 136 (2B). Bell Telephone.

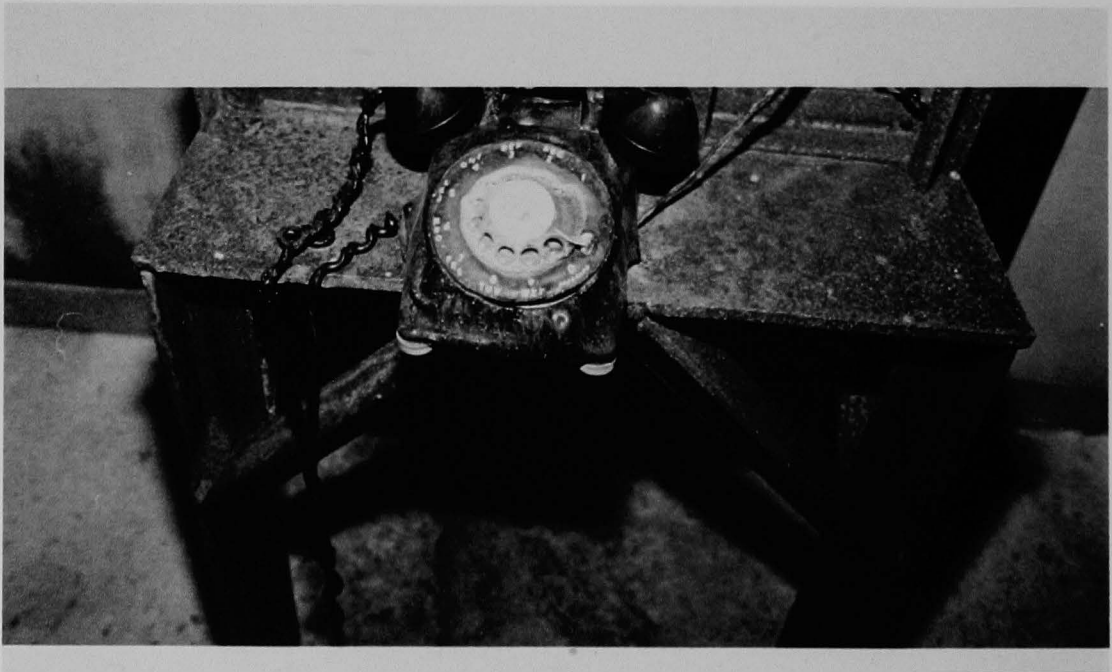
Figure 137 (5C). Closer view of Bell Telephone.

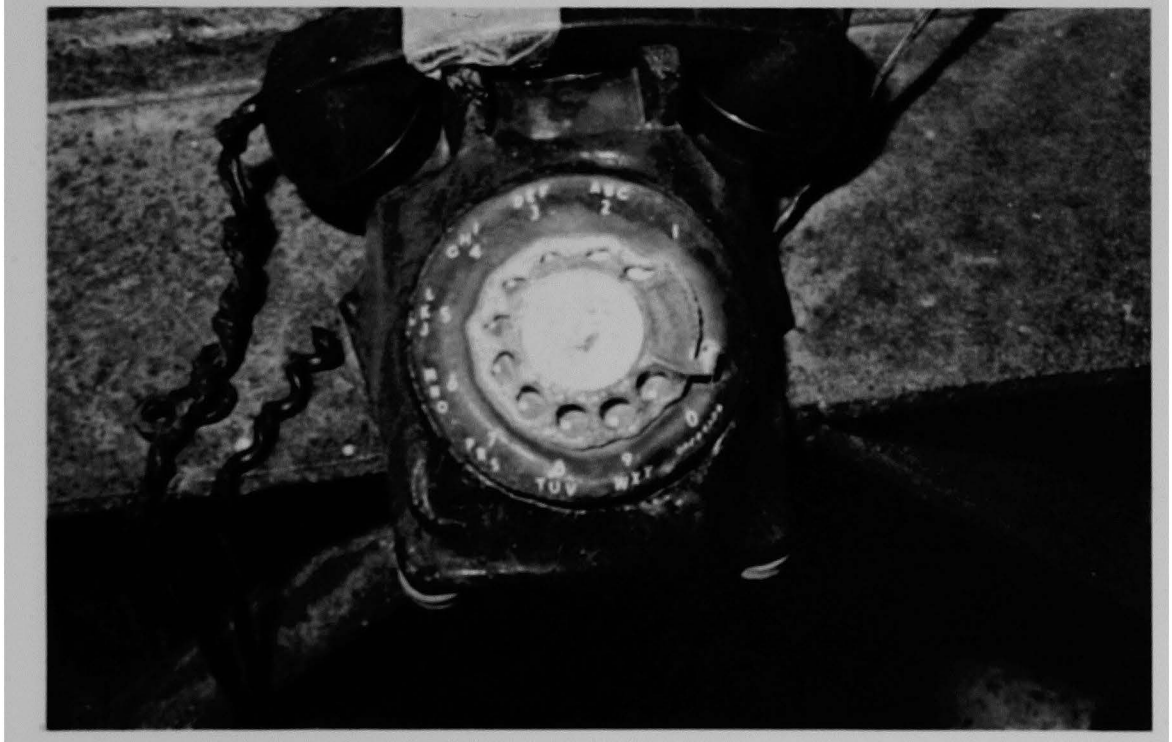
Figure 139 (4). Close-up of Bell Telephone, second view .

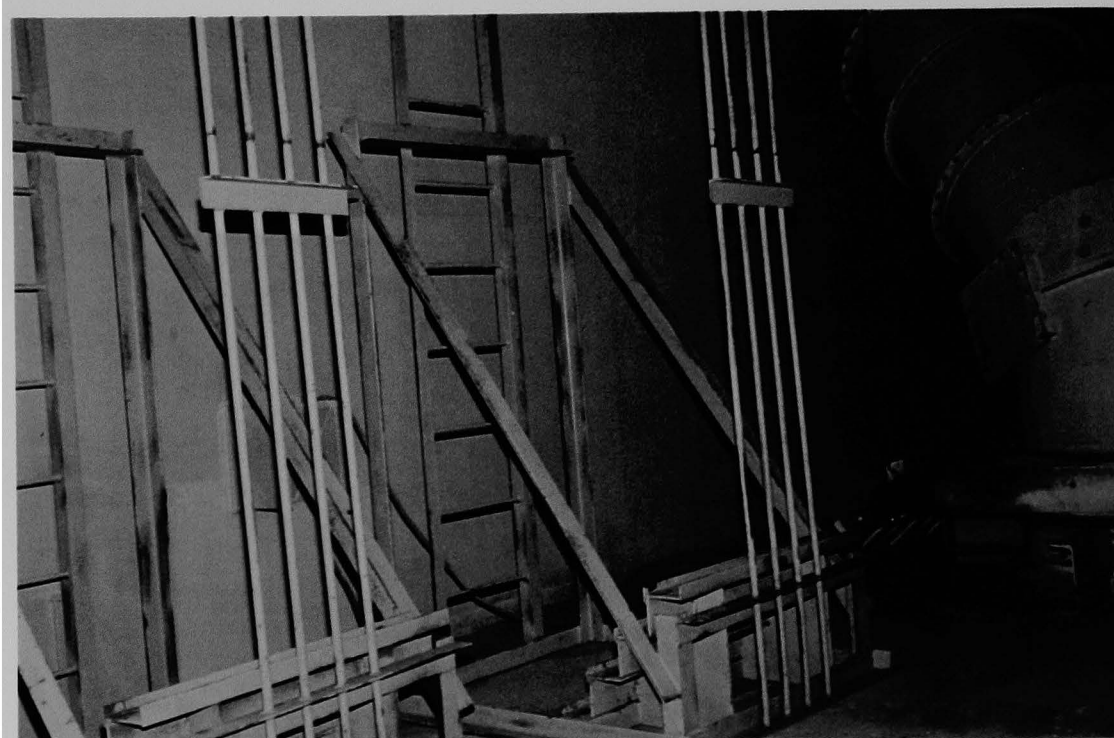
Figure 140 (2B). Storage stands for the mirror insulation.

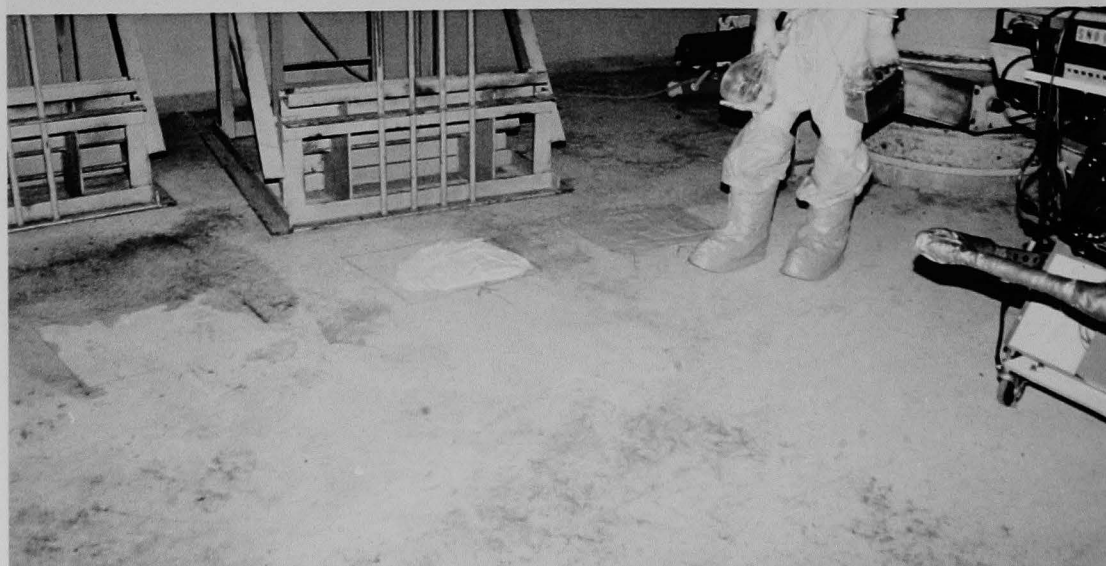
Figure 141 (5C). Decontamination test area in front of mirror insulation storage stands.

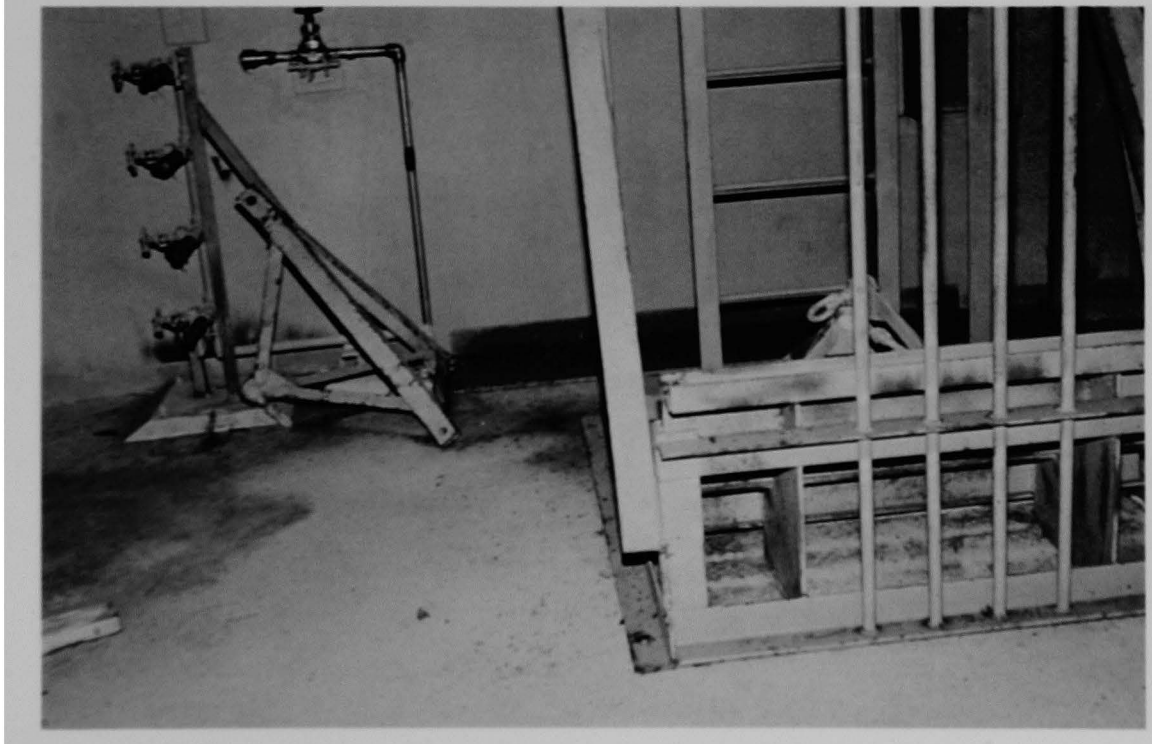
Figure 143 (2B). Close-up of the storage stand for the mirror insulation (standard carbon steel pinated).

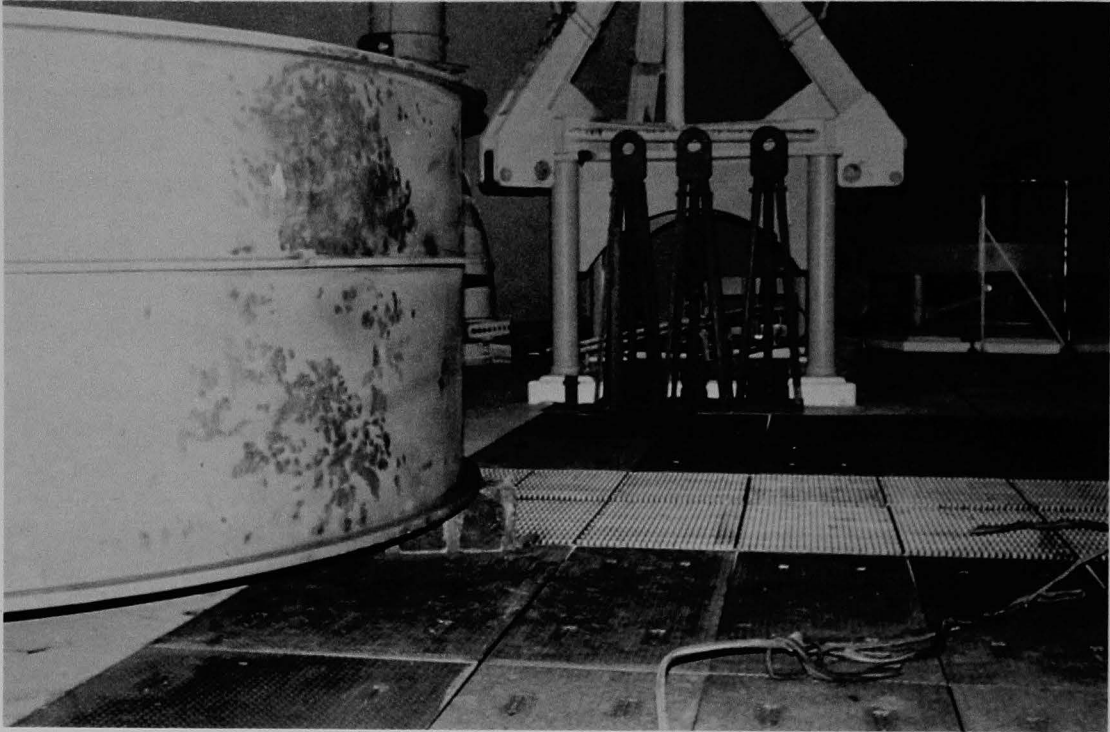
Figure 144 (2B). Panorama west from the enclosed stairwell; indexing fixture left, internals handling pendants in their storage stands and reactor coolant pump with vessel head and internals center.

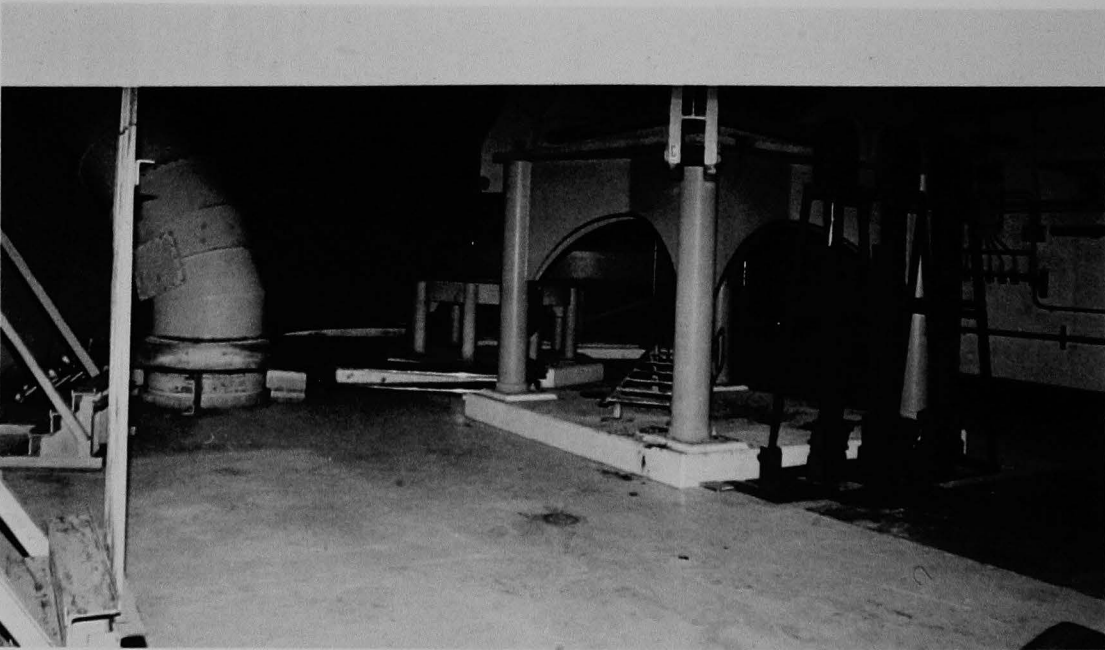
Figure 145 (5C). Reactor coolant pump alignment stand and internals handling pendants.

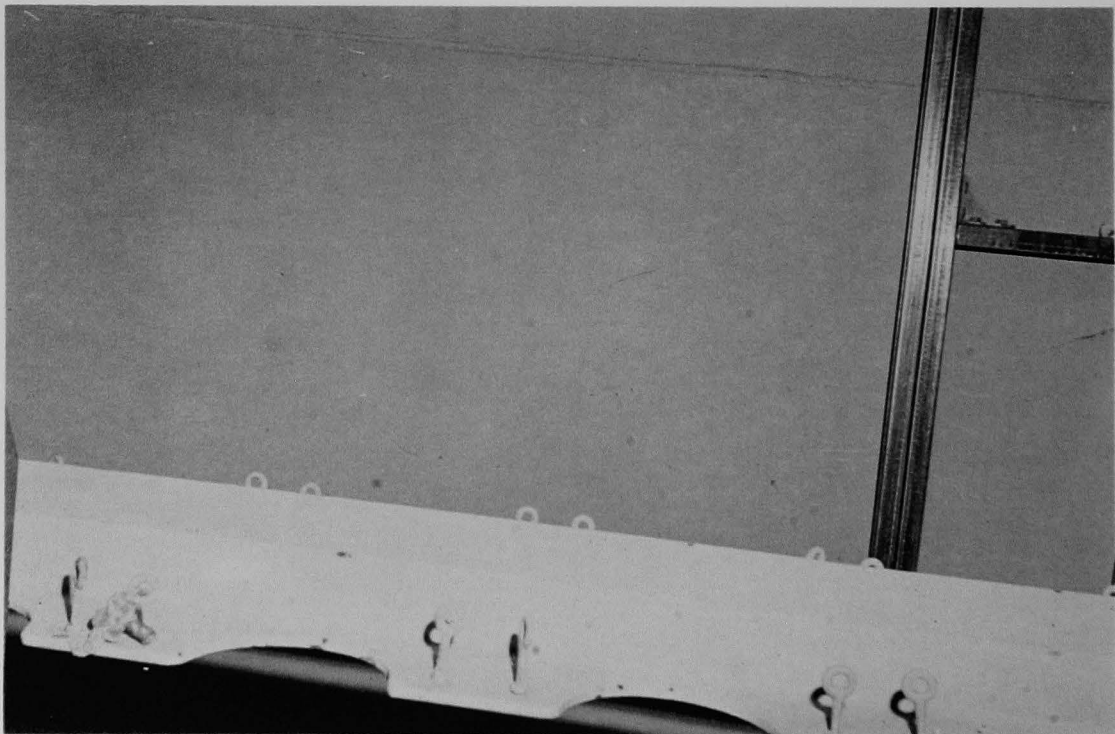
Figure 152 (4). Close-up of reactor vessel guide studs and melted rod rope.

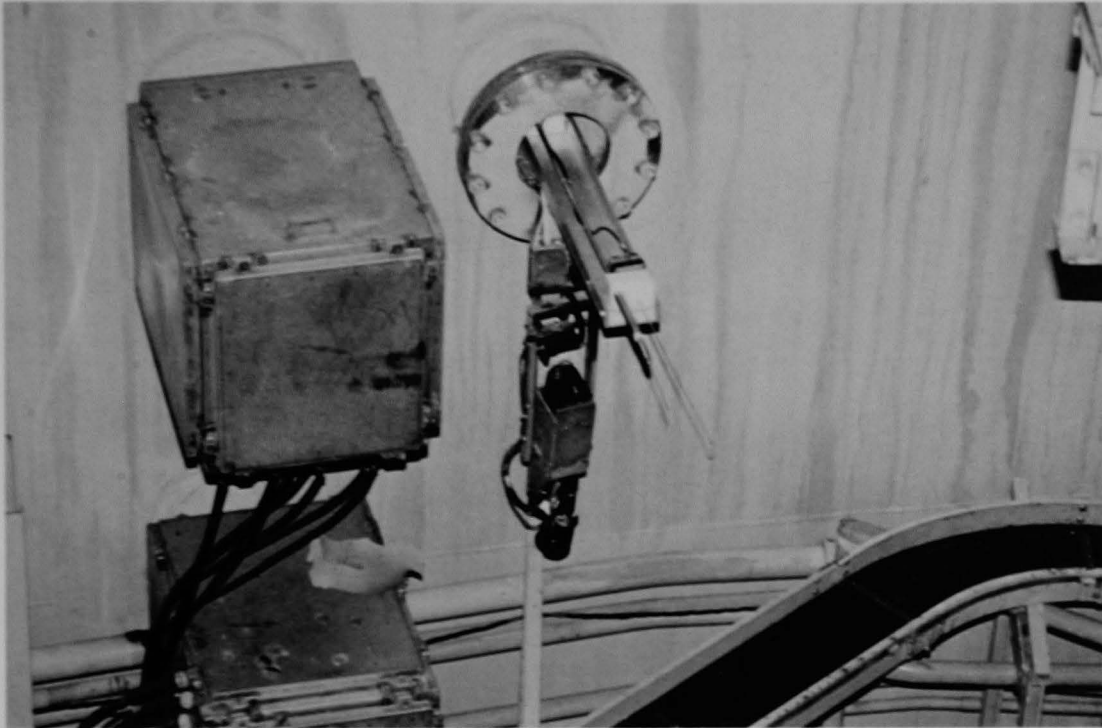
Figure 174 (4A). Incore instrumentation electrical connections; main fuel handling bridge background. (This photograph was taken to document boron crystal accumulation.)

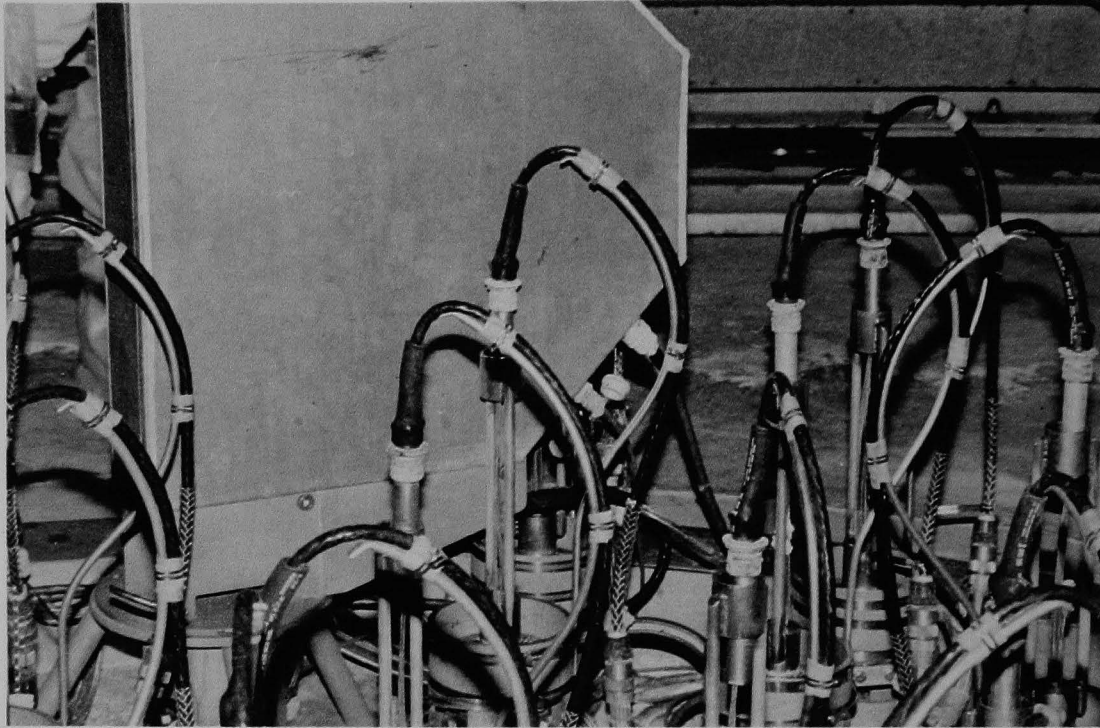
Figure 176 (4A). Incore instrumentation electrical connections, main fuel handling bridge background, closer view. (This photograph was taken to document boron crystal accumulation.)

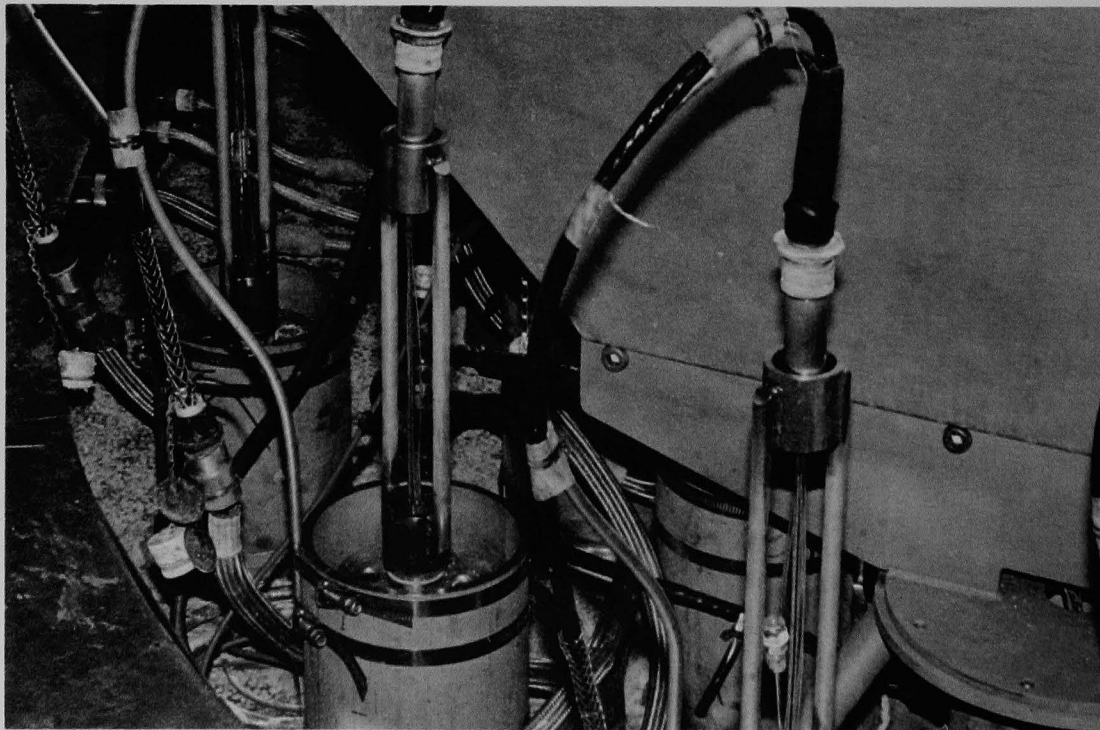
Figure 177 (4B). Incore instrumentation seal table (the metal cover houses the cable wheel for the movable incore detector. This photograph was taken to document boron crystal accumulation.)
