**Color Photographs
Of The Three Mile Island Unit 2
Reactor Containment Building:
Volume 1—Entries 1, 2, 4, 5, 6**

October 1981

**EG&G Idaho, Inc.
Idaho Falls, Idaho 83415**

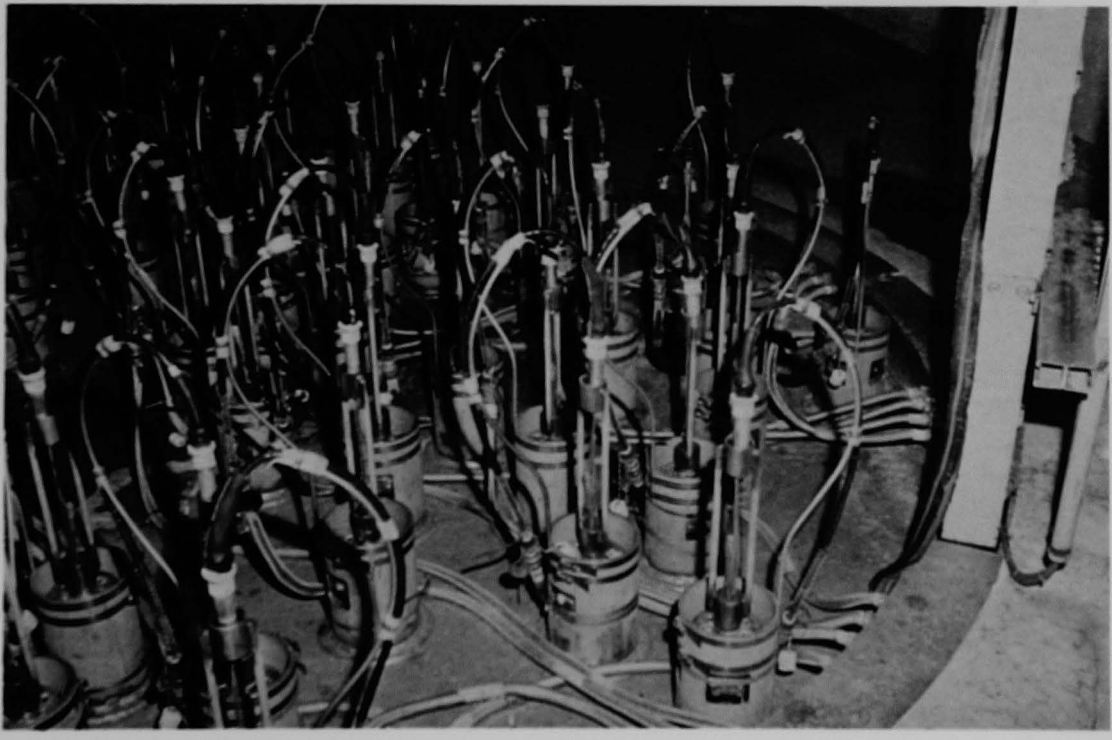
Figure 179 (4B). Incore seal table, view from above. (This photograph was taken to document boron crystal accumulation.)

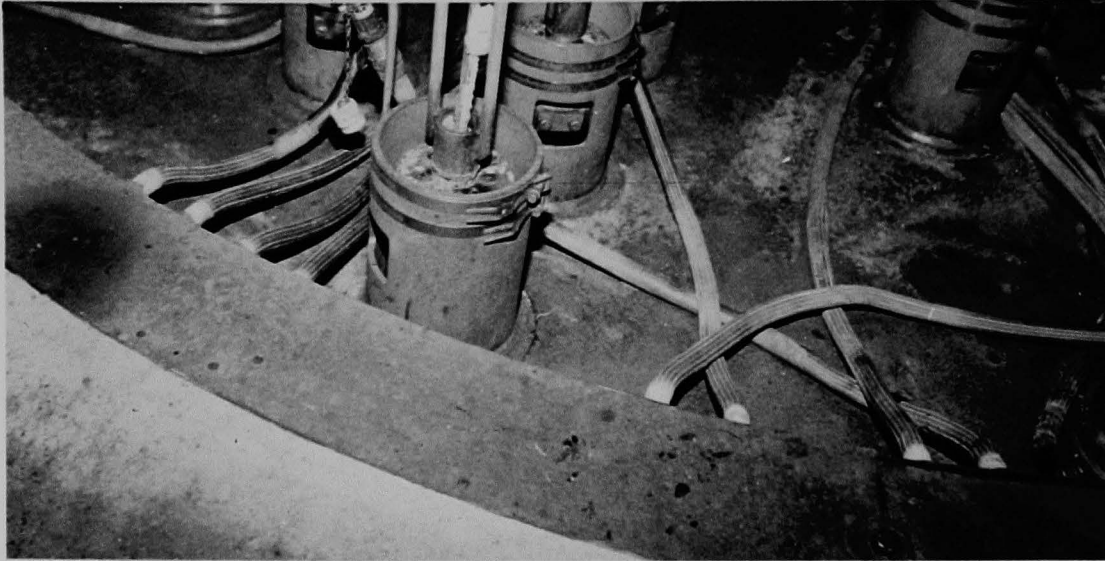
Figure 180 (4A). West side of the incore seal table. (This photograph was taken to document boron crystal accumulation.)

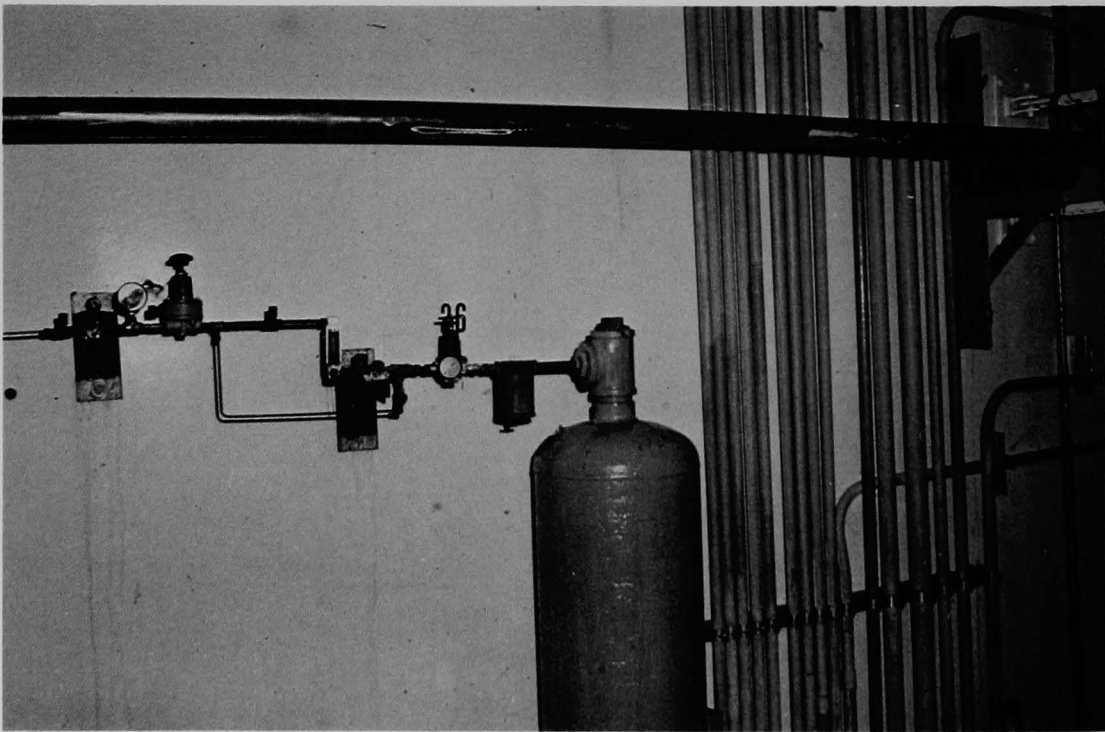
Figure 187 (4A). East side of D-ring B, showing air tank and gauges.

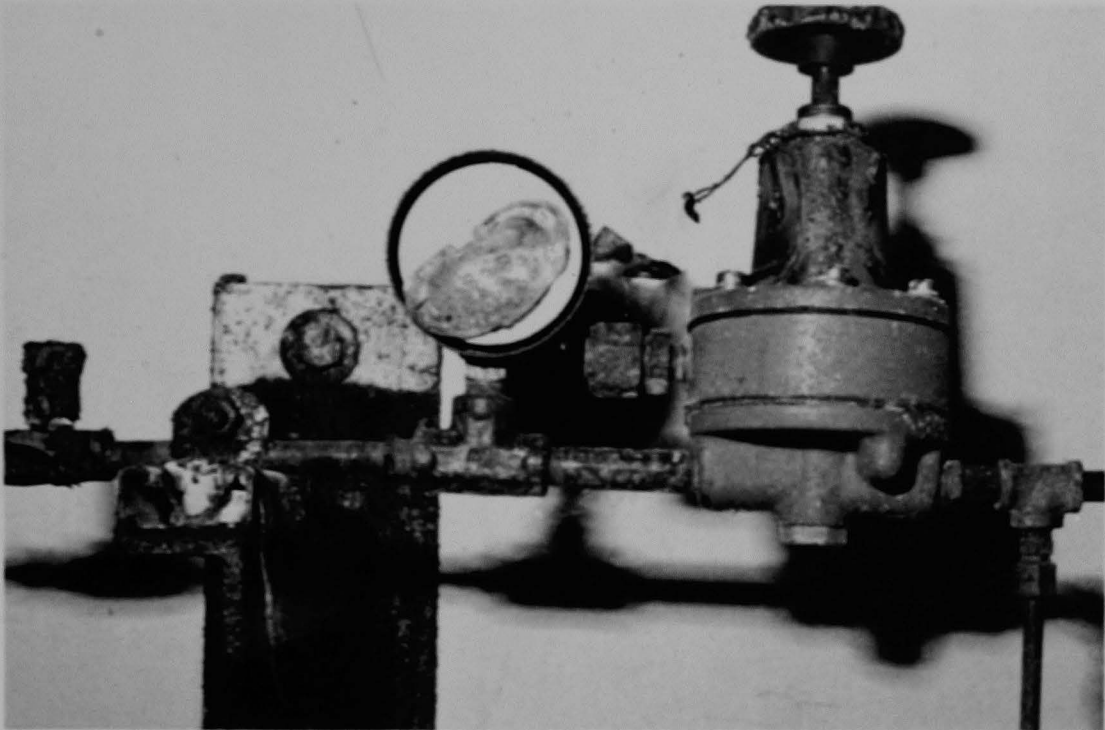
Figure 188 (4). Air pressure regulator mounted on the D-ring wall (see Figure 210) and a guage on which the lens has melted.

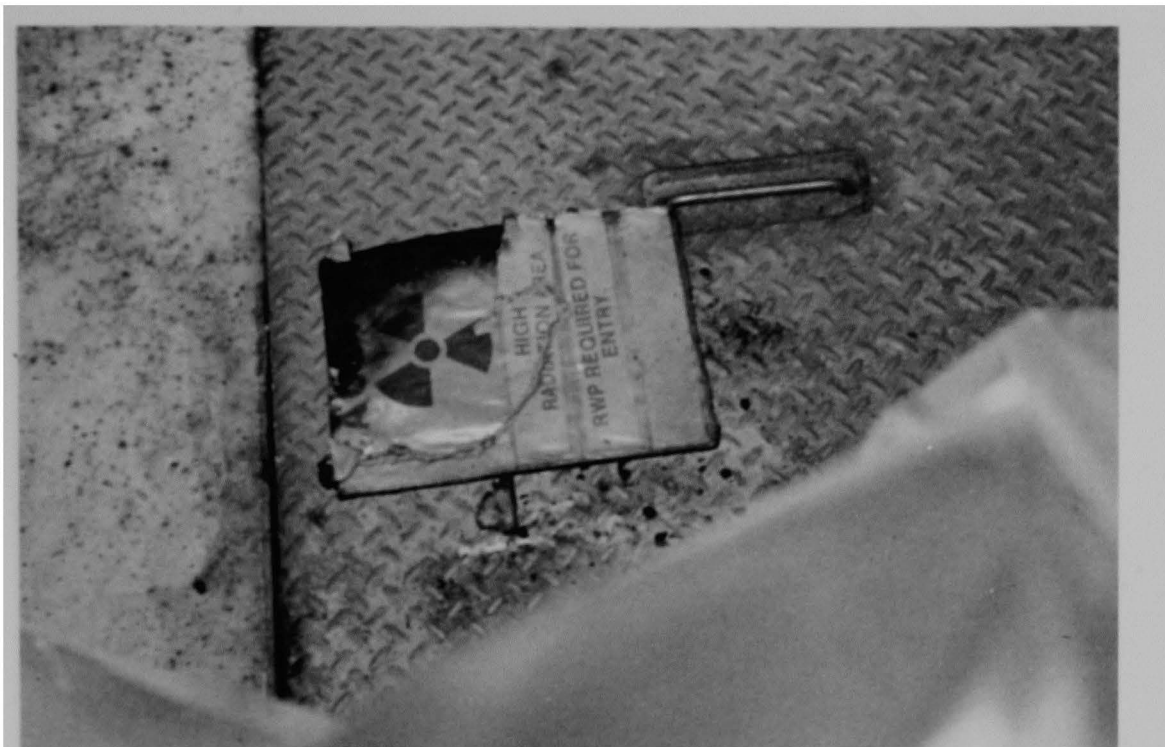
Figure 196 (4). Charred radiation sign lying on the decking over core flood tank A.

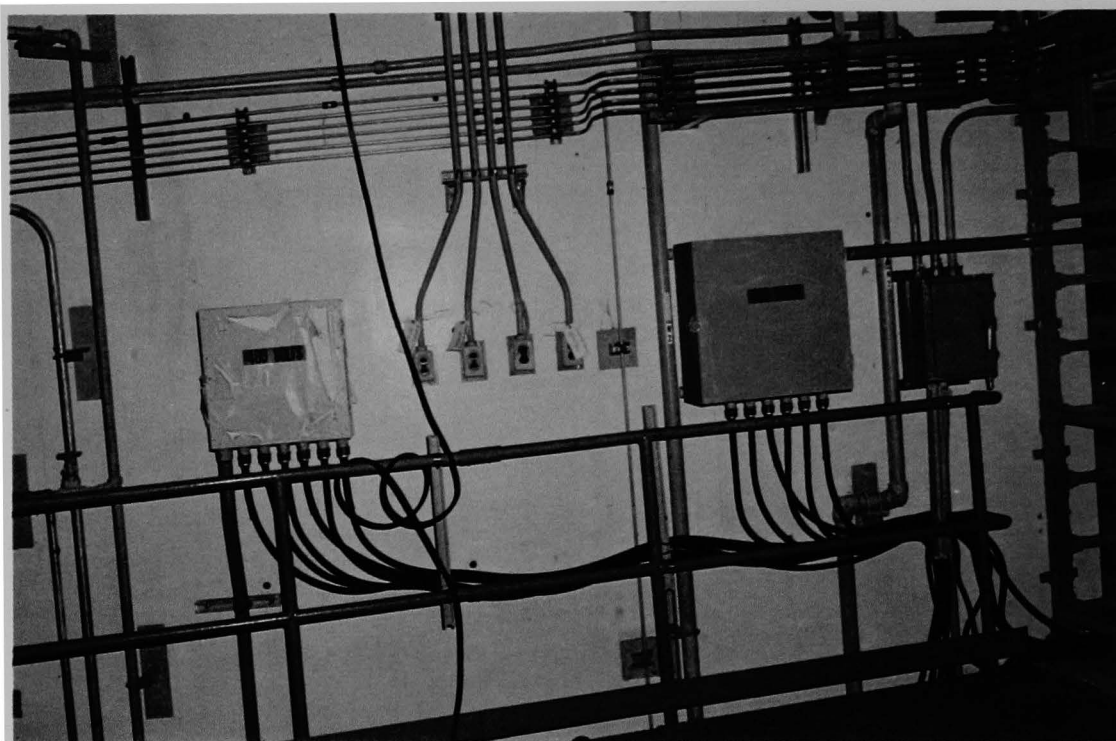
Figure 198 (4A). Energized electrical outlets.

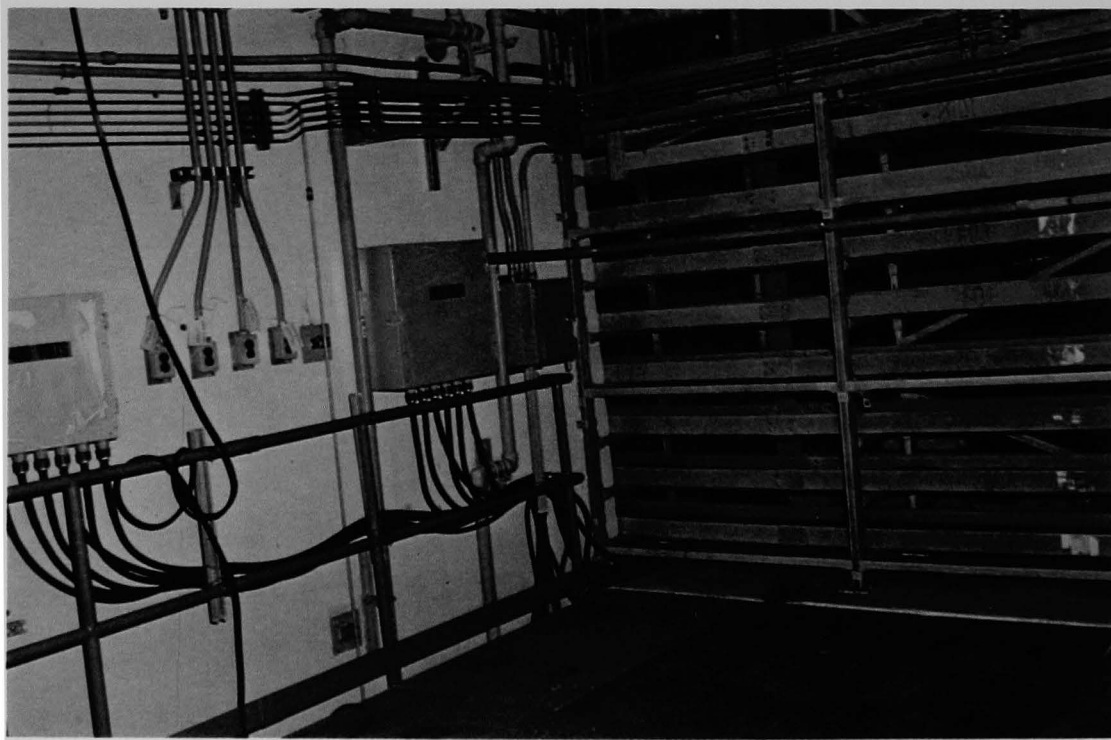
Figure 199 (4A). Energized electrical outlets and cable trays.

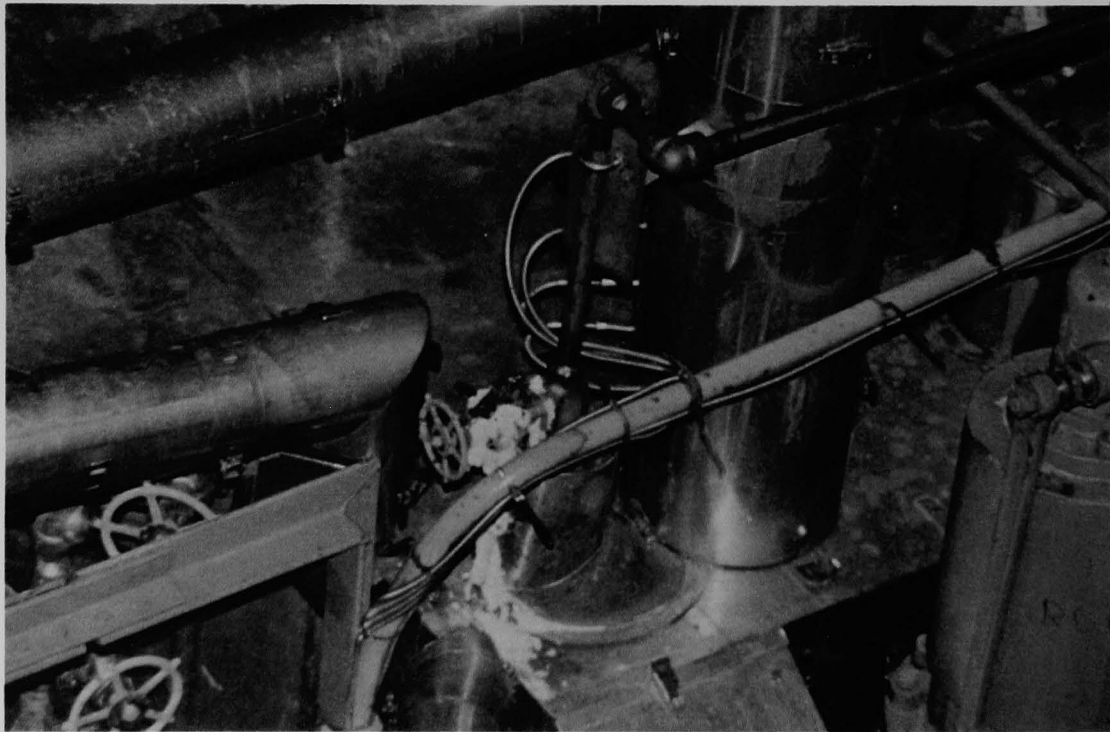
Figure 208 (4B). Valves and pipes above pressurizer (cf. Figure 178). The photograph was taken to document boron crystal accumulation.

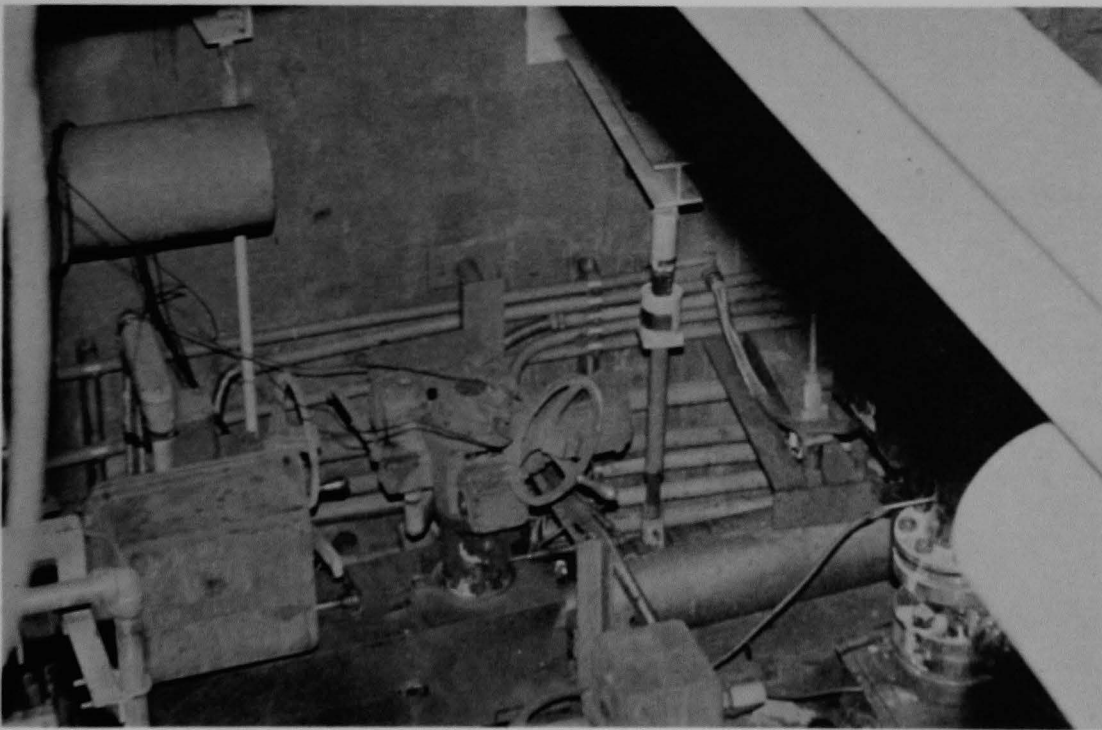
Figure 210 (4B). Pressure-operated release valve above the pressurizer. (The photograph was taken to document boron crystal accumulation).

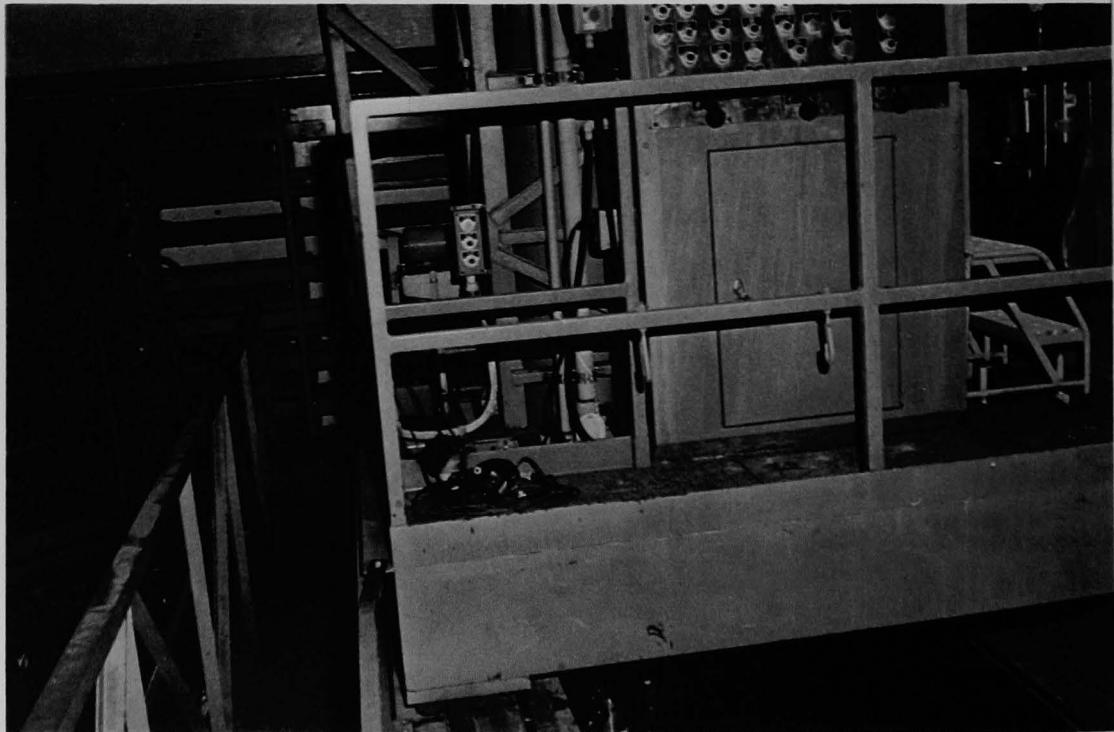
Figure 232 (4A). Auxiliary fuel handling bridge, view from northwest.

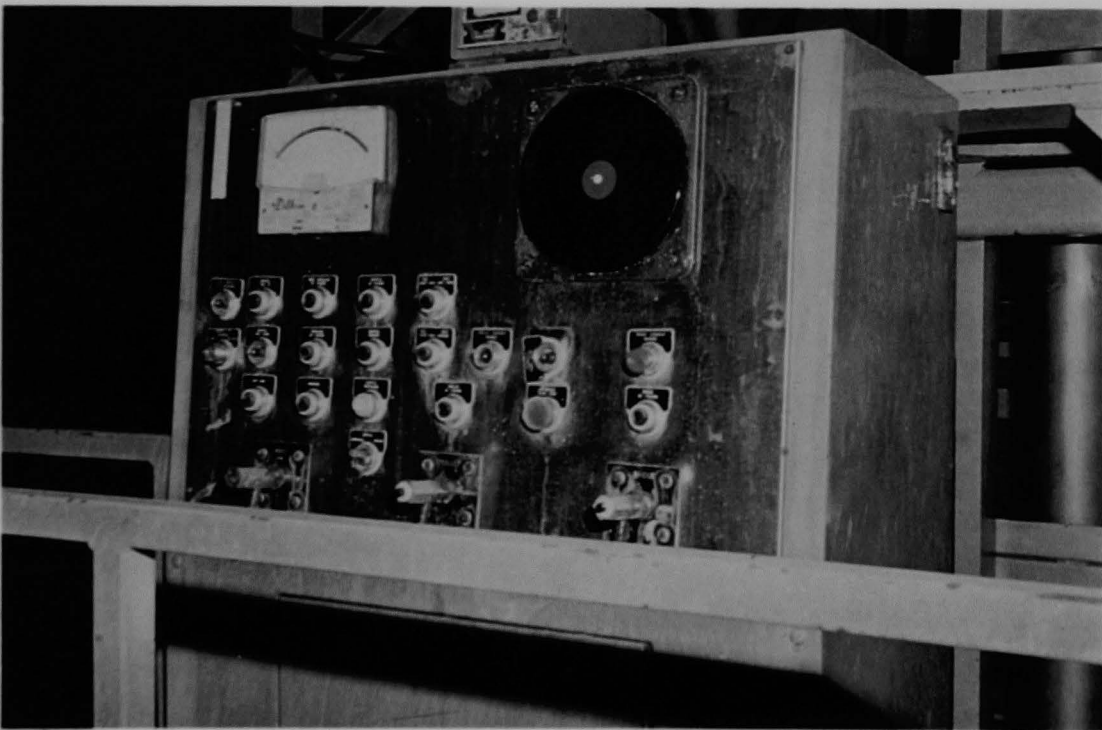
Figure 234 (6A). Operator's panel on the auxiliary fuel handling bridge, second or closer view.

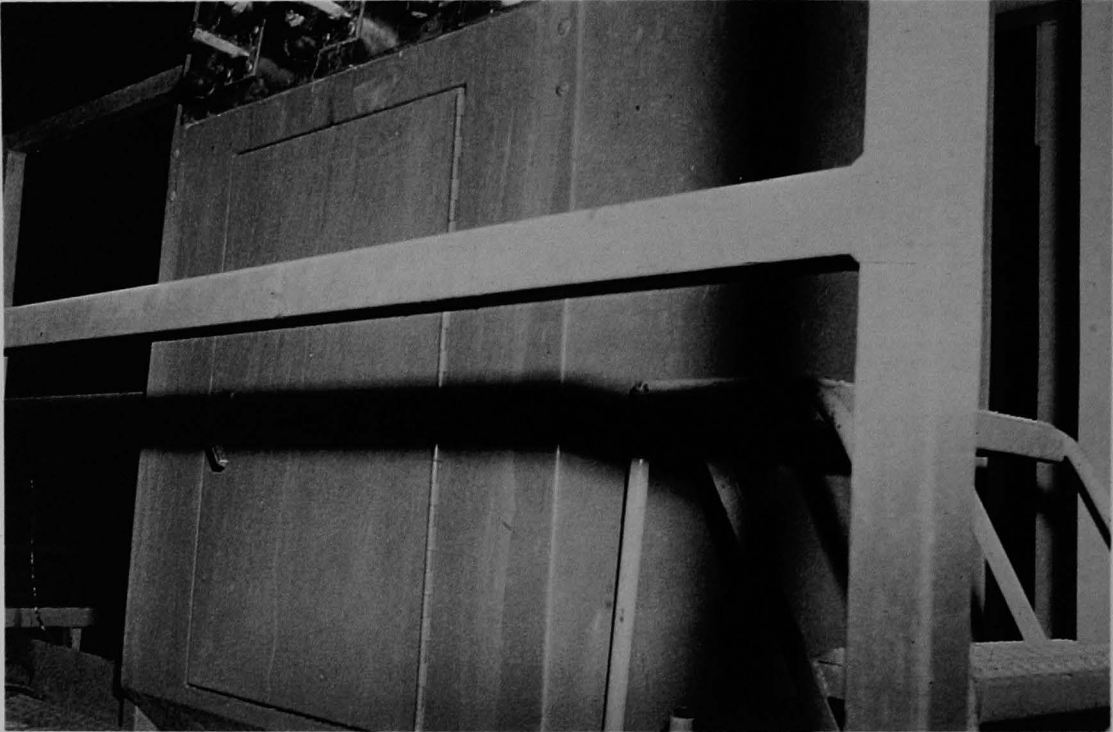
Figure 235 (6A). Lower portion of the control panel on the auxiliary fuel handling bridge.

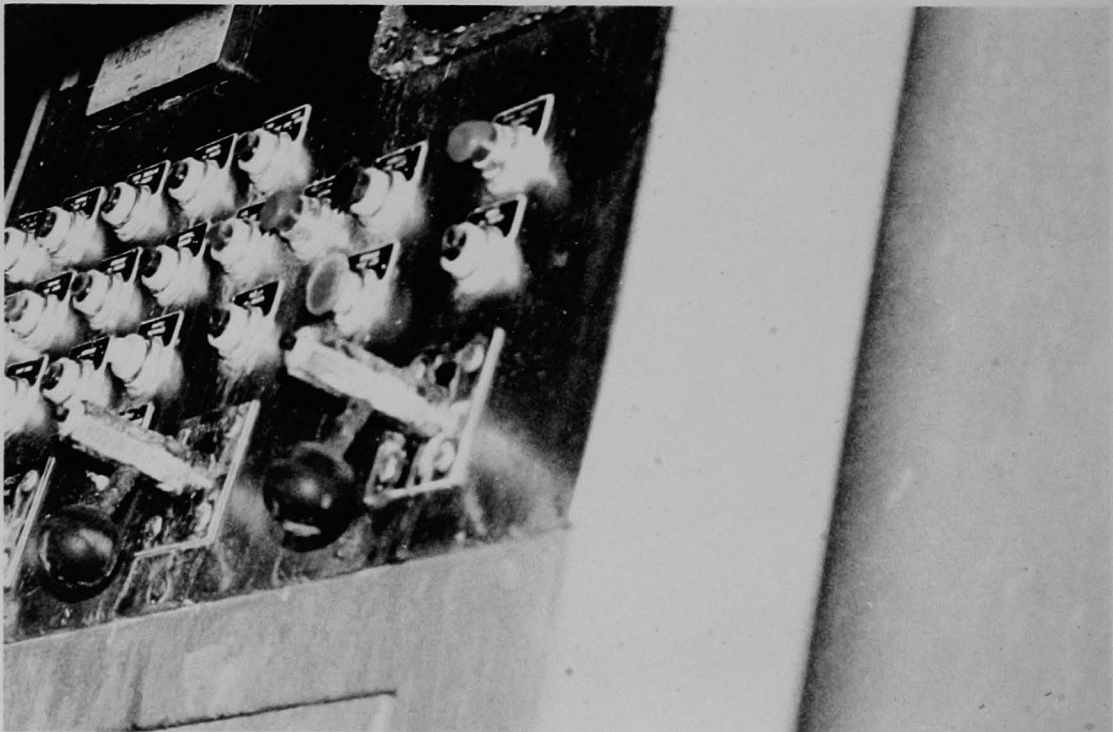
Figure 236 (5B). Close-up of the control panel on the auxiliary fuel handling bridge, first view.

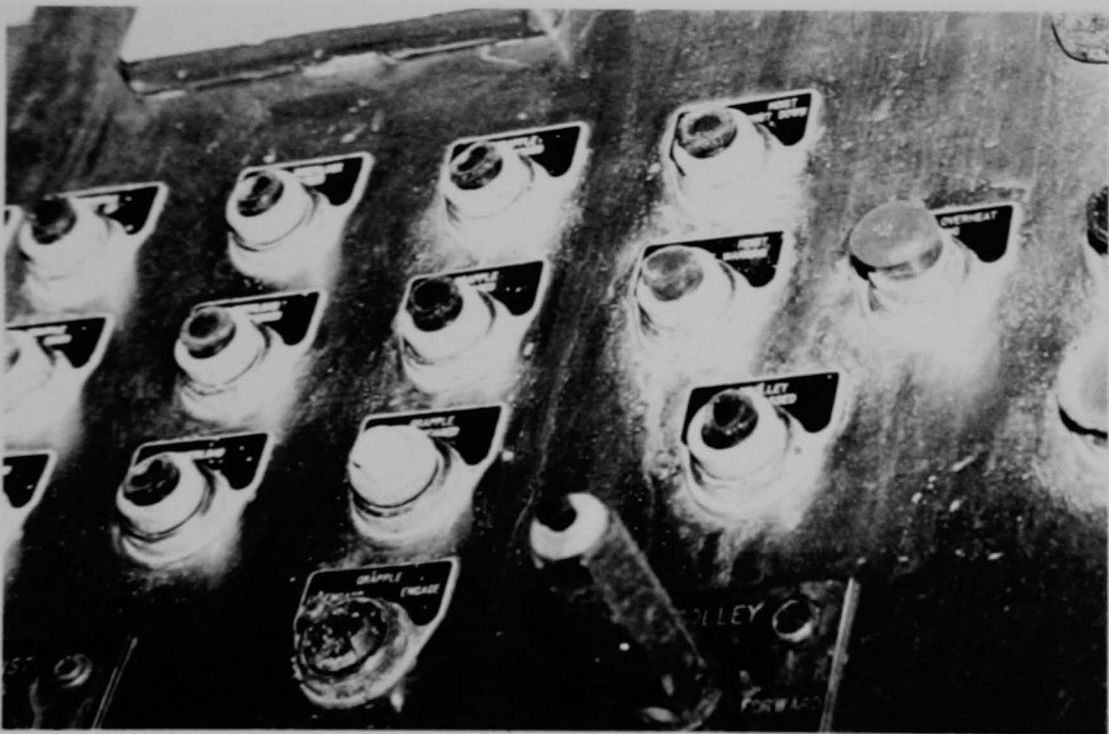
Figure 238 (5B). Close-up of the control panel on the auxiliary fuel handling bridge, third view.

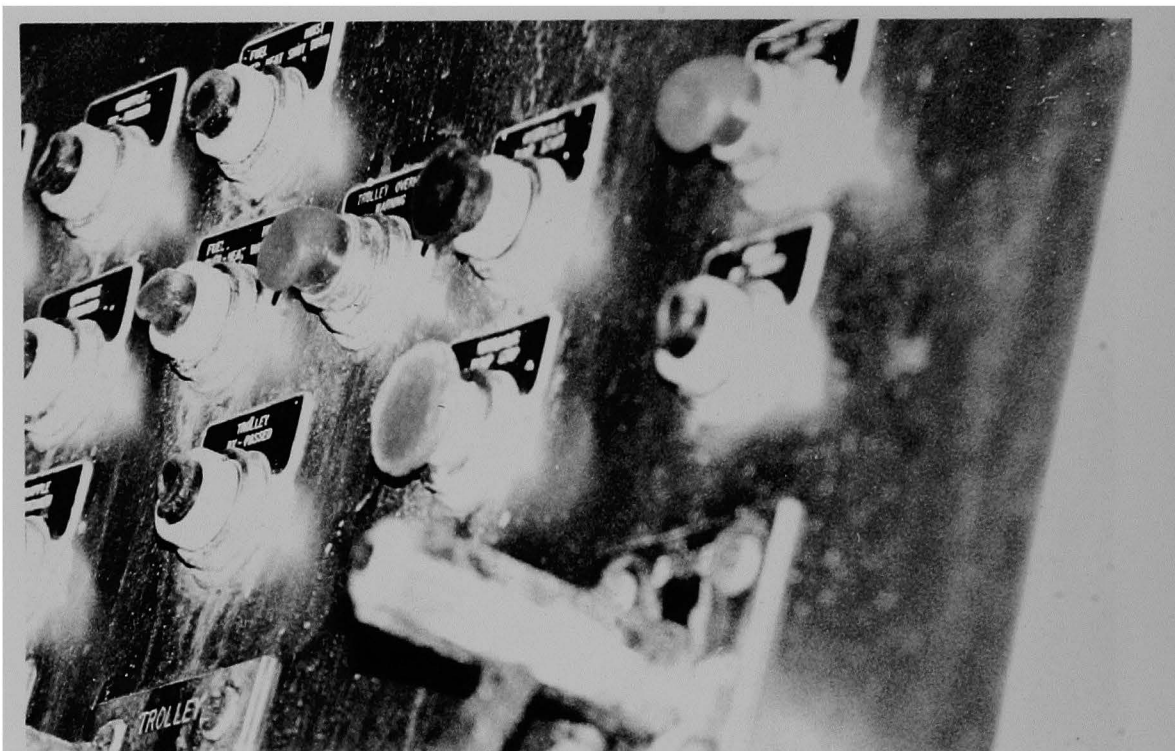
Figure 239 (5B). Close-up of the control panel on the auxiliary fuel handling bridge, fourth view.

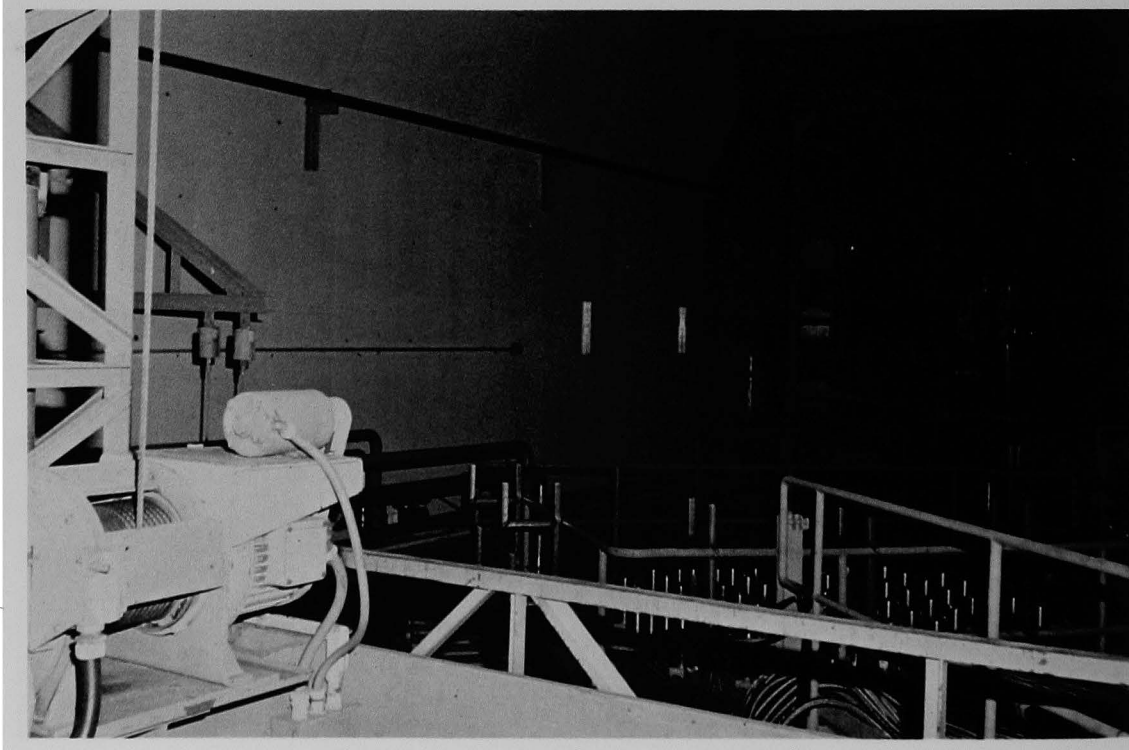
Figure 240 (2A). Top of the control rod drive mechanism (CRDM) platform above the reactor vessel; auxiliary fueling handling bridge foreground, main fuel handling bridge background right, first view.

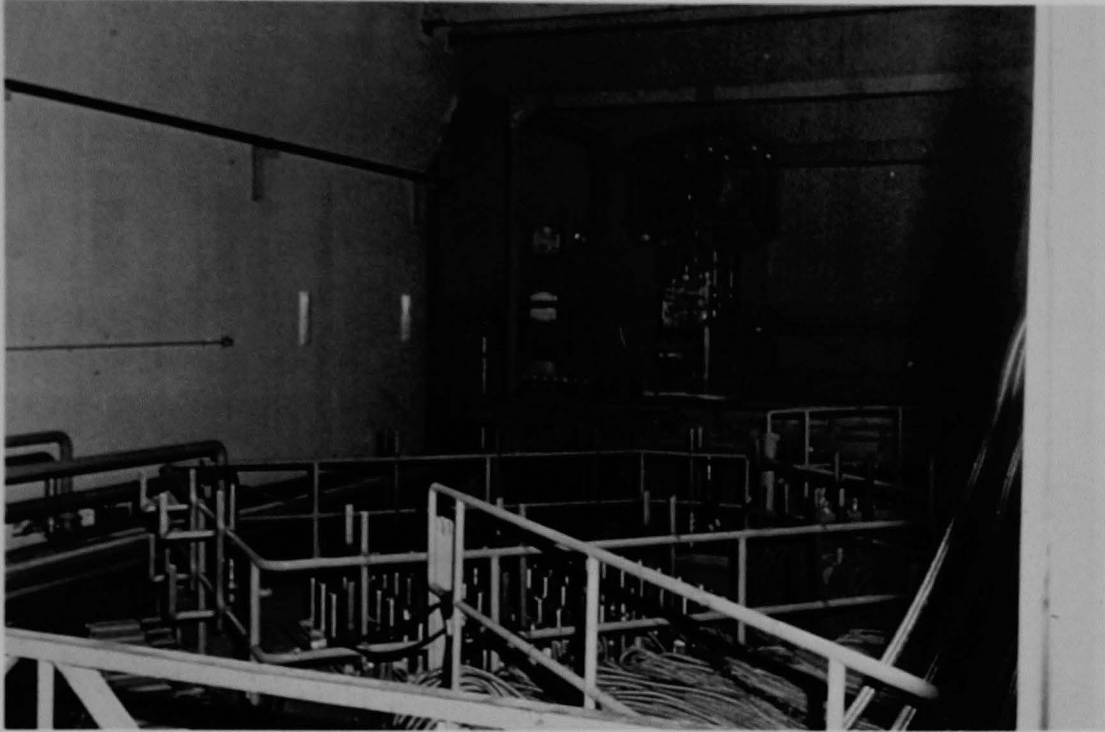
Figure 241 (2A). Control rod drive mechanism platform and power cables; main fuel handling bridge background, second view.

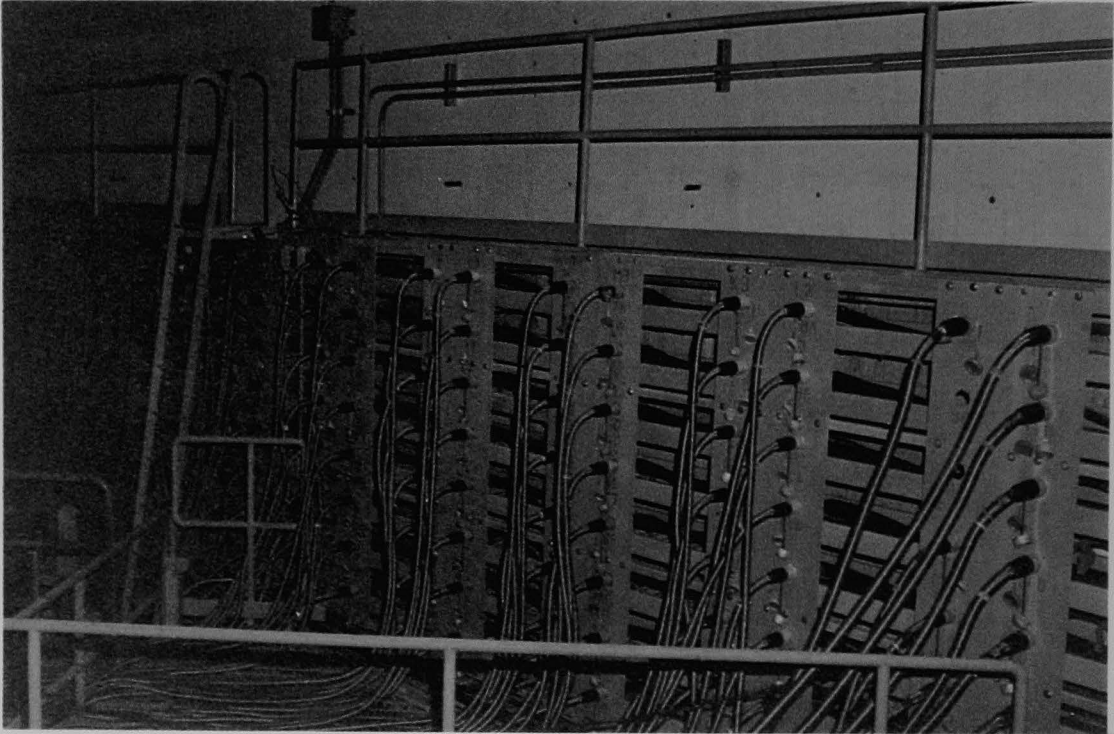
Figure 247 (6A). CRDM cable trays along D-ring B; walkway above, access ladder left.

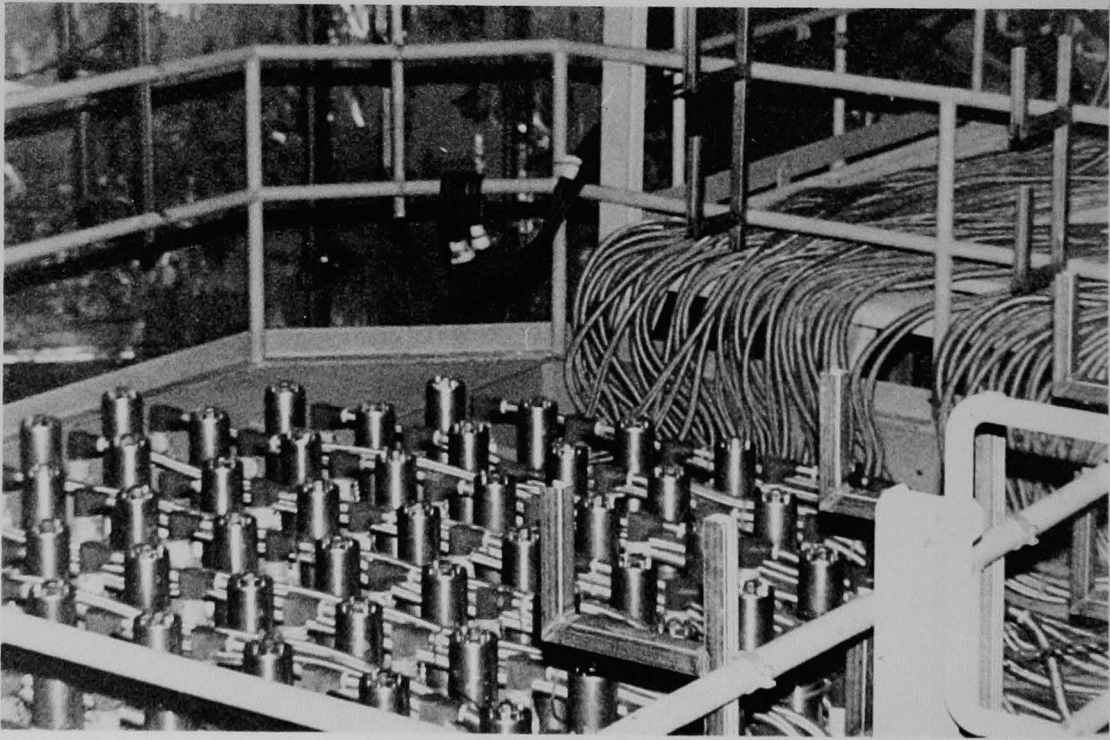
Figure 248 (5B). Close-up of the CRDM platform above the reactor vessel.

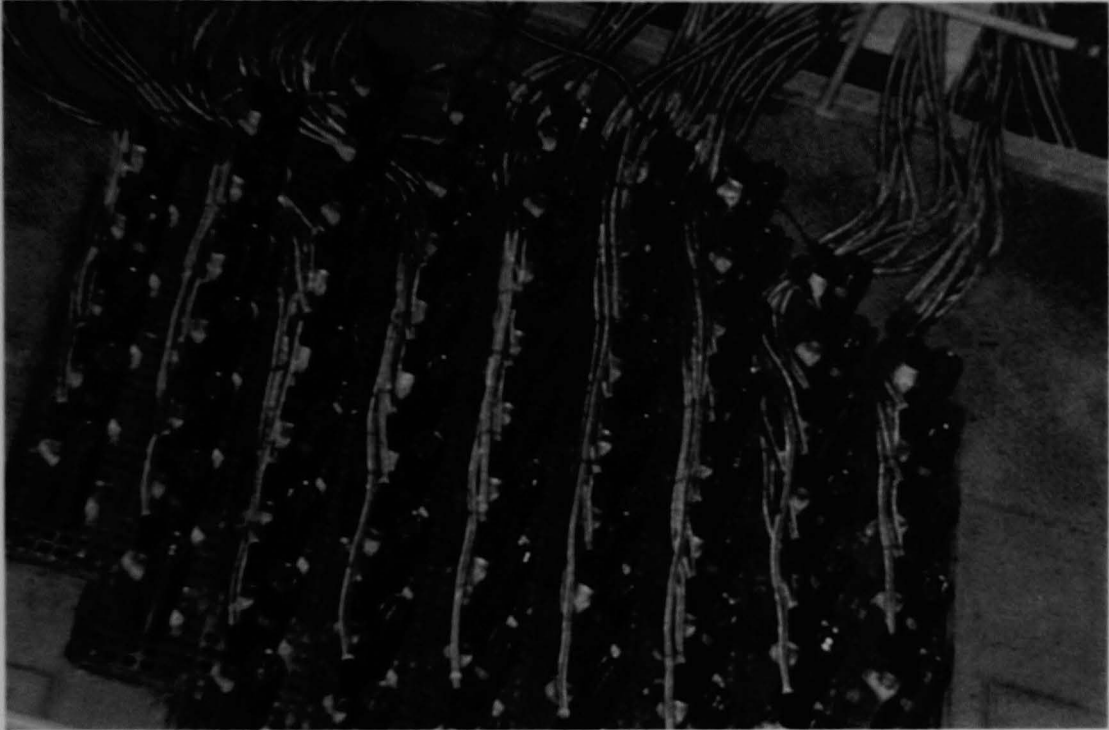
Figure 249 (4B). Close-up of the CRDM platform from overhead.

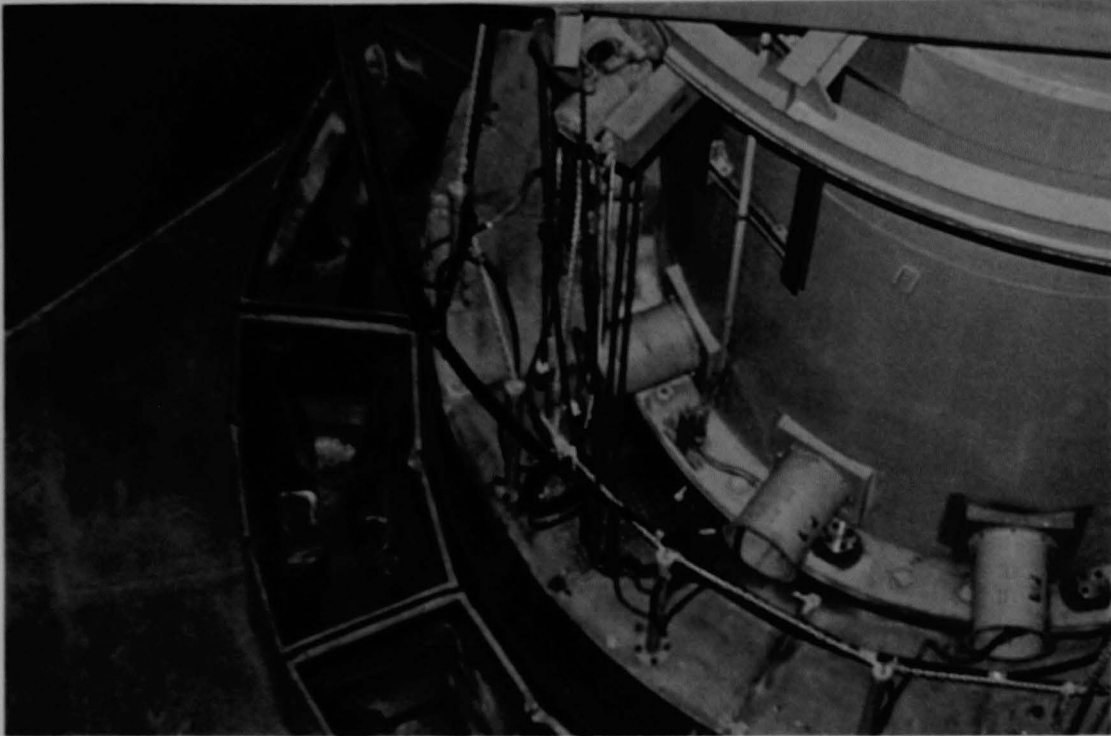
Figure 253 (4B). The reactor head from above (the neutron shield tanks appear to be dry).

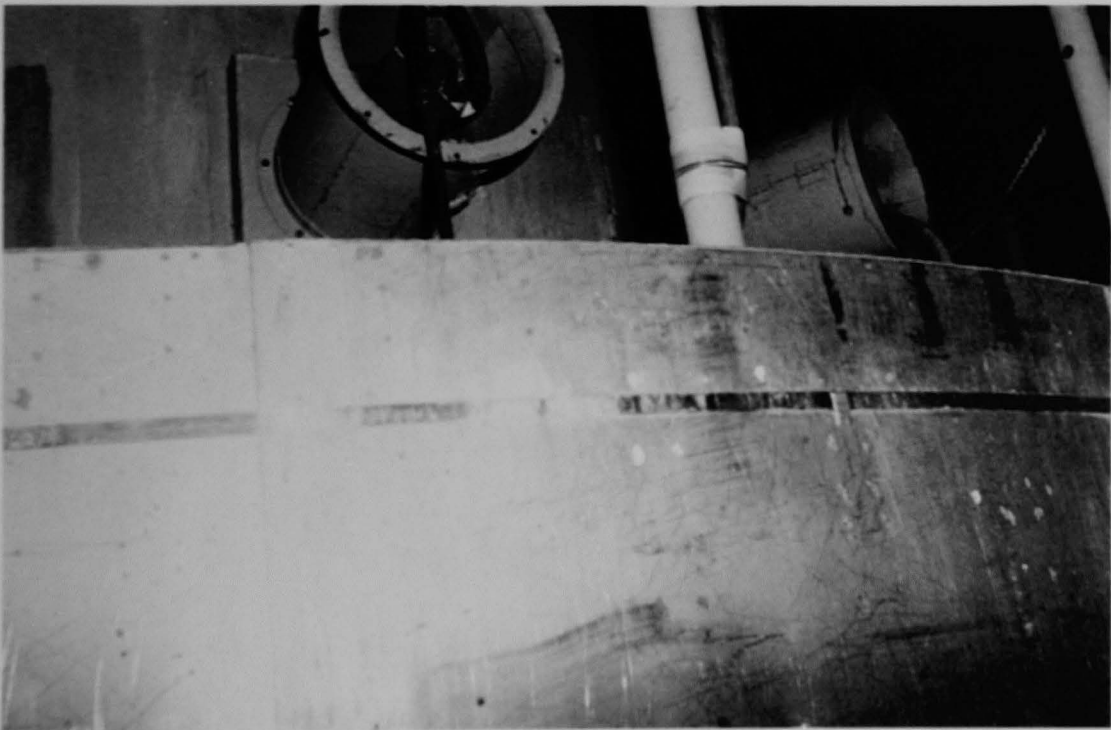
Figure 254 (5A). Fan housings on the reactor head.

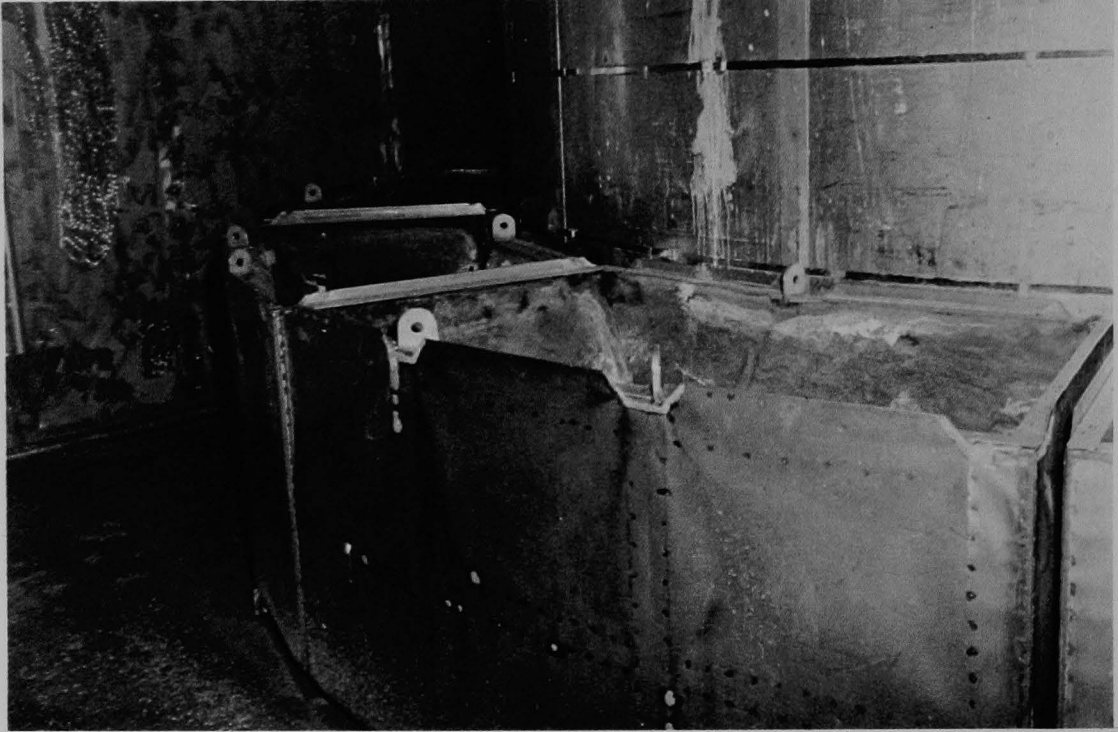
Figure 255 (5A). Base of the reactor vessel with neutron shield tanks.

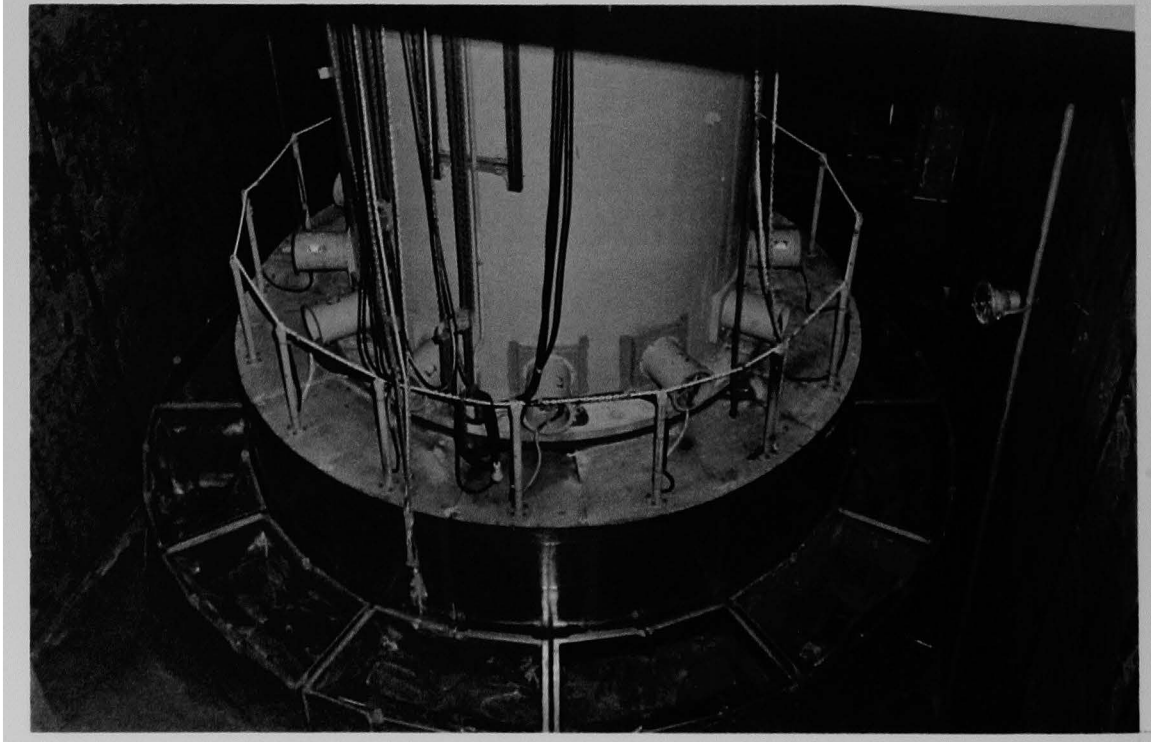
Figure 260 (2A). Reactor vessel head.

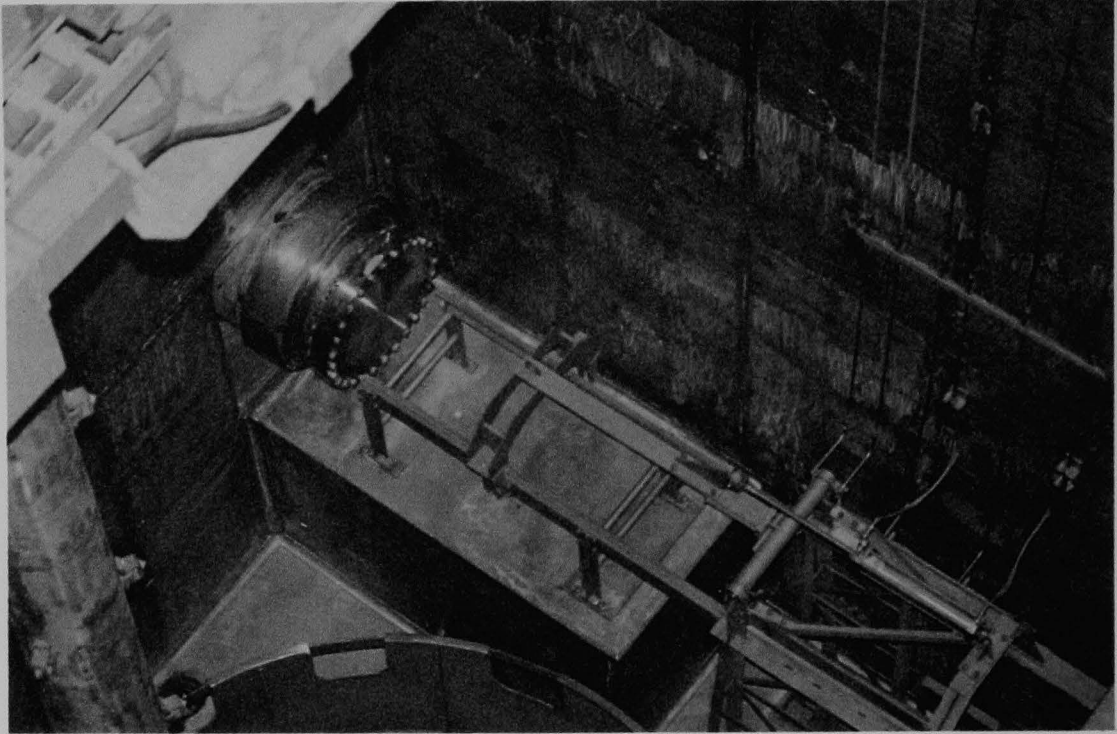
Figure 263 (4B). Deep (north) end of the fuel pool; main fuel handling bridge left, fuel transfer tube left center.

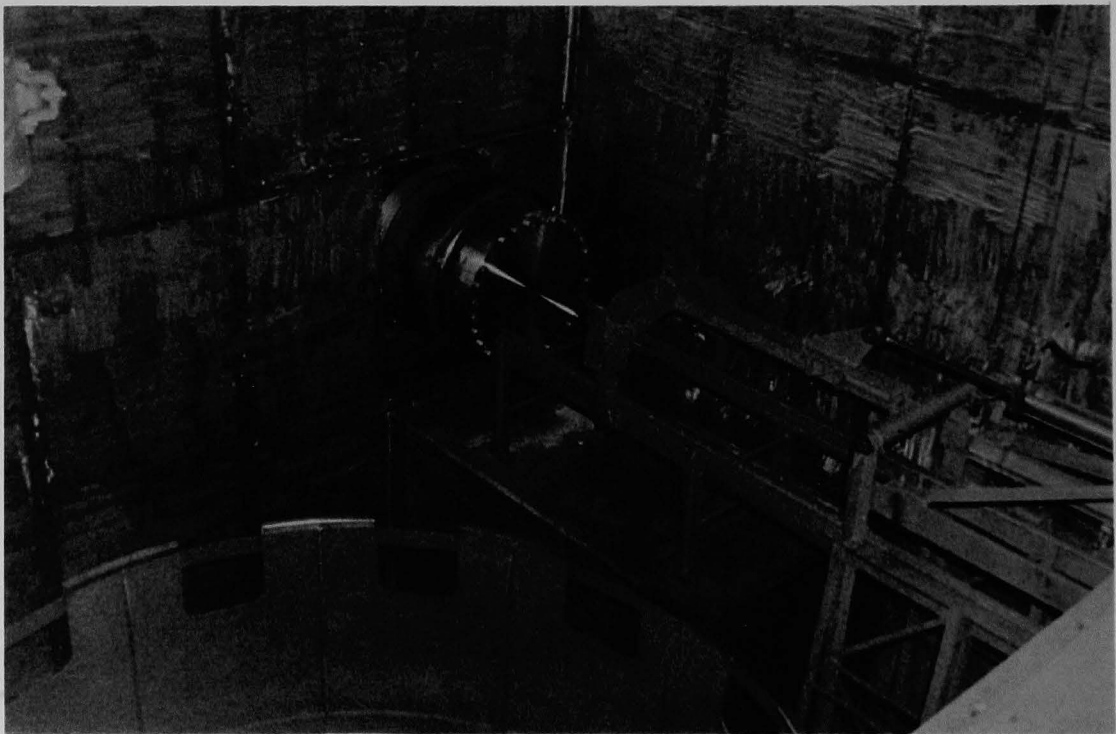
Figure 264 (5A). Deep (north) end of the fuel pool, second view.

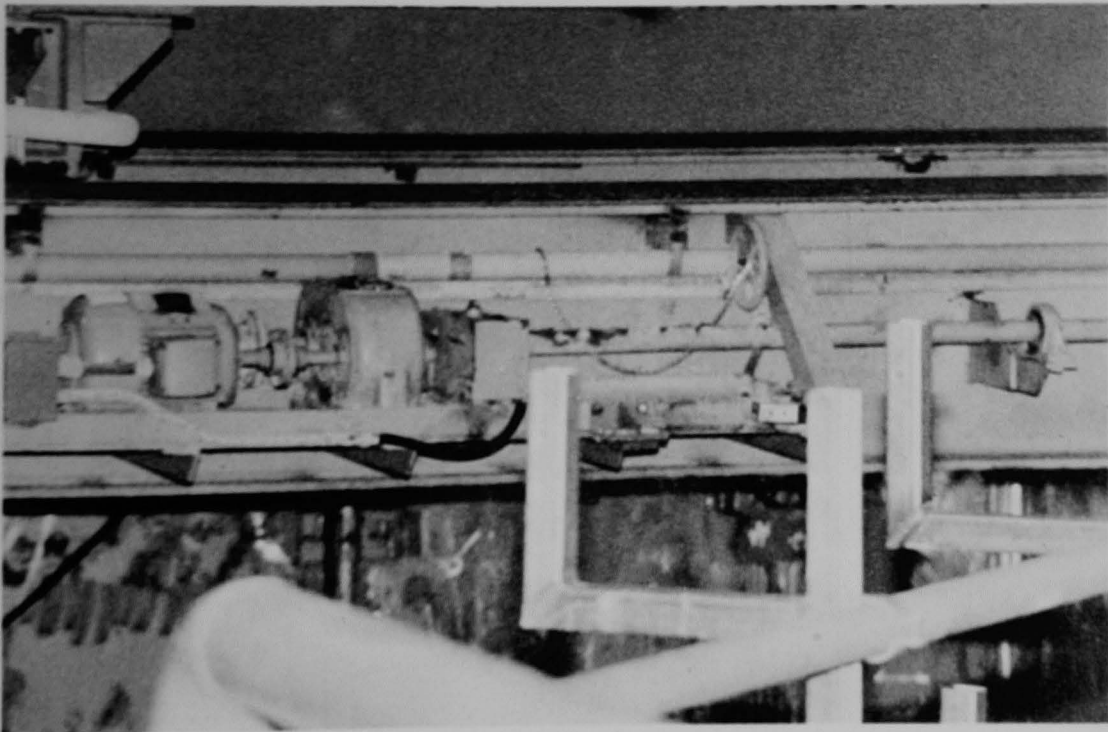
Figure 266 (5B). Motor, gear box, and drive shaft on south side of main fuel handling bridge.
