**Color Photographs
Of The Three Mile Island Unit 2
Reactor Containment Building:
Volume 1—Entries 1, 2, 4, 5, 6**

October 1981

**EG&G Idaho, Inc.
Idaho Falls, Idaho 83415**

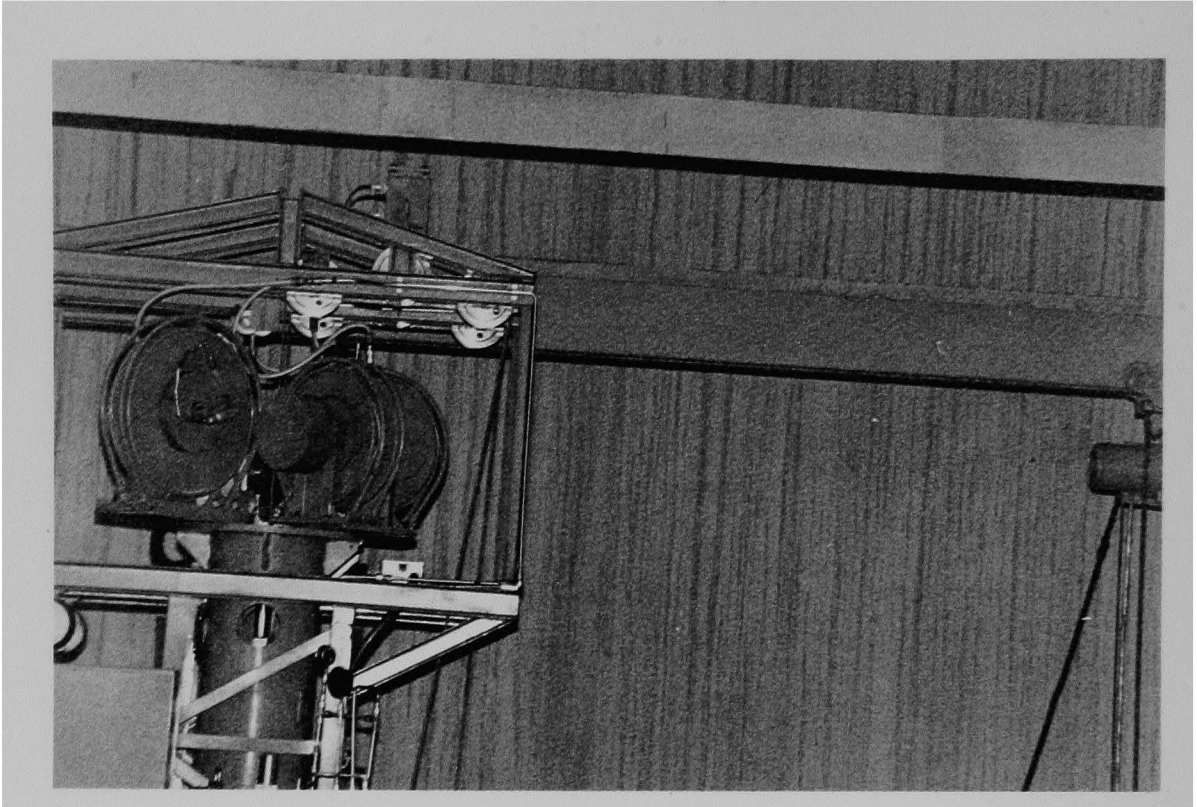
Figure 267 (5B). Upper portion of the main fuel handling bridge.

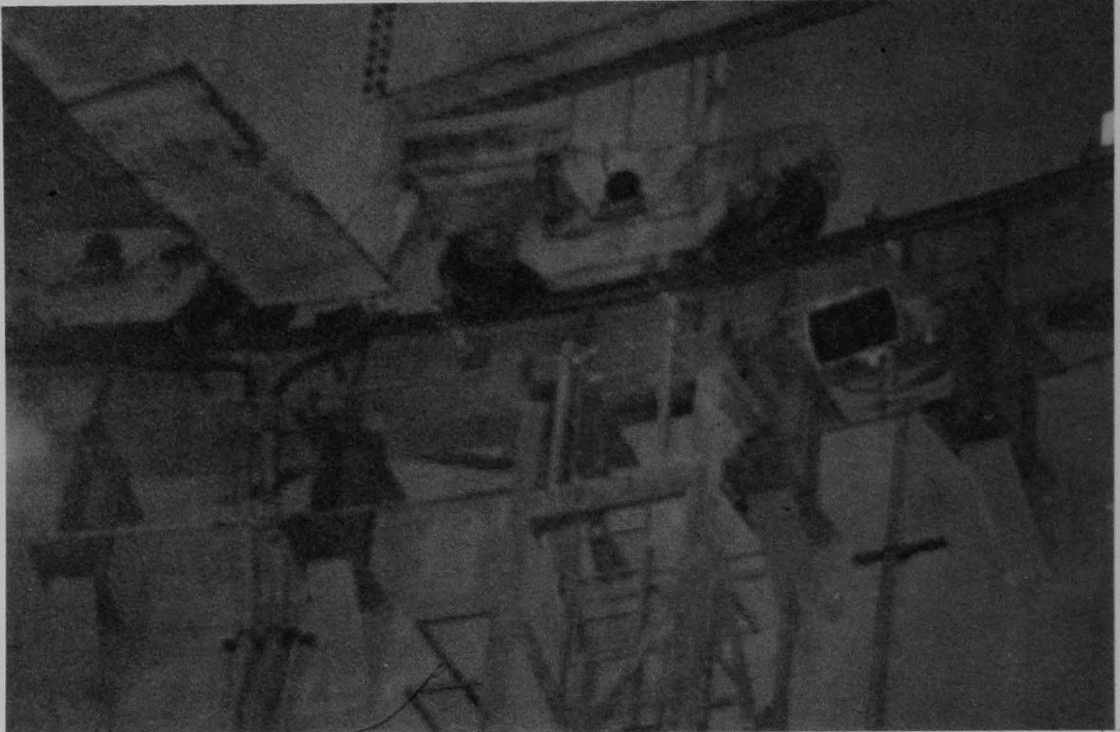
Figure 270 (4B). East side of polar crane near access platform.

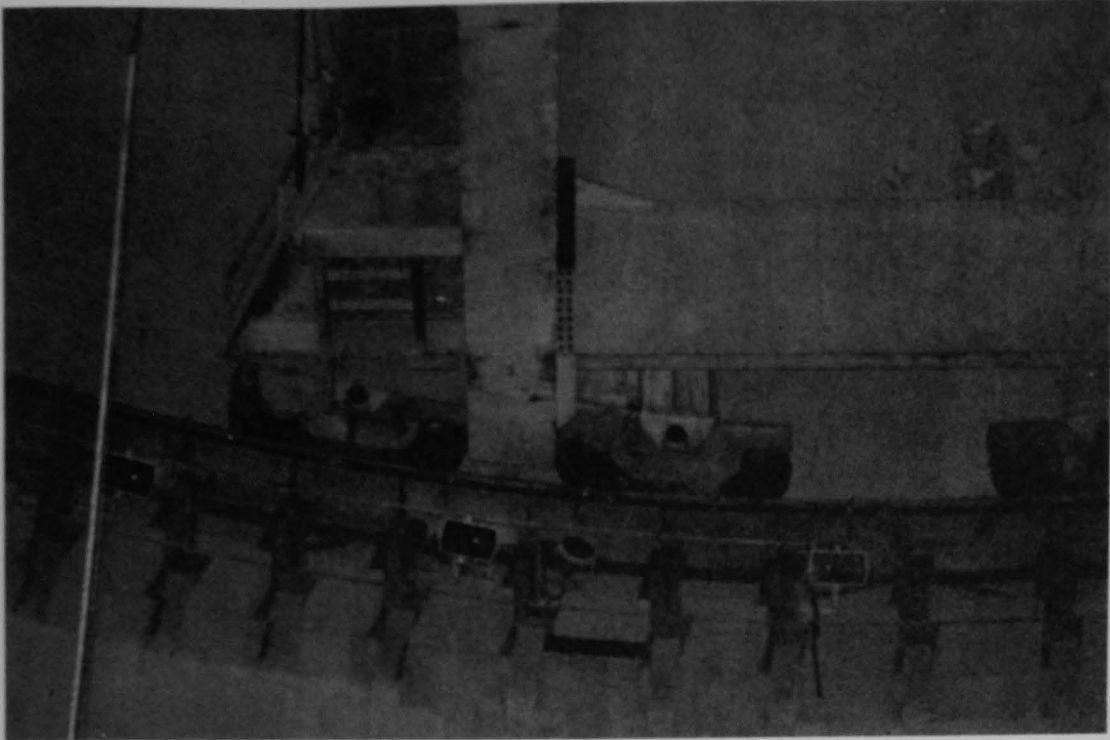
Figure 272 (4B). End of the polar crane opposite the operator's cab, northwest quadrant.

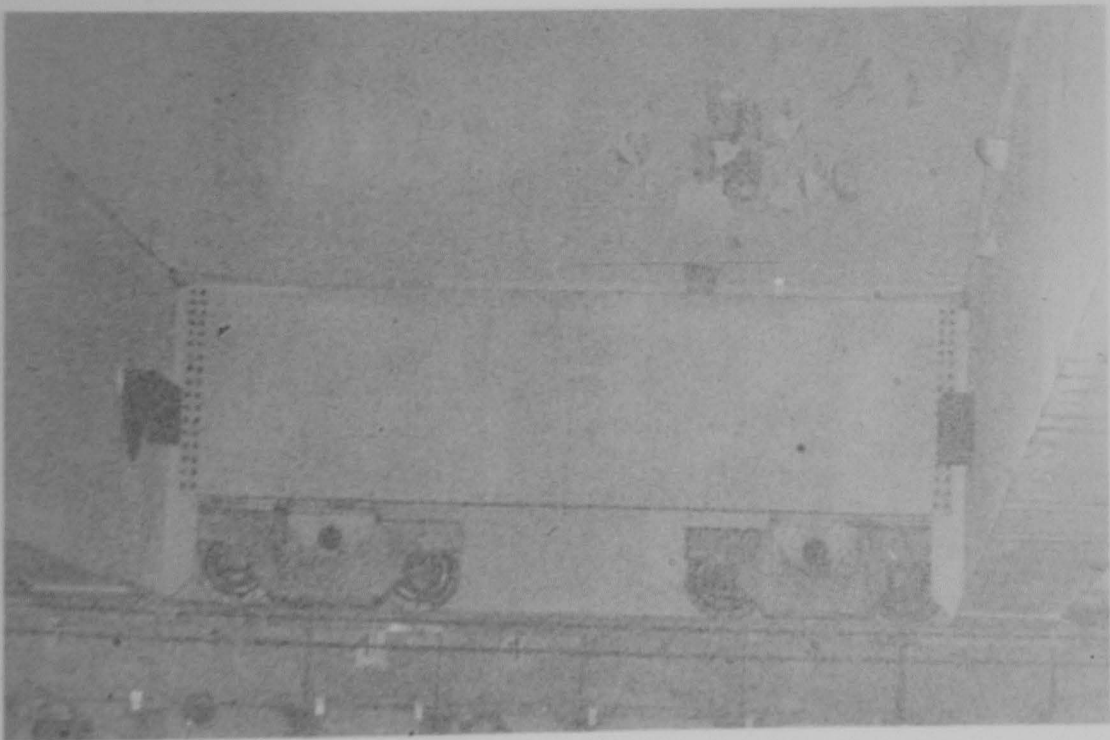
Figure 273 (5B). End of the polar crane opposite the operator's cab, northwest quadrant, second view.

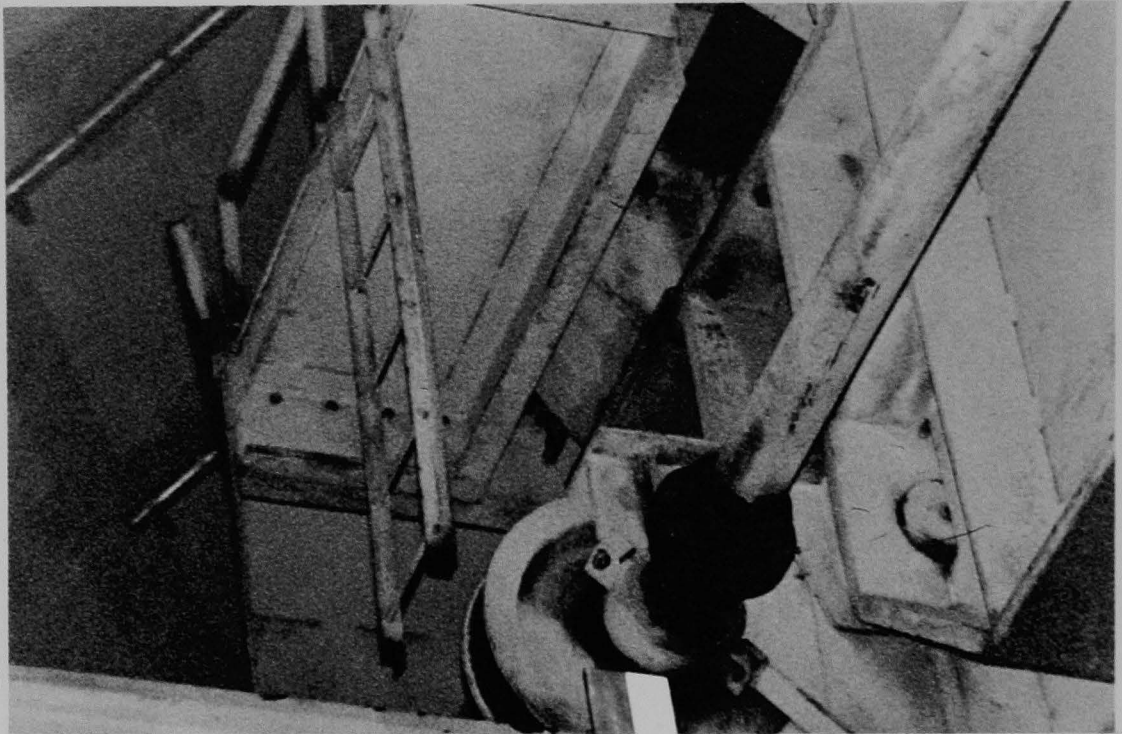
Figure 274 (5B). Trolley and one of its wheels.

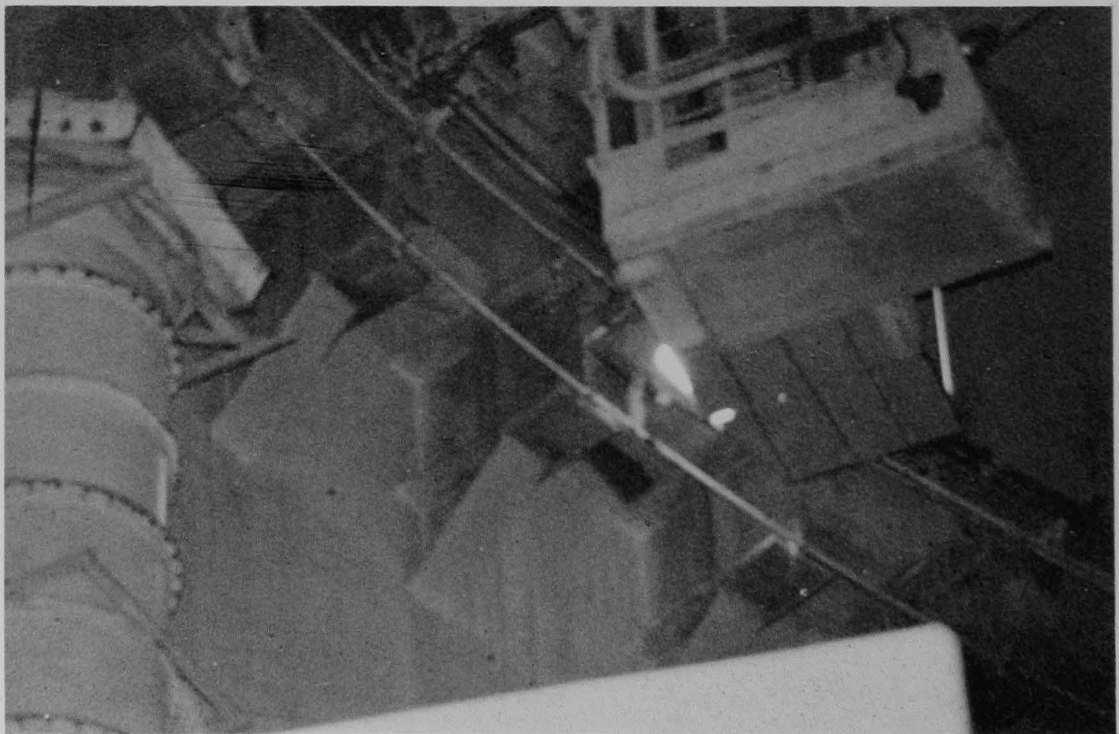
Figure 275 (5B). Polar crane cab and upper portion of ventilation duct left.

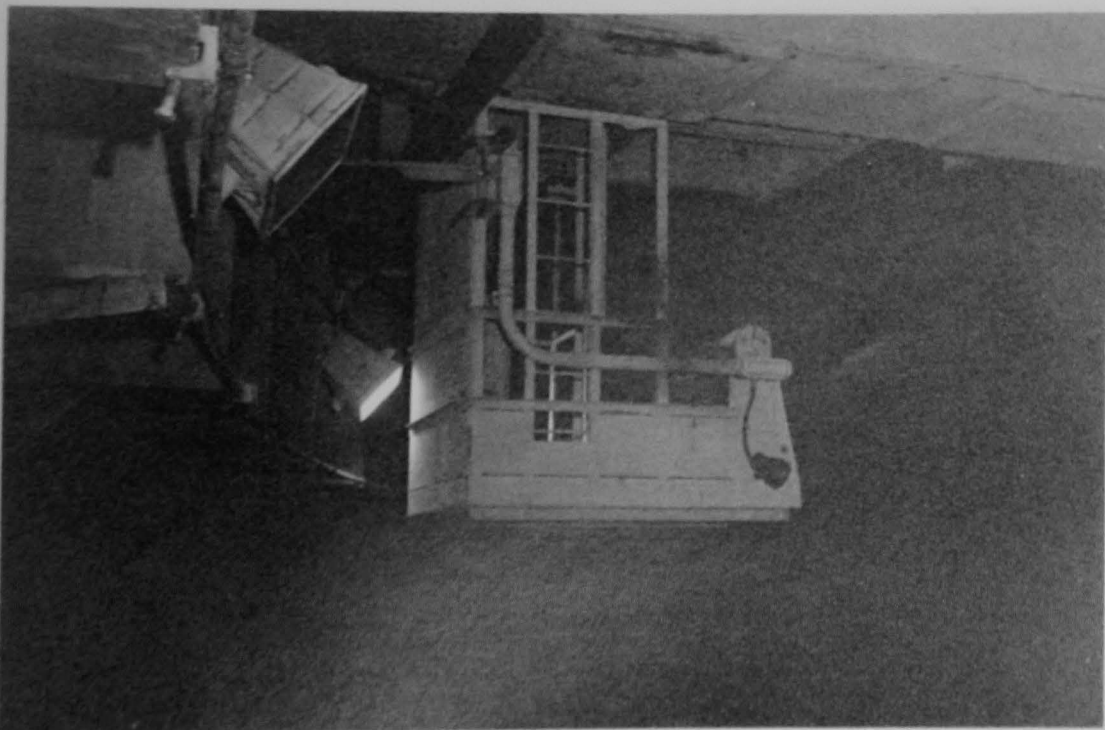
Figure 277 (5A). Polar crane cab (cf. Figure 275).

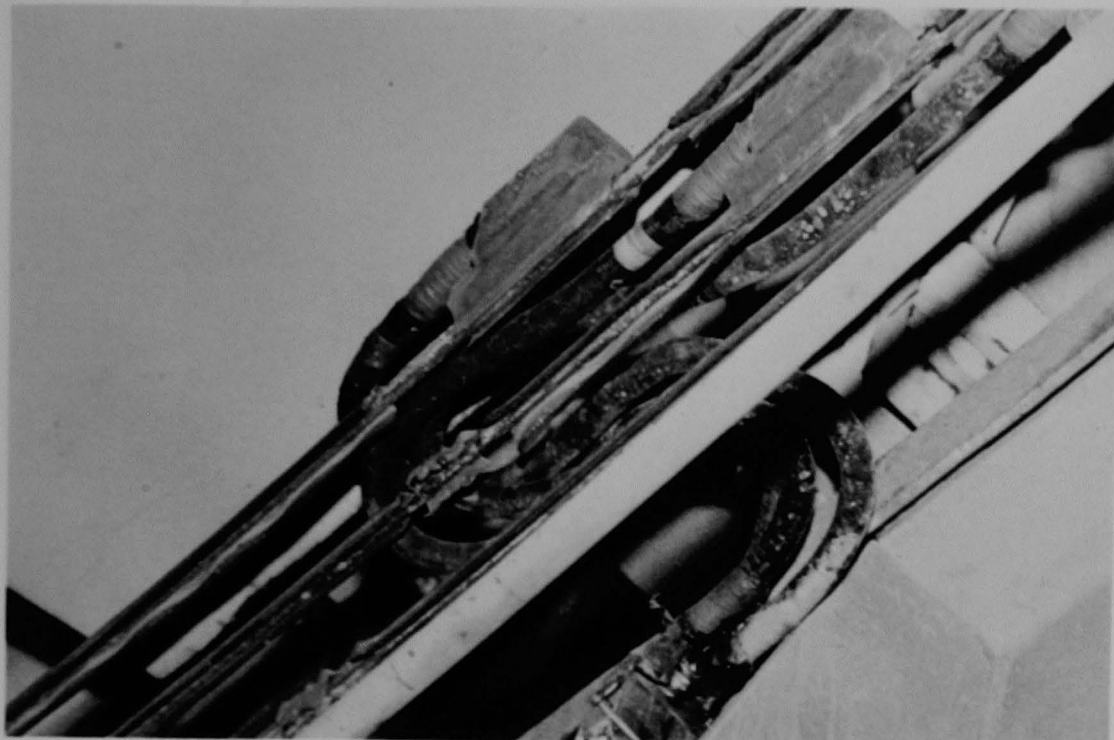
Figure 280 (5B). Close-up of power and controller buss bars for the polar crane.

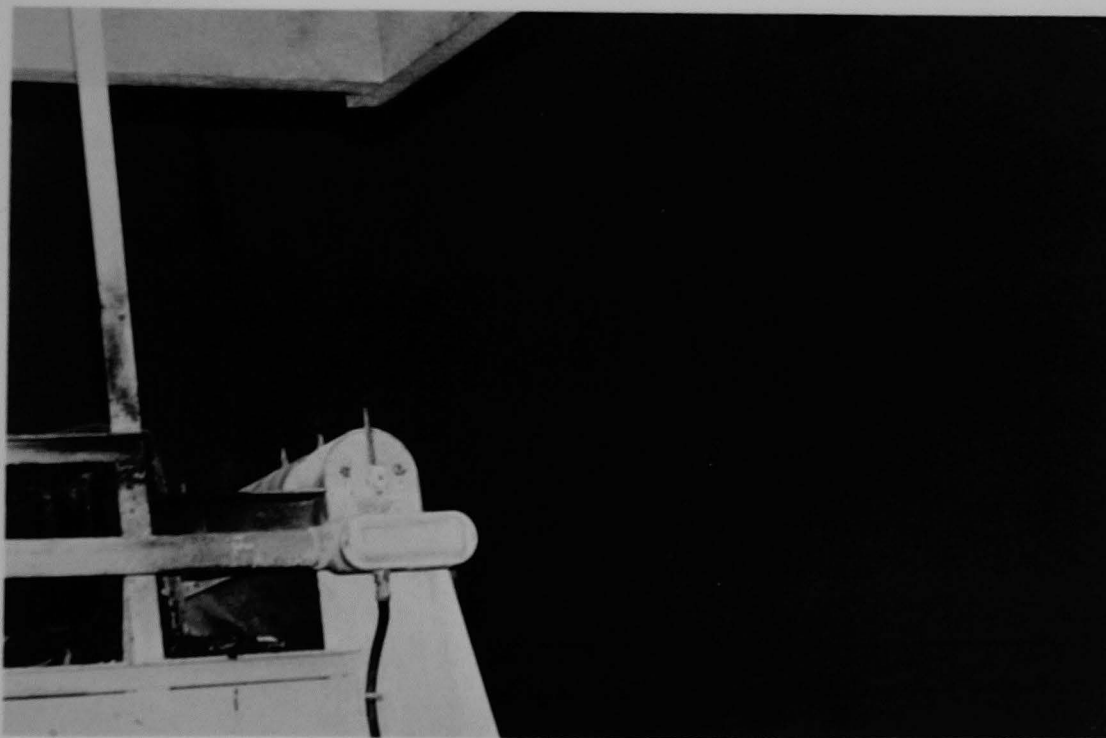
Figure 281 (5B). Control levers of the polar crane cab.

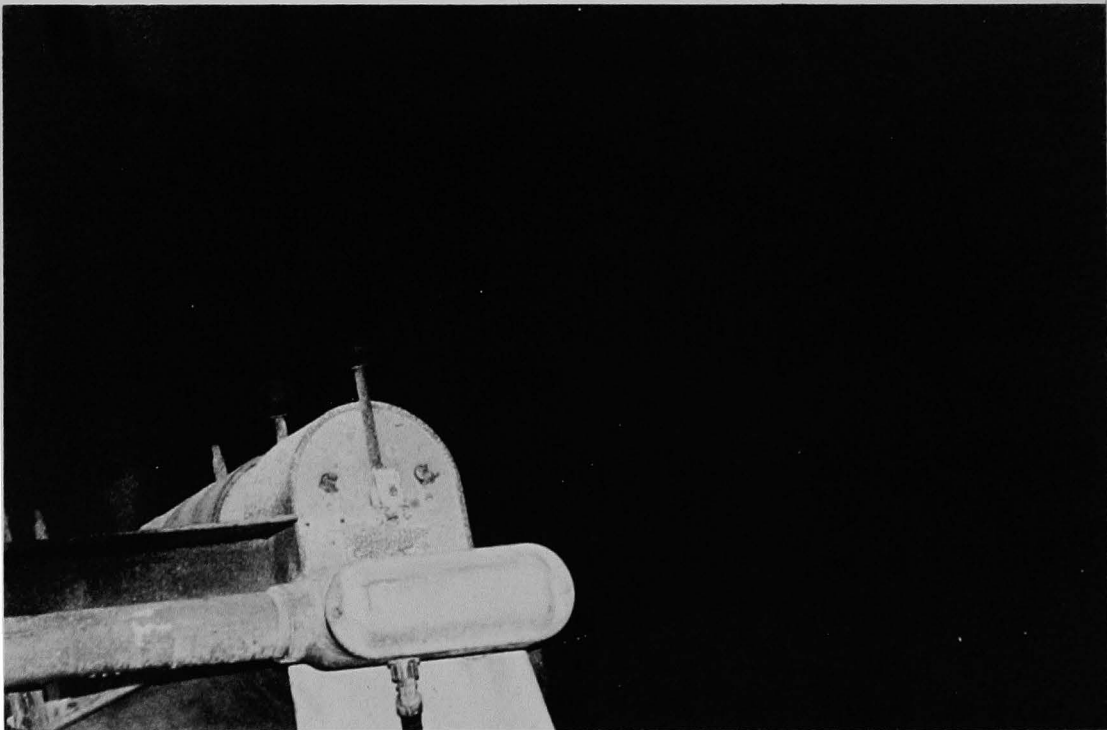
Figure 283 (5B). Close-up of levers of the polar crane cab.

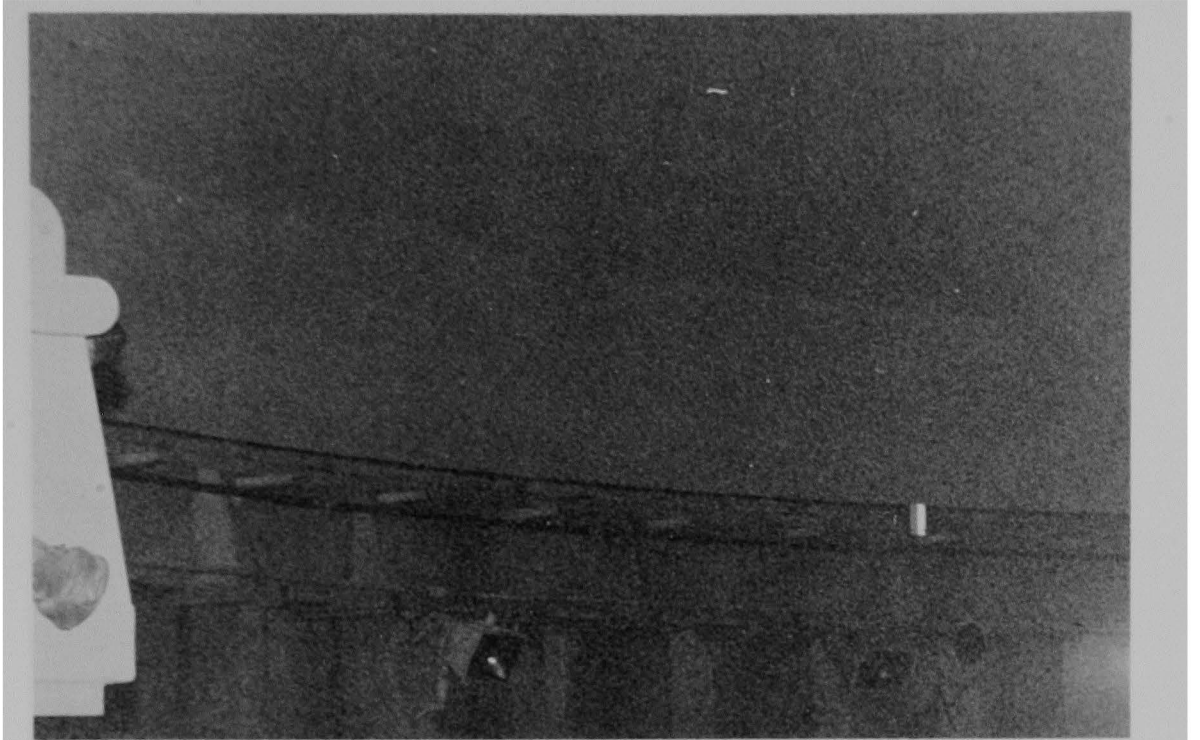
Figure 284 (5B). Lights around dome of the containment building; polar crane cab left.

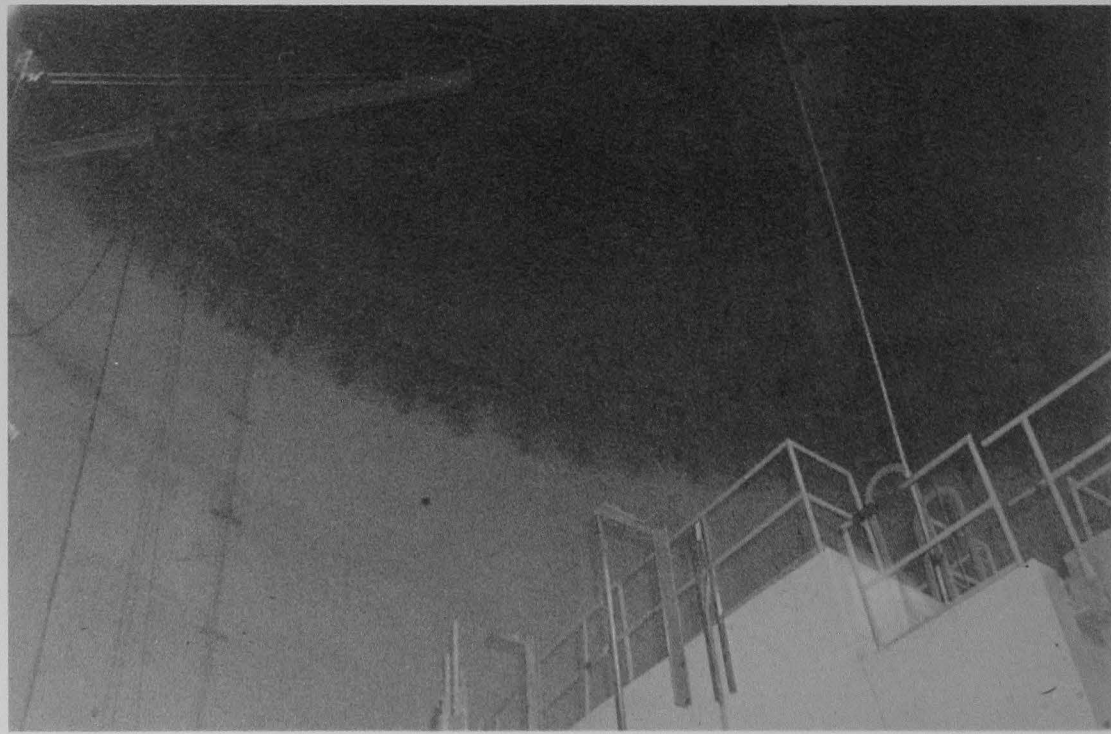
Figure 287 (6A). Jib crane; D-ring A lower right.

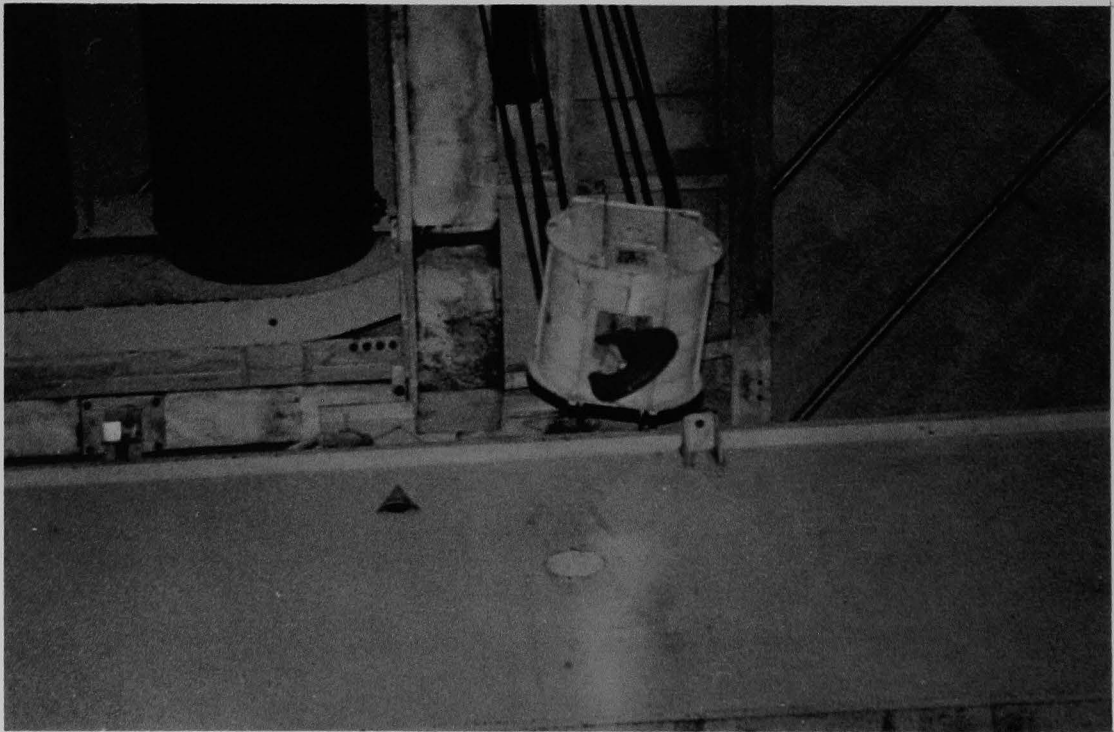
Figure 291 (4B). Auxiliary hook of the polar crane.

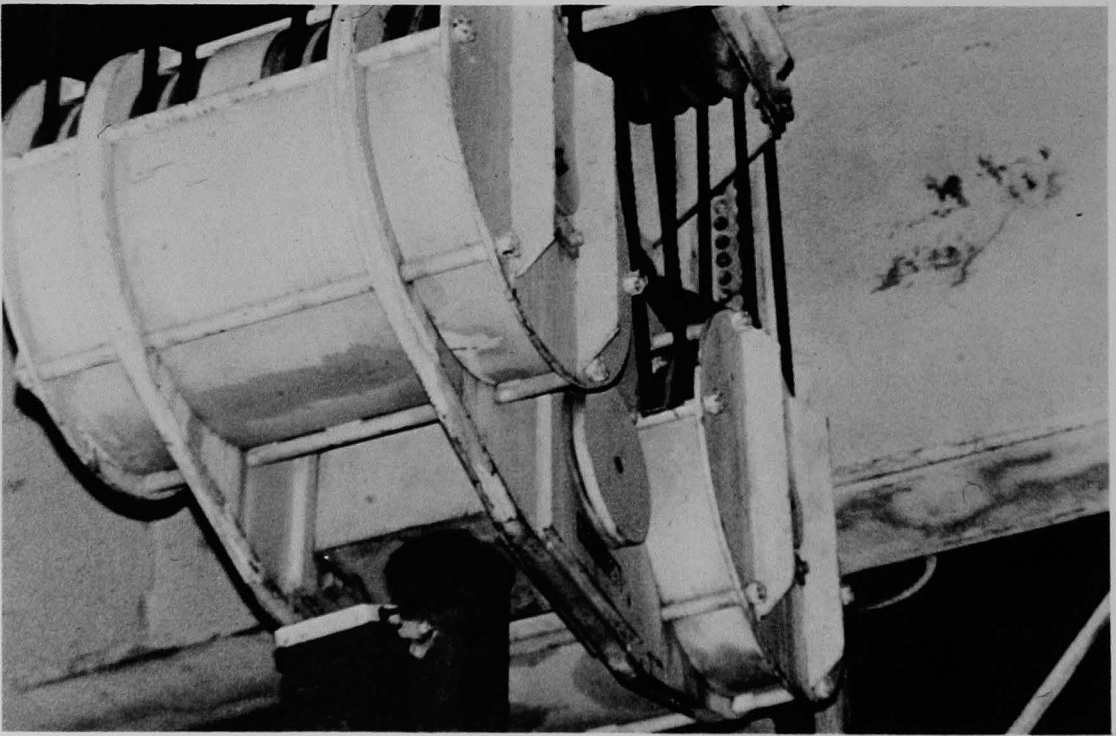
Figure 295 (5B). Main hook of the polar crane, fourth view.

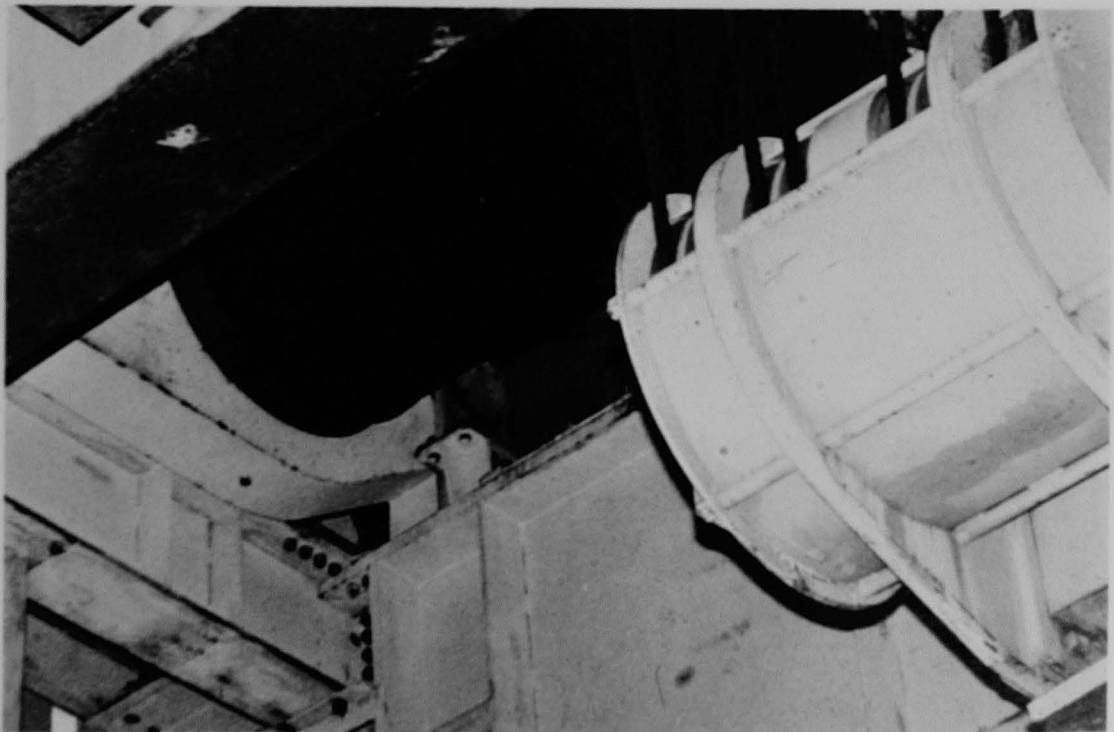
Figure 297 (5B). Cable drum and the main block of the trolley on the polar crane.

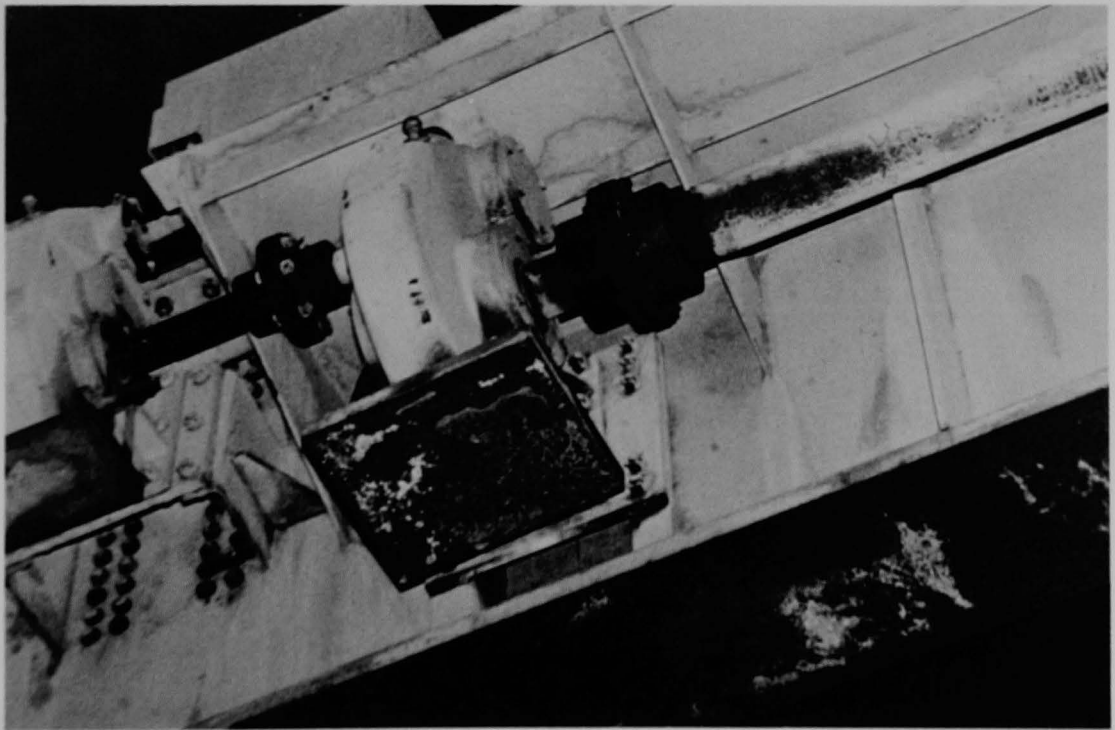
Figure 301 (5B). Gear housings and drive shafts on the trolley of the polar crane.

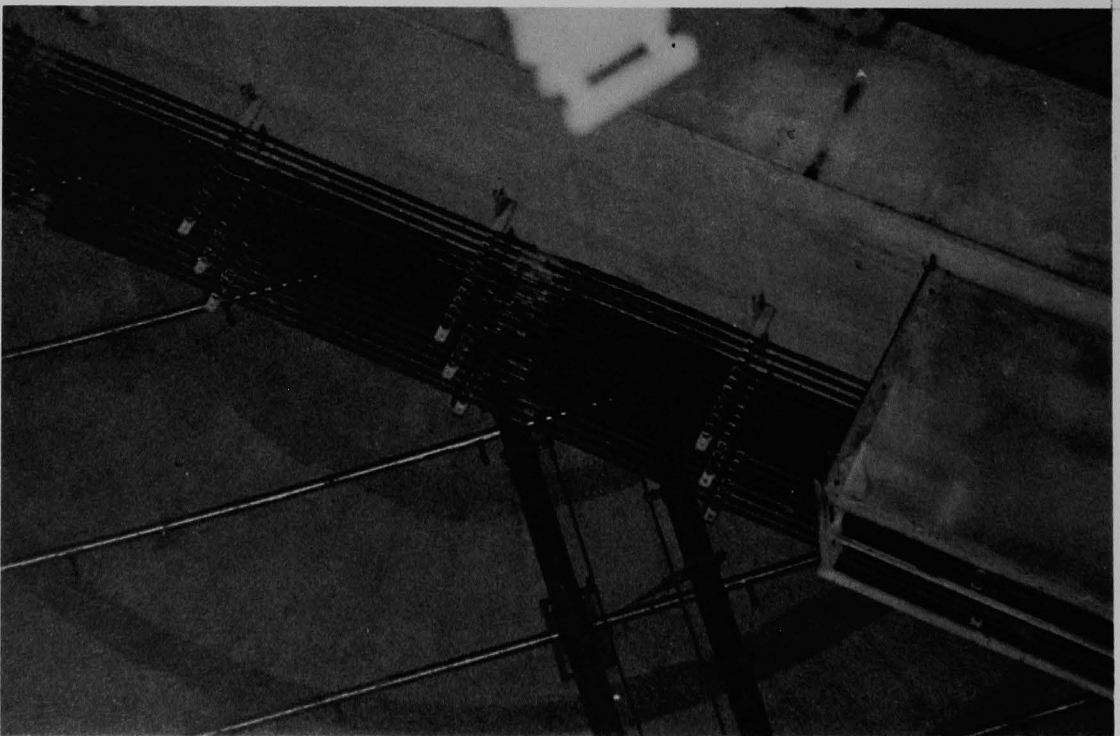
Figure 303 (4B). Trolley power and controller buss bars along side of girder B.

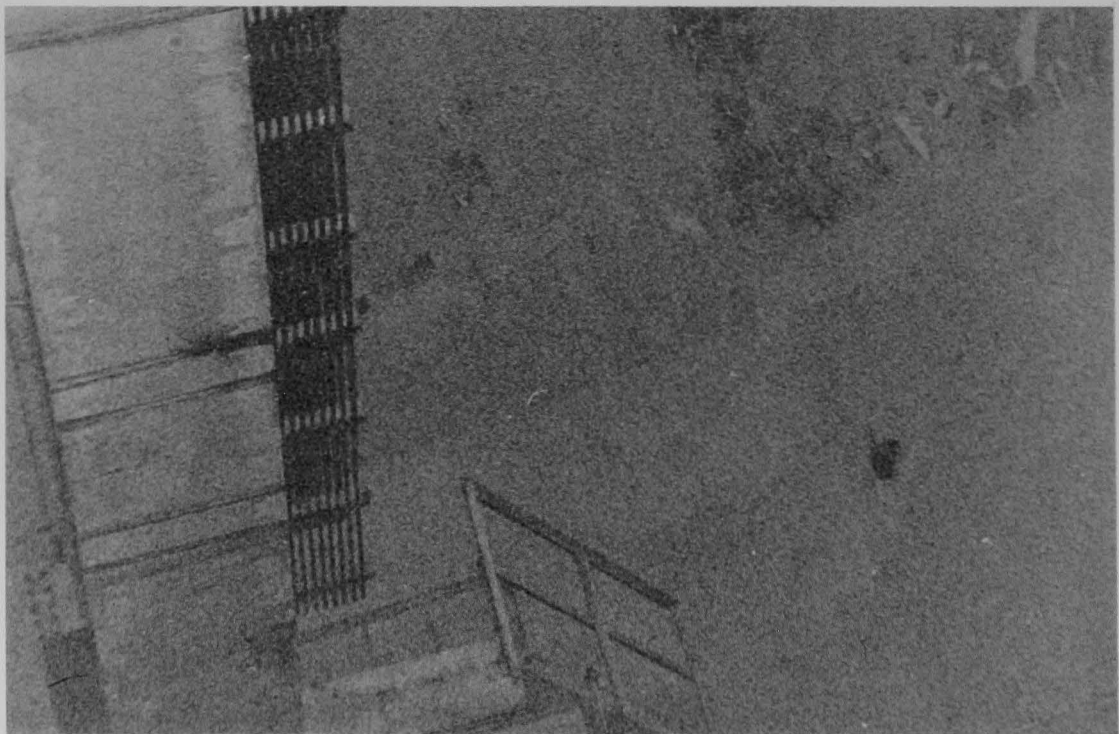
Figure 307 (5B). Northwest portion of girder B, showing trolley power and controller buss bars.
