NUREG/CR-6198 TMI V(94)EG01 EGG-2735

TMI-2 Nozzle Examinations Performed at the Idaho National Engineering Laboratory

Prepared by D. W. Akers, B. K. Schuetz

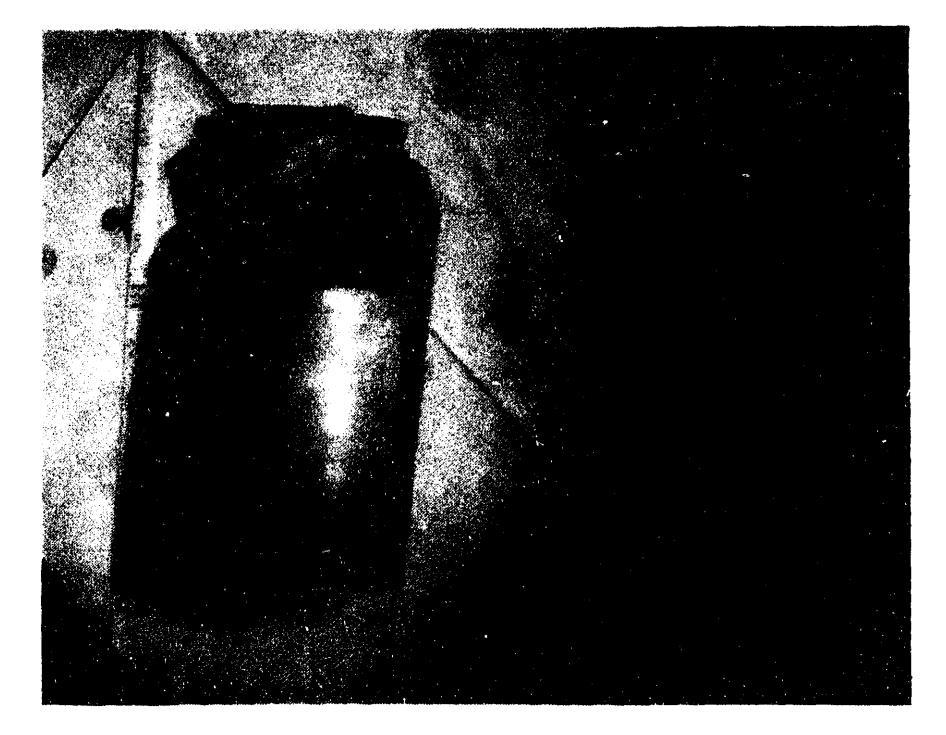
Figure 6. K-5 guide tube sample.

As shown in Figure 6, the K-5 guide tube suffered substantial damage at the lower end. The damaged edges created by melt interaction are slightly twisted outward. The original diameter of the guide tube was about 117 mm (4.6 in.); the remaining length on the longest side was 238 mm (9.4 in.), while the remaining length on the shortest side was only 149 mm (5.9 in.). The K-5 guide tube did not need to be gamma scanned or probed because the sample location was determined from visual examination of the nozzle section. As discussed in Appendix C, apparent molten fuel material interacted with the stainless steel of the guide tube and melted into its surface. In most cases, the clear separation between the stainless steel and the fuel material phases suggests that the mechanism for this interaction appears to be melting of the stainless steel with no apparent chemical interaction. However, Figure C-8 shows the presence of an apparent intermediate phase that may be the result of a dissolution of the stainless steel by the fuel debris.

The very bottom of the guide tube was cut transversely, at a depth of approximately 19 mm (0.75 in.). It was very difficult to section this sample, and an MPR Associates technician indicated that the damaged guide tube material was much harder to cut than as-fabricated stainless steel.

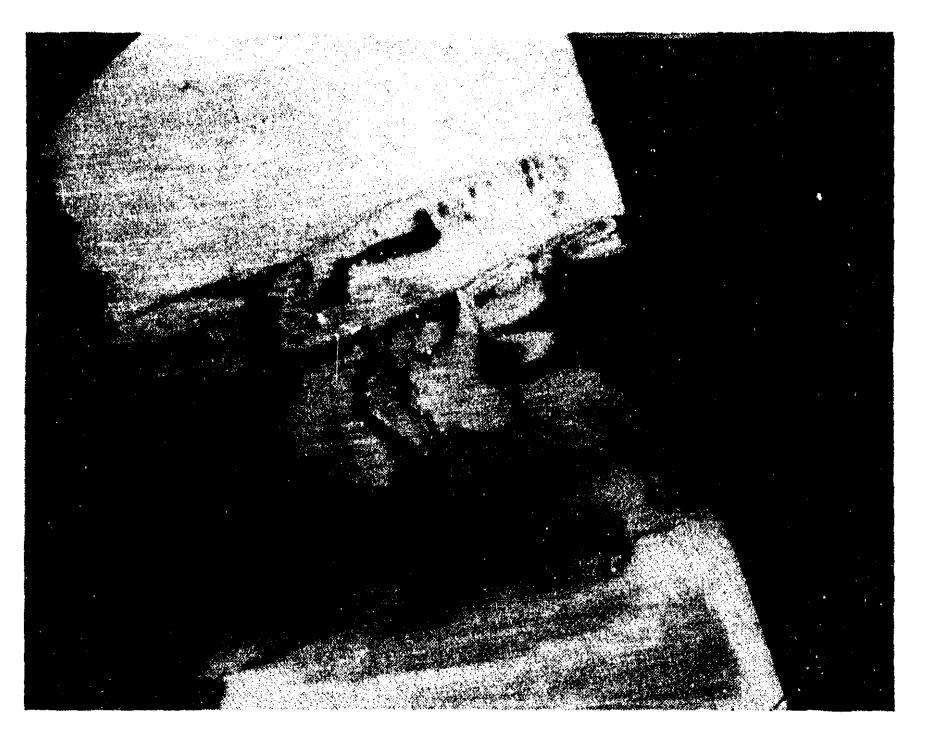
Figure B-7. Sample M-10-1A, from a longitudinal cut of M-10-1.

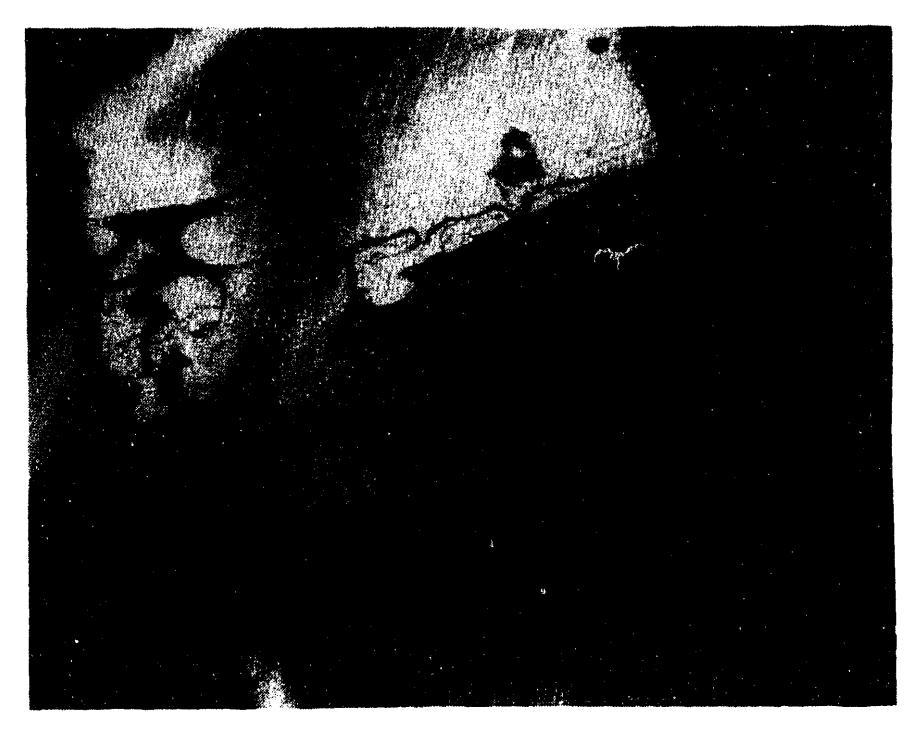
Figure B-8. Sample M-10-1B, showing melt/instrument string interaction.

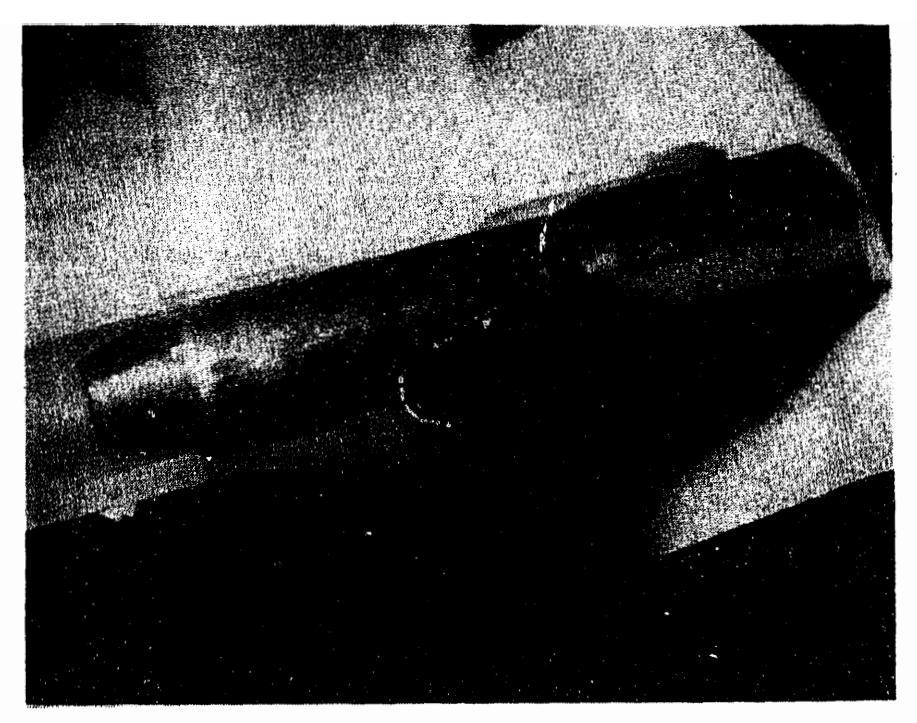
Figure B-12. Full-length (9-1/2 in.) view of the H-9 nozzle.

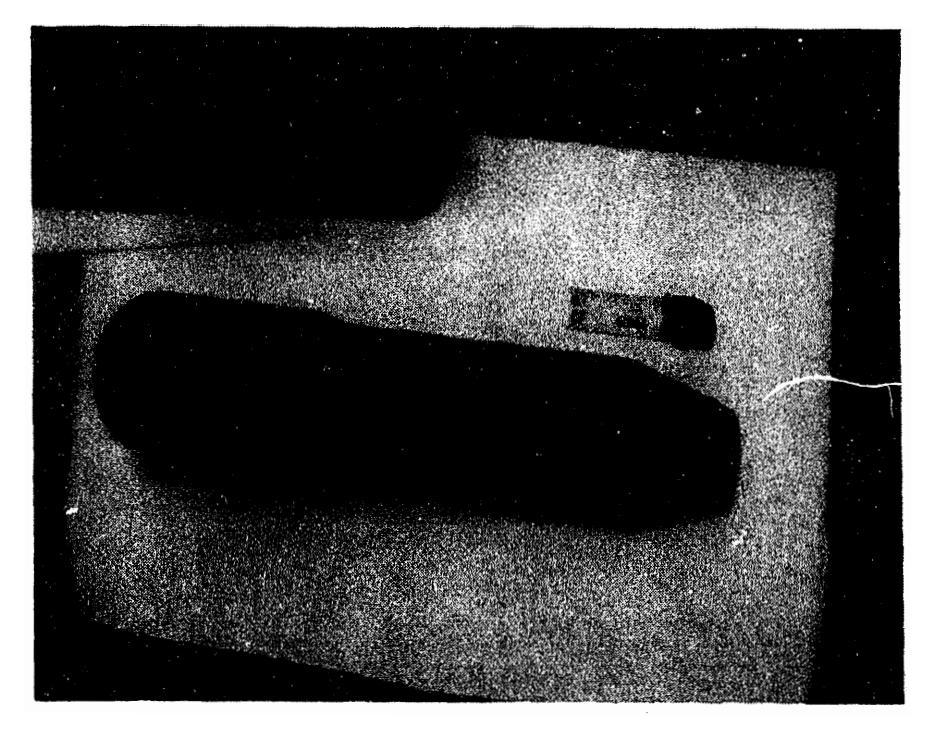
Figure B-13. A side (long) view of nozzle H-9, showing the instrument core string still intact.

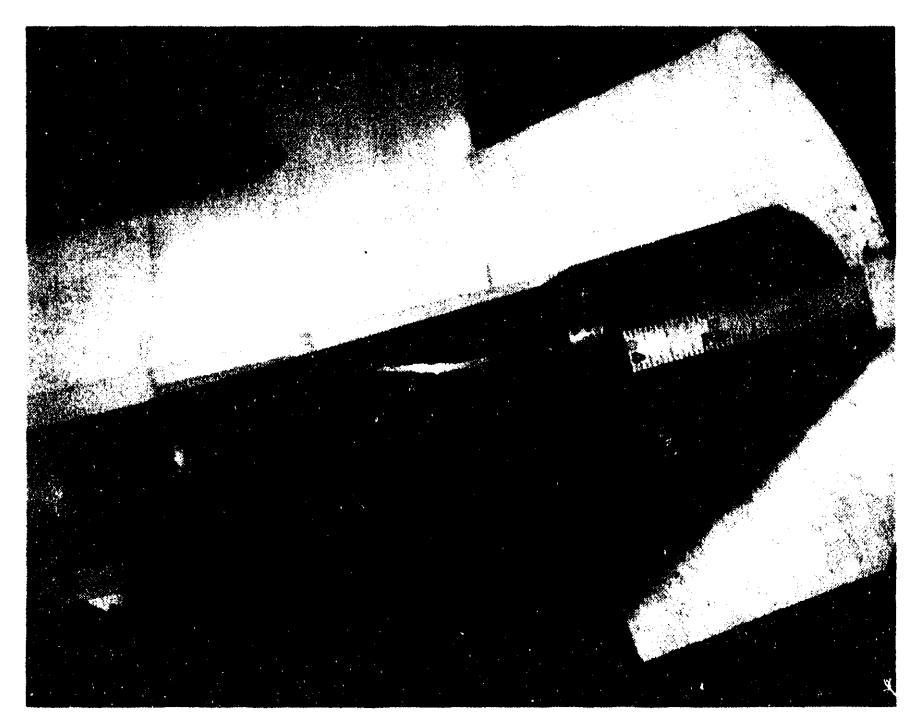
Figure B-25. Full-length (9-1/8 in.) view of the R-7 nozzle after melt bulb removal.

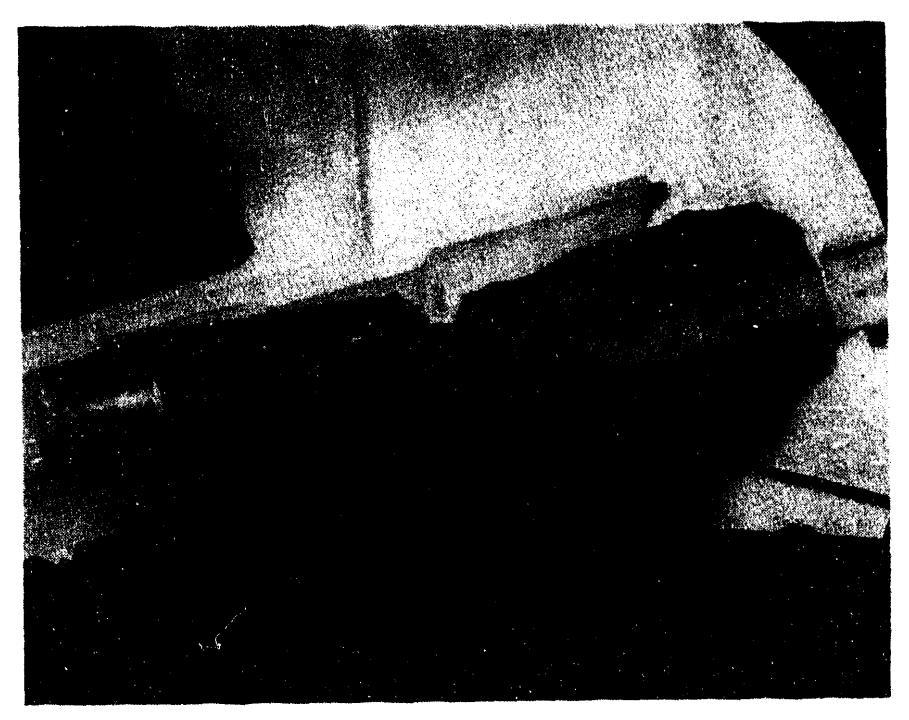
Figure B-31. K-11 nozzle with a 180-degree rotation.

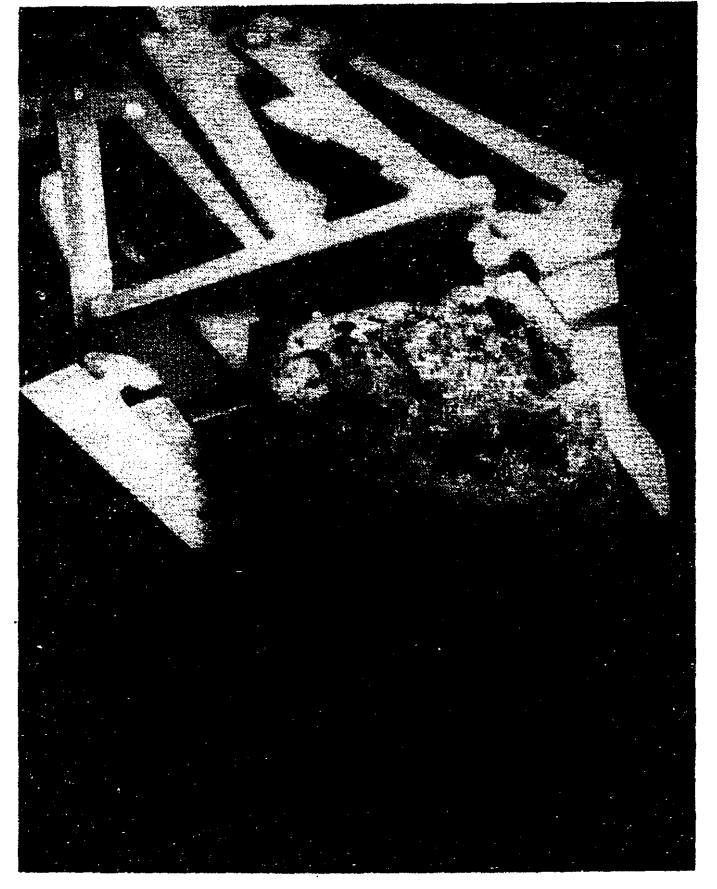
The G-5 nozzle (see Figure B-42) was approximately 4.4 cm (1.75 in.) long and was severely damaged. As shown in Figure B-43, melt was attached to the nozzle and its center was completely plugged with melt.

Figure B-42. Side view of the G-5 nozzle.

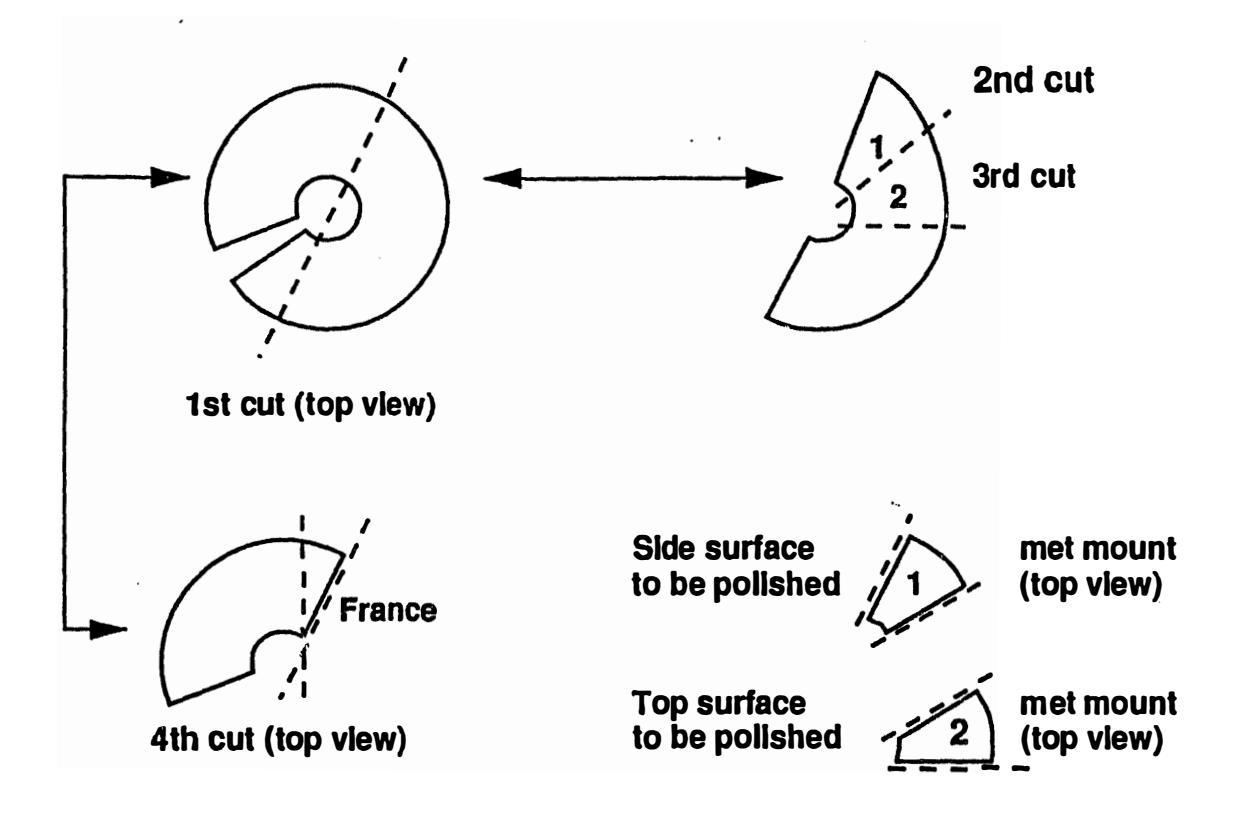
Gamma spectrometry was not performed on this nozzle because it was so short. After the sample was cut longitudinally, one of the halves split in two because of the crack that extended through the nozzle, leaving three sections. A pie-shaped segment was cut from the second largest of the three portions and shipped to CEA-CEN in France. The largest of the samples was cut twice longitudinally, creating sample E-7-1, which was mounted to show the longitudinal surface,

Figure B-46. Cutting diagram of the E-7 nozzle.

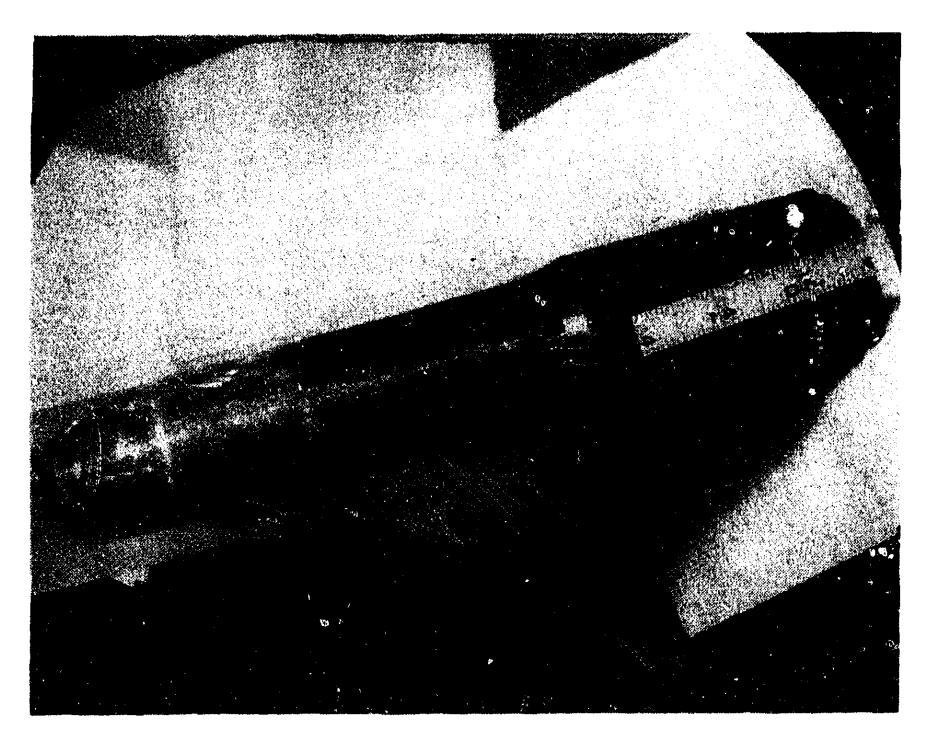
The K-12 nozzle sustained very little damage, as illustrated in Figures B-47 and B-48, (0- and 180-degree rotation, respectively). An identifying notch can be seen at the base of the nozzle in Figure B-47. The nozzle was 25.7 cm (10-1/8 in.) long with the instrument string and 24.4 cm (9-5/8 in.) long without the string.

Figure B-47. Full-length view (including instrument string, 10-1/8 in.) of nozzle K-12.

Figure B-48. Full-length view (excluding instrument string, 9-5/8 in.) of nozzle K-12.

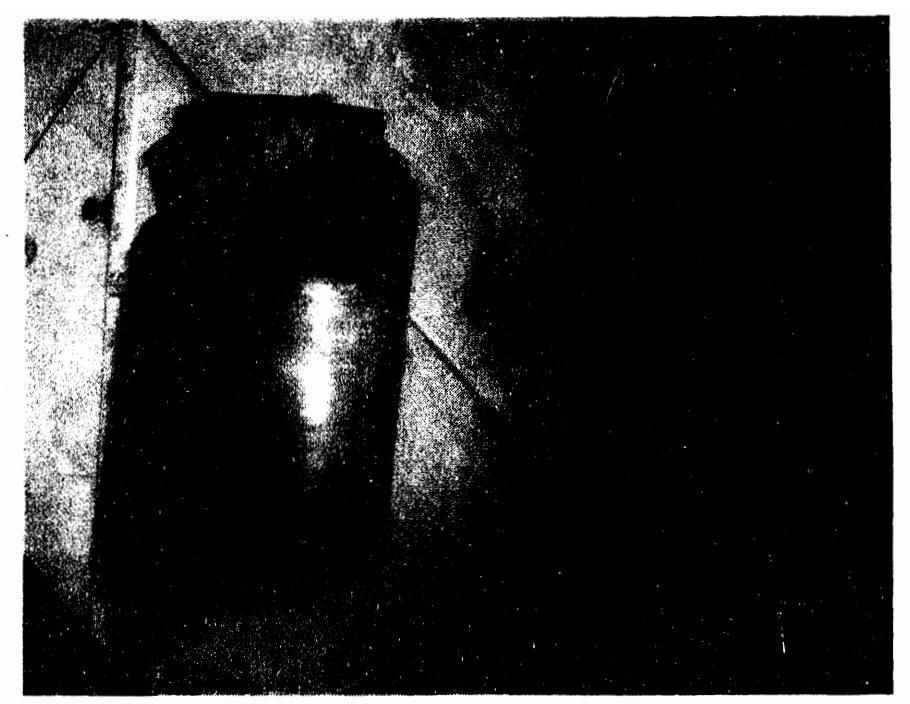
The K-5 guide tube, which was damaged by melt interaction, was found to be twisted and slightly misshapen (see Figure B-53). Its approximated diameter was determined to be 117 mm (4-5/8 in.). Length measurements around the guide tube varied from 23.9 cm (9.4 in.) to only 15 cm (5.9 in.).

Figure B-53. Full-length side view (~9-3/8 in.) of the K-5 guide tube.

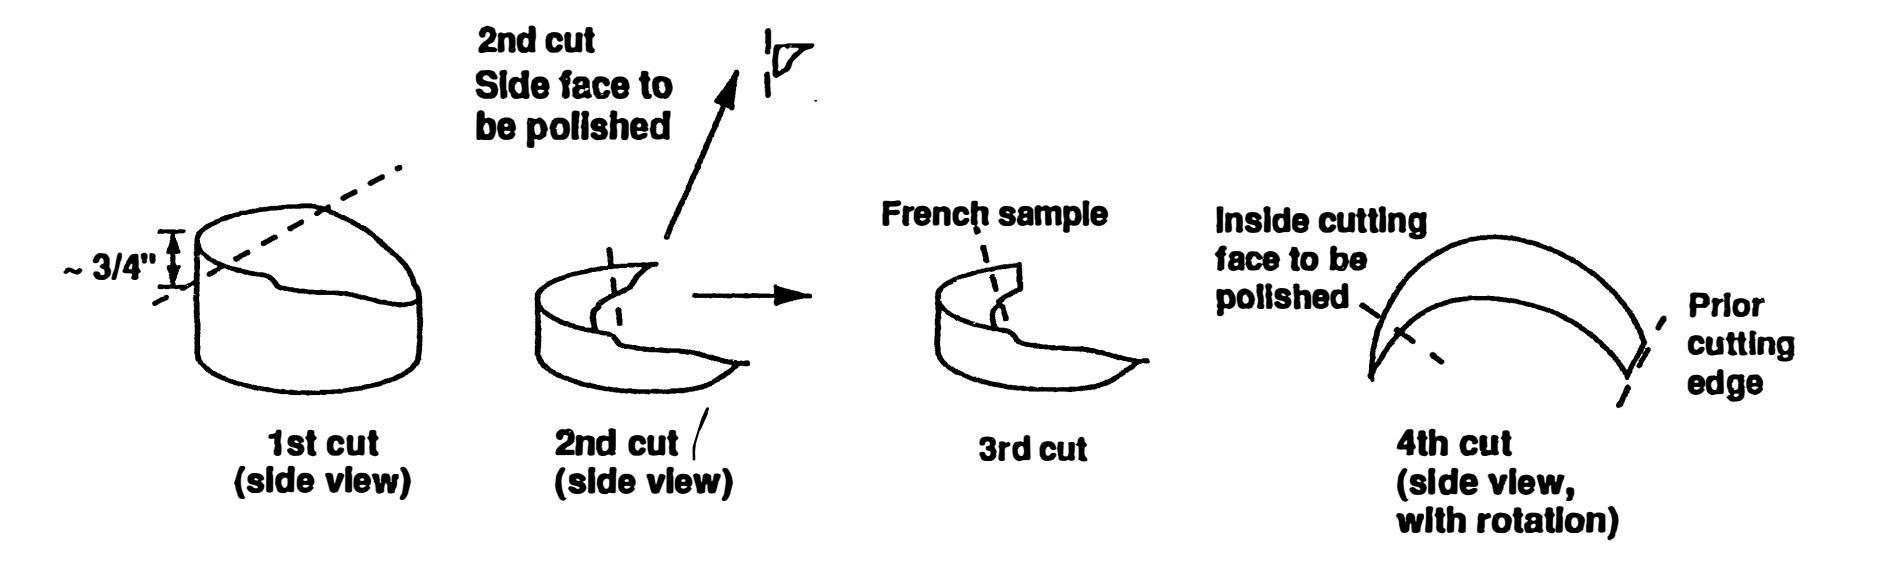
Figure B-54. Sectioning diagram of the K-5 guide tube.

The guide tube was sectioned as shown in Figure B-54. Several cutting blades were destroyed in the effort to perform the first transverse cut at approximately 1.9 cm (0.75 in.) from the bottom of the guide tube. MPR Associates reported this same difficulty during the removal of the guide tube samples from the reactor, stating that the damaged guide tube material was much harder than the as-fabricated stainless steel. A second cut was made longitudinally on one end of the primary section, creating sample K-5-1, which was polished longitudinally after it had been stabilized with sample supports. The same end was cut again longitudinally, and the resulting sample was shipped to France. A fourth cut was made on the opposite end of the primary section, again longitudinally, creating sample K-5-2. It was stabilized against another sample and polished transversely.

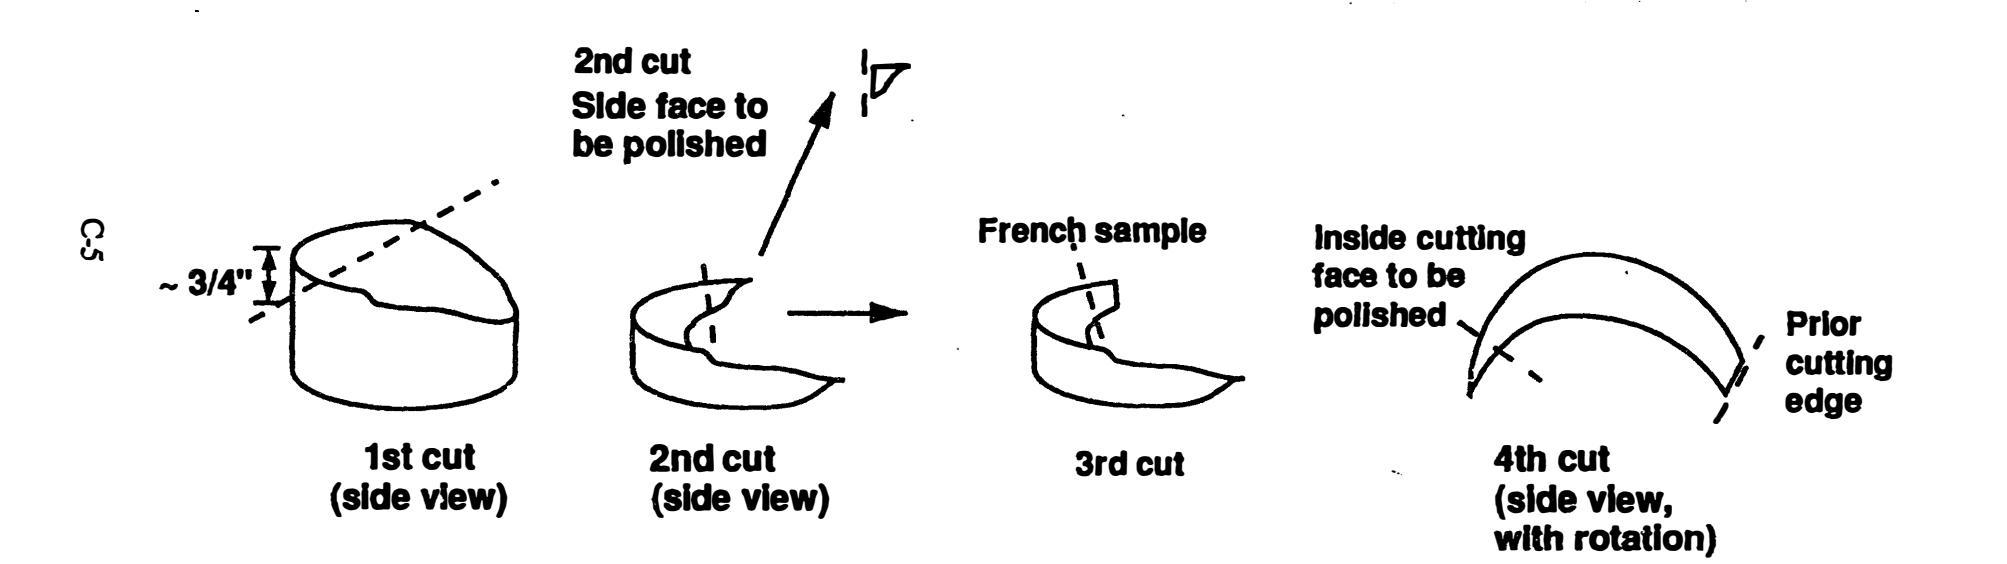
Figure C-1. Metallographic section of the K-5 guide tube.

The microstructural sample from the K-5 guide tube was obtained by the cutting sequence shown in Figure C-1. A second cut produced sample K-5-1, which was mounted and polished on the face exposed by the sectioning procedure (see Figure C-2). Sample K-5-1 was divided up into examination locations as shown in Figure C-3. Microstructural examinations were conducted at each of these locations or regions of interest (ROI) (91M209 through 91M214), as shown in Figures C-4 through C-9. These photomicrographs indicate that apparent molten fuel material interacted with the stainless steel of the guide tube and melted into its surface. In most cases, the clear separation between the stainless steel and the fuel material phases suggest that the mechanism for this interaction appears to be melting of the stainless steel with no apparent chemical interaction. However, Figure C-8 shows the presence of an apparent intermediate phase that may be the result of a dissolution of the stainless steel by the fuel debris. Further SEM/WDX analysis would be required to confirm the formation of this intermediate phase.

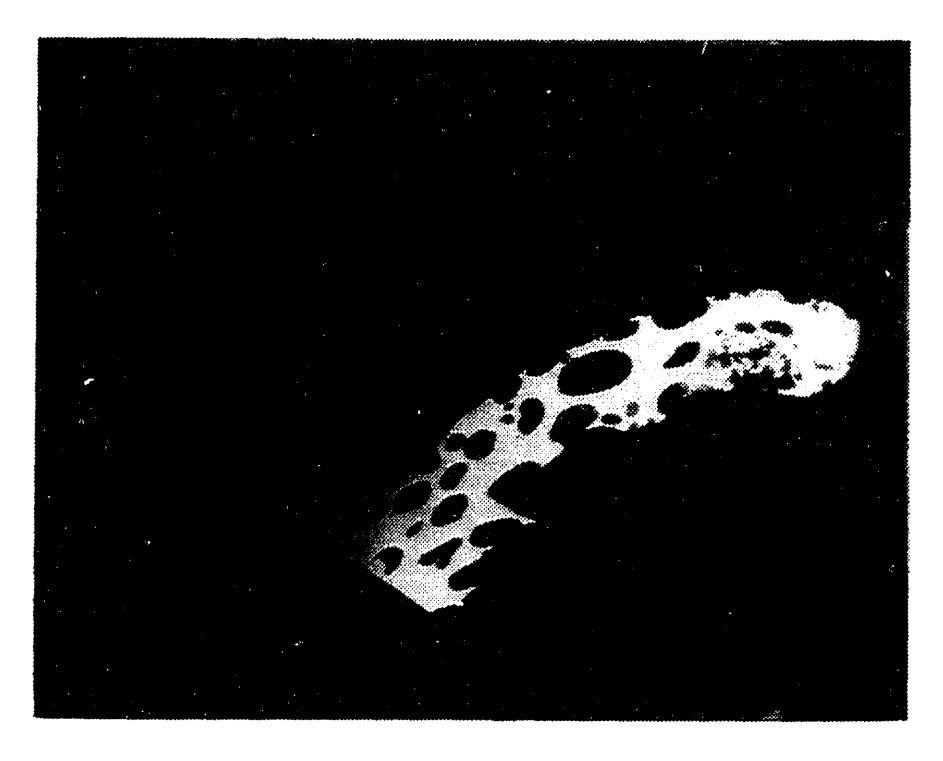
Figure C-2. Guide tube sample K-5-1 shown mounted and polished in the mount for metallography.

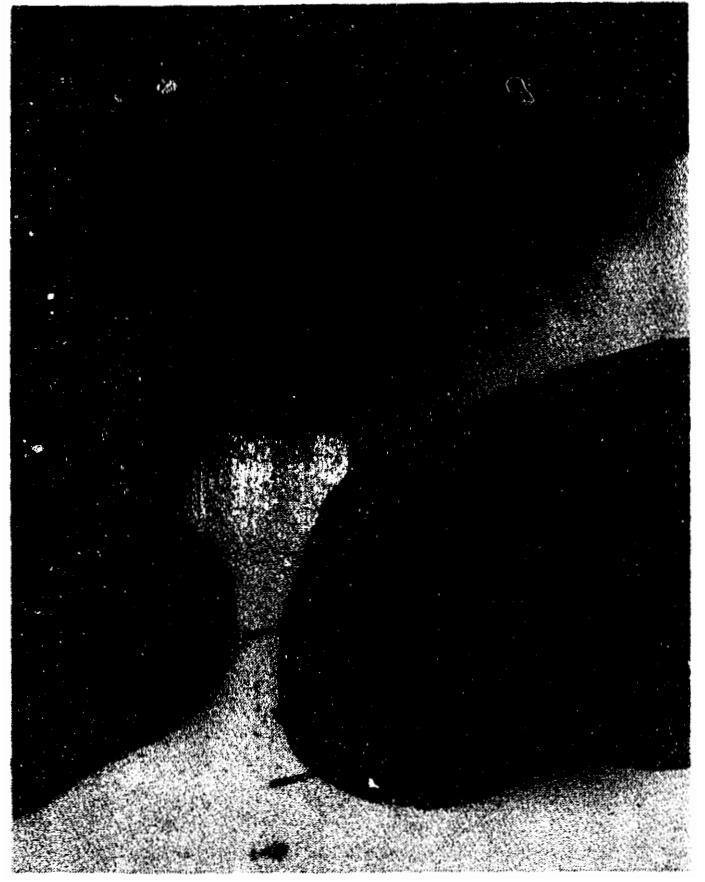
Figure C-7. ROI 91M212, showing porous K-5 material with attached melt.

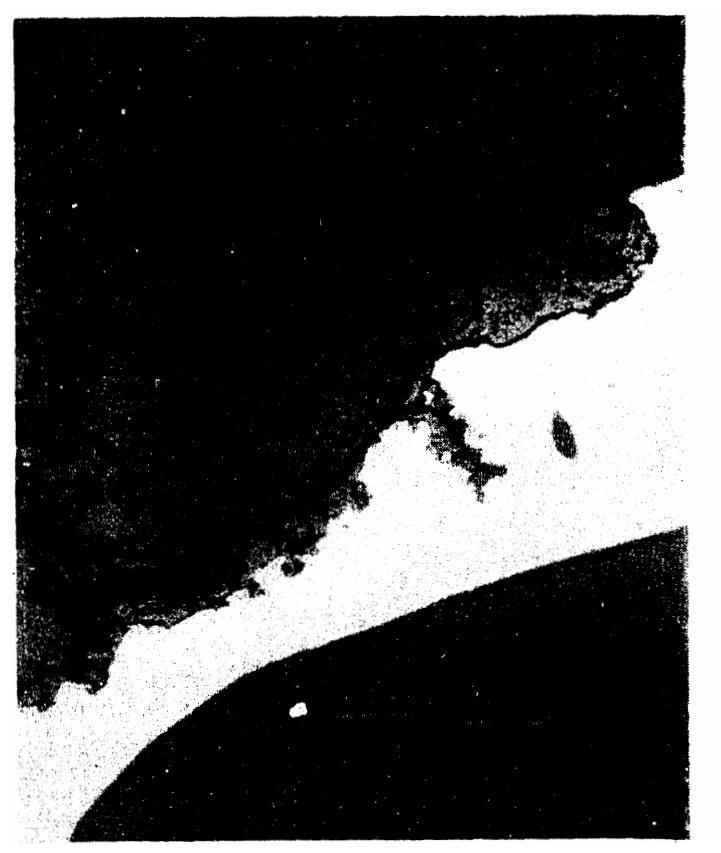
Figure C-8. ROI 91M213, displaying higher magnification view of fuel grains.

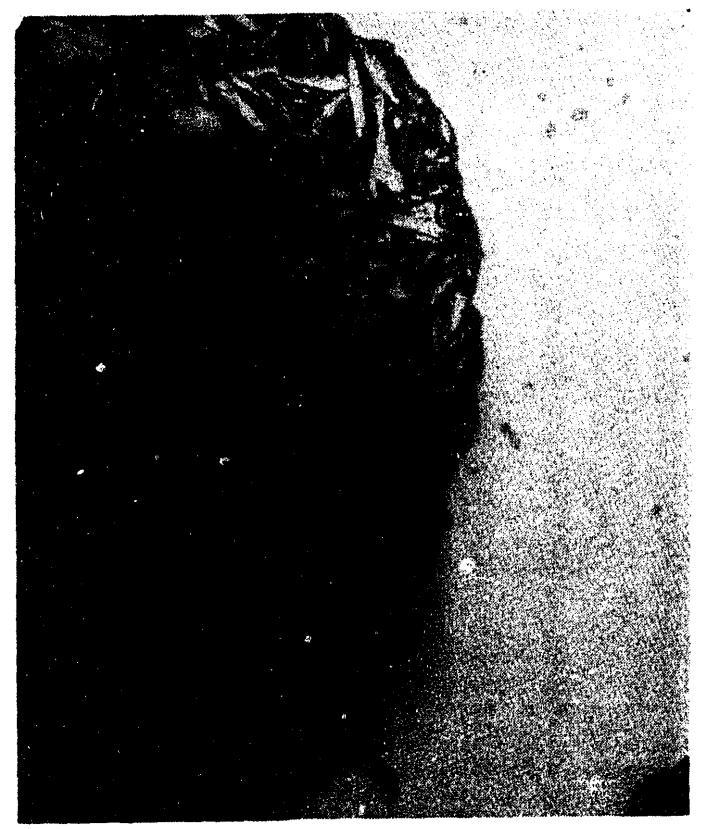
Figure C-24. ROI 91M217, showing debris inside hole (200x).

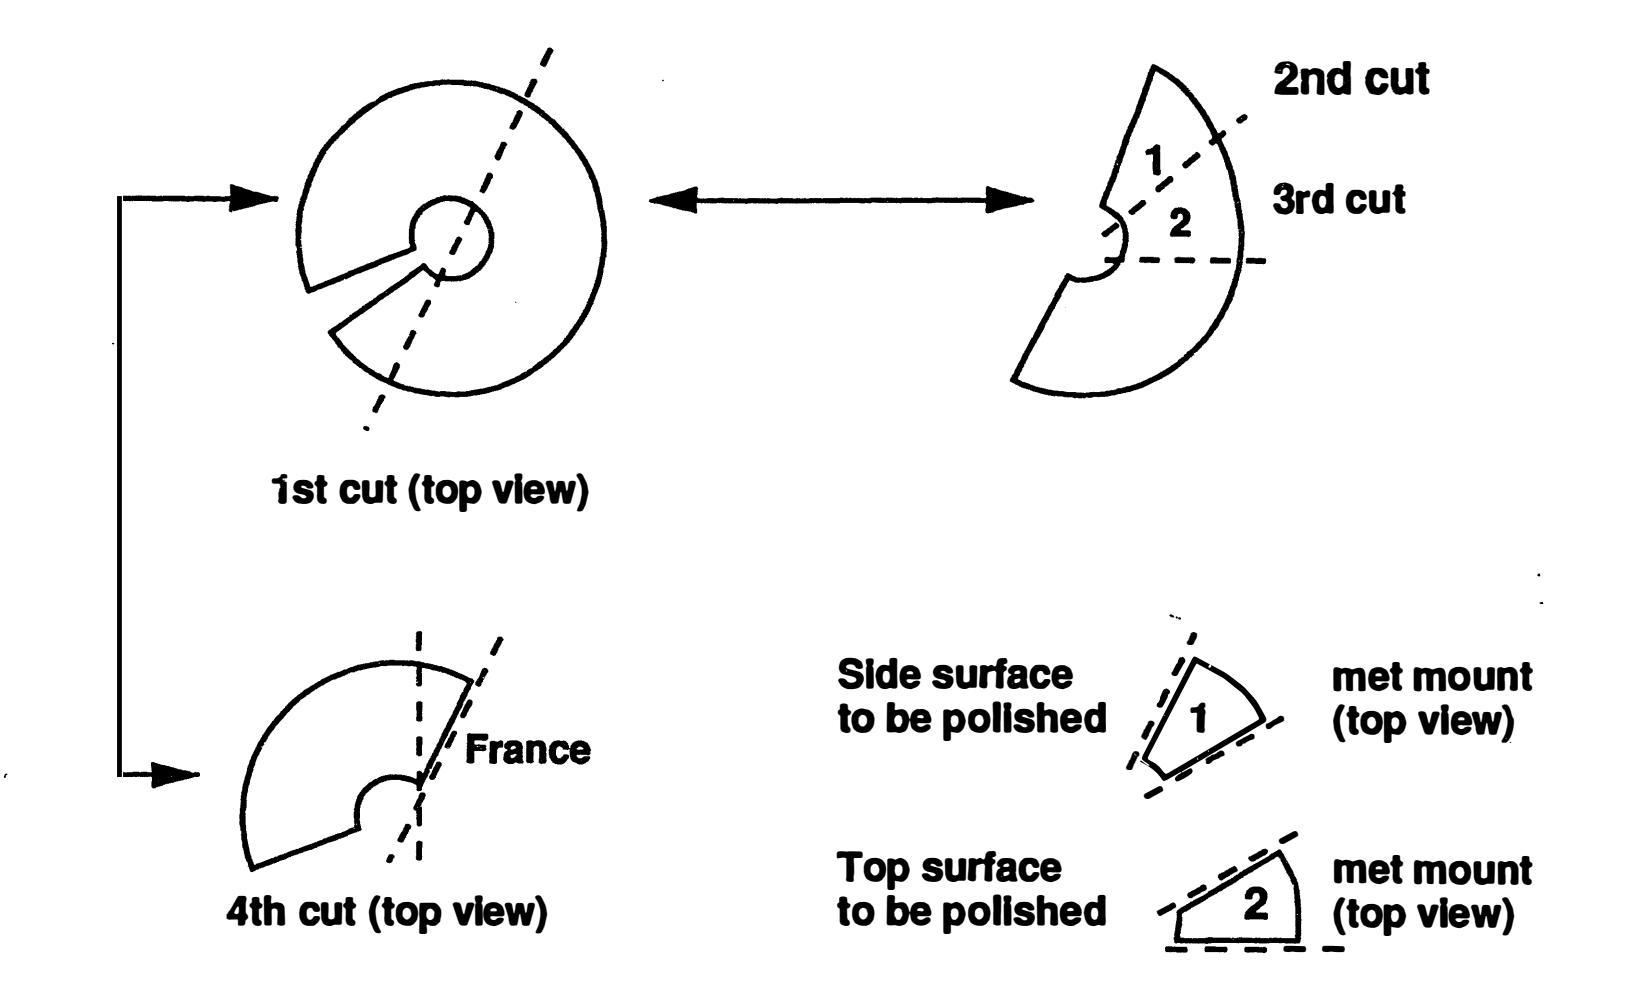
As shown in Figure B-45, approximately 5.1 cm (2 in.) of the E-7 nozzle was all that remained on the lower head after the shearing that occurred during the accident. The sample section removed was only 0.5 to 0.6 in. (1.3 to 16 cm) long. A crack extending entirely through one side of the nozzle was also observed.

Figure C-28. Sectioning procedure for the E-7 nozzle.

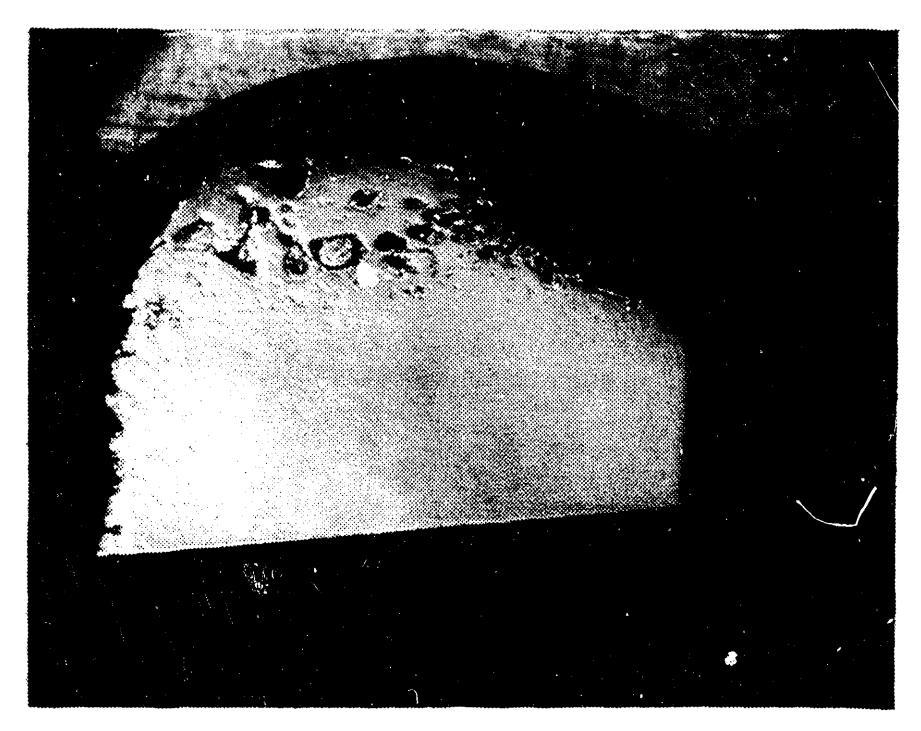
Figure C-29. Metallographic sample E-7-1, showing the side face.

Figure D-18 shows a BSE compositional image of a pore in sample E-7, as shown in Figures C-29 and C-30 in Appendix C. The BSE image indicates the presence of high Z material at the interface of the pore. Figures D-19 through D-20 show expanded views of the high Z material. Figure D-22 shows a Fe dot map, which indicates that these particles are Fe that has penetrated into the surface of E-7. In addition, Figure D-23 shows the presence of some Cd. The presence of Cd suggests that this material did not reach high temperatures or the highly volatile Cd would have been released from the melt. The dot map shown in Figure D-24 indicates that, in addition to the standard constituents of inconel, Zr was also present and had penetrated into the surface of sample E-7. Figure D-25 is a Cr dot map of sample E-7.

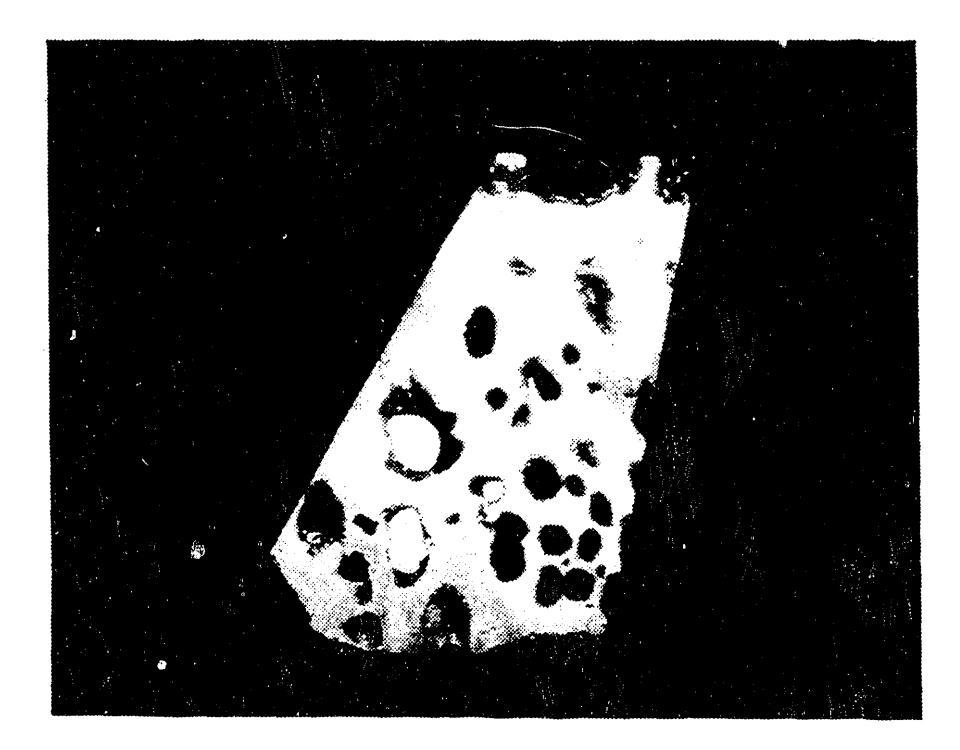
Figure C-30. Metallographic sample E-7-2, featuring the top surface.

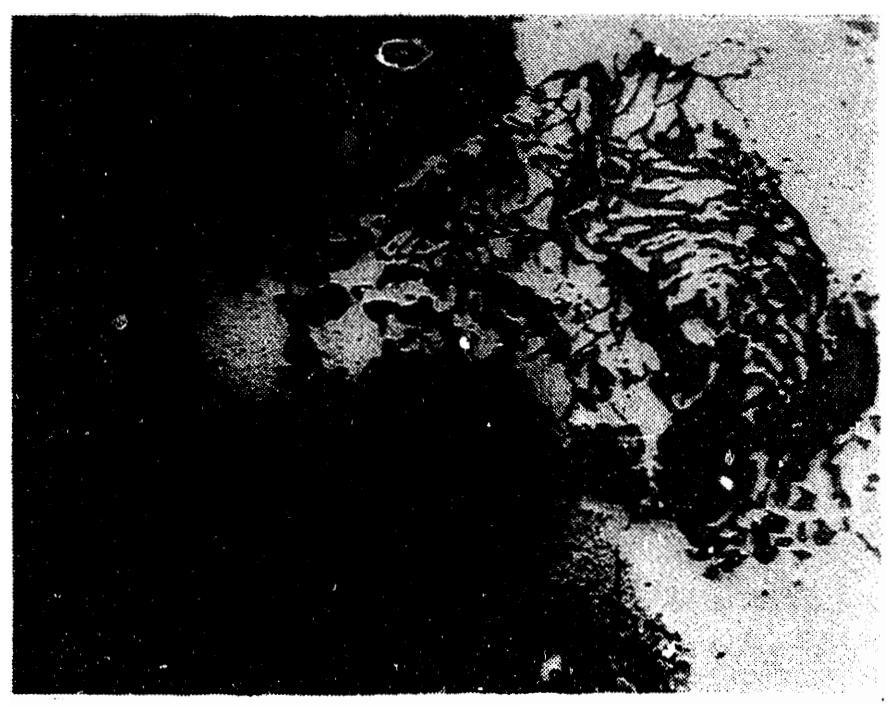
Figure C-35. ROI 91M182, showing indication of fluid melt interaction.

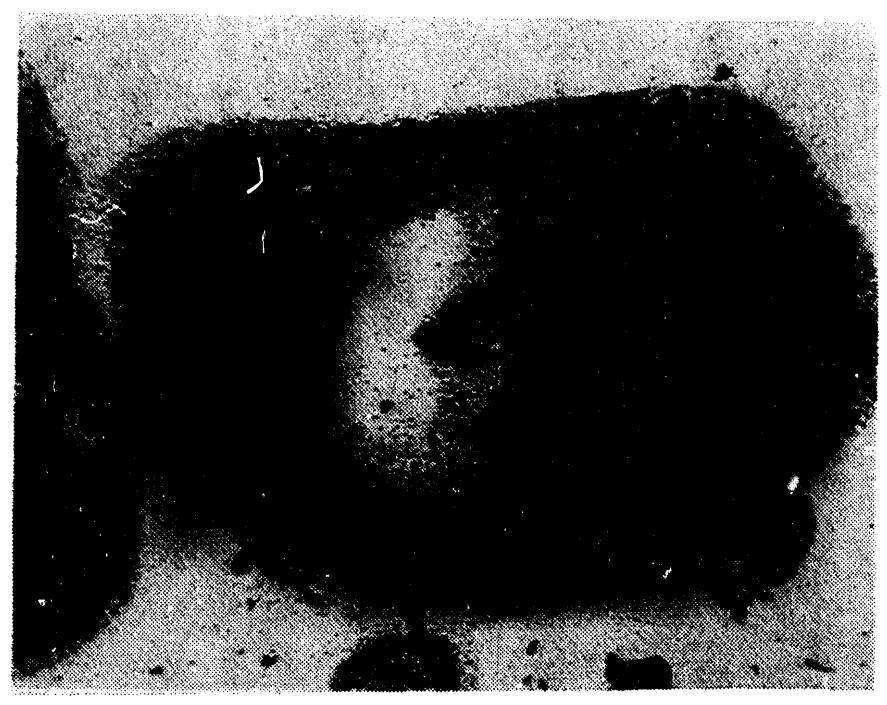
Figure C-37. ROI 91M183, showing macro view of spheroid material in hole.

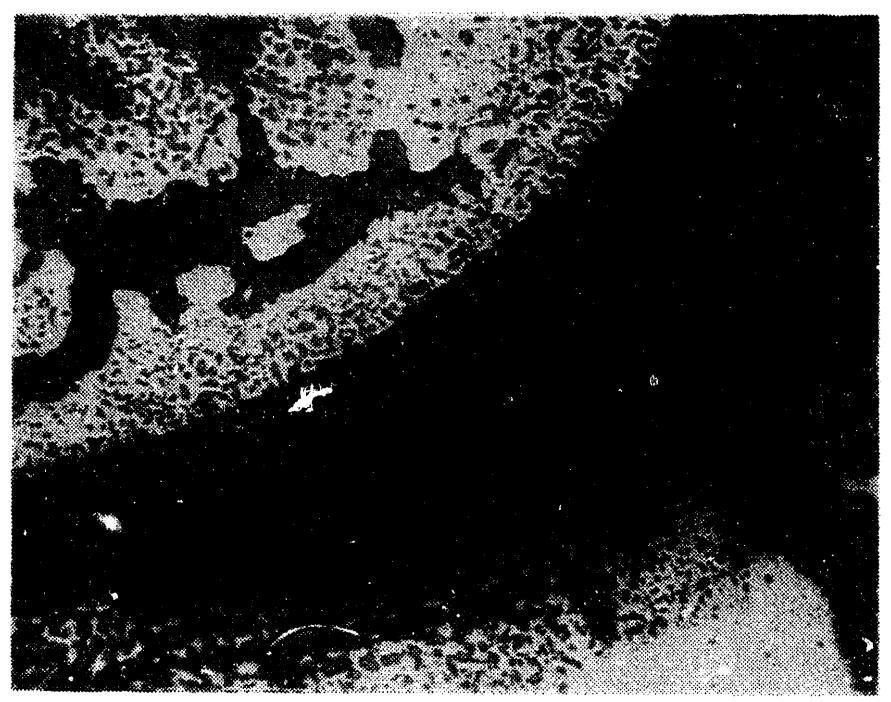
Figure C-38. ROI 91M184, showing higher magnification (200x) of hole.

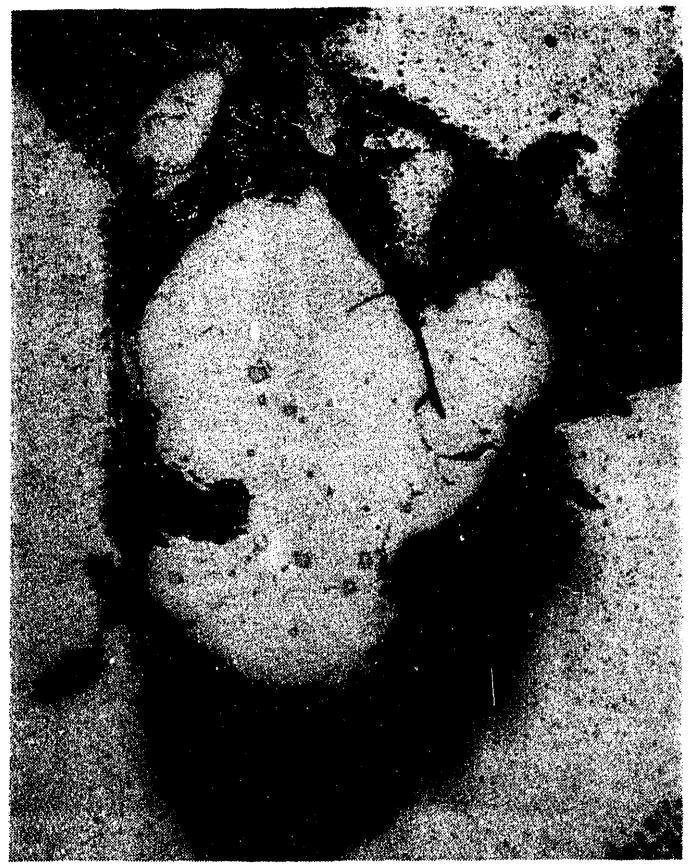
Figure C-42. ROI 91M189, showing pore material at 50x.

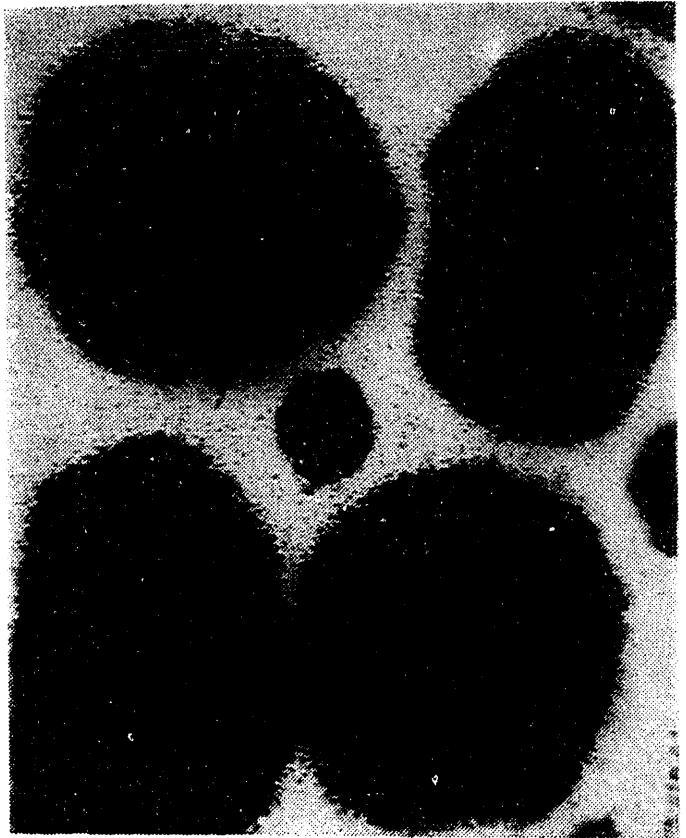
Figure C-45. ROI 91M192, displaying macro view of typical sample porosity.

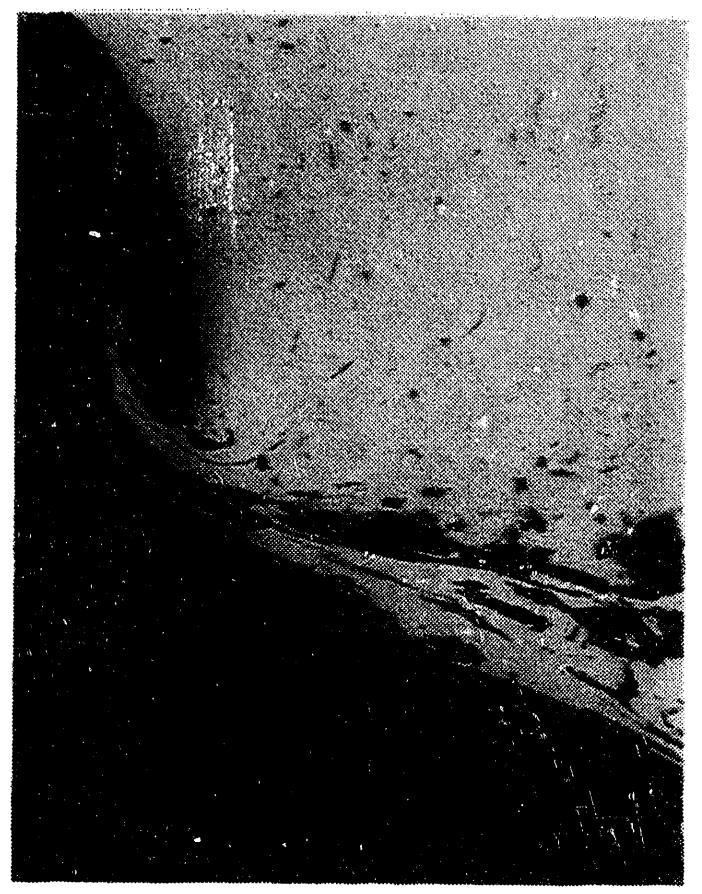
Figure C-46. ROI 91M193 at 200x, showing distinctive interface.

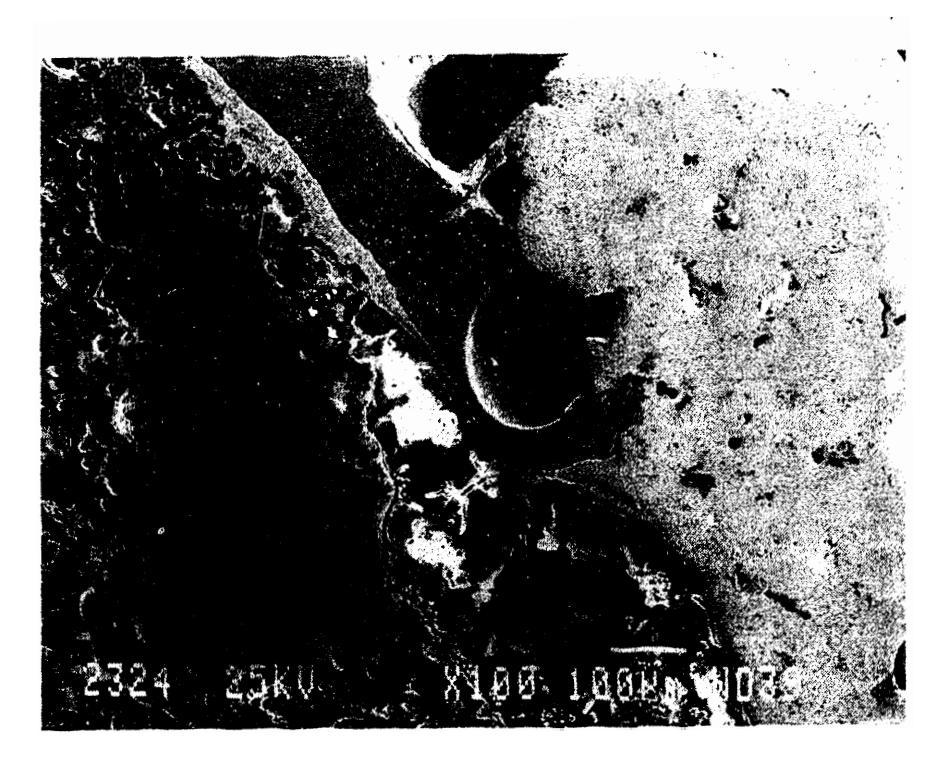
Figure D-3. R-7 Uranium and structural material interface (100x).

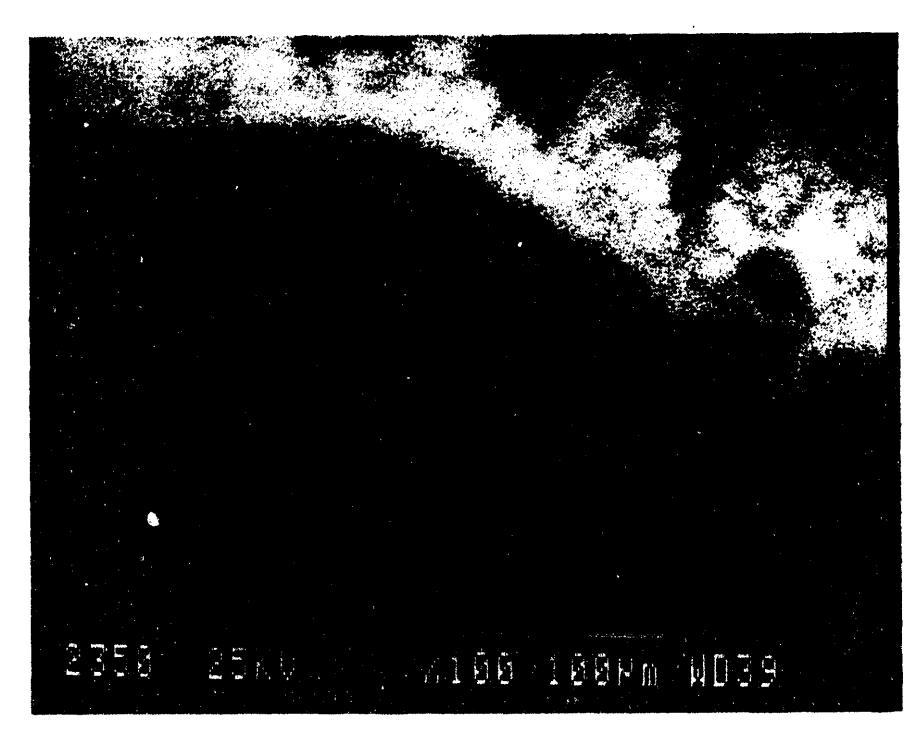
Figure D-13. R-7 instrument string dot map of Fe.
