NUREG/CR-6198 TMI V(94)EG01 EGG-2735

TMI-2 Nozzle Examinations Performed at the Idaho National Engineering Laboratory

Prepared by D. W. Akers, B. K. Schuetz

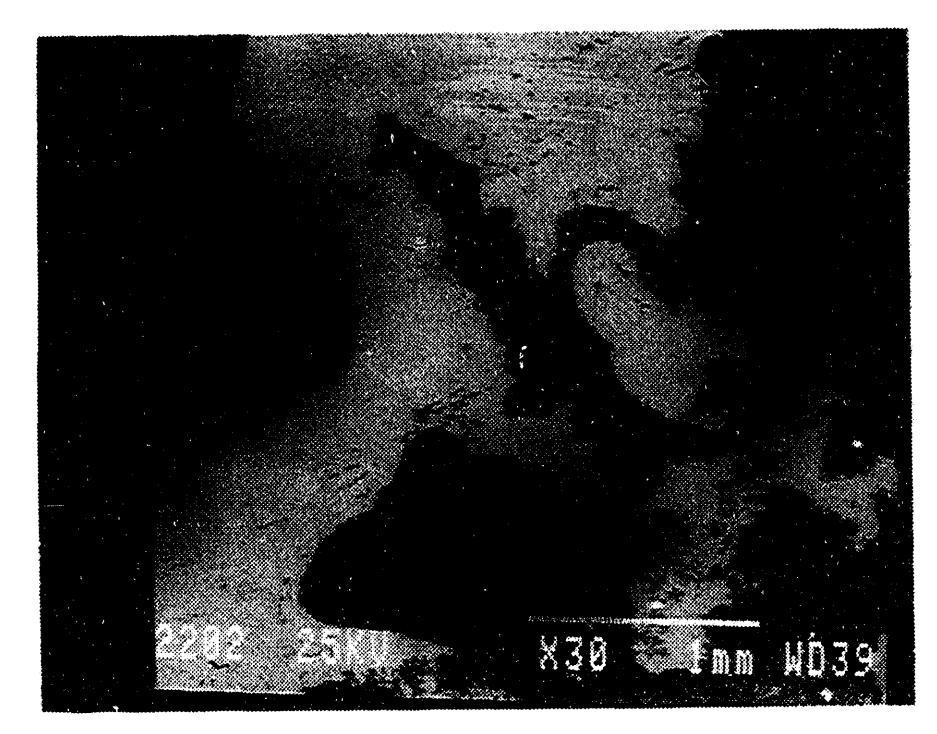
Figure D-17. R-7 instrument string dot map of Zr.

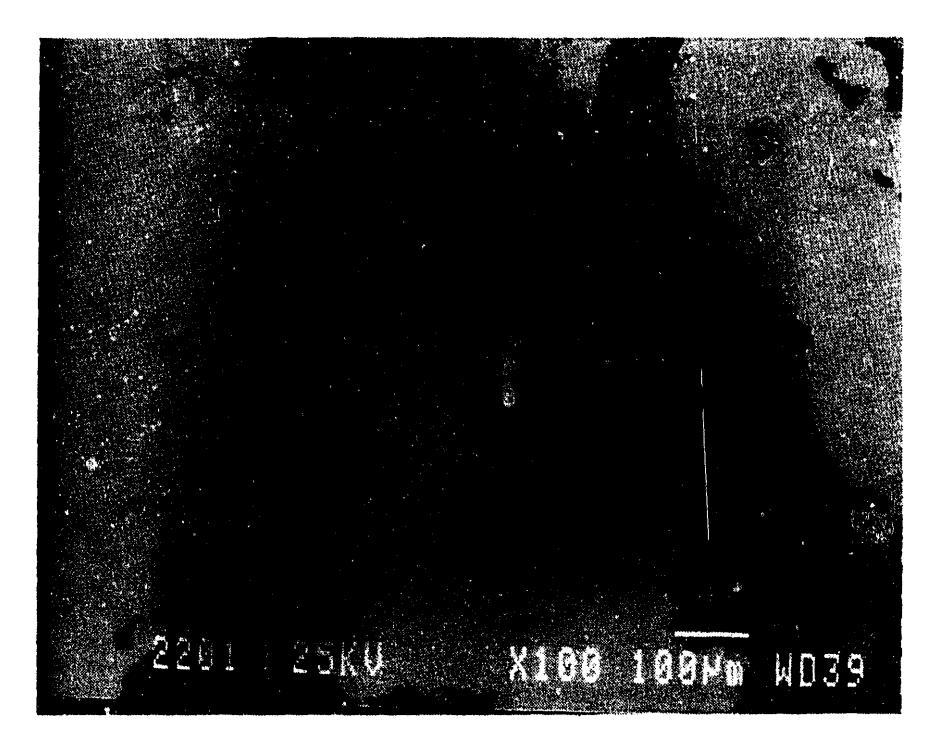
Figure D-18. E-7 cross section compositional (30x).

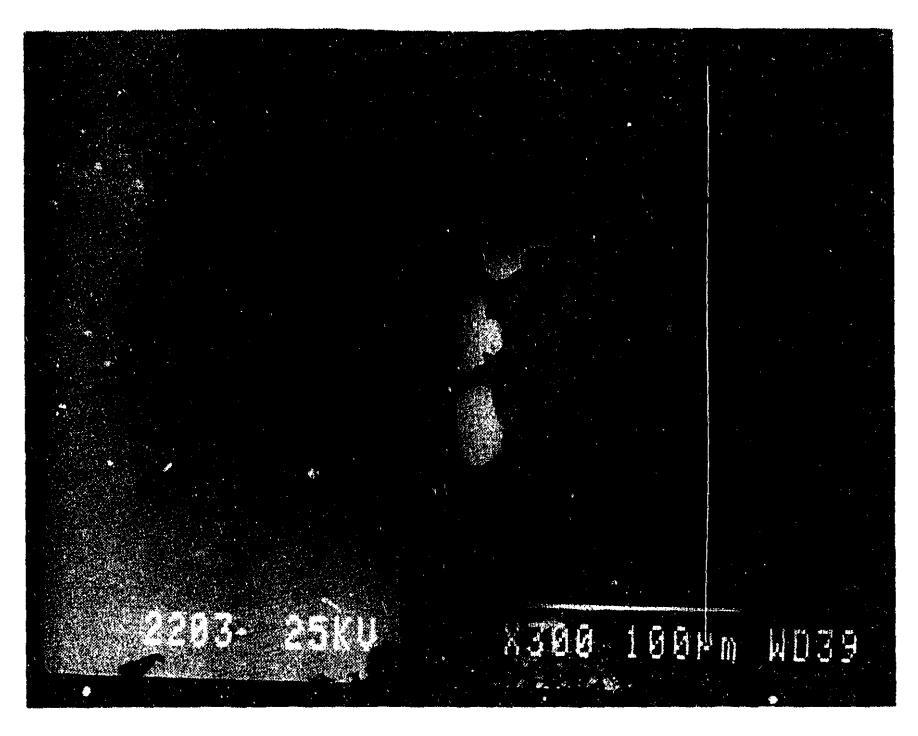
Figure D-19. E-7 cross section compositional (100x).

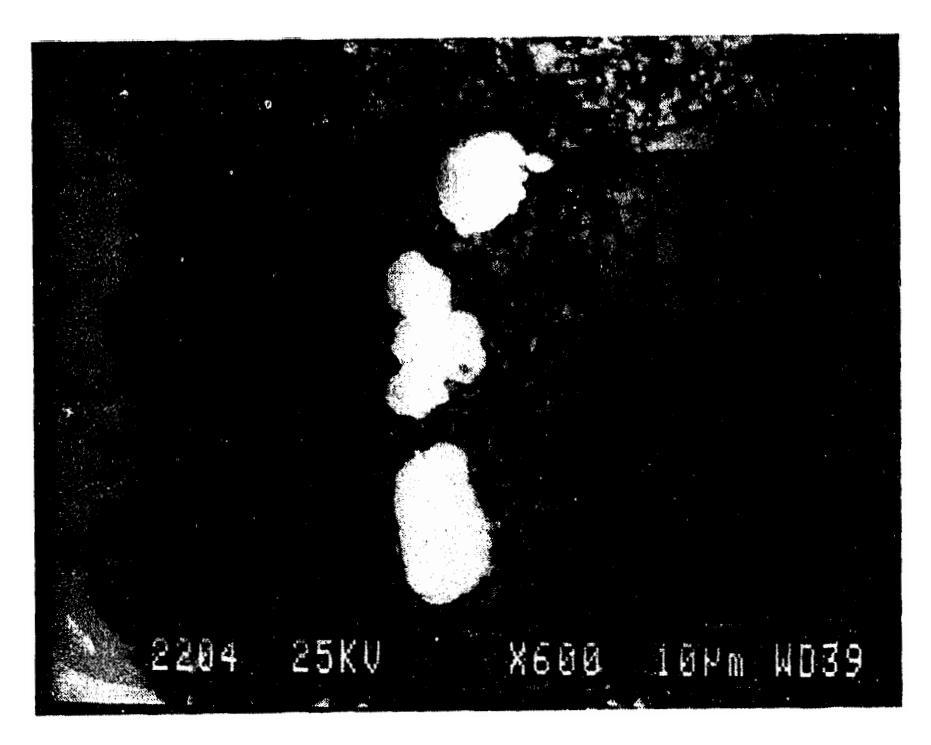
Figure D-20. E-7 cross section compositional (300x).

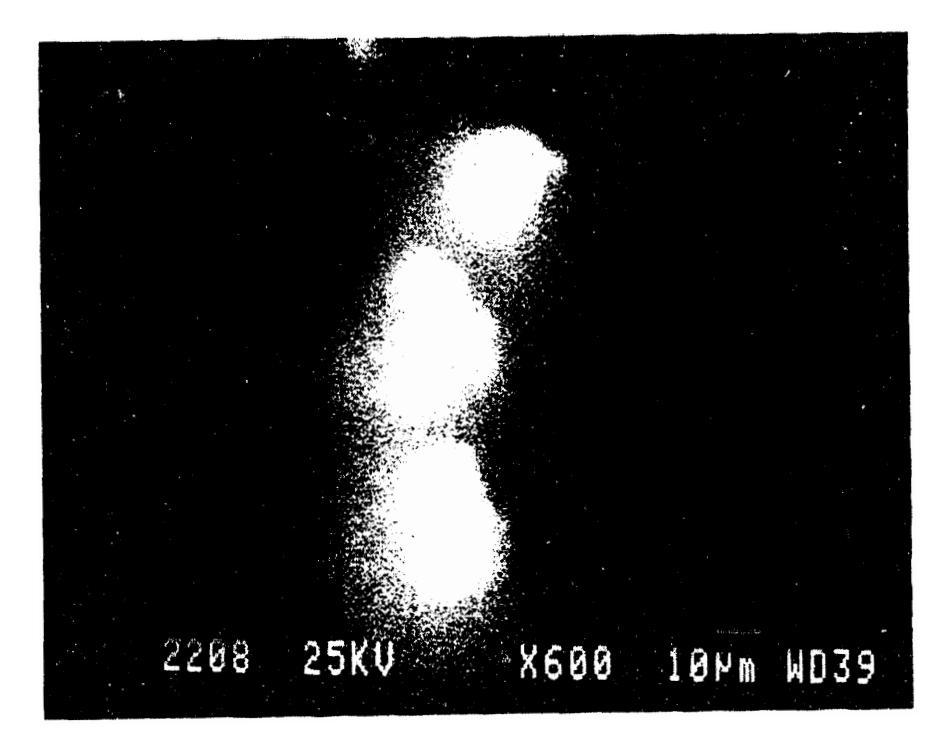
Figure D-21. E-7 cross section compositional (600x).
